HAYES CANAL WALL SURVEY

NESTLE FACTORY, HAYES

Client:	CAPITA
Author:	Mark Taylor
Reference:	14/179 Rev 1
Issue Date:	17/11/2014

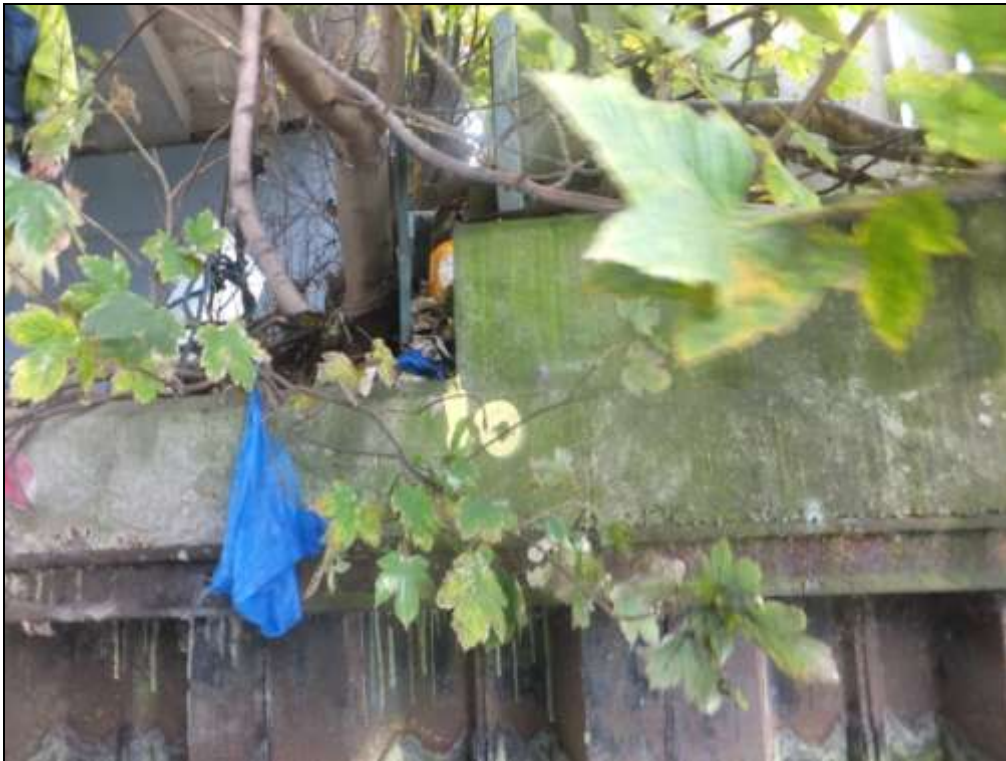
Photograph 1: Ch 0m – Location picture of chainage 0m.

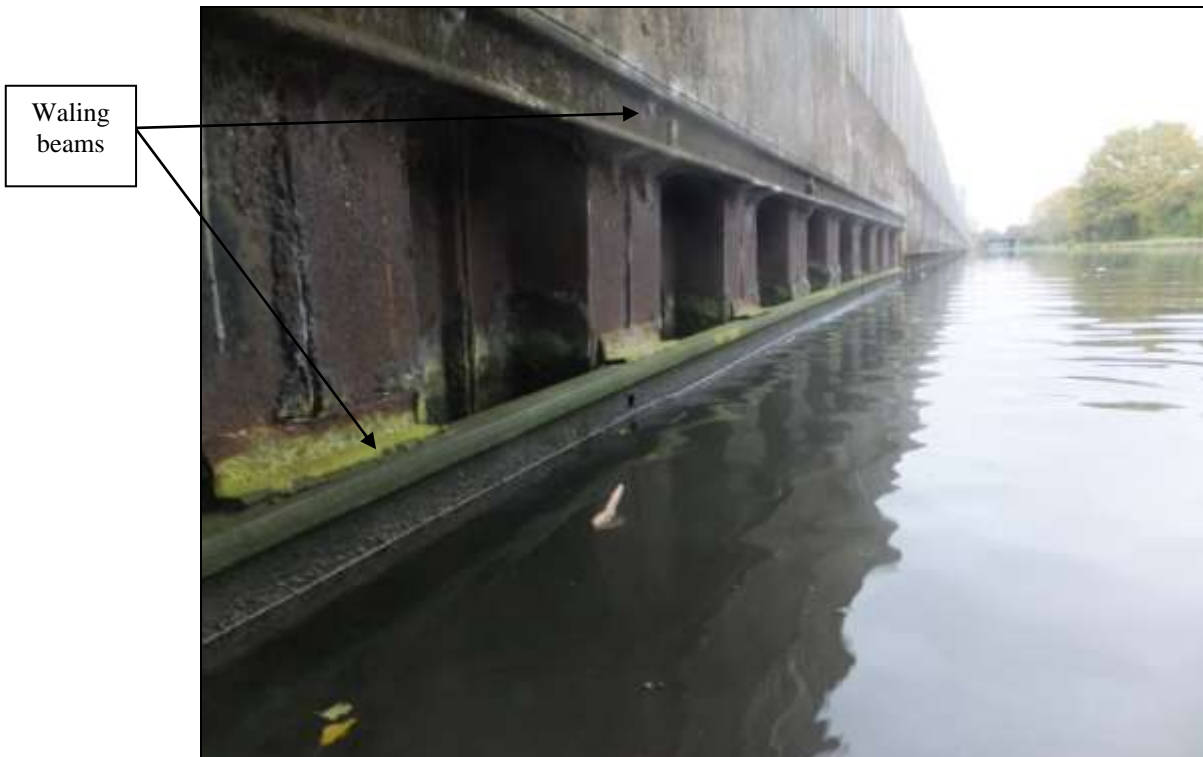
4.2 Ch 0m – 9m – The initial 9m of the retaining wall structure is formed of Frodingham “Z” type piles with 2# external waling beams with a concrete capping beam above. There is 1# waling beam at the waterline and 1# directly below the capping beam. The waterline waling beam appeared to be welded to the wall with “L” shaped brackets and the upper beam bolted through.

Photograph 2: Ch 0m – 9m – Initial 9m of the unknown sheet pile.

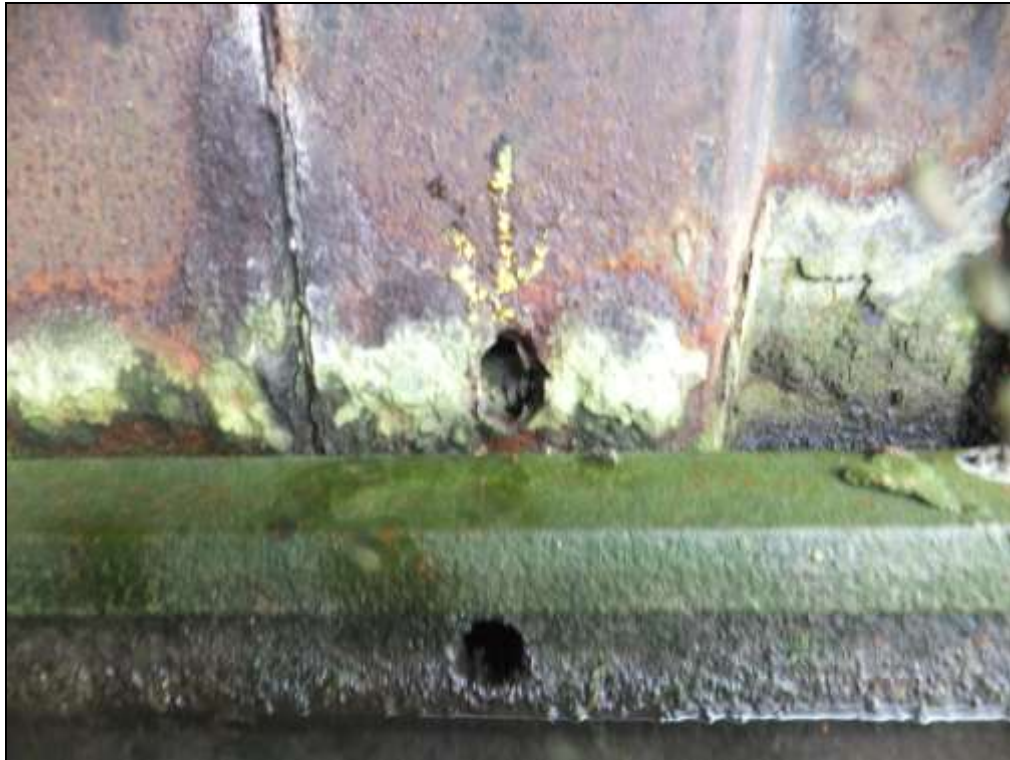
- 4.3 Ch 1m – There is a 30mm Ø hole in the sheet pile wall directly above the waterline waling beam. Note – the hole is adjacent to the waling beam fixing point.

Photograph 3: Ch 1m – Hole in sheet pile wall.

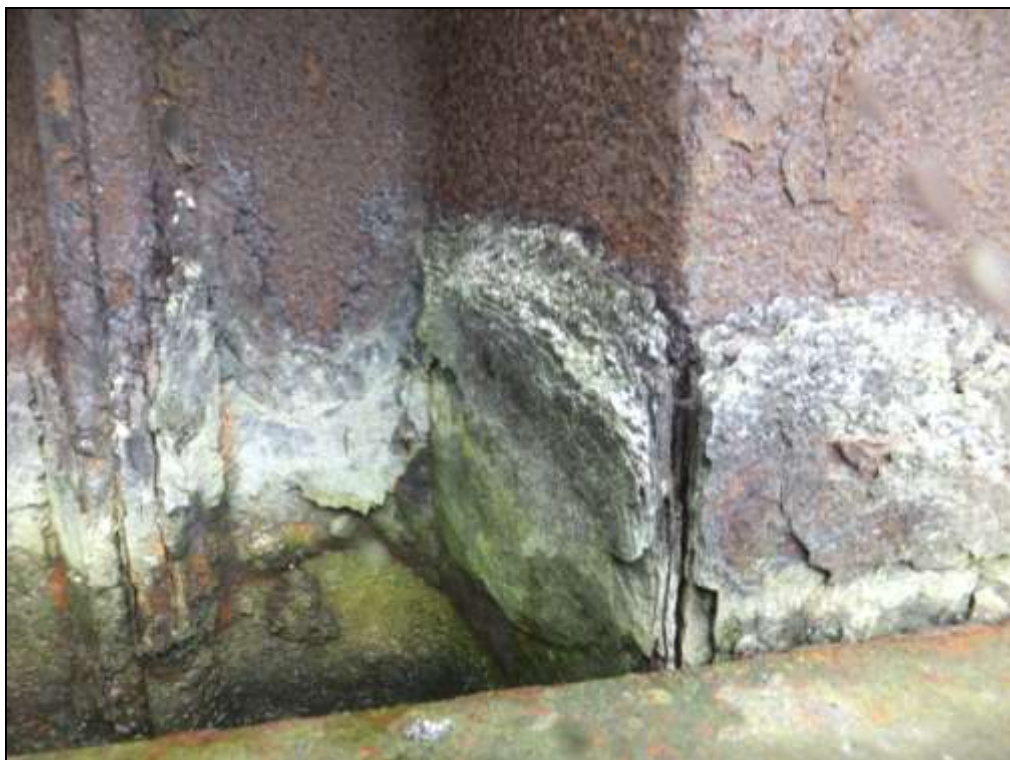
- 4.4 0m – 9m – The piles in the initial 9m section of the structure exhibit de-lamination of the steel in the splash zone to a varying thickness of between 5mm to 30mm. Refer to Appendix A for confirmation of pile thickness readings in this area.

Photograph 4: Ch 0m – 9m – De-lamination of the steel in the splash zone.

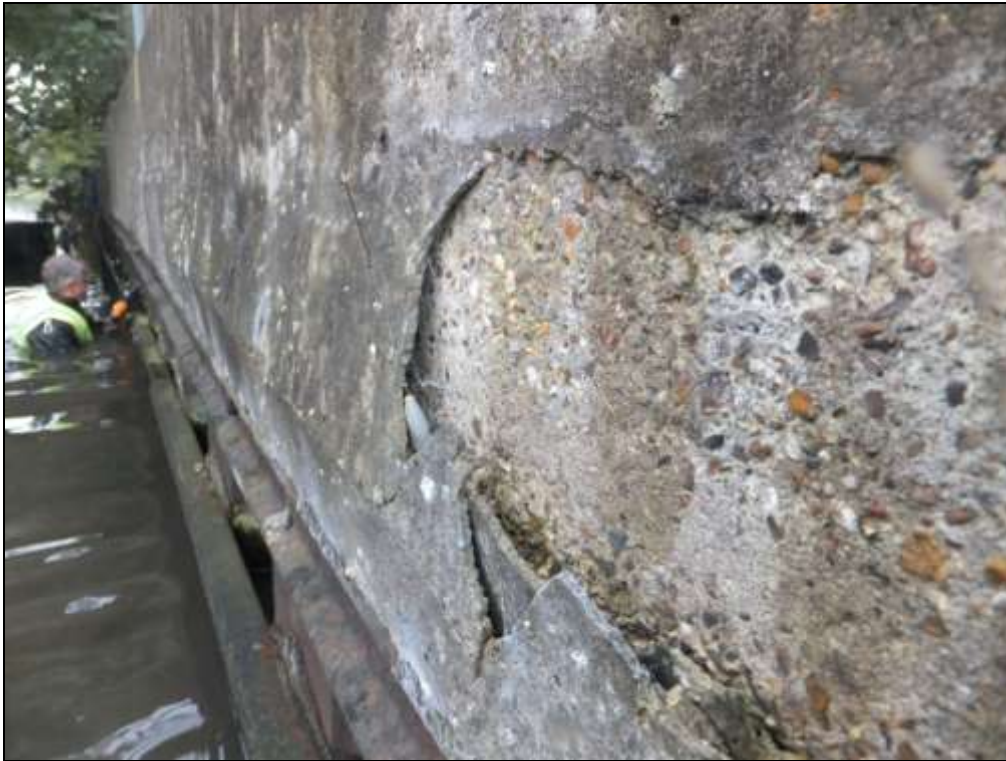
- 4.5 Ch 5m – 9m – There appears to be a render layer covering the cast concrete capping beam which has de-laminated and is failing in this location.

Photograph 5: Ch 16.5 – De-lamination of the render layer.

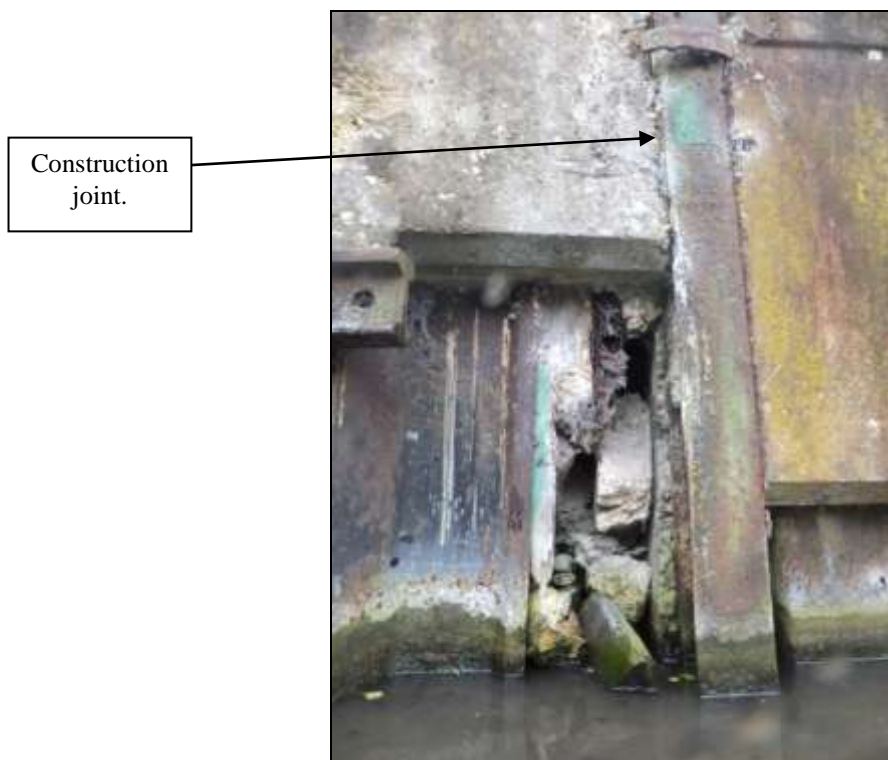
- 4.6 Ch 9m – At the interface between the differing sections of sheet pile wall there is void extending from bed level to below the capping beam which is approximately 300mm wide. The void is back filled with loose rubble. The construction joint in the capping beam structure above extends to a defect on the back face of the capping beam. See item 4.7 below for defect details.

Photograph 6: Ch32 – Void back filled with loose rubble.

Subject to the scope of redevelopment and intended usage we suggest that the minor repairs are carried out from chainage 0m to 234m including a panel repair and grout infill at chainage 9m to prolong the expectancy of the sheet pile wall.

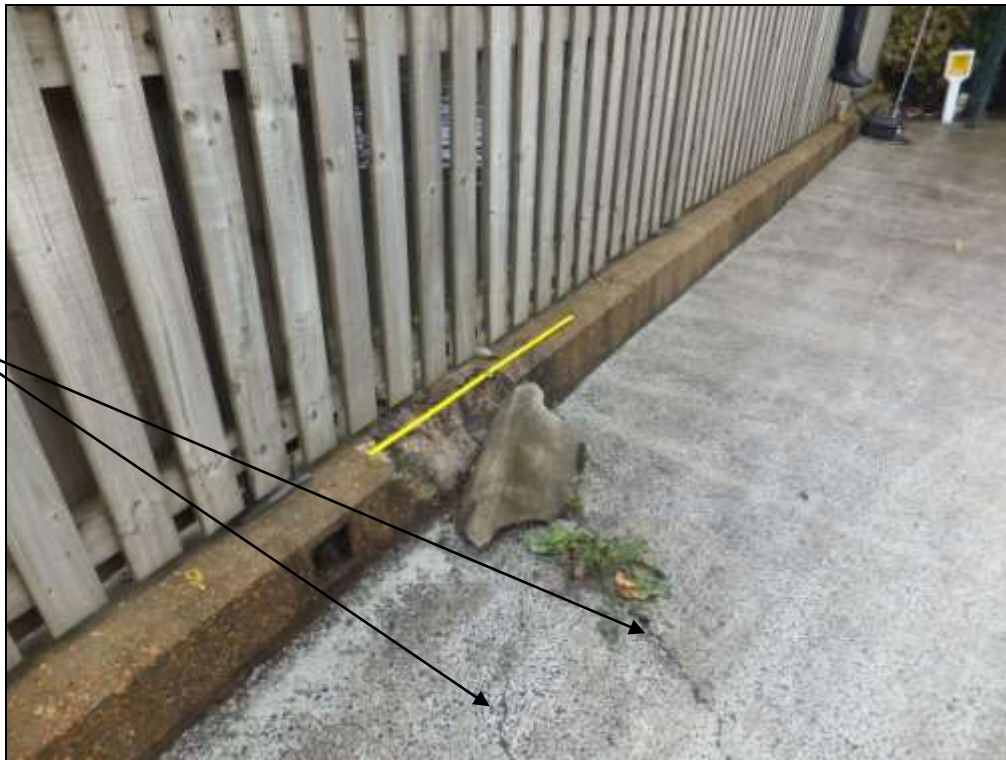
- 4.7 Ch 9m – As above – The construction joint between the 2# structures appears to have suffered movement causing the back face of the capping beam to crack and spall away. The defect has been previously repaired, this repair has failed. There are cracks a number of cracks migrating away from the defect on the hard stand.

Hairline cracks on hardstand.

Photograph 7: Ch 40m – Vertical crack running full height of wall.

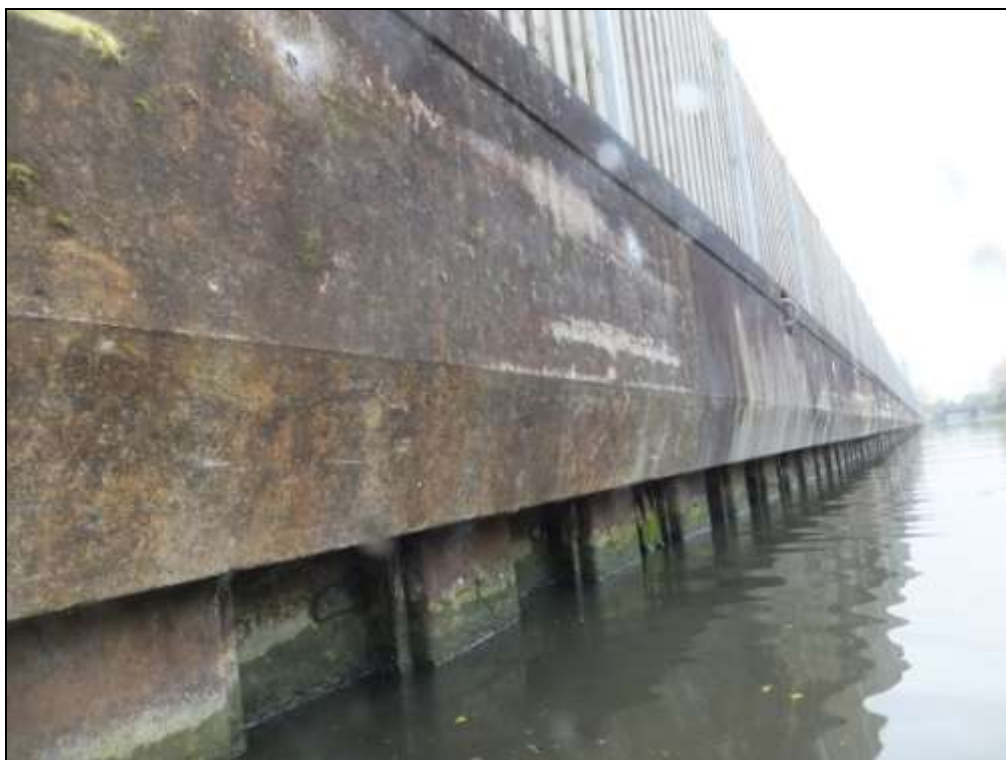
- 4.8 Ch 9m – 234m – The retaining wall between the stated chainage is constructed from Larssen “U” type steel sheet pile with a cast reinforced concrete capping beam above.

Photograph 8: Ch 9m – View of the canal retaining wall looking West along the structure.

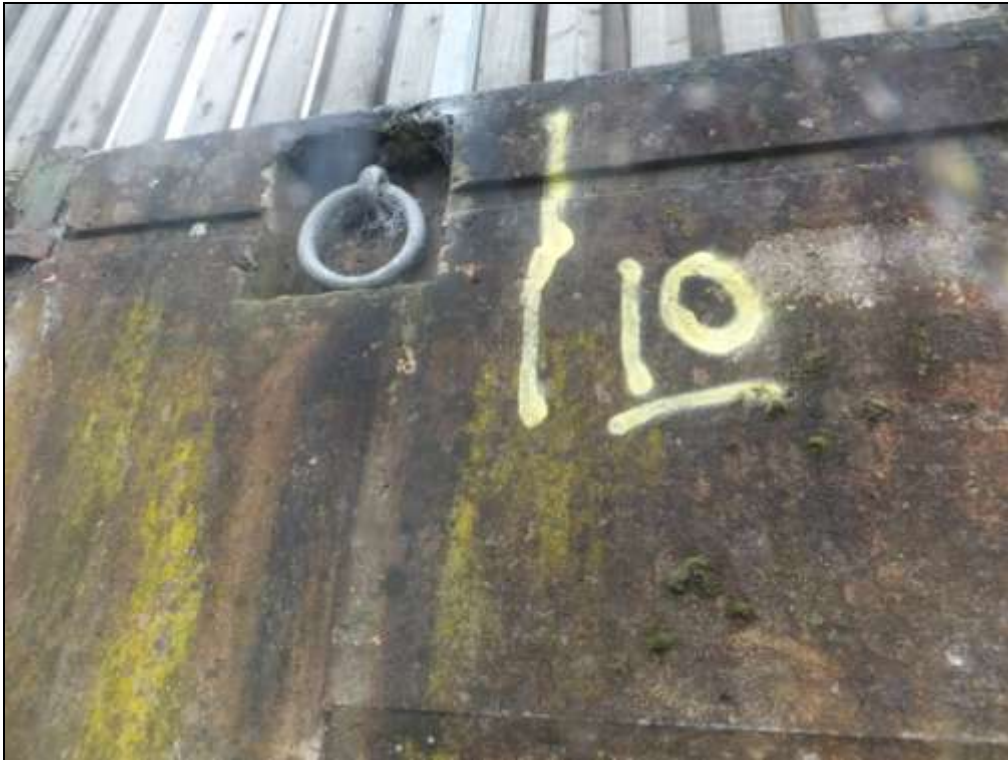
- 4.9 Ch 10m – 234m – The capping beam features mooring rings at approximate 5m intervals along the structure. These rings are recessed into the beam and are bolted through to the back face.

Photograph 9: Ch 10m – Mooring ring recessed into the capping beam.

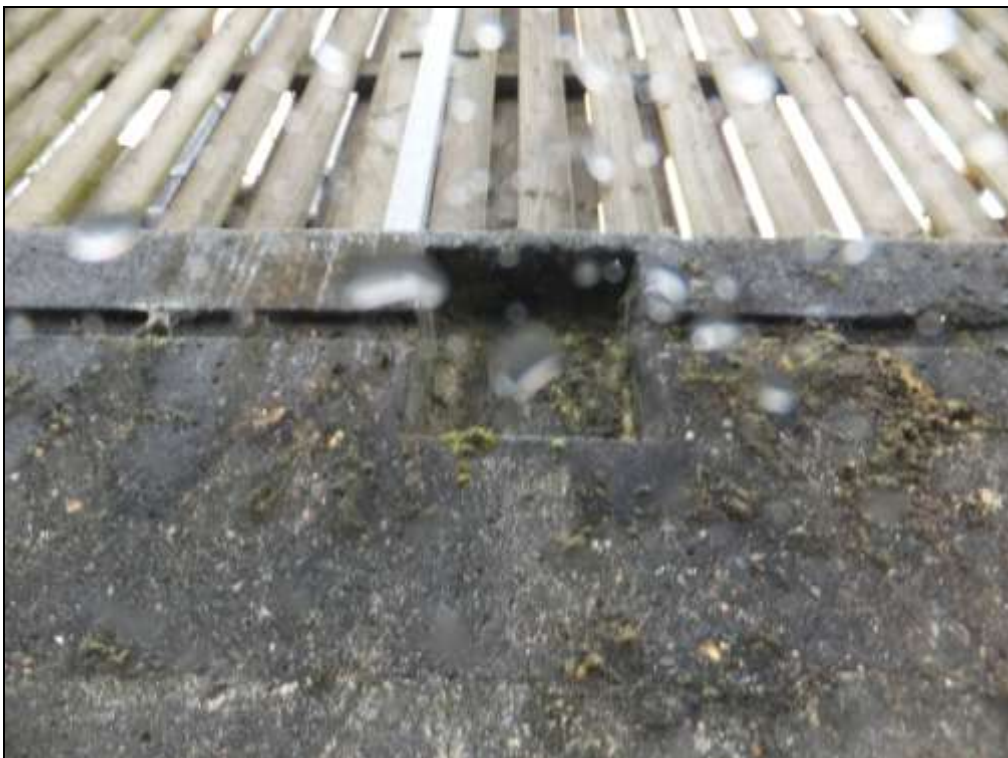
- 4.10 As above – Approximately 10# mooring rings are missing.

Photograph 10: Ch 176m – Missing mooring ring.

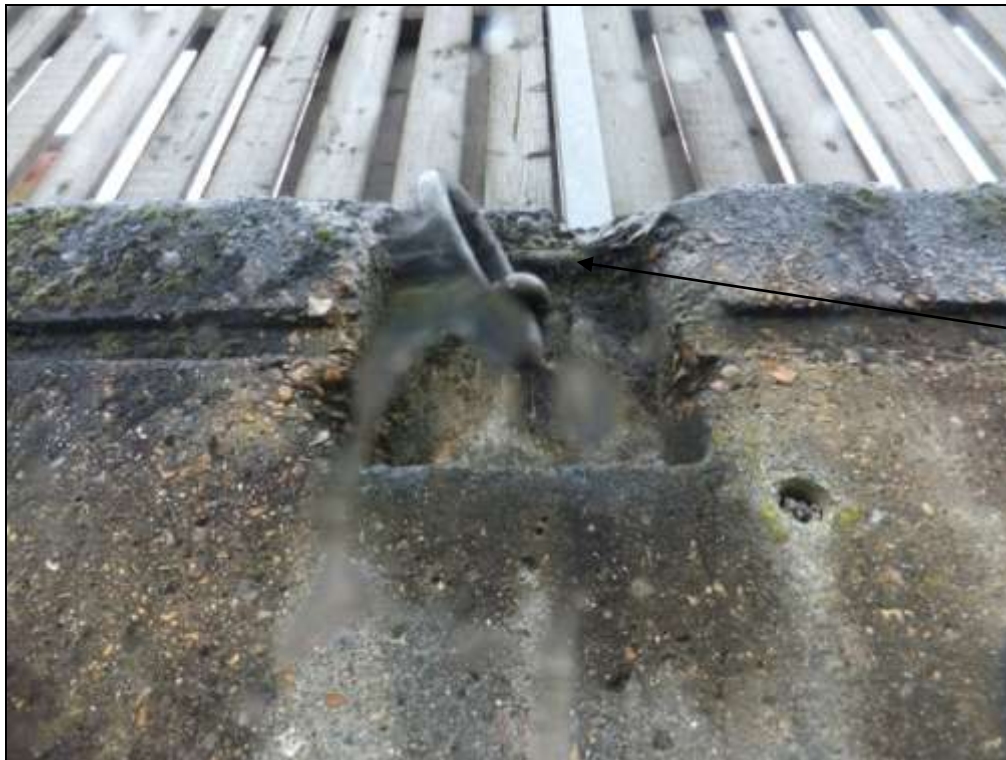
- 4.11 As above – Approximately 6# mooring ring recesses exhibit damage around the perimeter. On a number of these the structural re-bar has become exposed.

Structural re-bar exposed

Photograph 11: Ch 65m – Damage to mooring ring recess with re-bar exposed.

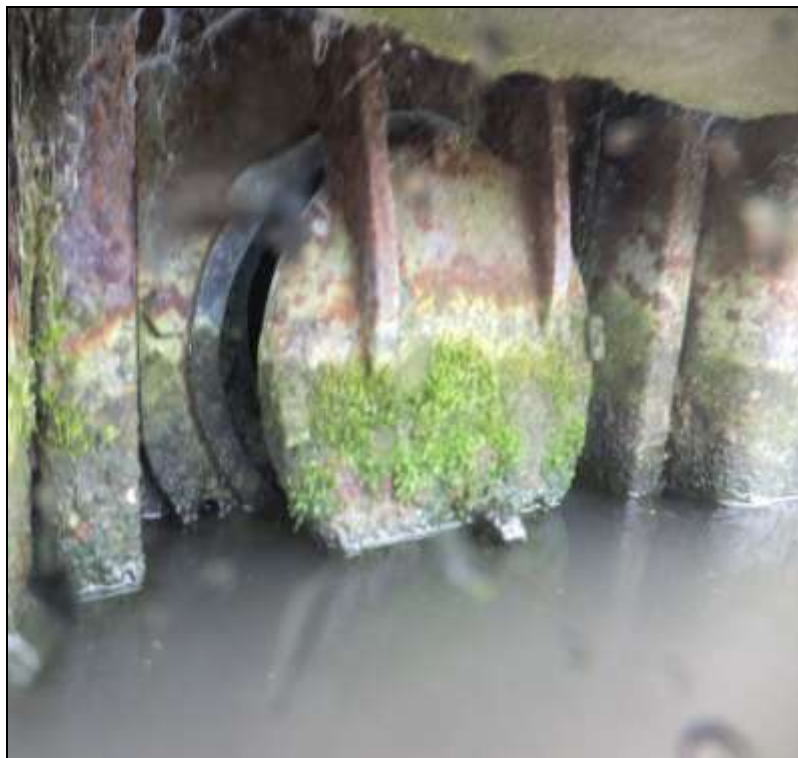
- 4.12 Ch 11m – There is an outfall pipe of 160mm Ø with a flap valve fitted over, directly below the capping beam. The flap valve was seized in an open position at the time of our inspection.

Photograph 12: Ch 11m – Outfall pipe fitted with a seized flap valve.

Consideration should be taken to the removal of the redundant flap valves with welded plates fitted over the resultant apertures and pipe ends.

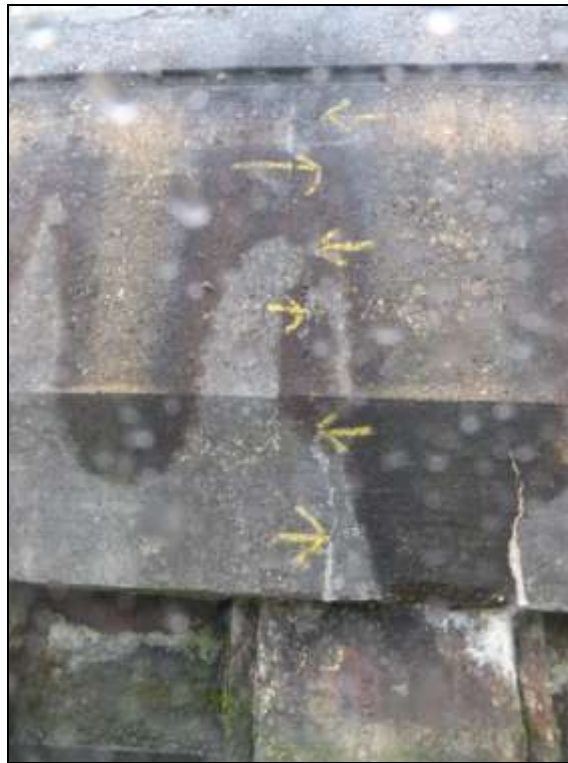
4.13 Ch 19m – 234m – There are approximately 100# cracks in the concrete capping the majority of which are hairline cracks. There efflorescence type deposits leeching from several of the cracks.

Photograph 13: Ch 56m – Hairline crack with efflorescence leaching at its base.

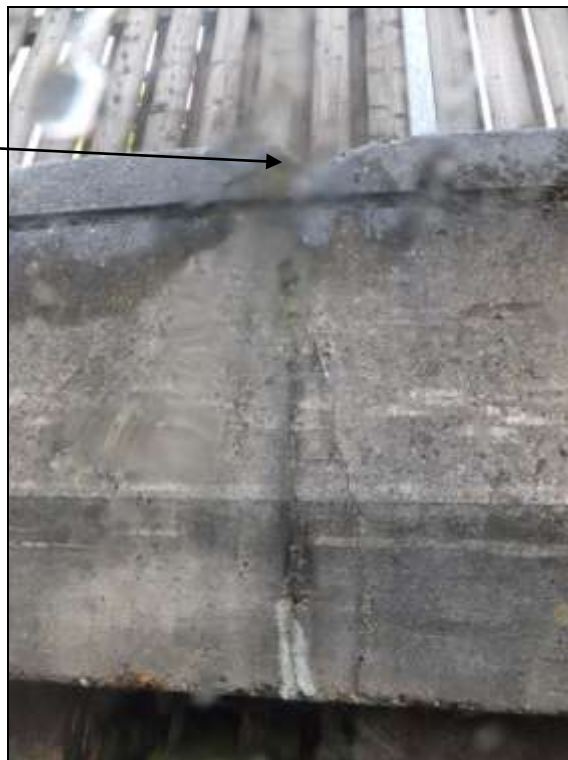
4.14 As above – Approximately 10# of the cracks are between 2mm and 5mm in width with the pictured crack below exhibiting an area of spalled concrete with re-bar exposed. Note – This defect is directly adjacent to an outfall pipe through the sheet pile wall below.

Spalled
area of
concrete

Photograph 14: Ch 114m – Open crack with spalled concrete adjacent to an outfall pipe.

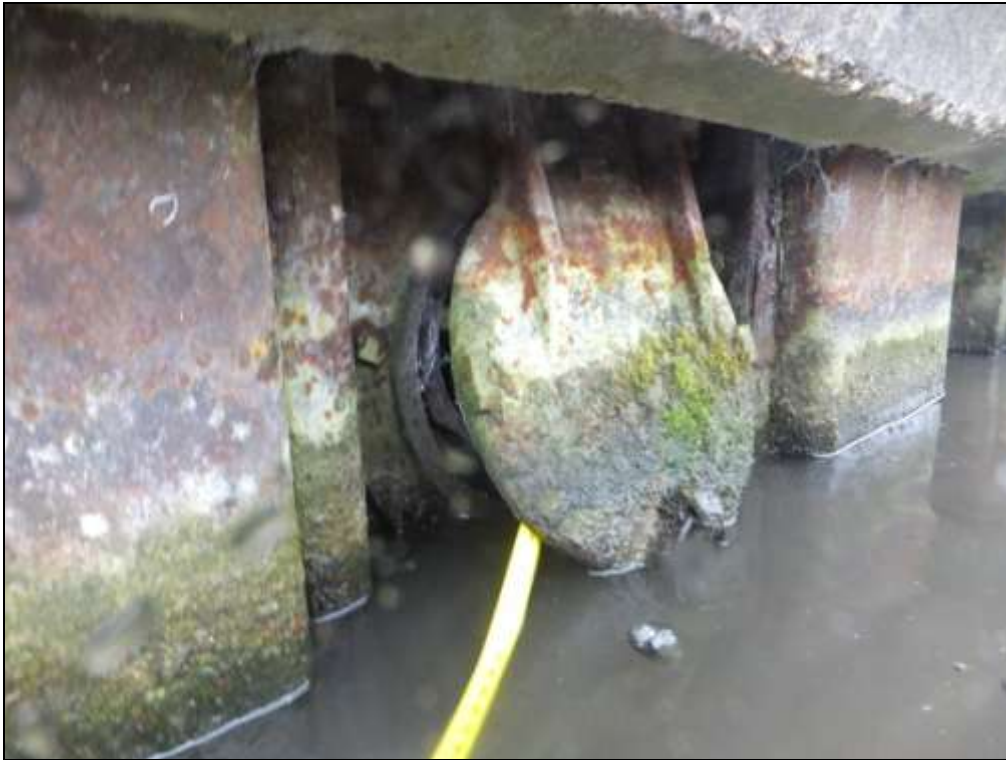
- 4.15 Ch 39.5m – There is an outfall pipe of 160mm Ø with a flap valve fitted over, directly below the capping beam. The flap valve was operational at the time of our inspection.

Photograph 15: Ch 39.5m – Outfall pipe with operational flap valve.

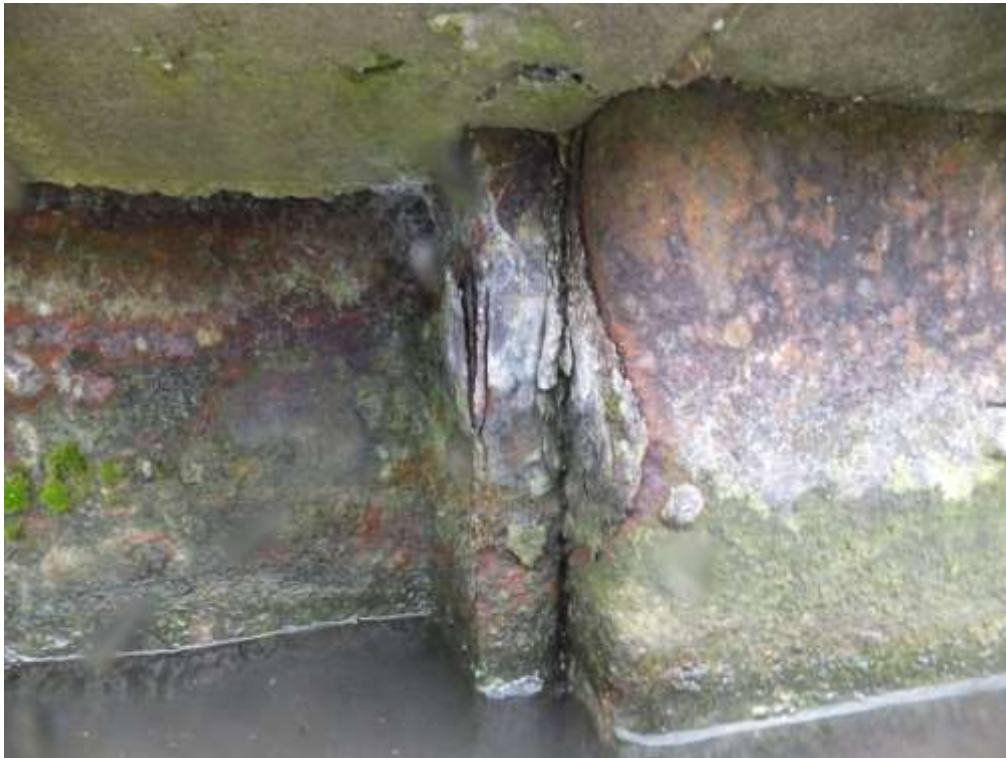
- 4.16 Ch 9m – 234m – There is general de-lamination of the steel around the clutch and web area of the sheet piles above the waterline.

Photograph 16: Ch 30m – De-lamination of the steel adjacent to the pile clutch.

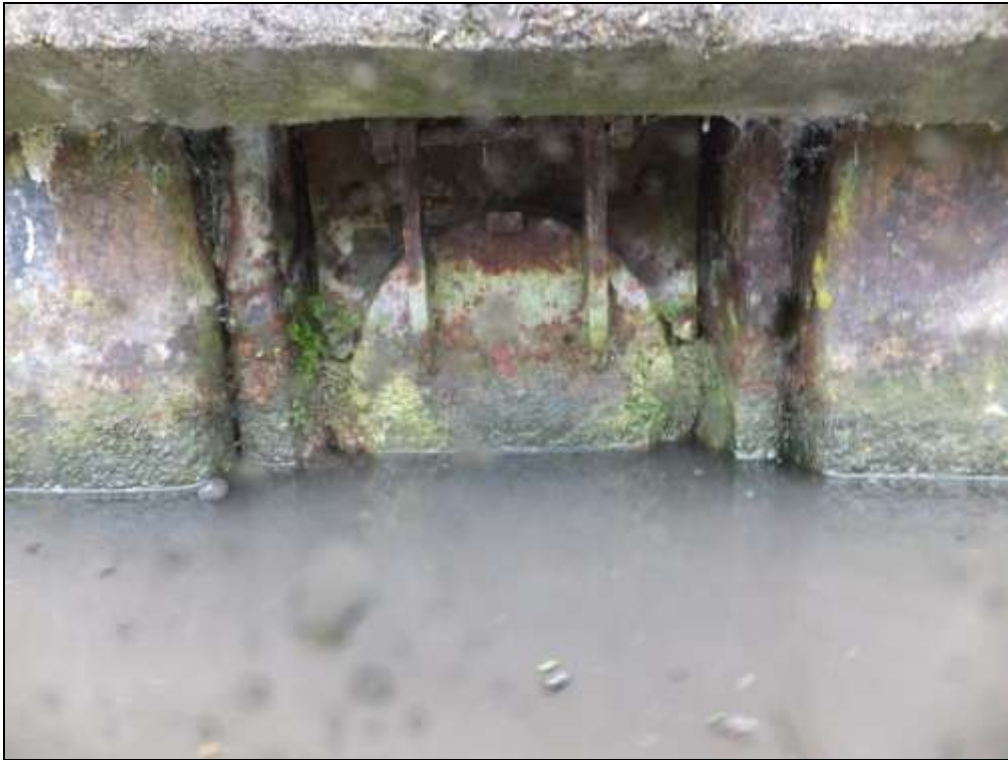
4.17 Ch 70.5m – There is an outfall pipe of 160mm Ø with a flap valve fitted over, directly below the capping beam. The flap valve was seized in a closed position at the time of our inspection.

Photograph 17: Ch 70.5m – Outfall pipe fitted with a seized flap valve.

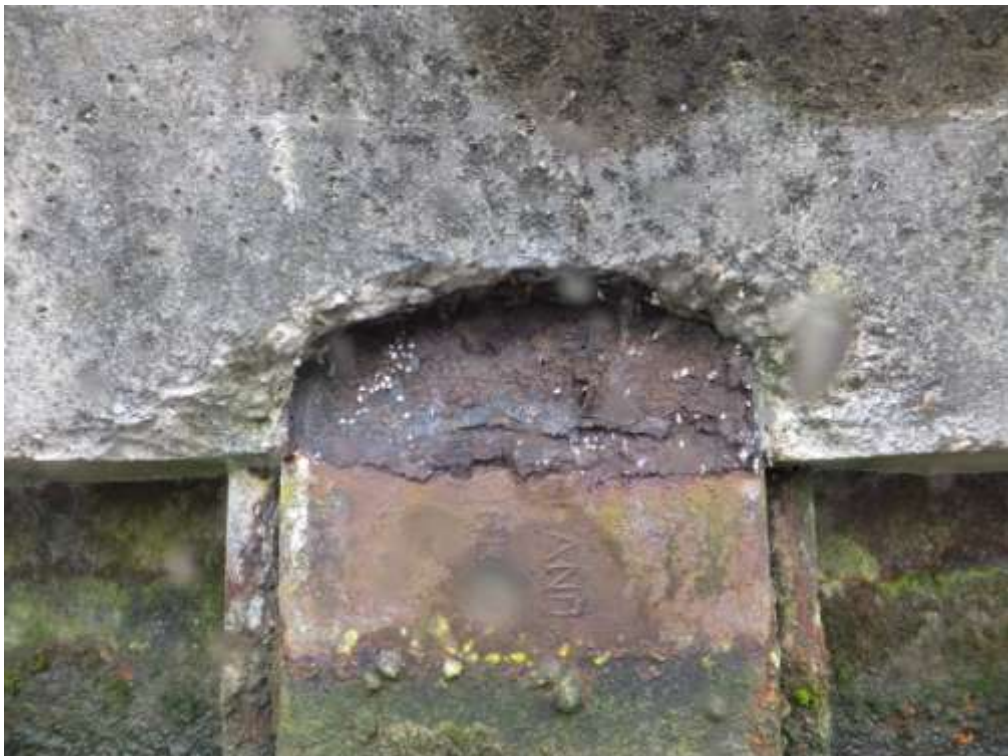
4.18 Ch 86m – 234m – There are a number of areas of steel de-lamination at the top of pile outpan's which has resulted in the concrete capping beam spalling away.

Photograph 18: Ch 86m – Spalling of the concrete capping beam as a result of steel de-lamination.

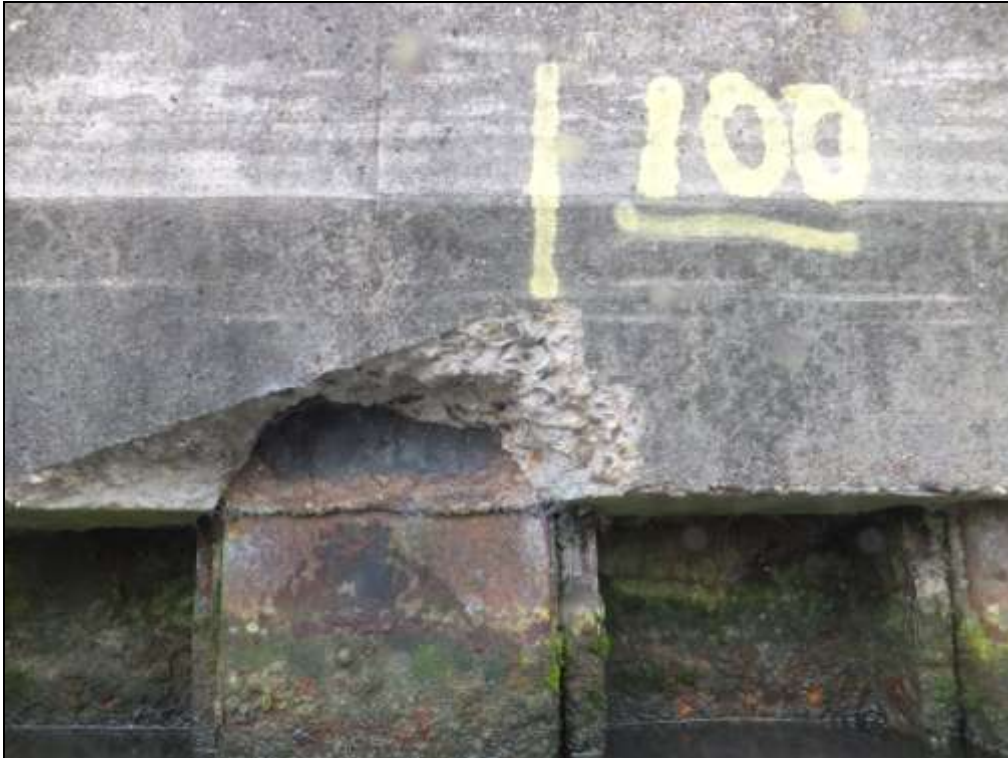
4.19 As above.

Photograph 19: Ch 100m – Spalling of the concrete capping beam, probably as a result of steel de-lamination.

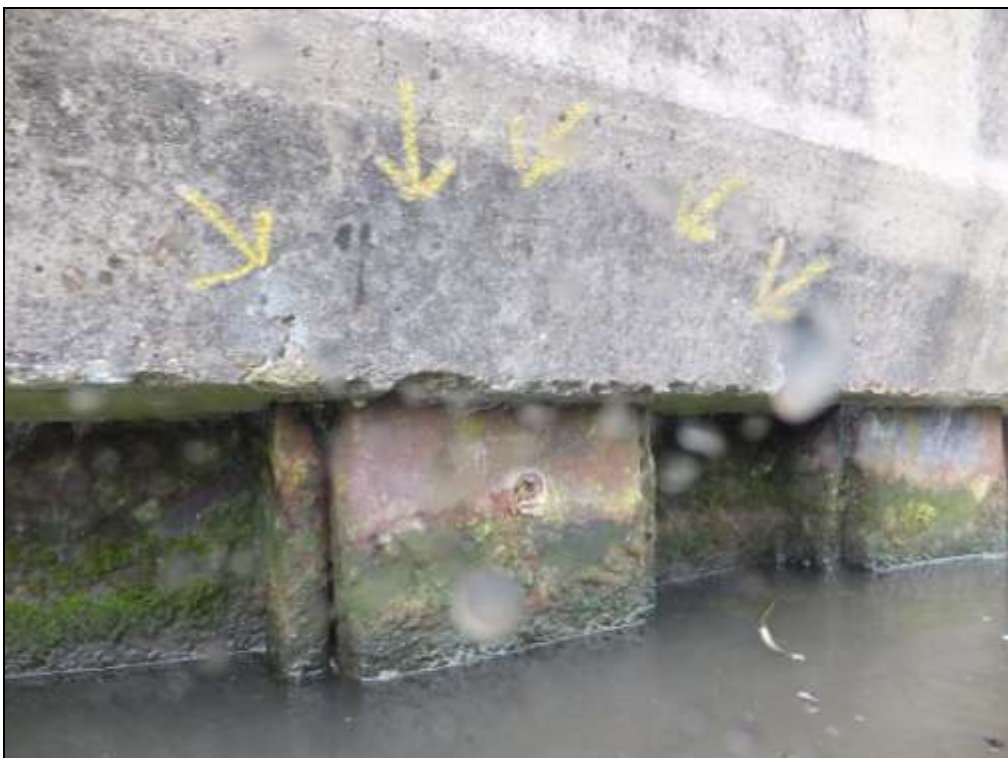
4.20 As above – There are a number of areas where the capping beam has cracked above the pile outpan with the probable cause being de-lamination of the underlying steel pile. In time it is probable these sections of concrete will spall away exposing the upper section of pile.

Photograph 20: Ch 95m – Cracking of the pile capping beam due to de-lamination of steel.

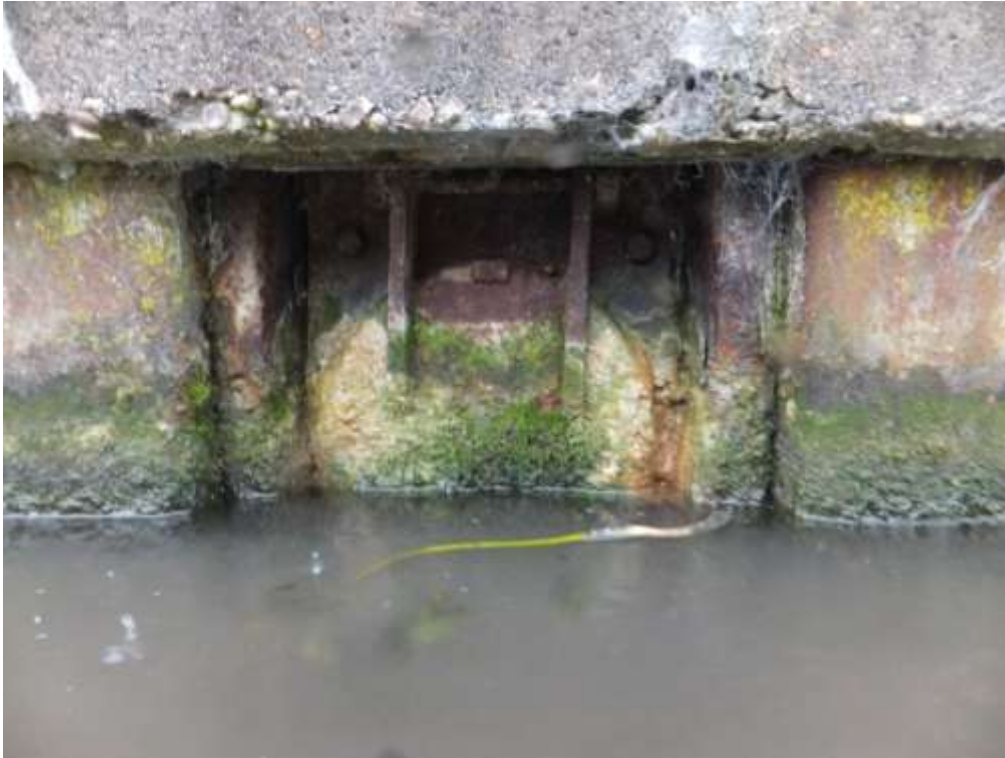
- 4.21 Ch 98m – There is an outfall pipe of 160mm Ø with a flap valve fitted over, directly below the capping beam. The flap valve was seized in a closed position at the time of our inspection.

Photograph 21: Ch 98m – Outfall pipe fitted with a seized flap valve.

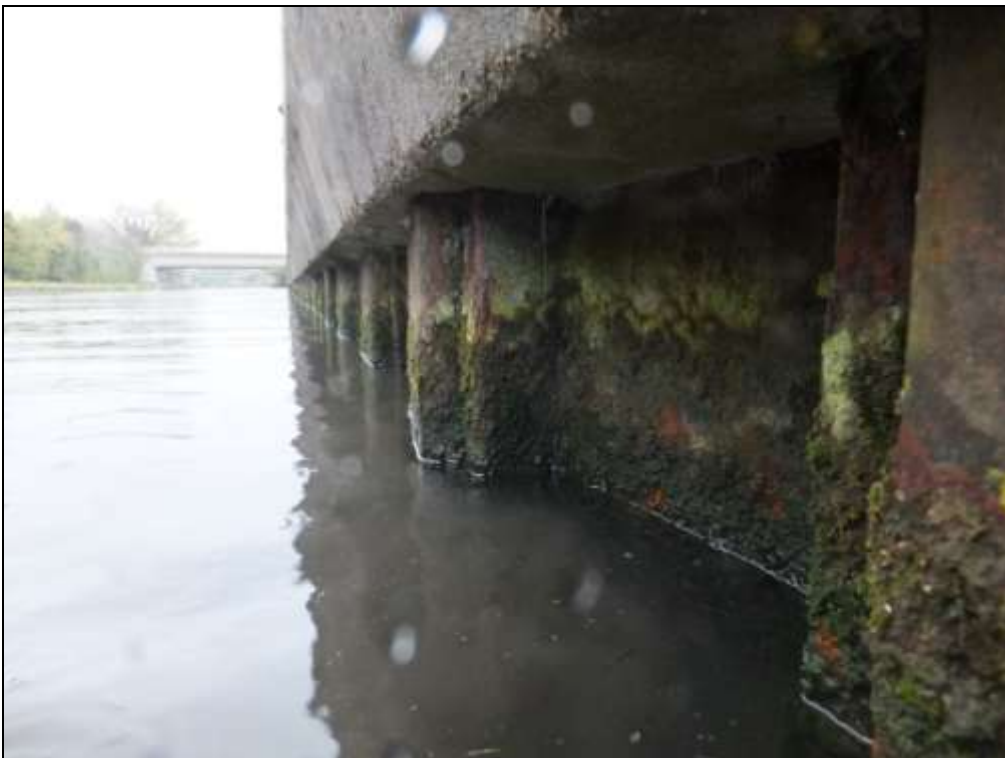
- 4.22 Ch 113m – There is slight misalignment of the piles. Note – there are no open clutches in the vicinity of the misaligned piles.

Photograph 22: Ch 113m – Misalignment of piles.

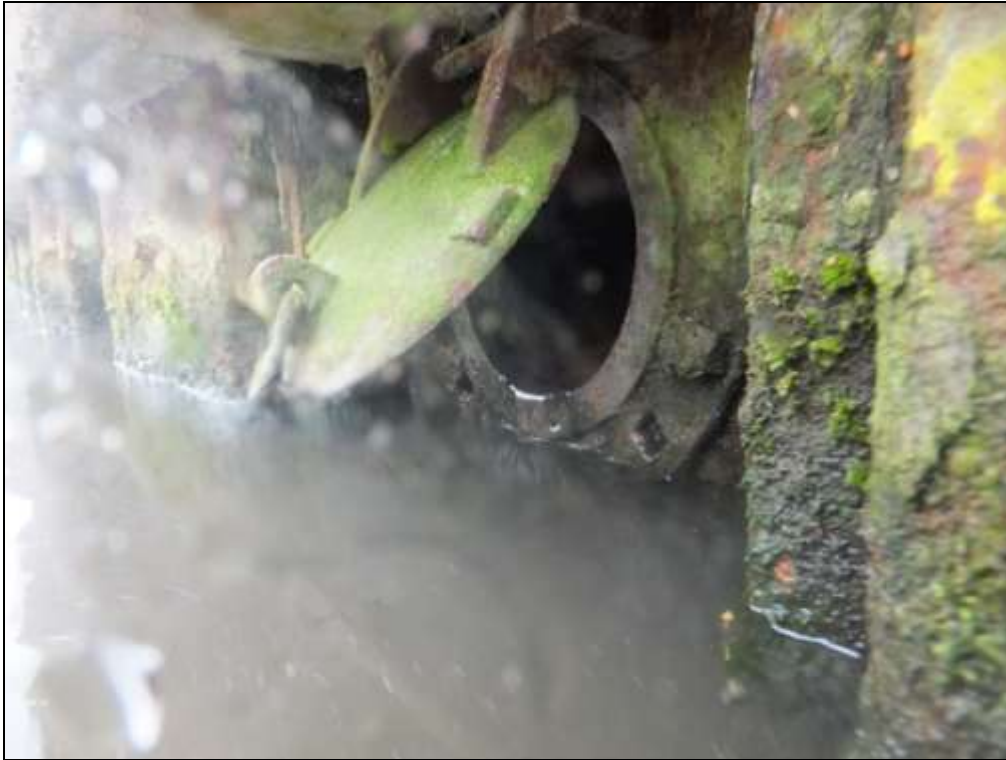
- 4.23 Ch 114m – There is an outfall pipe of 160mm Ø with a flap valve fitted over, directly below the capping beam. The flap valve was seized in an open position at the time of our inspection.

Photograph 23: Ch 114 – Outfall pipe fitted with a seized flap valve.

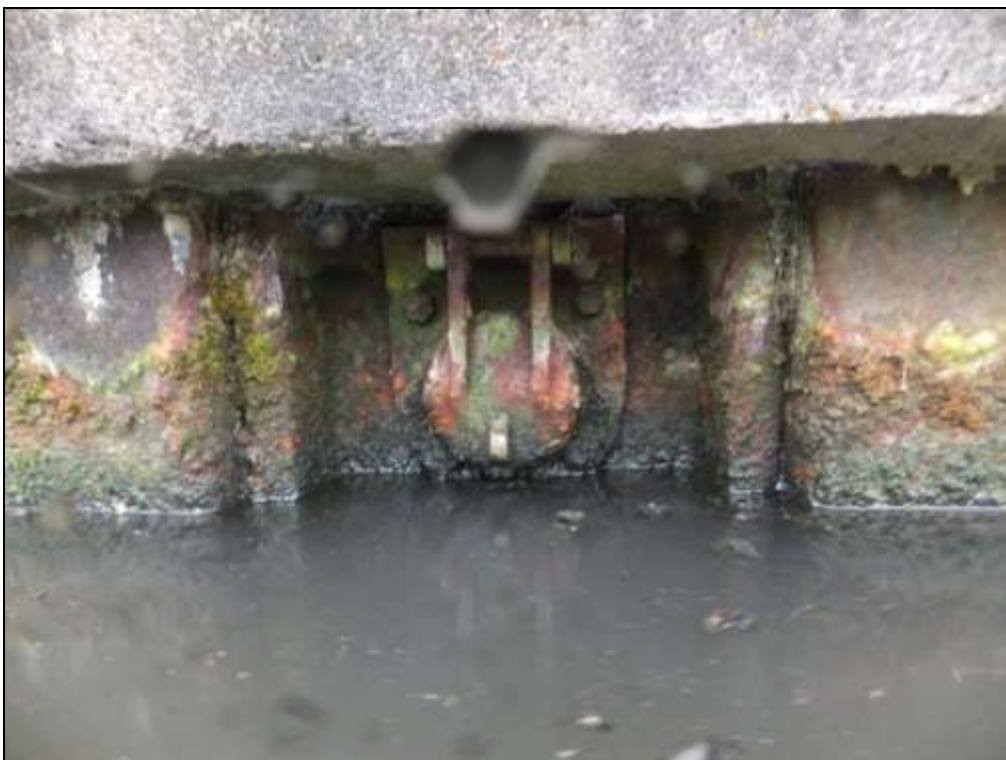
- 4.24 Ch 136m – There is an outfall pipe of 120mm Ø with a flap valve fitted over, directly below the capping beam. The flap valve was seized in a closed position at the time of our inspection.

Photograph 24: Ch 136m – Outfall pipe fitted with a seized flap valve.

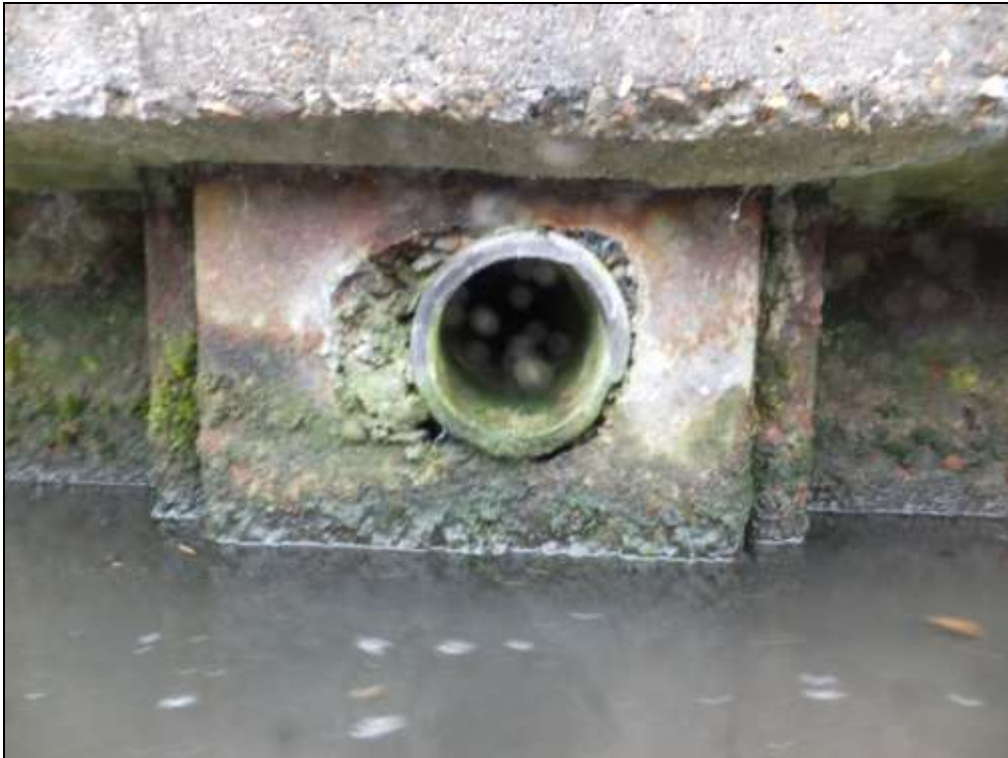
4.25 Ch 159m – There is an open pipe 100mm Ø, directly below the capping beam.

Photograph 25: Ch 159m – Open pipe.

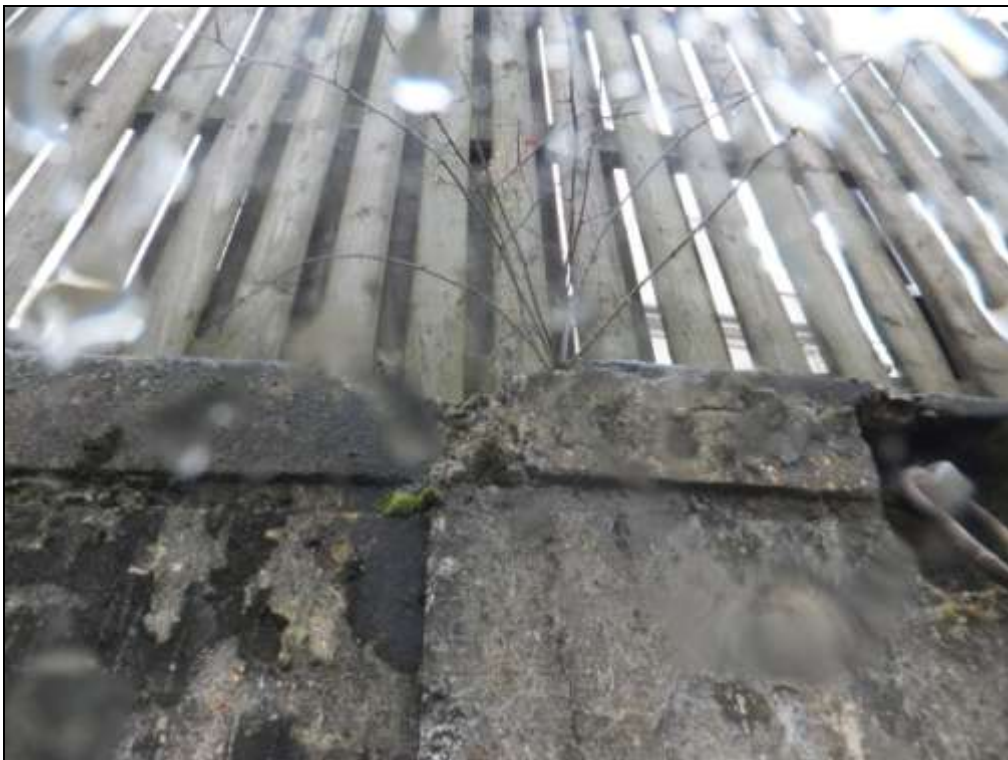
4.26 Ch 162m – Vegetation growing in the capping beam causing spalling to the adjacent concrete.

Photograph 26: Ch 162m – Vegetation causing spalling.

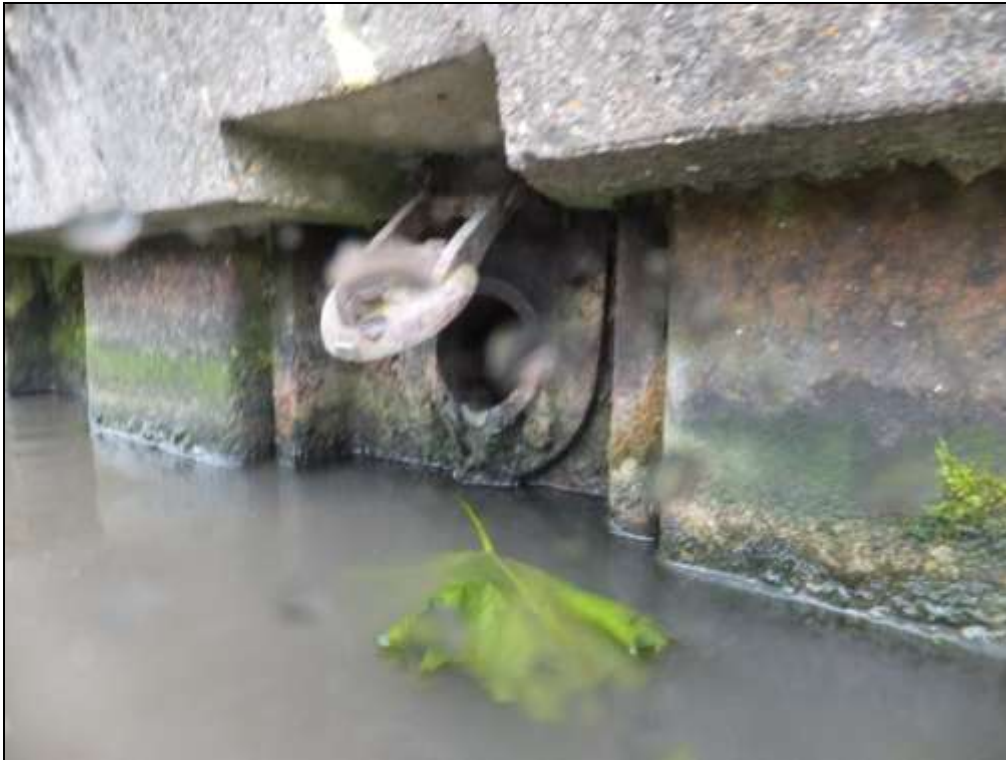
- 4.27 Ch 175m – There is an outfall pipe of 120mm Ø with a flap valve fitted over, directly below the capping beam. The flap valve was seized in an open position at the time of our inspection.

Photograph 27: Ch 175m – Outfall pipe fitted with a seized flap valve.

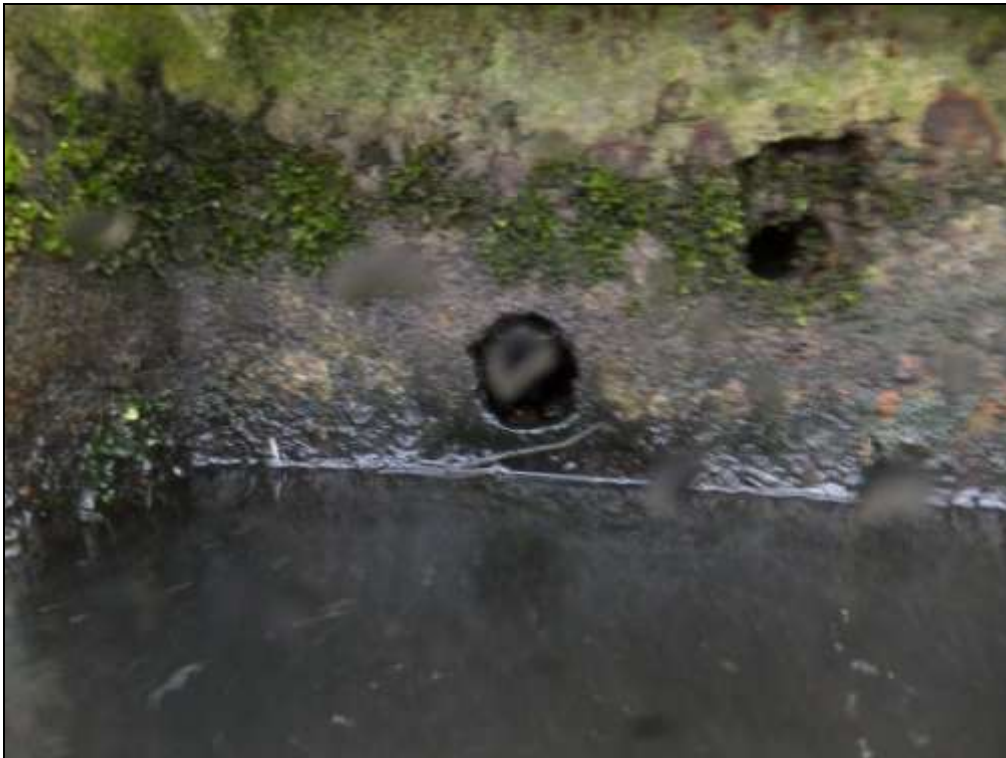
- 4.28 Ch 185m – There is a 30mm Ø and 40 mm Ø hole in the sheet pile wall above the waterline.

Photograph 28: Ch 180m – 2# holes.
