HAYES CANAL WALL SURVEY

NESTLE FACTORY, HAYES

Client:	CAPITA
Author:	Mark Taylor
Reference:	14/179 Rev 1
Issue Date:	17/11/2014

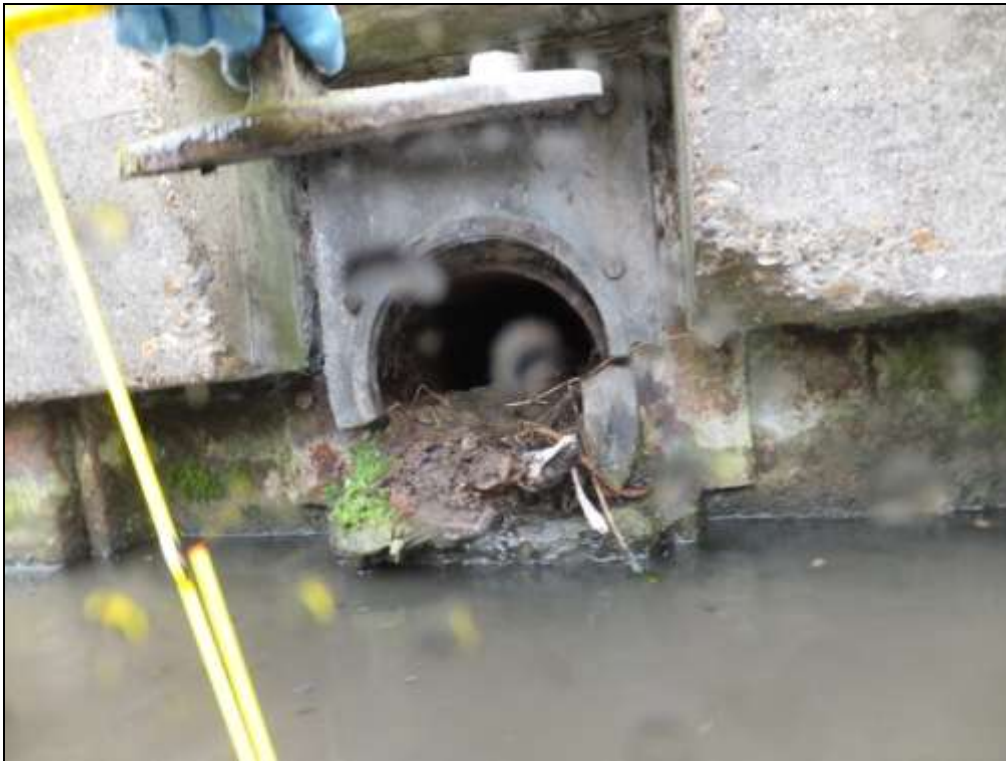
- 4.29 Ch 190m – There is an outfall pipe of 250mm Ø with a flap valve fitted over, directly below the capping beam. The flap valve was operational at the time of our inspection but the pipe was blocked with debris resulting in the flap valve not closing fully.

Photograph 29: Ch 190m – Outfall pipe blocked with debris..

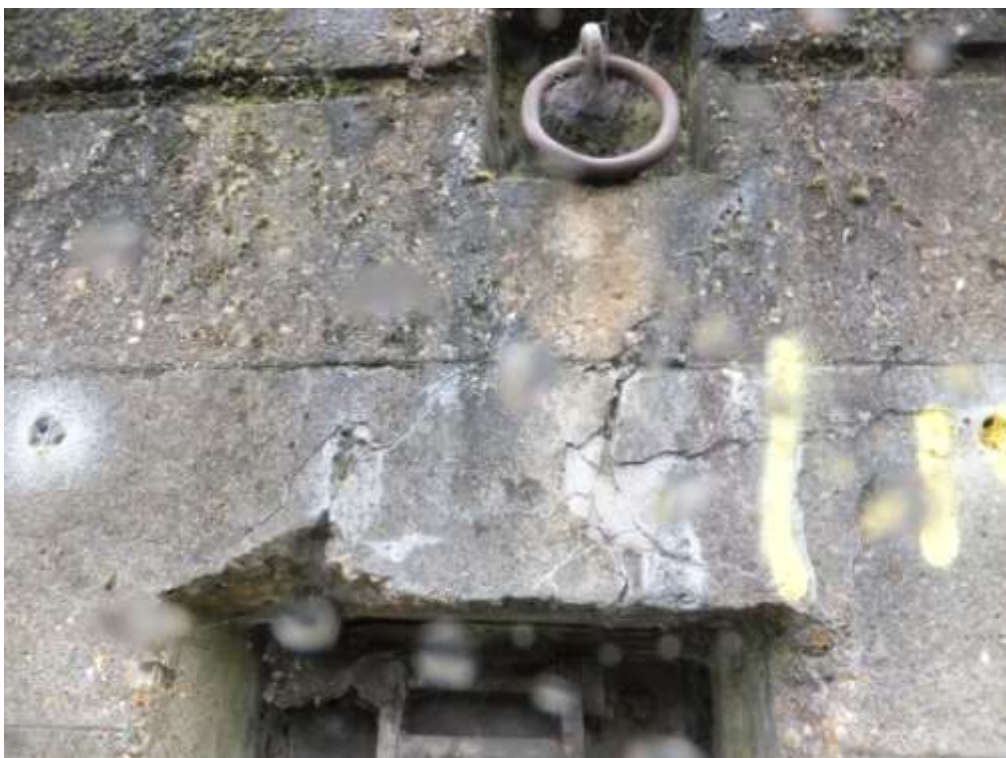
- 4.30 Ch 190m – As above – The capping beam above the outfall pipe is cracked with sections of concrete spalling away.

Photograph 30: Ch 210m – Defective area of concrete above capping beam.

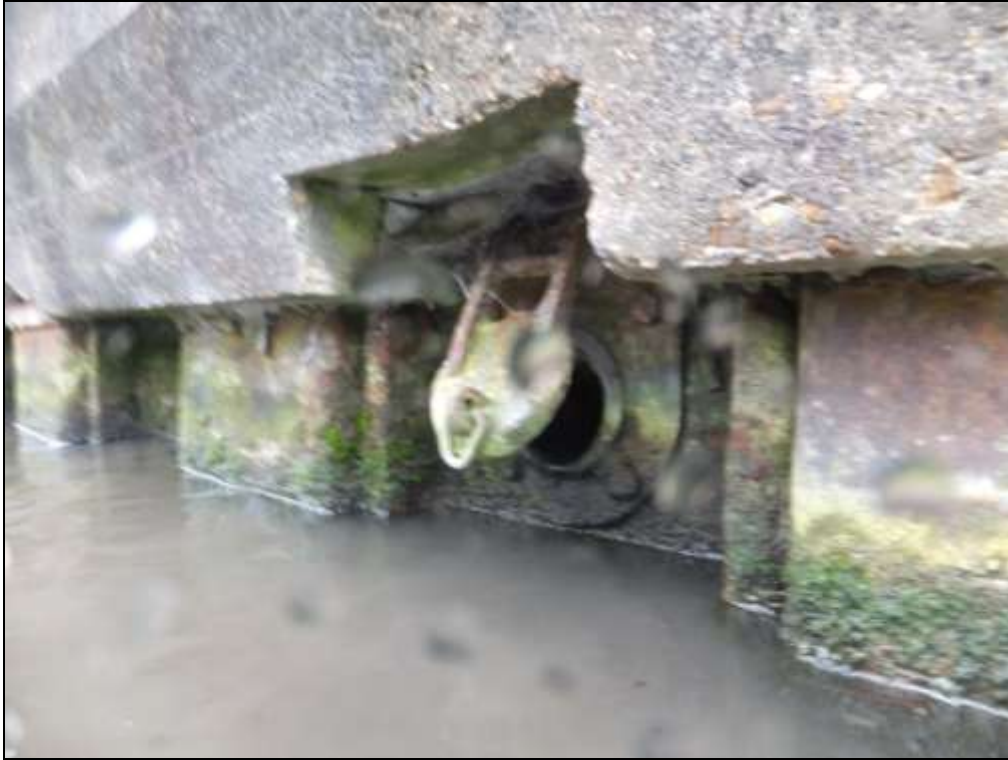
- 4.31 Ch 196m – There is an outfall pipe of 120mm Ø with a flap valve fitted over, directly below the capping beam. The flap valve was seized in an open position at the time of our inspection.

Photograph 31: Ch 196 – Outfall pipe fitted with a seized flap valve.

Consideration should be taken to the removal of the redundant flap valves with welded plates fitted over the resultant apertures and pipe ends.

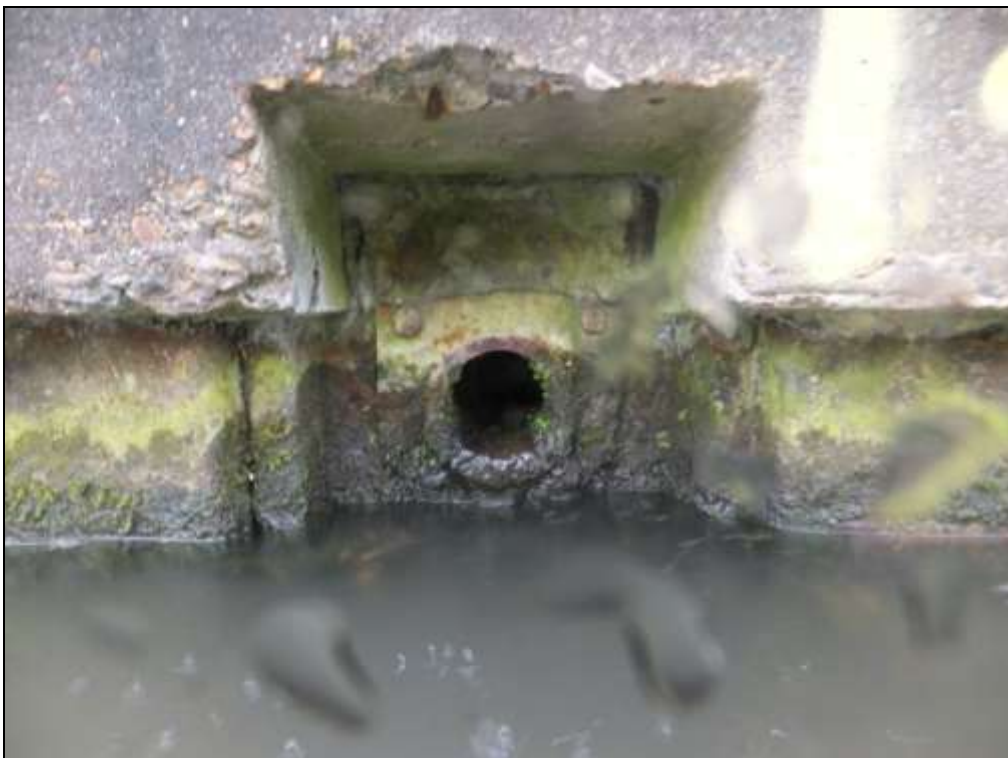
- 4.32 Ch 230m – There is an open pipe 100mm Ø, directly below the capping beam. The pipe appears to have featured a flap valve previously which is missing.

Photograph 32: Ch 230m – Outfall pipe with missing flap valve.

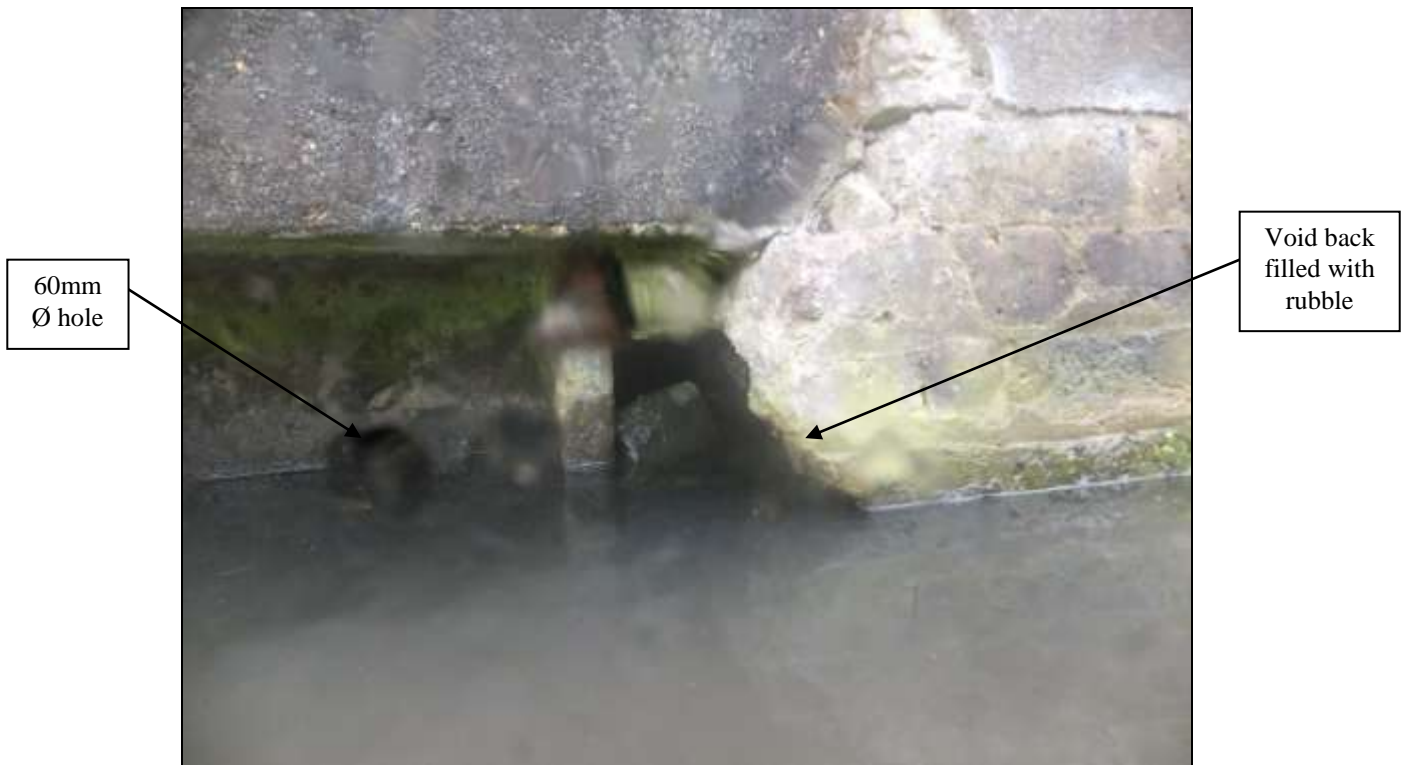
4.33 Ch 234m – The construction of the retaining wall changes to a brick built format with a void present from bed level to below the capping beam which is 200mm in width and 300mm penetration and back filled with loose rubble. Note there is a 60mm Ø hole on the final inpan at the waterline.

Photograph 32: Change in construction to Larssen No. 2 sheet piles.

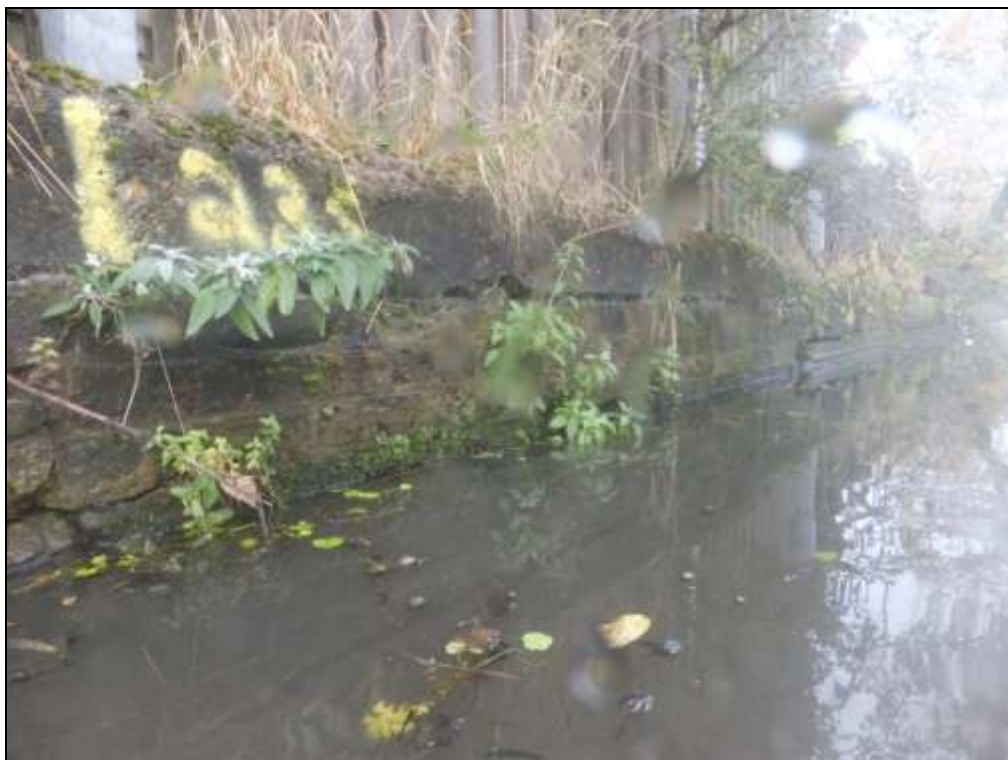
4.34 Ch 234m – 290m – Brick built construction with a coping stone above. The wall exhibits heavy vegetation growing from the mortar joints and hard stand.

Photograph 34: Ch 235m – Vegetation.

From chainage 234m to 300m the brick built section of the wall will require at least immediate short term repairs and in the long term total replacement in accordance with the usage of the adjacent canal bank.

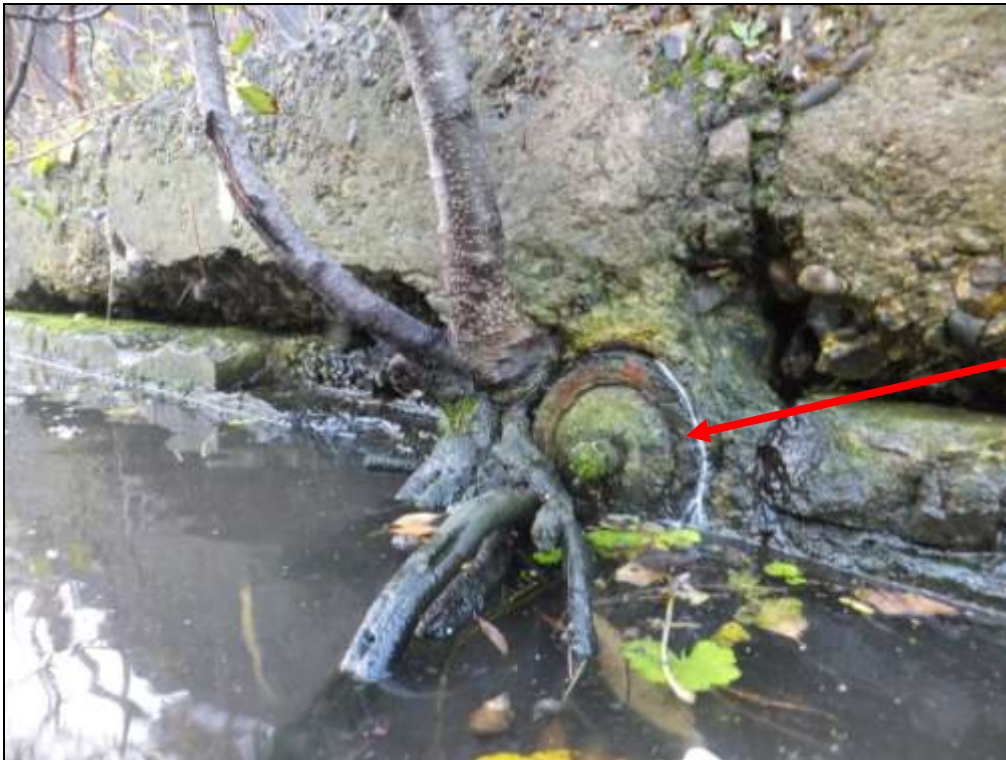
4.35 As above – Vegetation growing from the retaining wall. Note – Pipe blanked with pipe stopper.

Photograph 35: Ch 265.5m – Vegetation and blanked pipe.

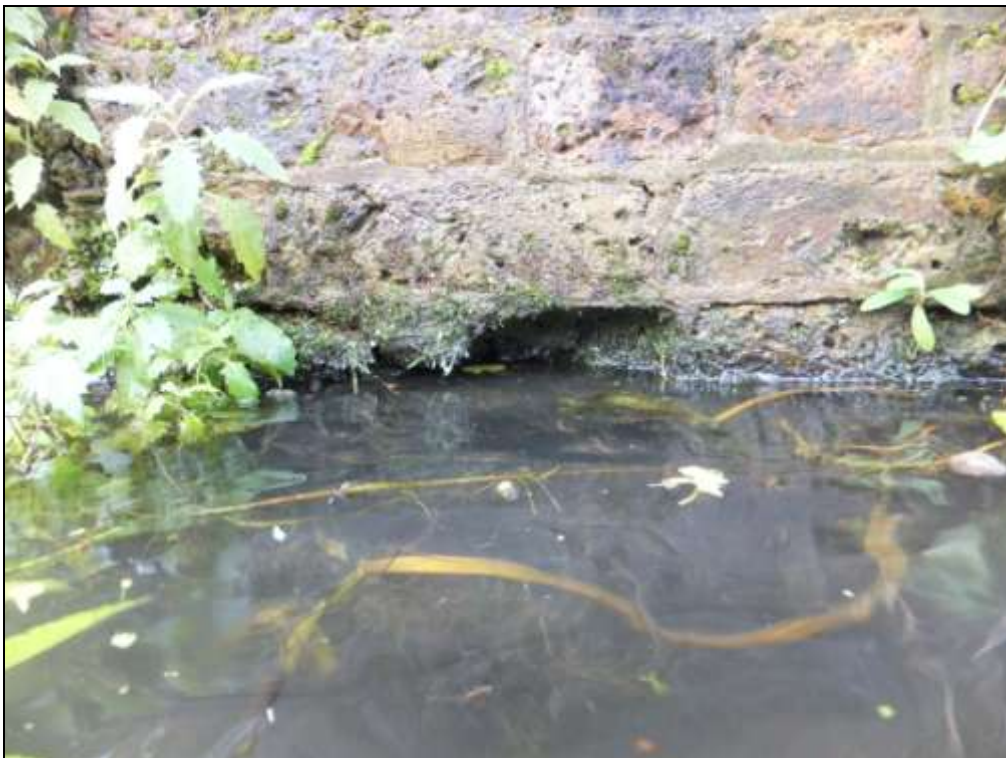
4.36 Ch 235m – There is a large void in the brickwork below the waterline 500mm wide x 250mm high with a penetration depth of >1000mm.

Photograph 36: Ch 235m Void in wall below the waterline.

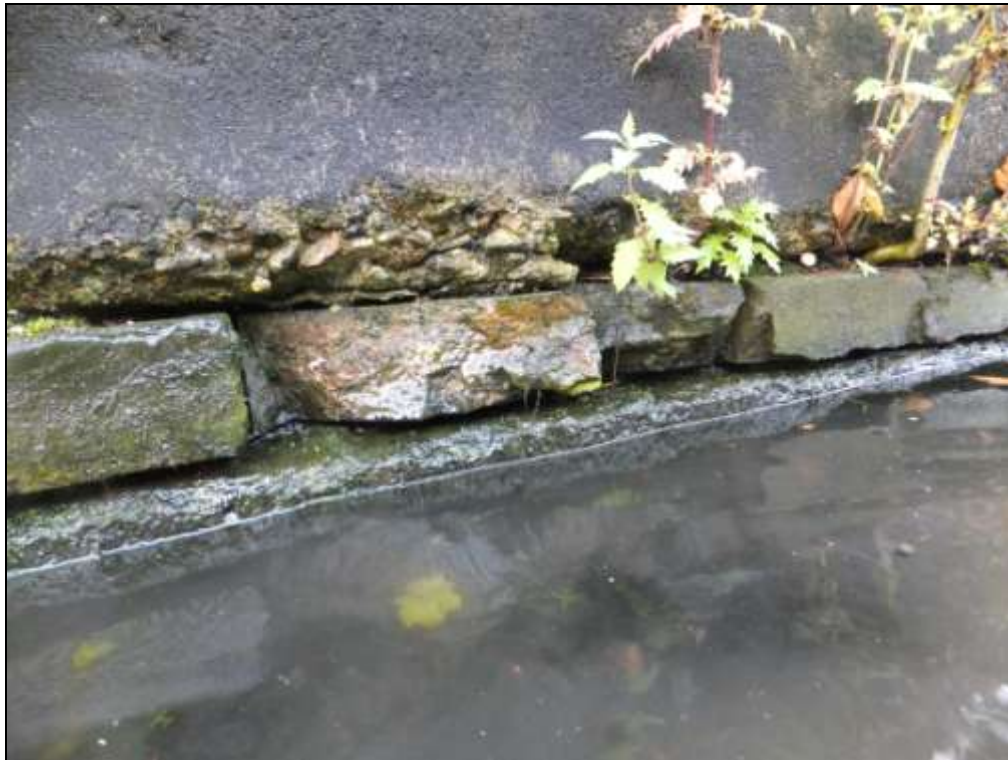
4.37 Ch 234m – 290m – A large proportion of the brickwork mortar joints are missing and recessed up to 75mm both above and below the waterline. The joint between the top of the brickwork wall and coping stone is also missing and spalled with large voids present.

Photograph 37: Ch 260m – Missing mortar joints.

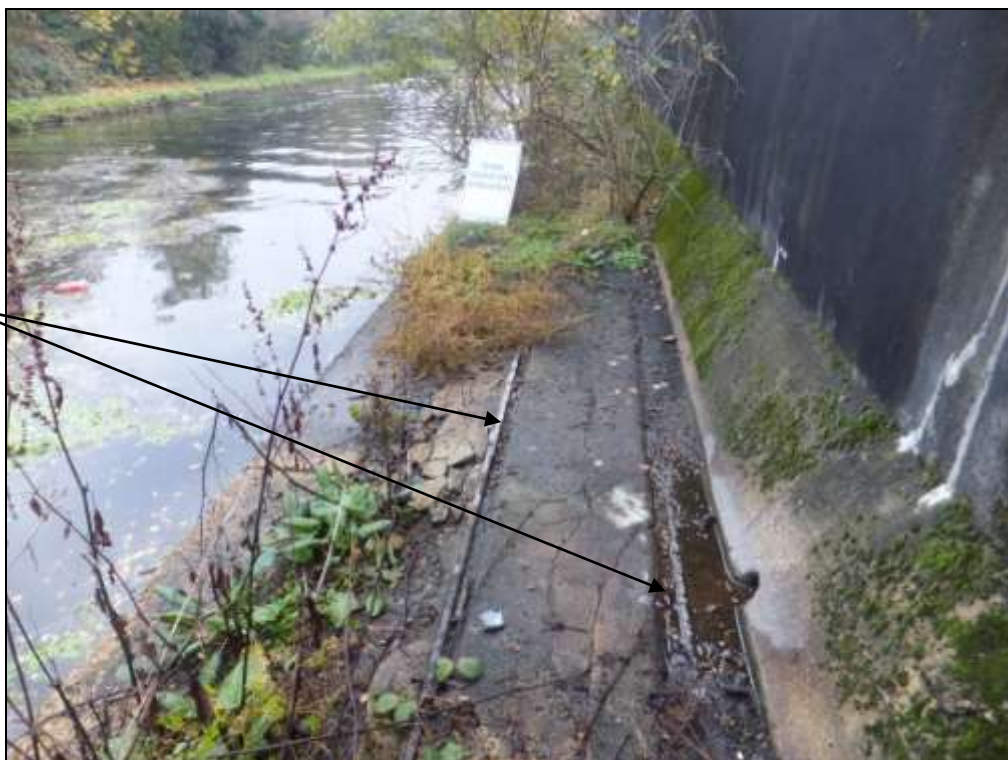
4.38 Ch 234m – 290m – The hard stand adjacent to the retaining wall exhibits heavy vegetation growth. The top layer of concrete is fragmenting and breaking up. Note – Rail tracks on hard stand indicating this section of wall was previously utilised as a loading area for trucks or narrow boats.

Rail tracks

Photograph 38: Ch 241m – Cracking to corner section of capping beam.

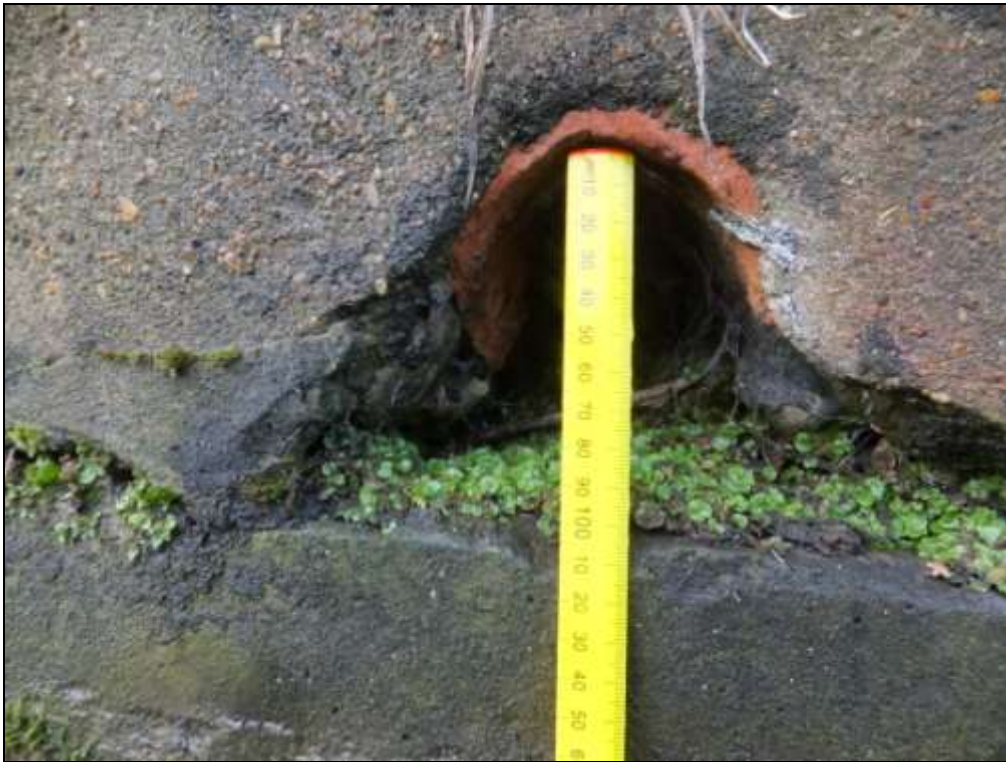
4.39 Ch 240.5m – 100mm Ø open pipe located in the base of the coping stone. There is a similar pile at Ch 257m.

Photograph 38: Ch 240.5m – Open pipe.

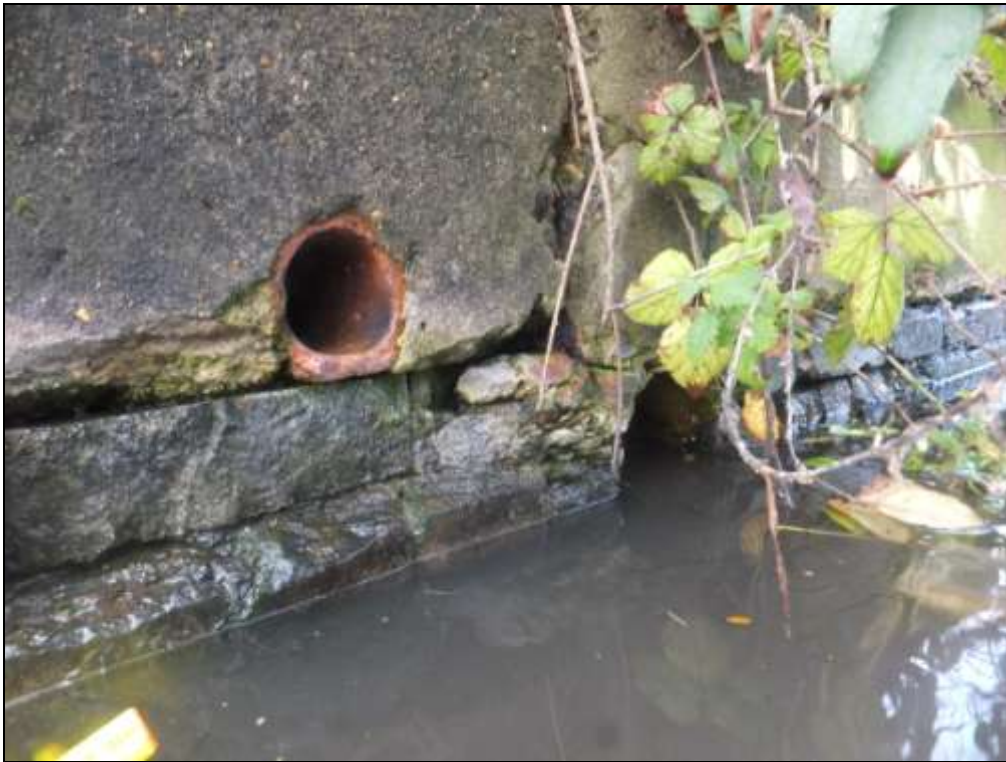
4.41 Ch 250m – There are 2# open pipes located below the coping stone of 70mm and 160mm Ø.

Photograph 41: Ch 250m – 2# open pipes

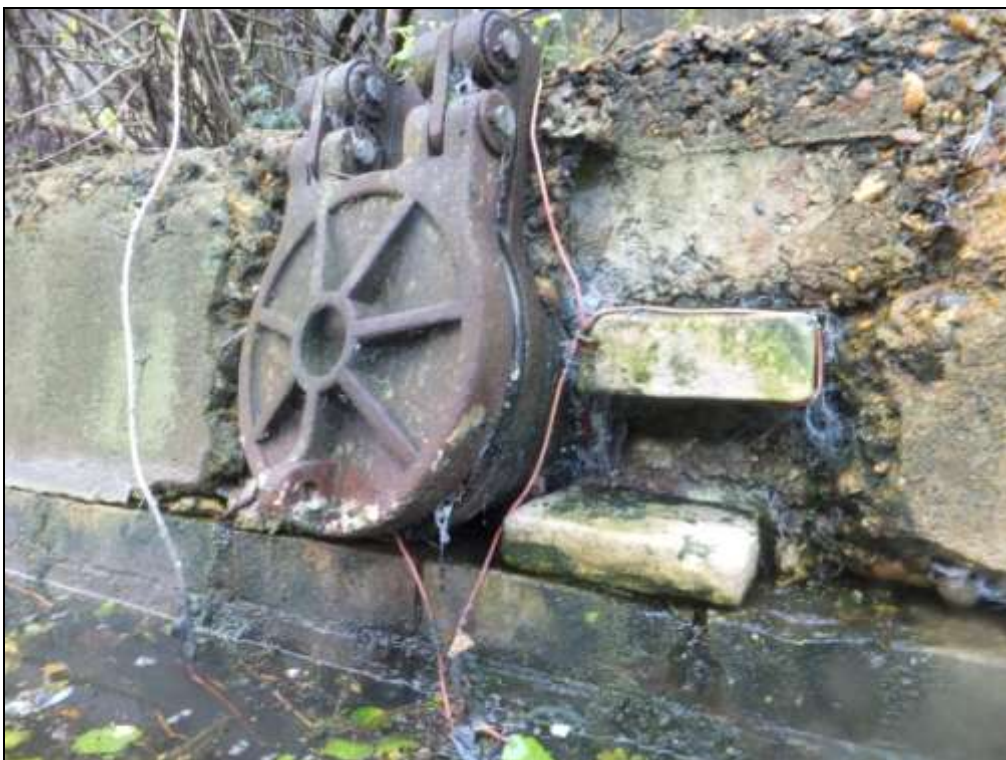
4.42 Ch 287m – There is an outfall pipe with a flap valve fitted over. The flap valve was operational at the time of our inspection.

Photograph 42: Ch 287m – Outfall pipe with flap valve.

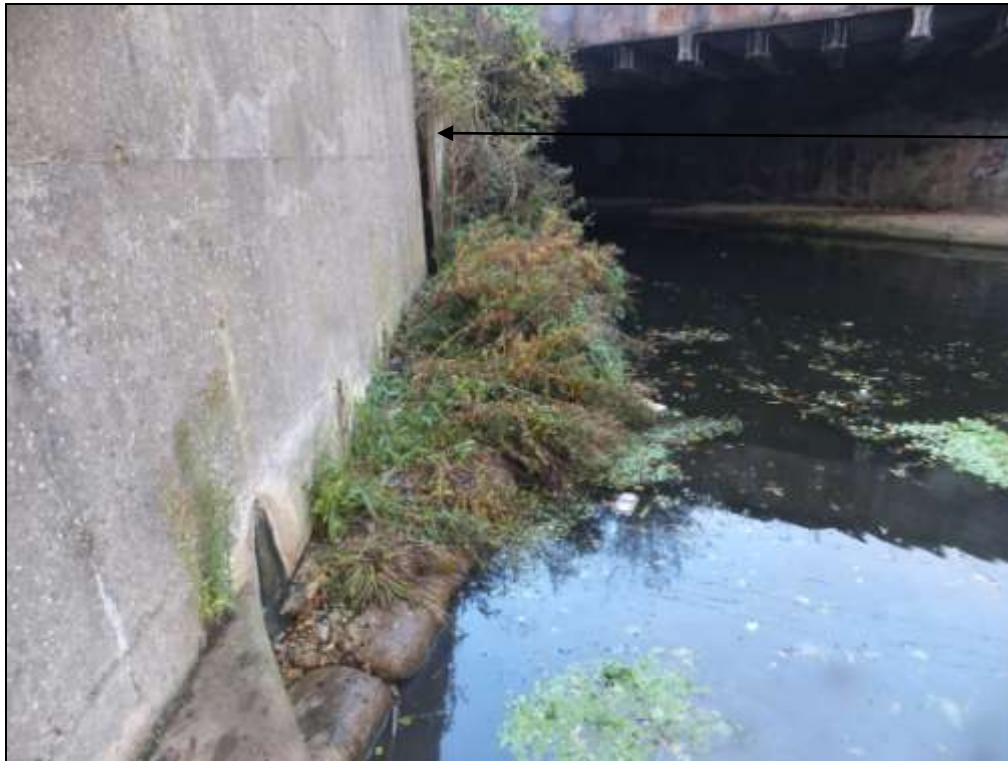
Chainage
298, end
of
structure.

4.43 Ch 290m – 298m – The final 8m of the structure is form of a cast concrete wall with concrete anti-scour bags positioned in front. No defects or scour were report on this section of wall. Note – Build up of heavy vegetation on bag work.
