TECHNICAL NOTE TN01

Former Nestle Site, Nestle Avenue, Hayes,

PERS AUDIT

Project No. 16018-01

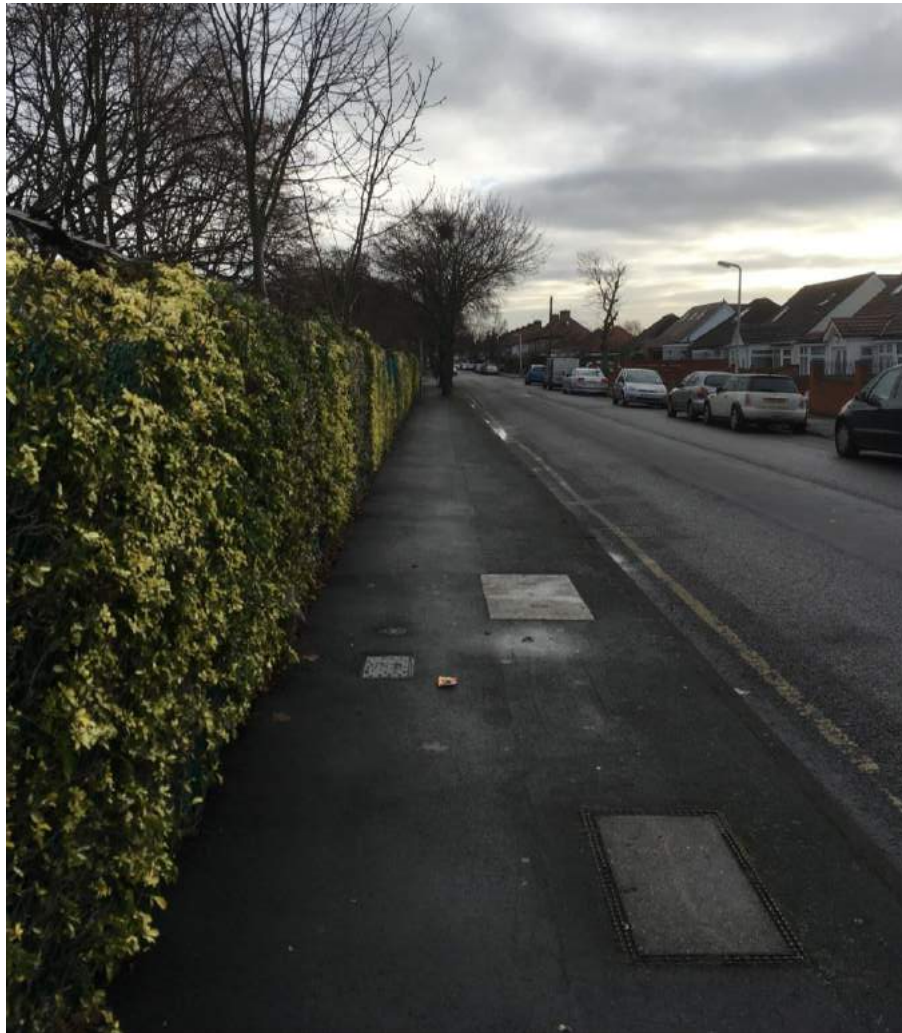
- 5.3 Many of the links benefit from wide accessible footways which are well lit, and which accommodate dropped kerbs and tactile paving at crossing points. **Photo 1** shows a typical footway along the northern side of Nestle Avenue which runs along the southern boundary of the site.

Photo 1 – North Western side of Footway, Nestle Avenue

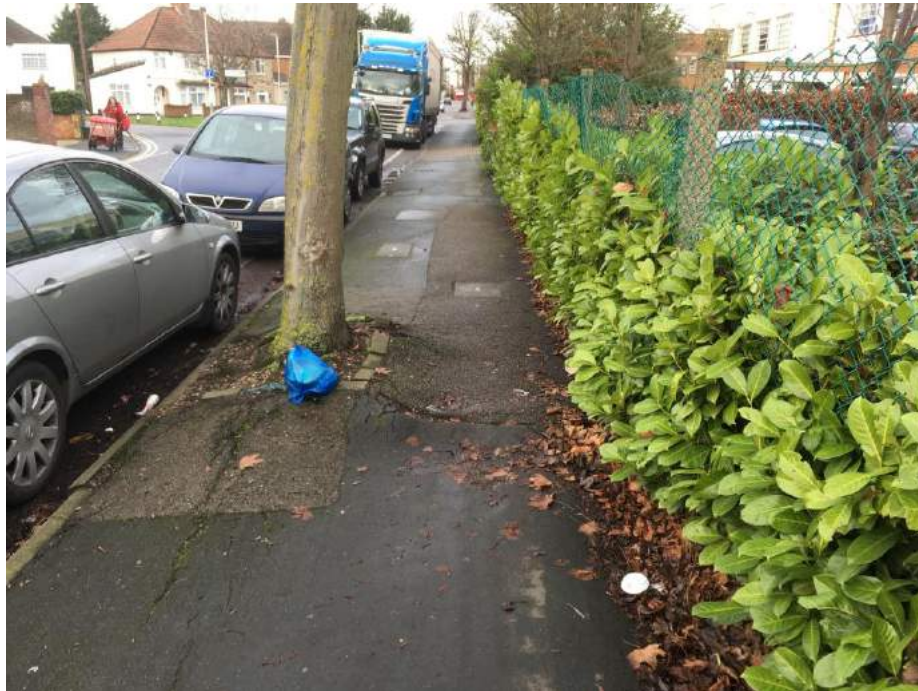
- 5.4 The majority of Nestle Avenue has a wide and safe footway, however trees along the pathway have affected the footway creating trip hazards and reduced footway widths. These potential issues are demonstrated in **Photo 2**.

Photo 2 – Trip hazard North Western side of Footway, Nestle Avenue

facilities. It is noted that the links surrounding the site achieved only an average score suggesting that footpath's improvements will provide a better pedestrian linkage between the station and other local facilities located in close proximity to the site. The only improvements needed in regards to links are along Nestle Avenue. Improvements are needed to ensure that footpath surfaces are flat and free of trip hazards / obstacles such as the uneven footpaths adjacent to trees.

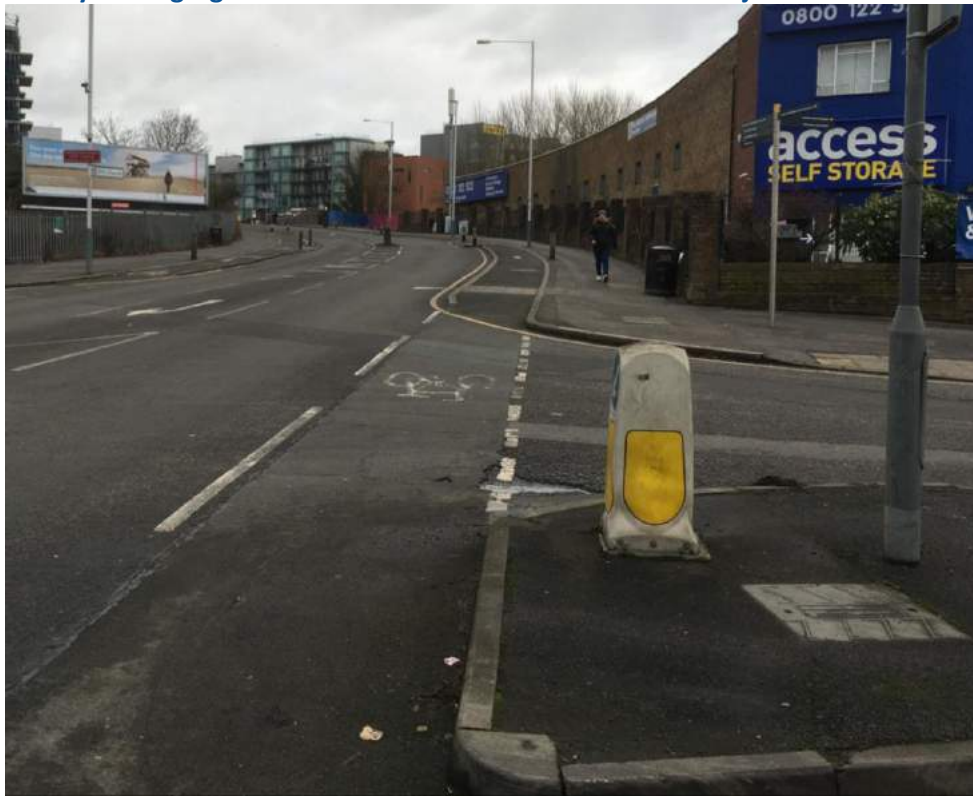
- 5.5 **Photos 3 and 4** show a typical footway on the roads surrounding the site (Station Road and North Hyde Road) which both received an overall 'Average' (Amber) RAG score. The footways have widths varying between 2m-4m, are well lit, and benefit from desirable gradient, however both suffer with low to average surface quality. Station Road benefits from pedestrian friendly markings with pedestrian way-finder signs and Legibility London boards in different locations along this route.

Photo 3 – Station Road access leading to Hayes and Harlington Station and the town centre, with way-finding signs on the Station Road and Nestle Avenue junction.

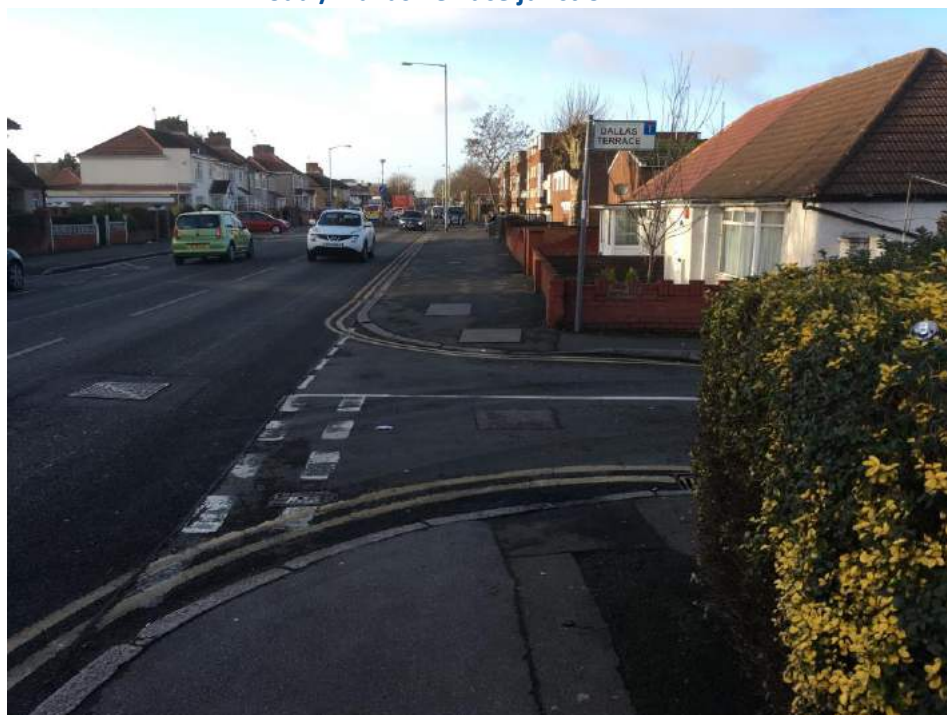
- 5.6 North Hyde Road provides an effective footway width which is adequate for the capacity using this route, however North Hyde Road scores negatively for tactile information and drop kerb facilities. North Hyde Road either provides poor quality tactile information or none at all, discouraging pedestrians from using this route.

Photo 4 – North Hyde Road footway widths and lack of tactile information on the North Hyde Road / Dallas Terrace junction

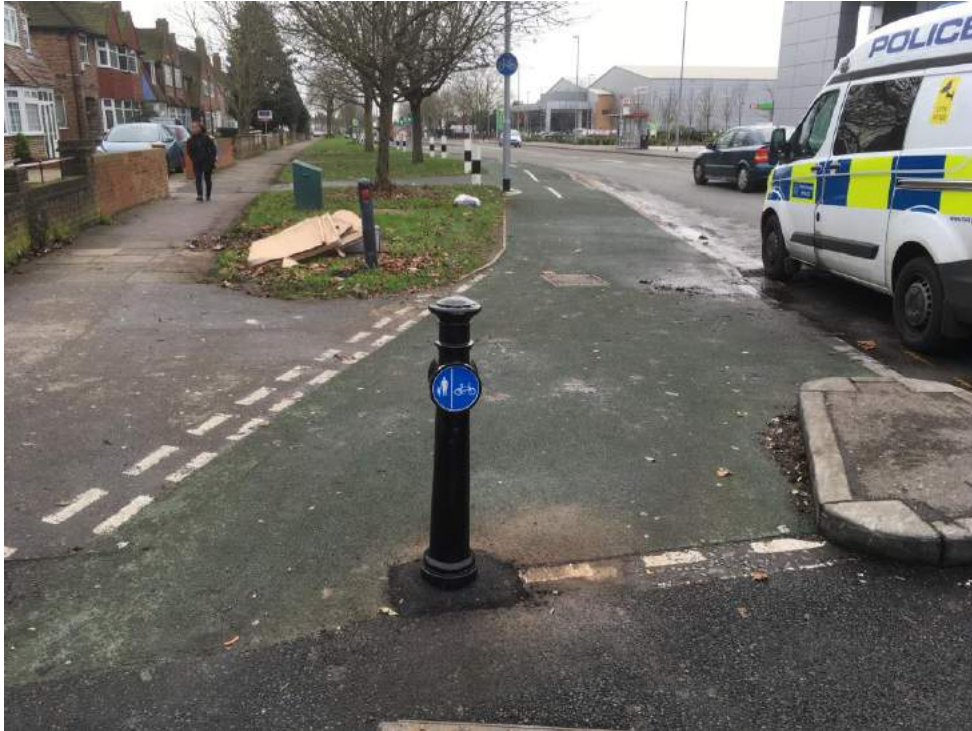
- 5.7 **Photo 5 and 6** present Station Road travelling south, which has recently experience major improvements due to the ASDA supermarket development. Station Road on both the eastern and western side scored highly, with high quality surfaces and wide and effective footways. The eastern side of Station Road was awarded a high level for its segregation from the cycle lane, providing a safe pedestrian and cycle route for both users, which is presented in **Photo 5**.

Photo 5 – Station Road eastern side, with segregated pedestrian footway and cycle lane

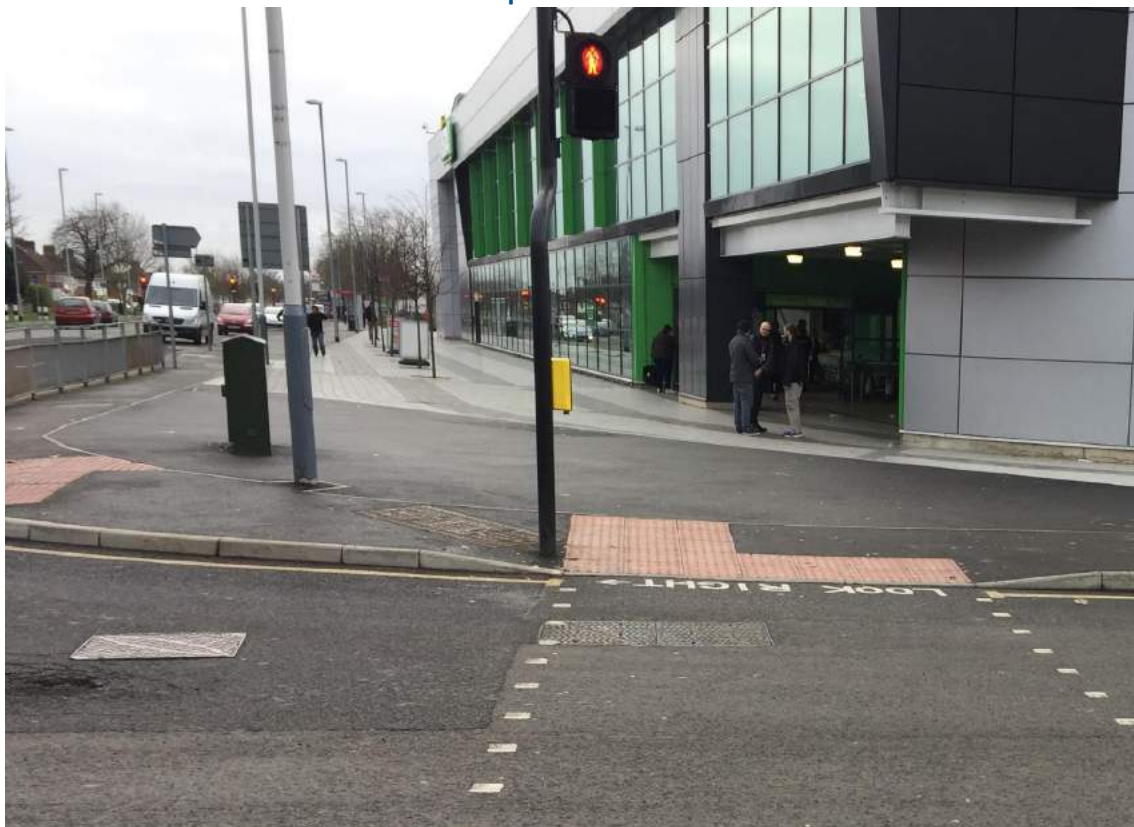
Photo 6 – Improved pedestrian footpath and pedestrian crossing outside the new ASDA supermarket

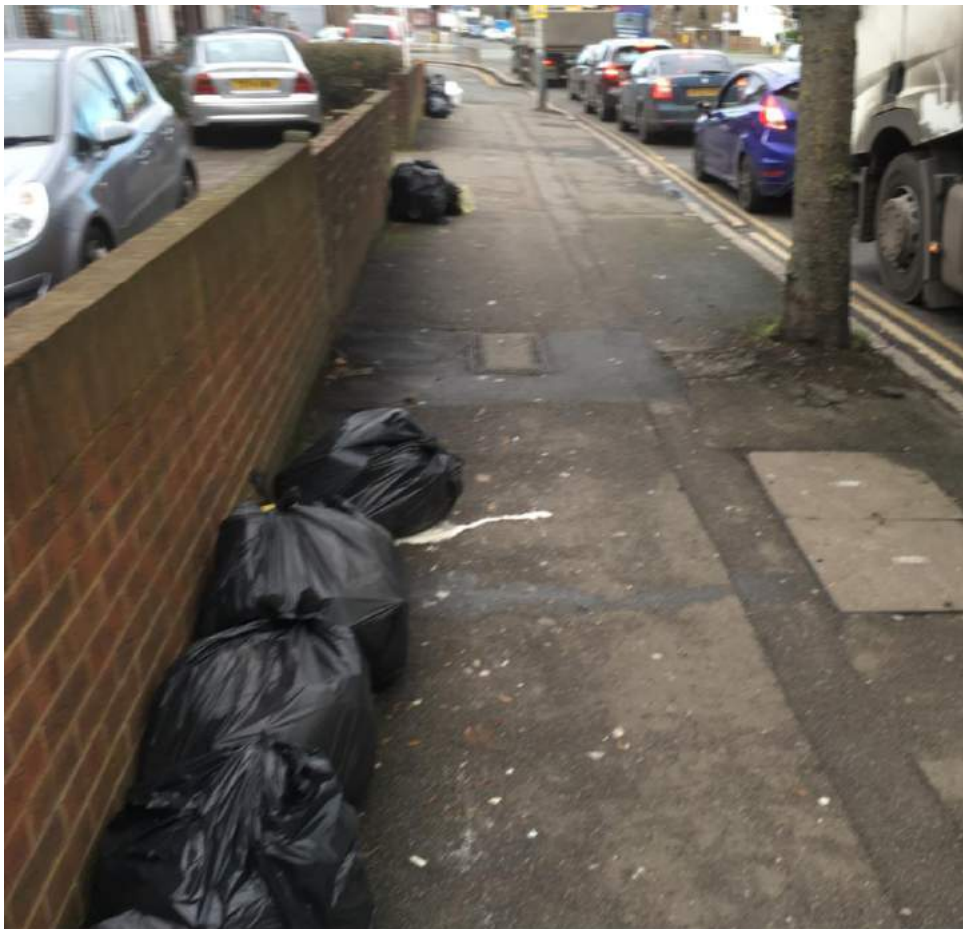
- 5.8 **Photo 7** shows the south-western side of the North Hyde Road (L7), which received an 'Average' (Amber) score. The link was scored negatively for surface quality, lack of tactile information at junctions, trip hazards due to raised footpath due to tree roots and an uneven footpath, cleanliness and drainage. **Photo 7** below demonstrates the poor quality of the footway and the bins bags which are outside every house along the street.

Photo 7 – Residential bin-bags located along the south-western side of the North Hyde Road

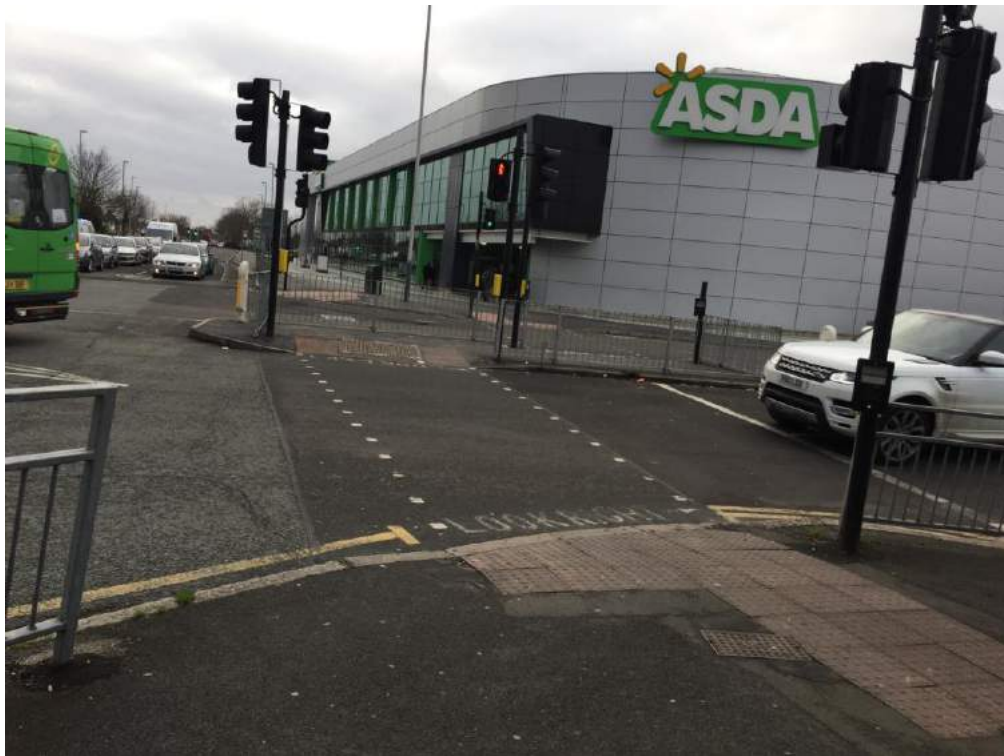
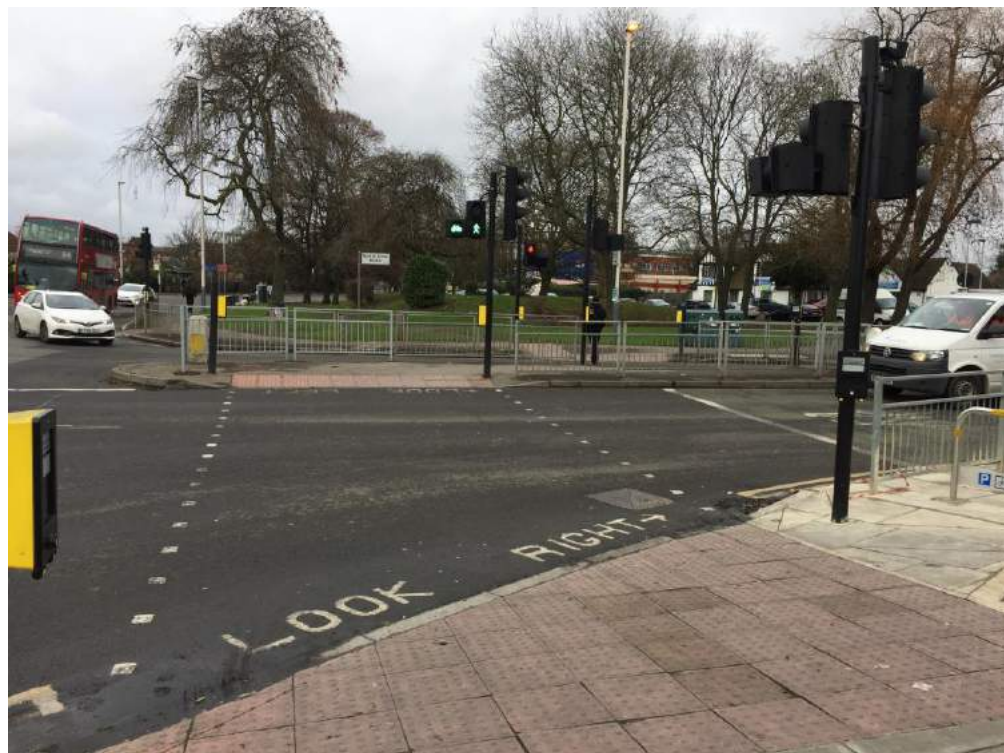
6.4 **Photo 8 and 9** shows the staggered signalised pedestrian crossings at Station Road / North Hyde Road (C4) and these crossing were rated as 'Good' (Green). As is evident, the tactile paving and dropped kerbs are fit for purpose, adequately maintained and are located along pedestrian desire lines. The refuge island is of adequate width and size for the capacity of people using the crossing.

Photo 8 – Station Road / North Hyde Road - Signalised Crossing (C4)

Photo 9 – Station Road / North Hyde Road - Signalised Crossing (C4)

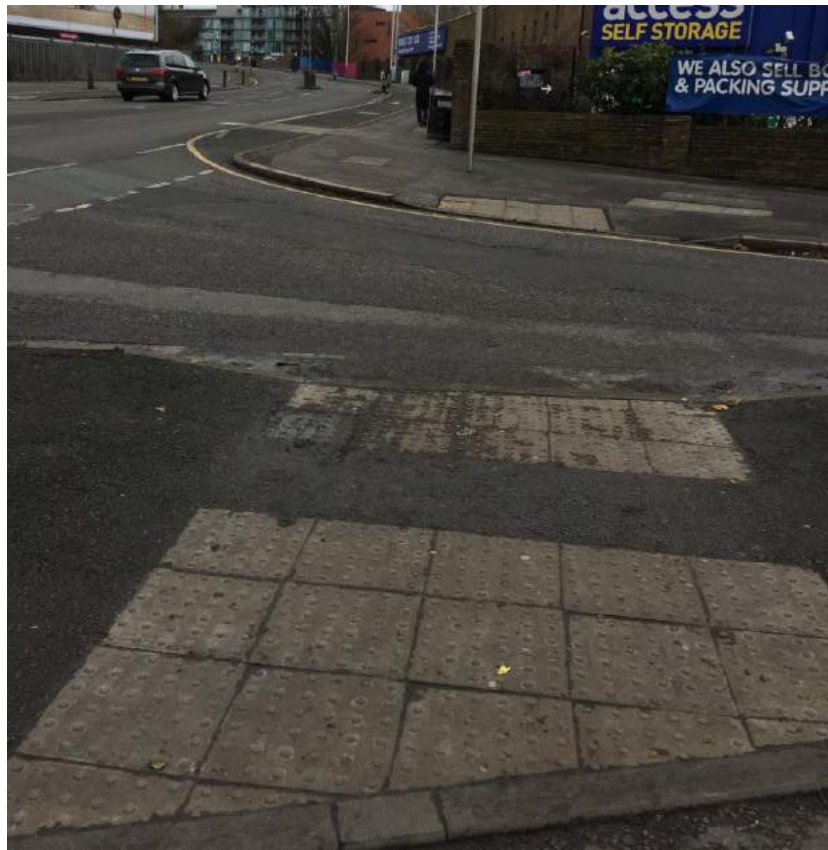
- 6.5 **Photo 10** show details of the Station Road / Nestle Avenue / Keith Road refuge island crossings (C1). **Photo 10** displays that the crossing provides adequate refuge island width, tactile information with colour contrast to help the partially sighted and benefits from a desirable gradient. However, the crossing didn't score so highly for cleanliness, drainage, and trip hazards. The photo displays evidence of mud and ponding which could cause people to slip.

Photo 10 – Junction of Nestle Avenue / Station Road – Refuge Island Crossing (C1)

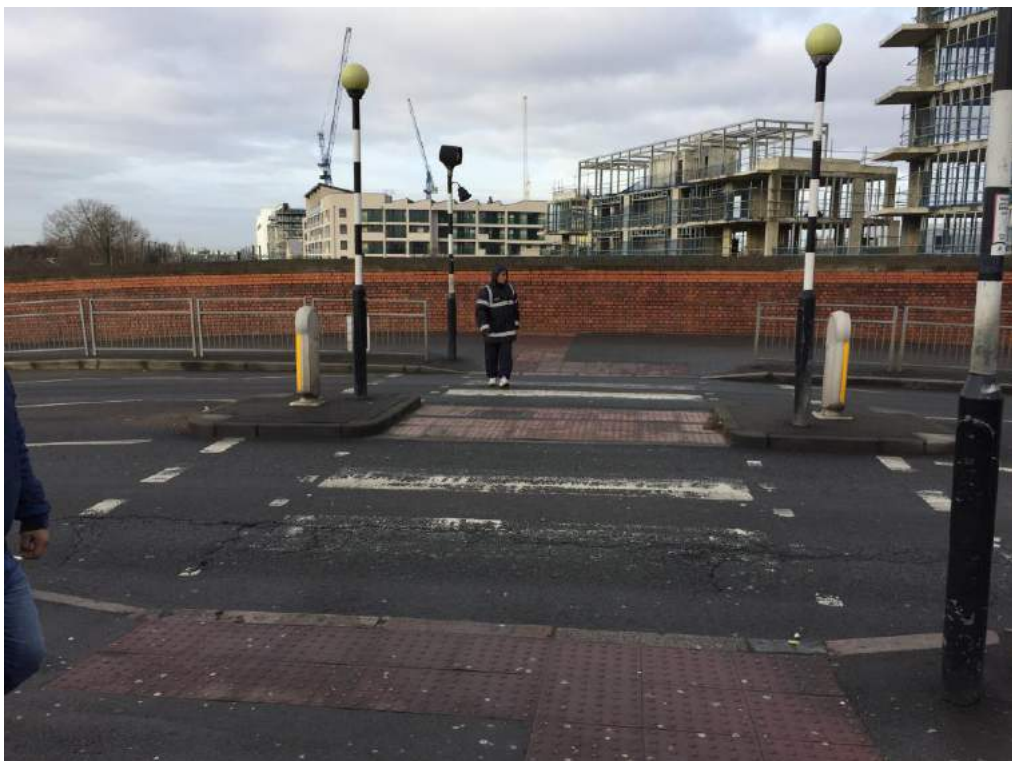
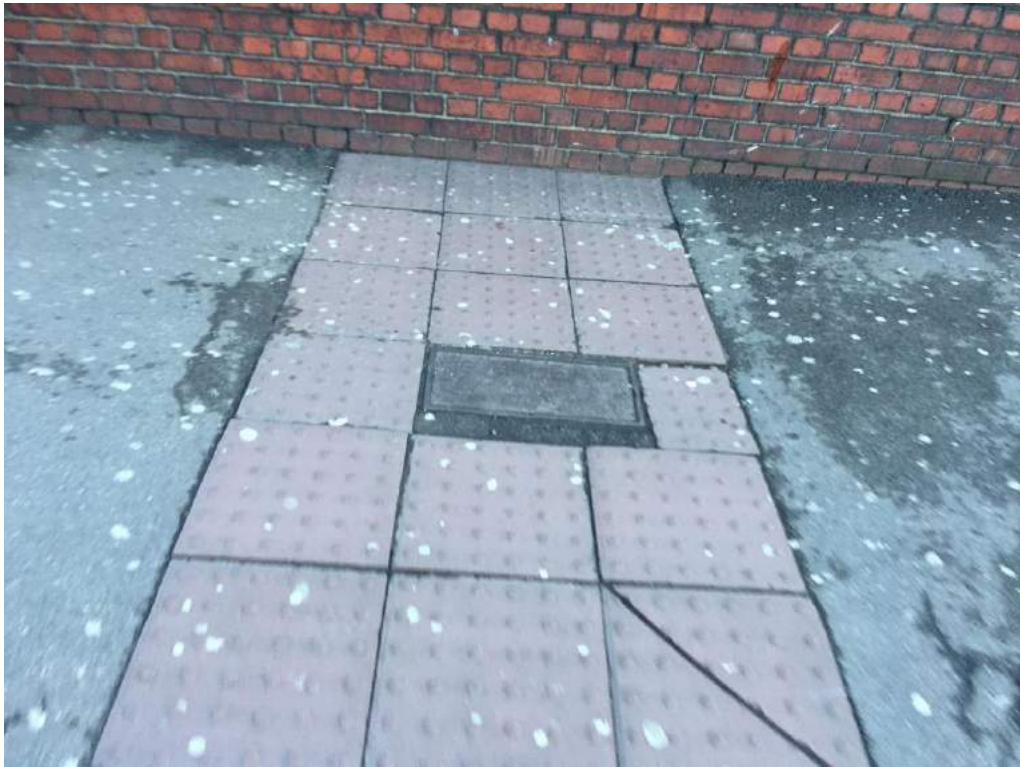
- 6.6 **Photo 11 and 12** identify the zebra crossing located on Station Road (C2), located north of Hayes and Harlington Station. This zebra crossing was awarded a 'Good' score (Green) due to crossing performance, crossing capacity and the short waiting time to cross. The crossing scored negatively for tactile information. **Photo 12** also identifies that although the tactile information has colour contrast, there are drain covers over the tactile on the centre island as well as on the eastern side of station road, which could be confusing for blind or partially sighted pedestrians. The crossing also suffered negative scoring for clear crossing lines and litter/chewing gum, which is clearly presented in **Photo 11 and 12** below.

Photo 11 – Station Road - Zebra Crossing (C2)

Photo 12 – Poor tactile information on the Station Road – Zebra Crossing (C2)

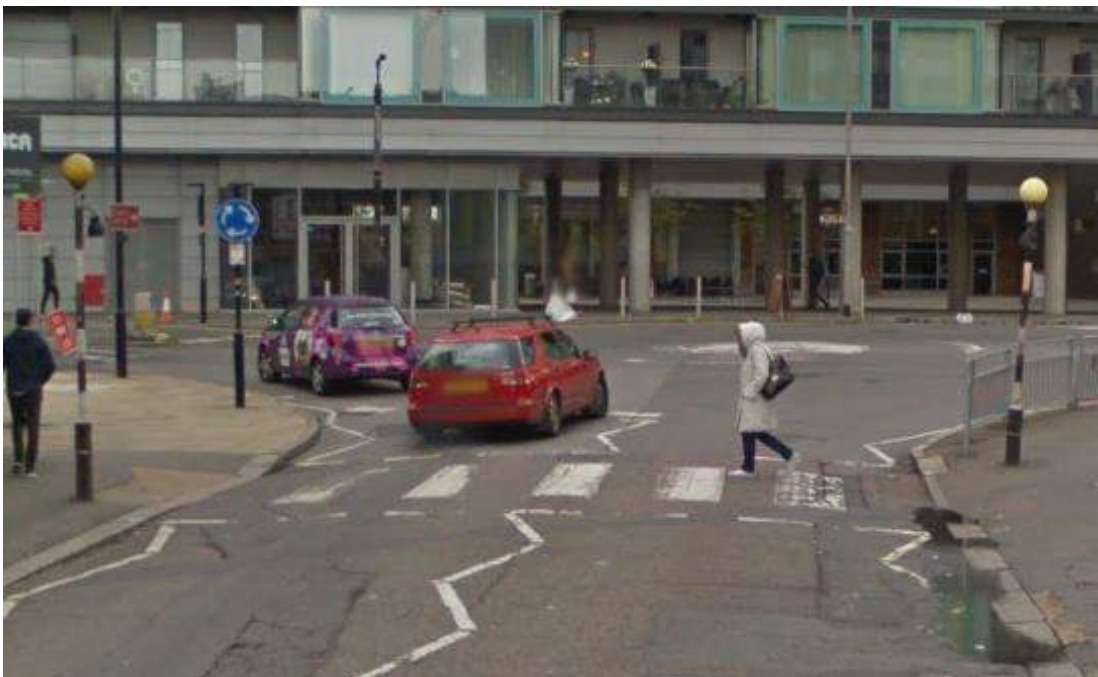
- 6.7 The Station Road / Clayton Road zebra crossing (C5) was awarded a low 'Average' (Amber) score, and is shown below as **Photo 13**. The low scoring is due to the lack of tactile information on both sides of the zebra crossing. Therefore, this is a dangerous crossing for partially sighted and blind pedestrians due to the lack of tactile and lack of signalised crossing information. The crossing also scored negatively due to drainage and trip hazards on the crossing, as well as unclear zebra crossing lines.

Photo 13 – The Station Road / Clayton Road zebra crossing (C5)

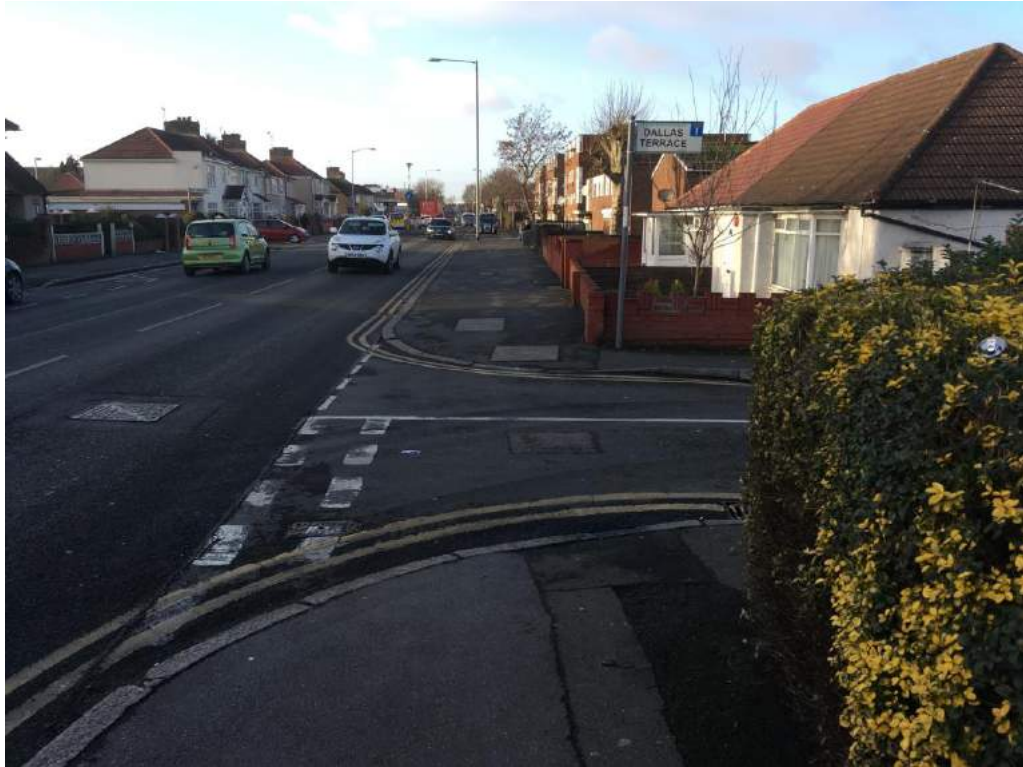
6.8 The North Hyde Road was awarded low scores while being assessed as a number of links (L8, L9, L11 and link L12), due to lack of tactile information along this road on a number of different

small junctions. **Photo 14** below conveys the typical crossing along this road, showing the lack of tactile information, which is dangerous for partially sighted and blind pedestrians crossing here.

Photo 14 – Lack of tactile at the North Hyde / Dallas Terrace junction

6.9 In summary, and as indicated in **Table 6.1**, although some of the highlighted suffer from poor tactile information, the majority of assessed crossings benefit from appropriate crossing provision, well maintained tactile dropped kerb facilities along the desire line and a good level of legibility for all users. The score achieved by the zebra crossing situated on the junction of Station Road / Clayton Road (C5) was a low average, which needs improvements in regards to legibility for all user types, particularly tactile information. These improvements are anticipated to raise their scores.

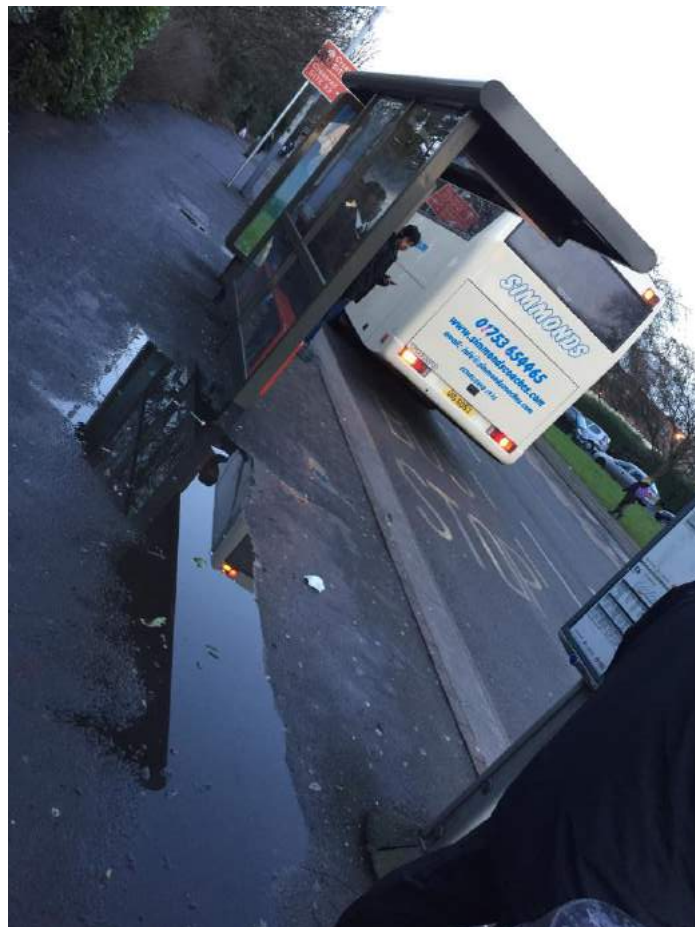
- 7.4 There are no existing bus stops along Nestle Avenue, with the closest bus stops to the site being situated along North Hyde Road and Station Road. A bus stop situated close to the site is the sheltered bus stop located to the north of the Station Road / North Hyde Road Junction. This bus stop is shown in **Photo 15**, and is typical of the Public Transport Waiting Area's identified within this audit and scored a 'Good' (Green) rating (PT10). This bus stop waiting area score highly for public transport information, raised kerbs and gaps minimised, infrastructure at waiting area including real time information, and area waiting comfort due to the shelters capacity and seating being easy to reach. The bus stop did score negatively for drainage and evidence of neglect, due to heavy ponding in close proximity to the bus stop, which is identified in **Photo 15**.

Photo 15 - Sheltered bus stop located to the north of the Station Road / North Hyde Road Junction

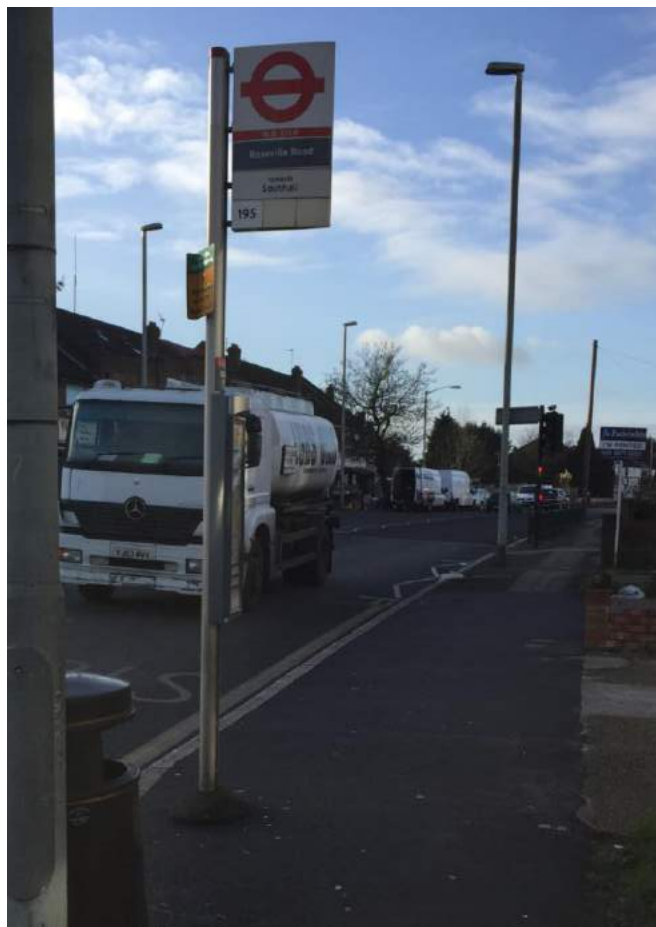
- 7.5 **Photo 16**, identifies the flag bus stop situated on North Hyde Road (PT6). This bus stop was scored an 'Average' (Amber) rating due to the lack of waiting area comfort, lack of security measures and poor lighting facilities. The bus stop scored highly for sightlines and cleanliness which is clear from **Photo 16** below.

Photo 16 – Flag Bus Stop situated on the north-western side of North Hyde Road

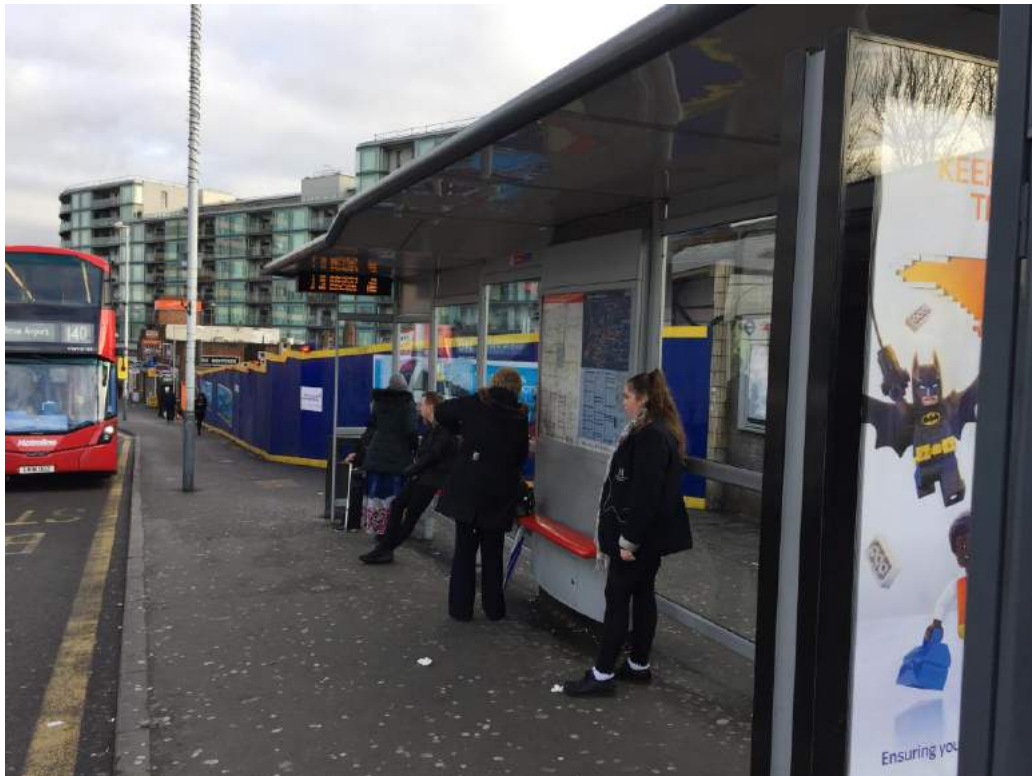
- 7.6 **Photo 17** shows the two sheltered bus stops located on Station Road and close to the Hayes and Harlington Station. The eastern side bus stop (PT4) which is directly adjacent to the station access scored a 'Good' (Green) rating, and is presented in **Photo 17**. The station scored very highly in regards to public transport information and real time information. The bus stop also scored highly for security measures including formal surveillance, informal surveillance and publicised surveillance. The western bus stop (PT11) on Station Road, which is opposite the Hayes and Harlington Station but on the opposite side of the road. The bus stop was scored an 'Average' (Amber) rating, due to lack of pedestrian crossing at pedestrian desire

lines. Pedestrians were witnessed leaving the bus and crossing Station Road dangerously, not using the northern zebra crossing to enter the station. The bus stop also scored negatively for capacity, but scored highly for the information provided at the waiting area which included real time information, well-lit and adequate drainage.

Photo 17 – Sheltered Bus Stop on the Eastern side of Station Road, adjacent to Hayes and Harlington Station (PT4)
