**SUBJECT**  
**Response to Drainage Planning questions –**  
**Warrender Primary School**

**CLIENT**  
 London Borough of Hillingdon

**DATE**  
 01 February 2017

**PROJECT NUMBER**  
 35311100

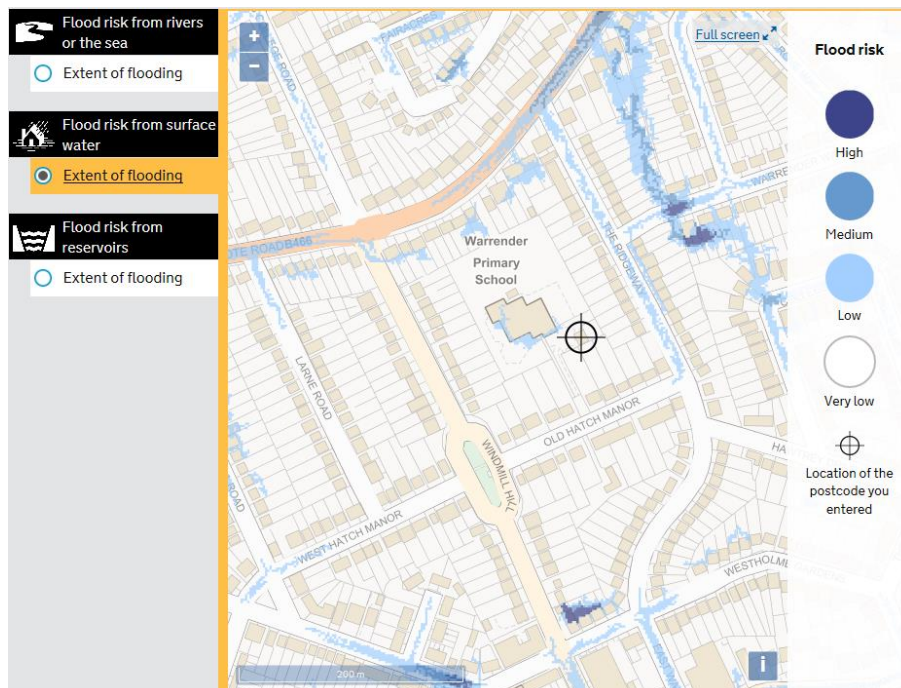
Evidence of surface water flooding to the north of the site was identified by the Waterco Consultants Flood Risk Assessment in October 2016. See Figure 1 below, Flood Risk from Surface Water Flooding.

We were advised during design team meeting with the school that during extreme storm events, surface runoff from the paved courts within the school boundary flowed over the grassed area to the north of the school, and towards the residential houses on Eastcote Road. This was identified as flooding to gardens only and no cases of properties flooding was brought to the attention of the Design Team.

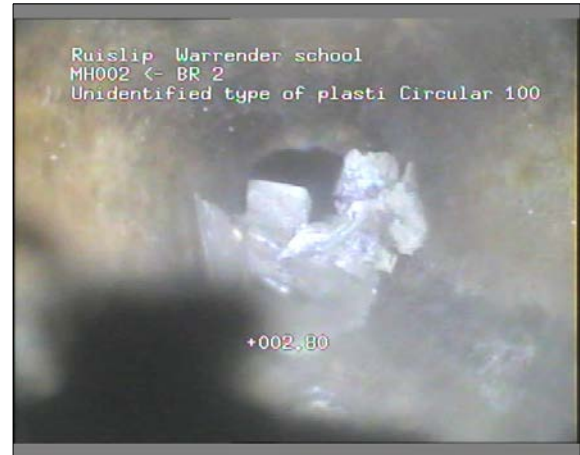
Photo: 4\_4\_14\_A.JPG  
 2.8m, Settled deposits, hard or compacted, 70% cross-sectional area loss

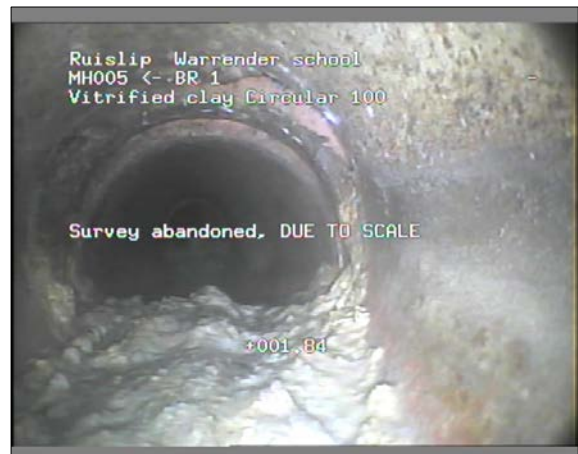
Structural defects			
Section	PLR	Grade	Fault description
6	BR 1 X	5	Deformed sewer/drain, 60%
13	BR 1 X	3	Fracture, circumferential, from 9 to 3 o'clock
20	MH007 X	5	Multiple defects at 24.3m

Photo: 14\_14\_55\_A.JPG  
 1.71m, Fracture, circumferential, from 9 to 3 o'clock

Grade 3; Best practice suggests consideration be given to repair in the medium term

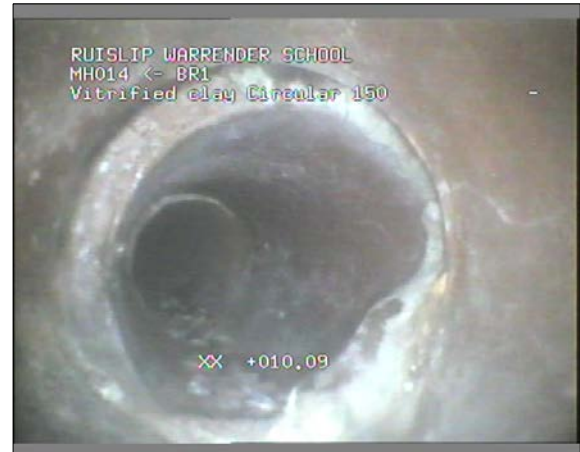
Photo: 48\_48\_183\_A.jpg  
10.09m, Joint displaced, medium
