Site Vision Surveys

Warrender School

19 December 2016

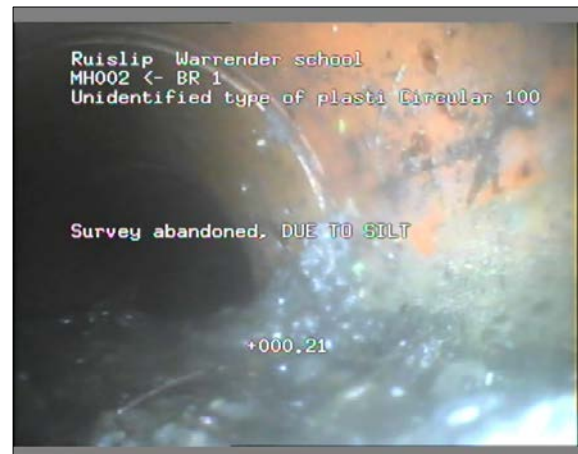
Photo: 3\_3\_8\_A.JPG  
 0.21m, Settled deposits, fine, 40% cross-sectional area loss

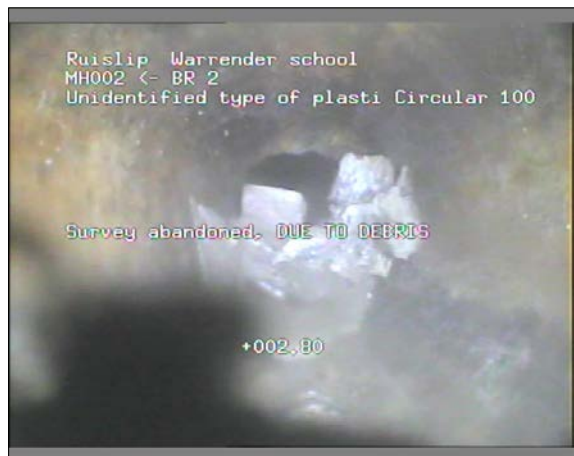
Photo: 4\_4\_14\_A.JPG  
2.8m, Settled deposits, hard or compacted, 70% cross-sectional area loss

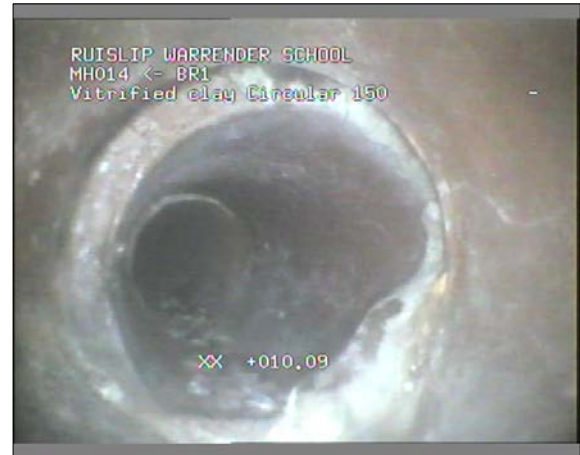
Photo: 48\_48\_183\_A.jpg  
10.09m, Joint displaced, medium
