ARTEMIS
TREE
SERVICES

London School of Theology,
Green Lane, Northwood,
HA6 2UW

29th November 2022

Arboricultural Report AR-26450

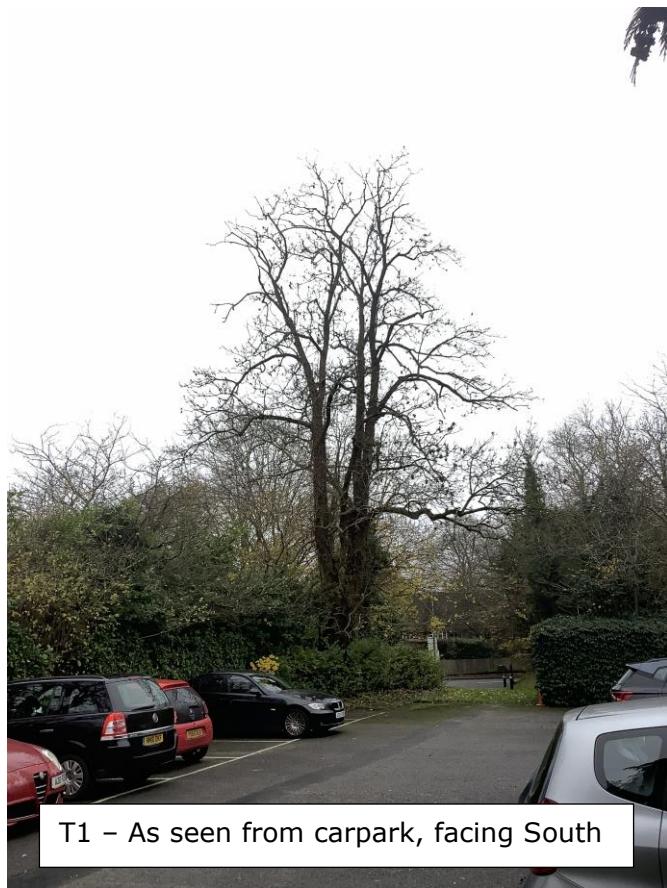
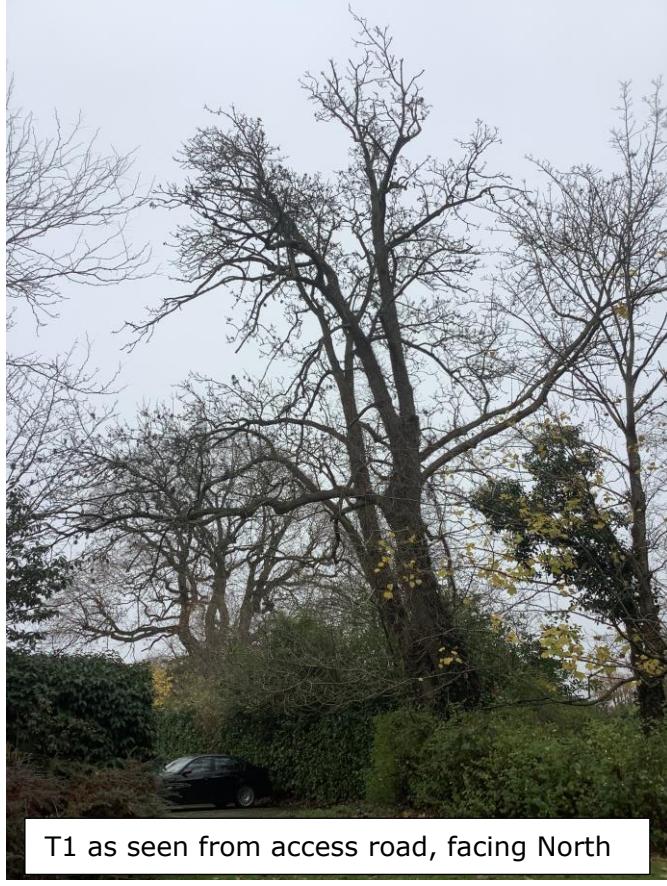
- 10.1 The tree has a noticeably sparse crown from around 8-9m upwards with major deadwood (over approximately 40mm diameter) visible throughout and major deadwood noted on the ground around the tree. It is possible that the tree is in decline though this is difficult to confirm from a single visit.

- 10.2 The twin stems of the tree do not appear to have fused together and have formed an included area of bark from the base upto around 3m. This is a potential area of structural weakness and could become an issue if the tree continues to add annual incremental growth. If the tree is not determined to be in terminal decline in future visits and can be retained for the reasonably foreseeable future, it would be prudent to install a flexible bracing system within the crown to help distribute additional stress between the stems during adverse weather conditions.

- 10.4 The dead Ivy is not likely to cause any serious issue, though does partially obscure closer inspection of the stems making any possible bleeding areas, cracking or fungal fruiting bodies hard to identify (should they occur). This Ivy should be removed to aid future inspections of the tree.

- 10.3 It is highly recommended that the major deadwood is removed as soon as reasonably practicable to prevent branches falling into the adjacent parking bays . This work is likely to leave the upper crown sparse and unbalanced overall and it is therefore recommended that the lower crown is reduced to shape and rebalance.
