# Drainage Report

**Uxbridge College**  
**Uxbridge**

**1ST CALL DRAIN CLEARANCE & TECHNICAL SERVICES LTD**

## Uxbridge College 31 07 19 - CCTV Survey Report : 31/07/19

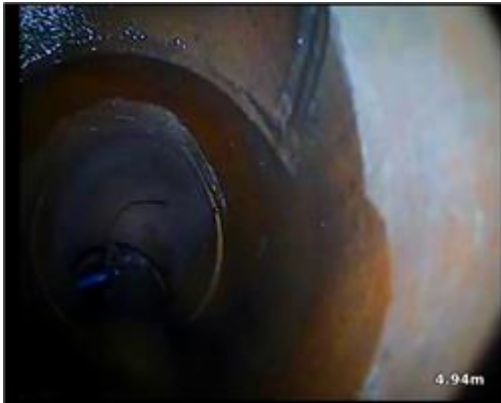
| Pos | Video Ref | Code | Description | Image |
|---|---|---|---|---|
| 04.94m | 0:00:28 | CN | Connection other than junction at 12 o'clock: 100mm Diameter<br>Blind connection from Gully 2 | Image Provided - Ref: 0_2<br> 4.94m |

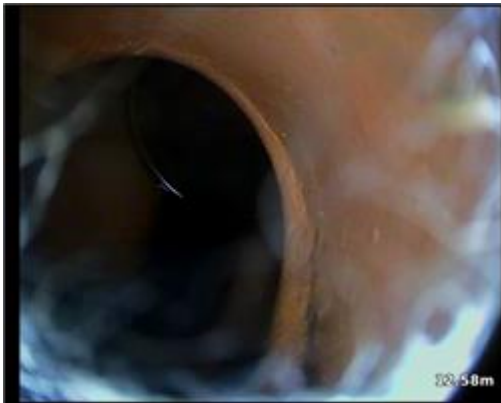
| Pos | Video Ref | Code | Description | Image |
|---|---|---|---|---|
| 12.58m | | SA | Survey abandoned<br>Survey abandoned, camera unable to pass multiple bends | Image Provided - Ref: 0_9999<br> 12.58m |

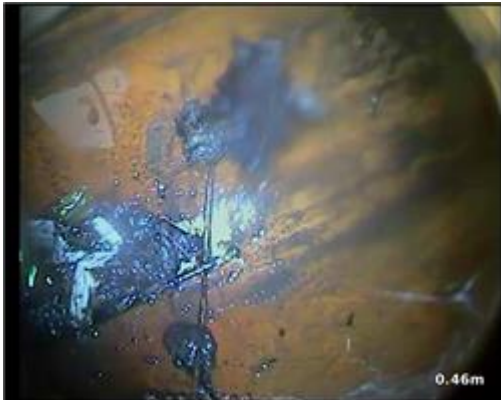
| Pos | Video Ref | Code | Description | Image |
|---|---|---|---|---|
| 00.46m | | OCF | Finish node type, other special<br>chamber<br>Entry to Mainline | <p>Image Provided - Ref: 1_9999</p> |

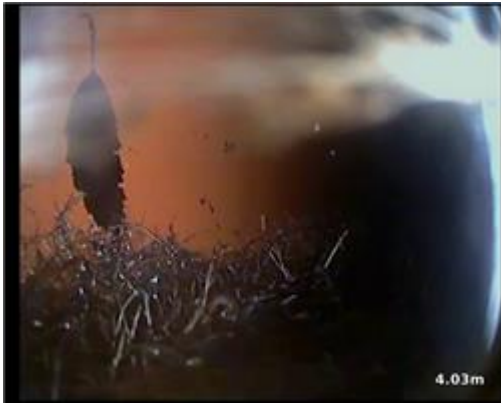
| Pos | Video Ref | Code | Description | Image |
|---|---|---|---|---|
| 04.03m | 0:00:22 | R | Roots - Severity 3<br>Root Ingress | Image Provided - Ref: 3_2<br> 4.03m |

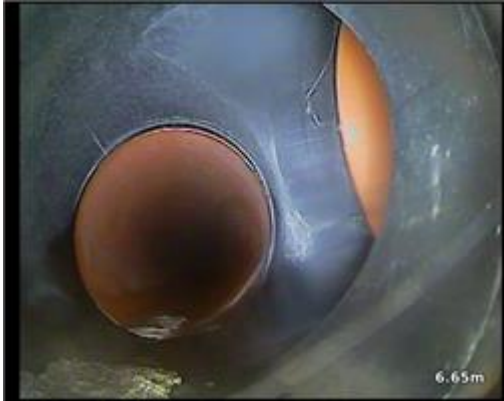
| Pos | Video Ref | Code | Description | Image |
|---|---|---|---|---|
| 06.65m | 0:01:01 | CN | Connection other than junction<br>at 03 o'clock: 0mm Diameter<br>Blind connection | Image Provided - Ref: 4_2<br> |

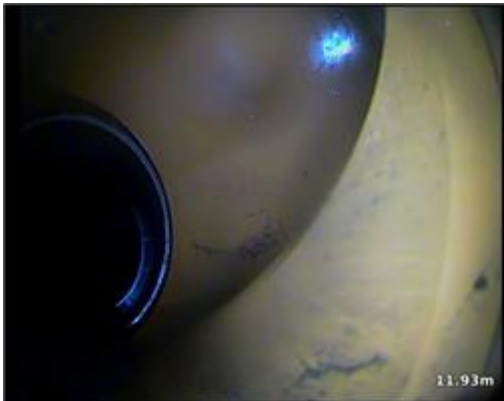
| Pos | Video Ref | Code | Description | Image |
|---|---|---|---|---|
| 11.93m | 0:01:45 | CN | Connection other than junction<br>at 02 o'clock: 0mm Diameter<br>Blind connection | Image Provided - Ref: 4_3<br> |

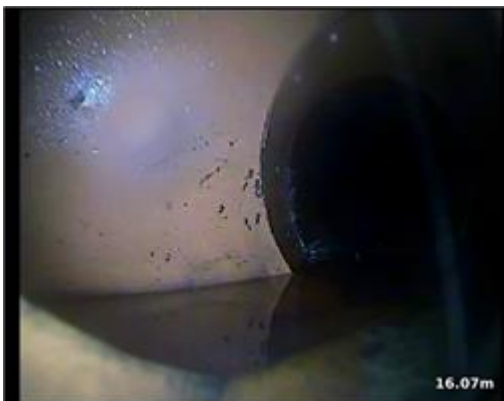
| Pos | Video Ref | Code | Description | Image |
|---|---|---|---|---|
| 16.07m | 0:02:30 | CN | Connection other than junction<br>at 09 o'clock: 0mm Diameter<br>Blind connection. | Image Provided - Ref: 4_4<br> |

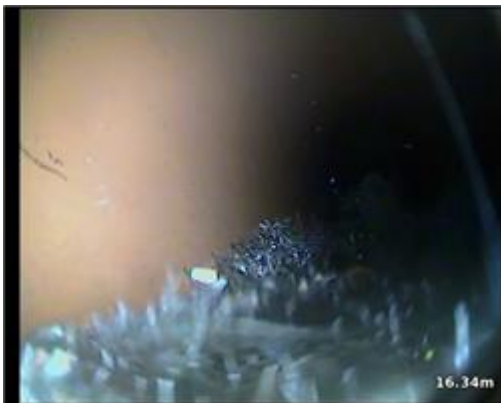
| Pos | Video Ref | Code | Description | Image |
|---|---|---|---|---|
| 16.34m | 0:02:33 | R | Roots - Severity 3<br>Root Ingress | Image Provided - Ref: 4_5<br> 16.34m |

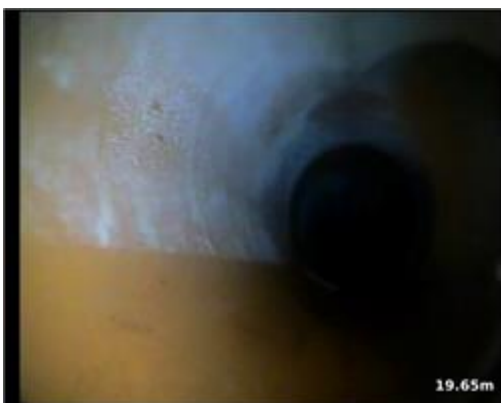
| Pos | Video Ref | Code | Description | Image |
|---|---|---|---|---|
| 19.65m | 0:03:17 | CN | Connection other than junction<br>at 03 o'clock: 0mm Diameter<br>Blind connection | Image Provided - Ref: 4_6<br> 19.65m |

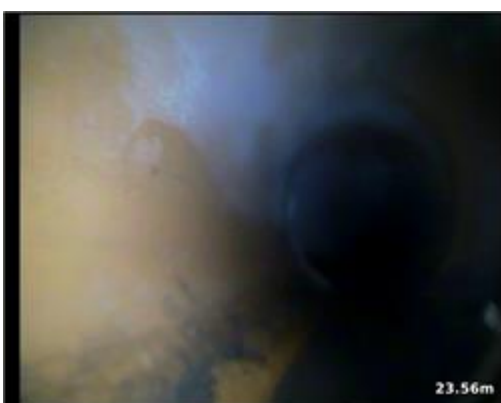
| Pos | Video Ref | Code | Description | Image |
|---|---|---|---|---|
| 23.56m | 0:04:01 | CN | Connection other than junction<br>at 03 o'clock: 0mm Diameter<br>Blind connection | Image Provided - Ref: 4_7<br> 23.56m |

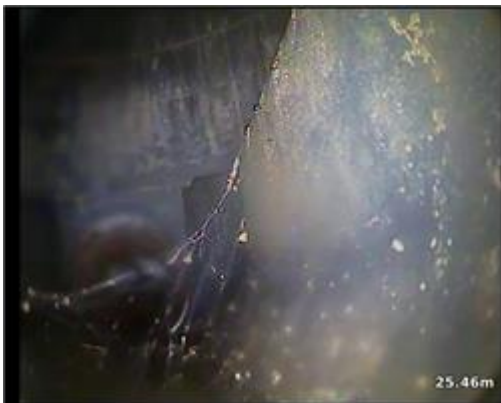
| Pos | Video Ref | Code | Description | Image |
|---|---|---|---|---|
| 25.46m | | MHF | Finish node type, manhole S1 | <p>Image Provided - Ref: 4_9999</p> |

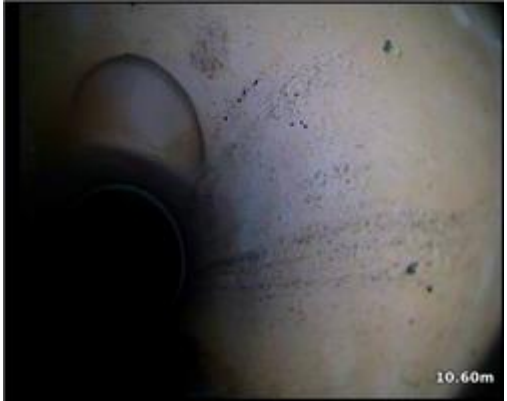
| Pos | Video Ref | Code | Description | Image |
|---|---|---|---|---|
| 10.60m | 0:00:40 | CN | Connection other than junction<br>at 01 o'clock: 100mm<br>Diameter<br>Blind connection | Image Provided - Ref: 5_2<br> 10.60m |

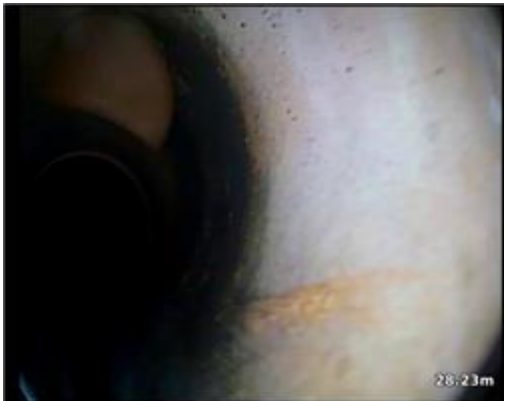
| Pos | Video Ref | Code | Description | Image |
|---|---|---|---|---|
| 28.20m | 0:01:40 | CN | Connection other than junction<br>at 01 o'clock: 100mm<br>Diameter<br>Blind connection | Image Provided - Ref: 5_3<br> 28.23m |

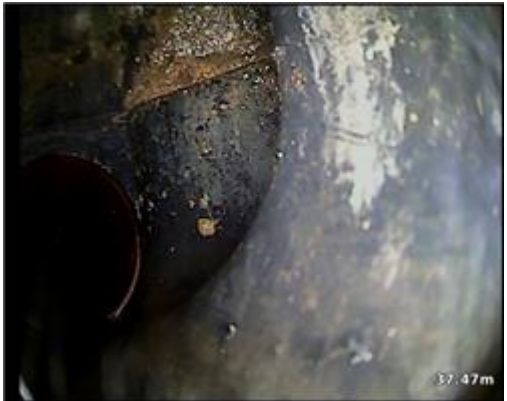
| Pos | Video Ref | Code | Description | Image |
|---|---|---|---|---|
| 37.47m | | MHF | Finish node type, manhole<br>S2 - Concealed | Image Provided - Ref: 5_9999<br> 37.47m |
