# ARBORICULTURAL ASSESSMENT REPORT

| <b>For:</b> | <b>Client:</b> | Sedgwick International UK |
| | <b>Address:</b> | 133 Long Lane, Hillingdon, Uxbridge, Middlesex, UB10 0AT |
| <b>Refs:</b> | <b>PRI Ref:</b> | 129407 |

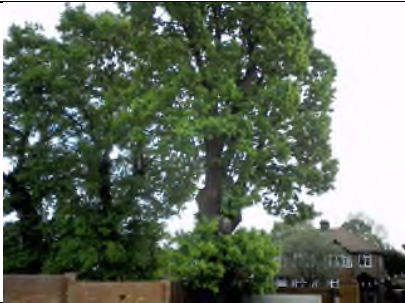
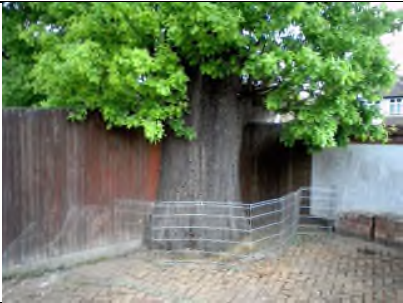
| T1 - Oak | T1 - Oak |

| Tree No | Common Name | Age Class | Condition | Height (m) | Crown Spread (m) | Stem diam. (mm) | Dist to bldg. (m) | Roots Implicated | Pruning history | Recommendation | Tree work constraints | Notes | Owner address | Owner |
|---|---|---|---|---|---|---|---|---|---|---|---|---|---|---|
| T1 | Oak | Mature | Fair | 18.1 | 7.0* | 950* | 14 | Y | Subject to recent management | Fell and Treat Stump | | | 133 Long Lane<br>Hillingdon<br>Uxbridge<br>Middlesex<br>UB10 0AT | PH |

| Tree No: | Species | Works Required |
|---|---|---|
| T1 | Oak | Fell and Treat Stump |

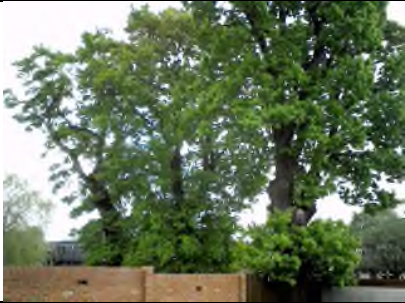
| T2 - Oak | T3 - Oak |

| Tree No | Common Name | Age Class | Condition | Height (m) | Crown Spread (m) | Stem diam. (mm) | Dist to bldg. (m) | Roots Implicated | Pruning history | Recommendation | Tree work constraints | Notes | Owner address | Owner |
|---|---|---|---|---|---|---|---|---|---|---|---|---|---|---|
| T2 | Oak | Mature | Fair | 17* | 6* | 800* | 17* | Y | Subject to recent management | Fell and Treat Stump | | | 135 Long Lane<br>Hillingdon<br>Uxbridge<br>Middlesex<br>UB10 0AT | P3P |

| Tree No: | Species | Works Required |
|---|---|---|
| T2 | Oak | Fell and Treat Stump |

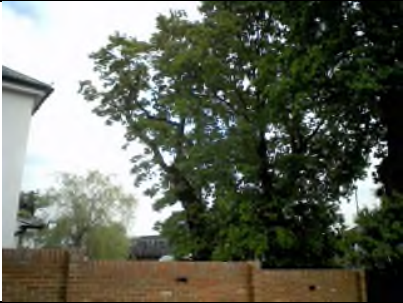
| Tree No | Common Name | Age Class | Condition | Height (m) | Crown Spread (m) | Stem diam. (mm) | Dist to bldg. (m) | Roots Implicated | Pruning history | Recommendation | Tree work constraints | Notes | Owner address | Owner |
|---|---|---|---|---|---|---|---|---|---|---|---|---|---|---|
| T3 | Oak | Mature | Fair | 16.5 | 6 | 900* | 18* | Y | Subject to recent management | Fell and Treat Stump | | | 135 Long Lane<br>Hillingdon<br>Uxbridge<br>Middlesex<br>UB10 0AT | P3P |

| Tree No: | Species | Works Required |
|---|---|---|
| T3 | Oak | Fell and Treat Stump |

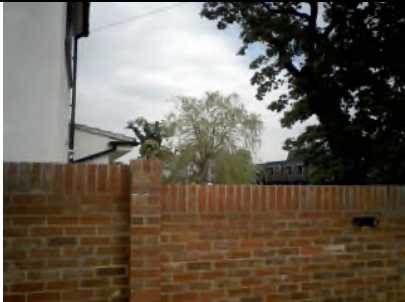
| T4 - Willow | |

| Tree No | Common Name | Age Class | Condition | Height (m) | Crown Spread (m) | Stem diam. (mm) | Dist to bldg. (m) | Roots Implicated | Pruning history | Recommendation | Tree work constraints | Notes | Owner address | Owner |
|---|---|---|---|---|---|---|---|---|---|---|---|---|---|---|
| T4 | Willow | Mature | Fair | 13* | 8* | 300* | 31* | N | Subject to recent management. | No work required. | | | 135a Long Lane<br>Hillingdon<br>Uxbridge<br>Middlesex<br>UB10 0AT | P3P |
