# Optera Structural Solutions

## Arboricultural Method Statement to install root barrier across the front of the property & neighbouring property.

**POLICY HOLDER ADDRESS:** 133 Long Lane, Hillingdon, Uxbridge, Middlesex, UB10 0AT

**OUR REFERENCE:** 5549

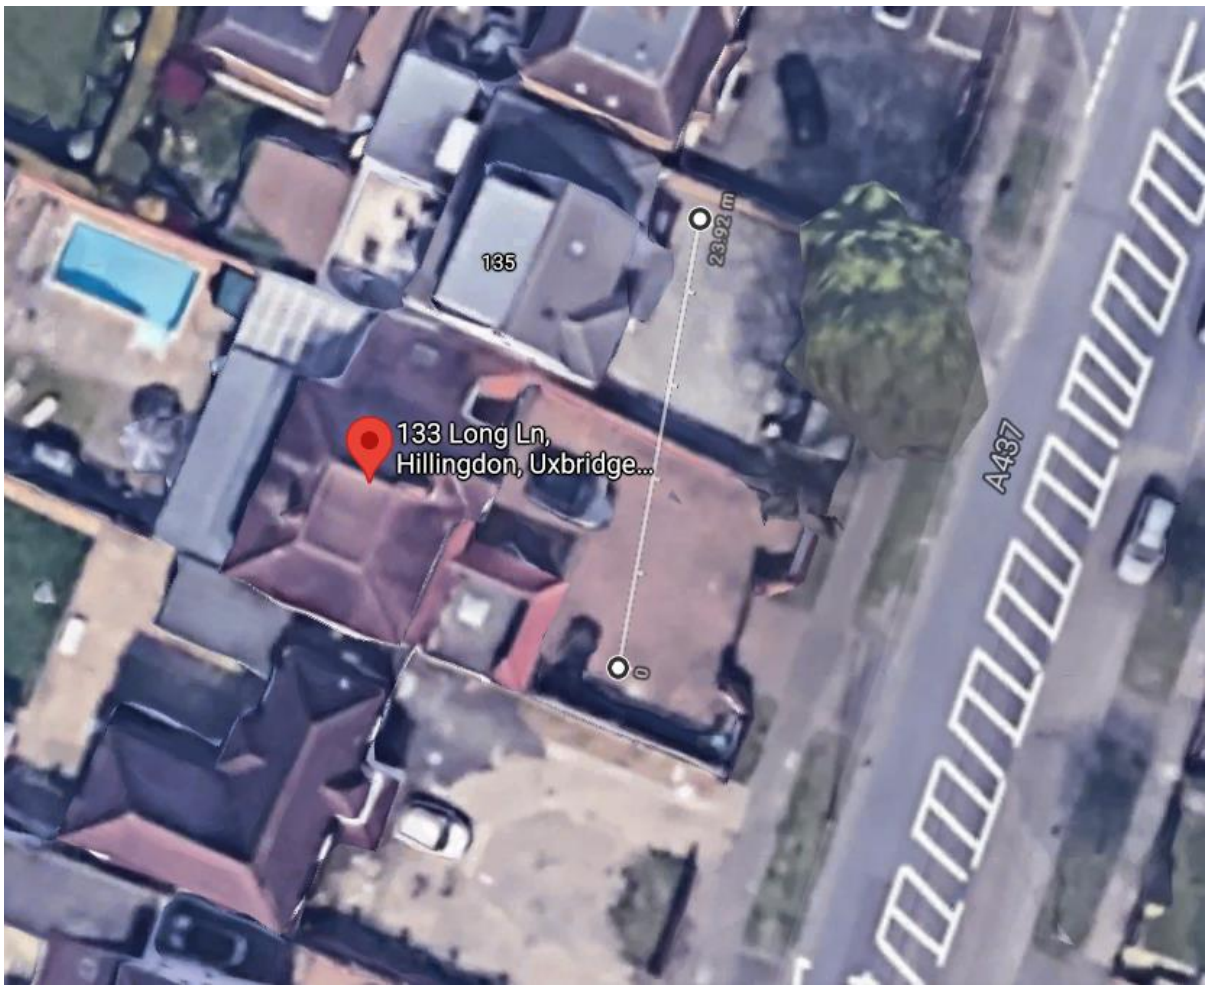
The aerial image below indicates the size and position of the proposed barrier:

The barrier will cover the front of the insured's property and also the neighbouring property at 135 as they have trees in their garden and simply excavating to the boundary would pose risk of the barrier being outflanked.

A 300mm wide trench to 4m in depth will be dug. Excavations in the top 50 cm of soil will be under supervision so that any significant roots (>25 mm diameter) will be identified and cut cleanly with a sharp saw on the edge of the trench closest to each tree. The arisings will be placed in a 3 ton dumper and conveyed to the spoil pile where it will be periodically collected by grab lorry. Once the first 5m has been formed, the trench will be lined with the copper impregnated bio-barrier and bund the leading edge of the excavation with sheet piles. The trench will then be backfilled with 20mm stone to within 200mm of the surface and the process repeated until all 24m of the barrier is installed.
