# **Former Anglers Retreat Public House, Cricketfield Road, West Drayton**

## **Level 1 Historic Building Record**

Project Ref: 33116 | Rev: AA | Date: December 2017

# **Masonry Condition Report**

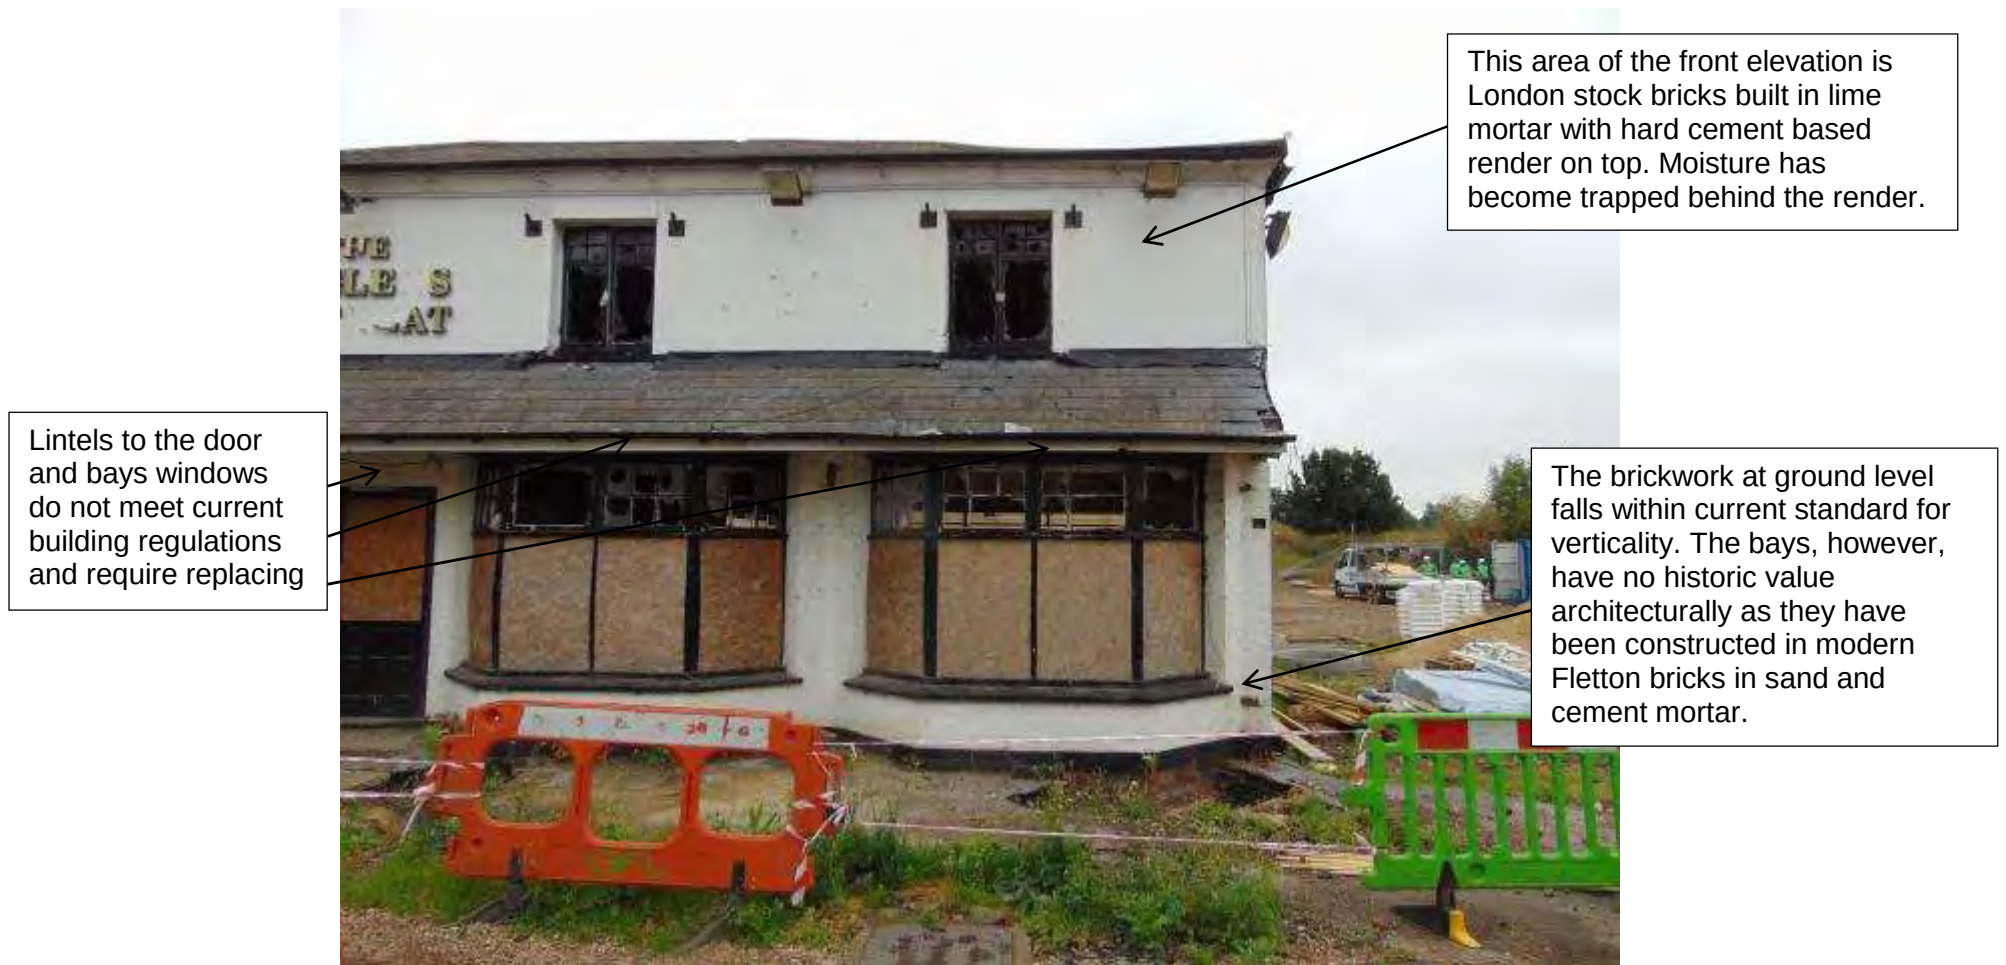
Figure 7 Showing right hand side of front elevation

Whilst the brickwork in this area falls within current standards for verticality, it requires tying back to maintain the structural integrity of the front elevation

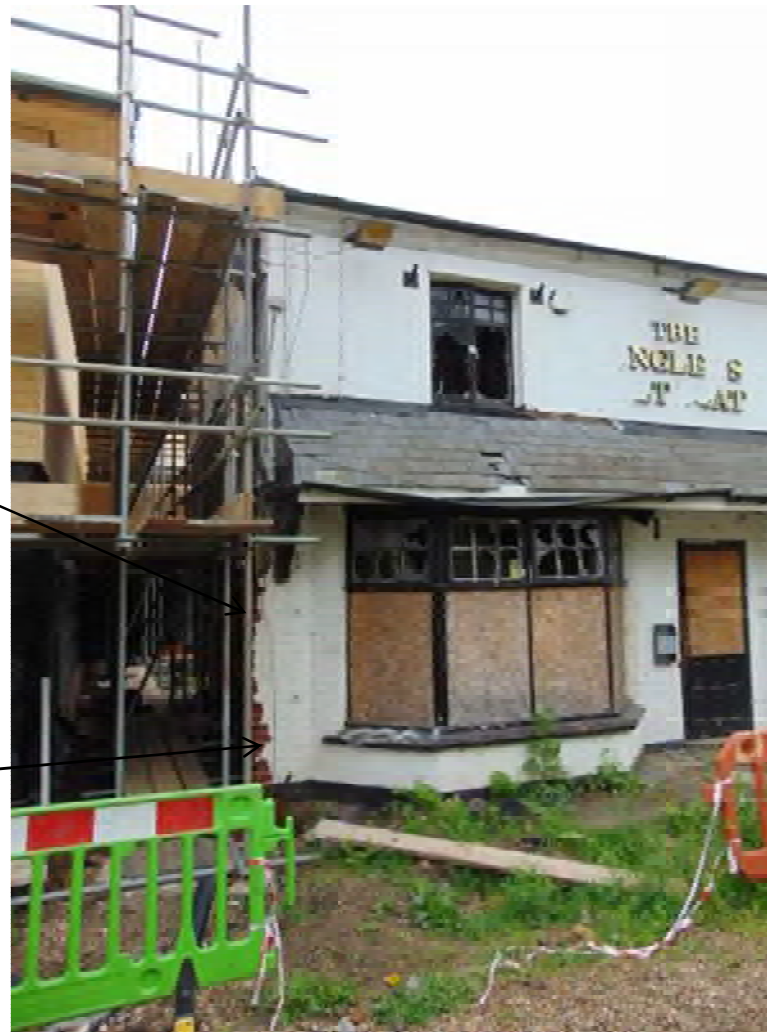
**Figure 8 Showing left hand side of front elevation**

Red stock bricks laid in stretcher bond in a sand and cement mortar indicating that this area has been re-built at some point.

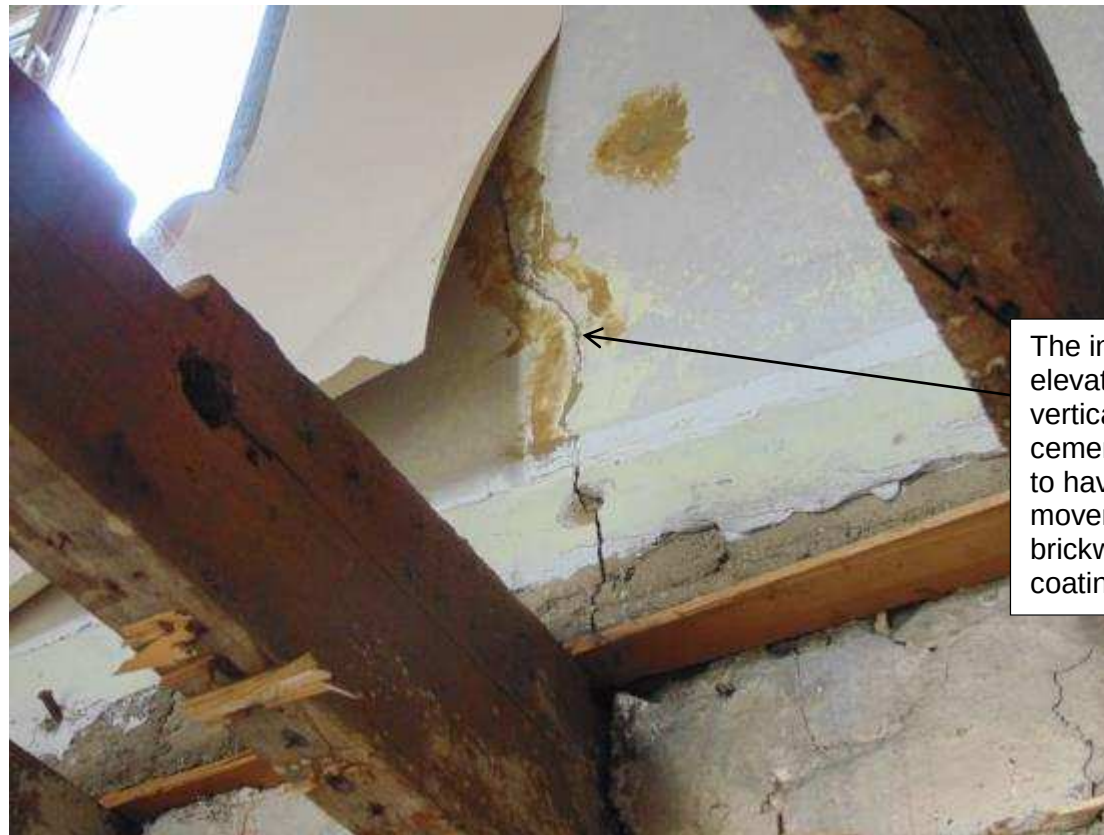
**Figure 9 Close up of internal cracking to front elevation**

The upper first storey brickwork, whilst built in the original London stock brick, has been rendered externally and plastered with sand and cement internally. This made it very difficult to access the structural integrity of the masonry; however several surface cracks were evident, as can be seen in figure 9, indicating thermal movement in the masonry.

The internal surface of the front elevation exhibits several vertical cracks in the internal cement render. These are likely to have been caused by thermal movement between the lime brickwork and the cement coating internally and externally

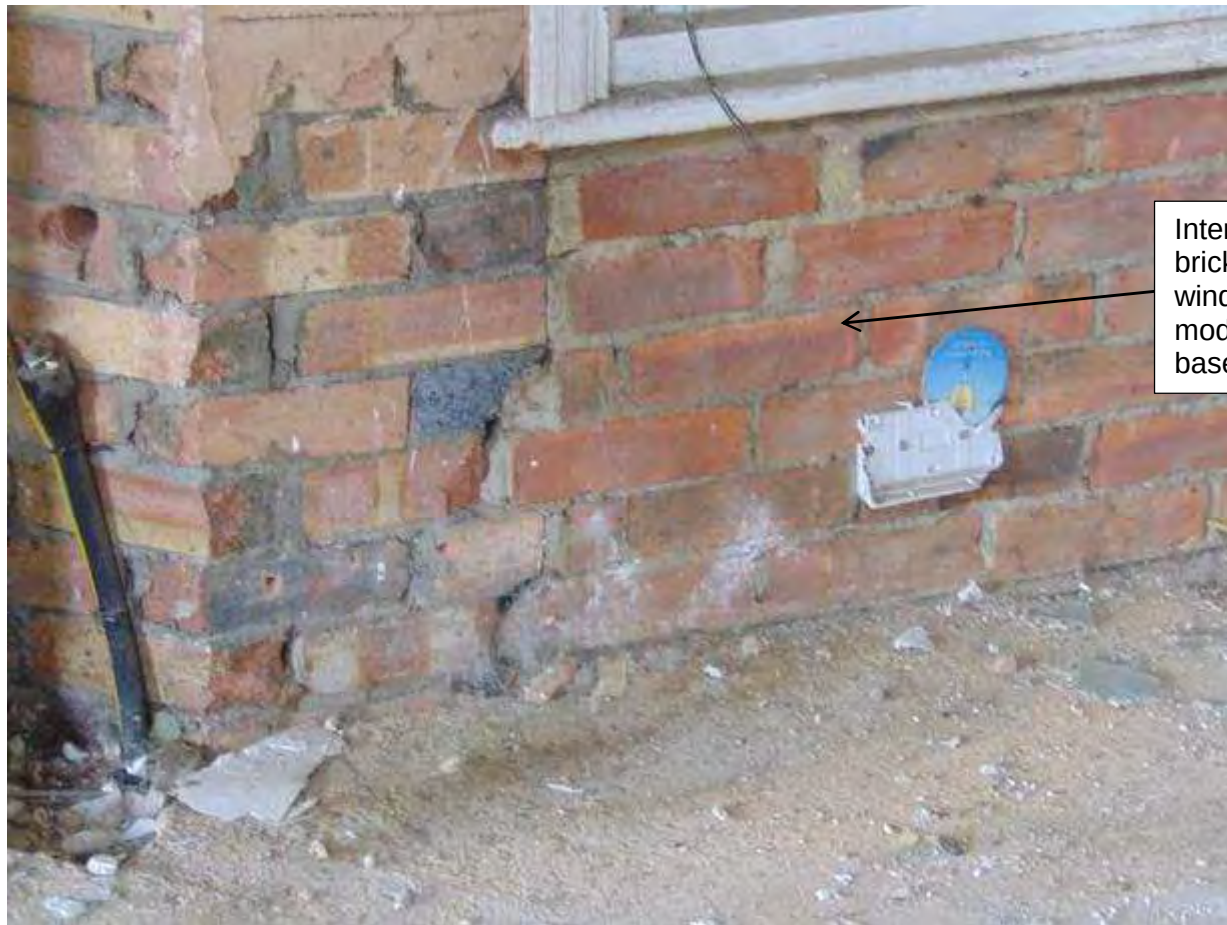
**Figure 10 Close up of modern brickwork to bay windows**

Internal modern Fletton brickwork to the bay windows, indicating a modern addition in cement based mortar.

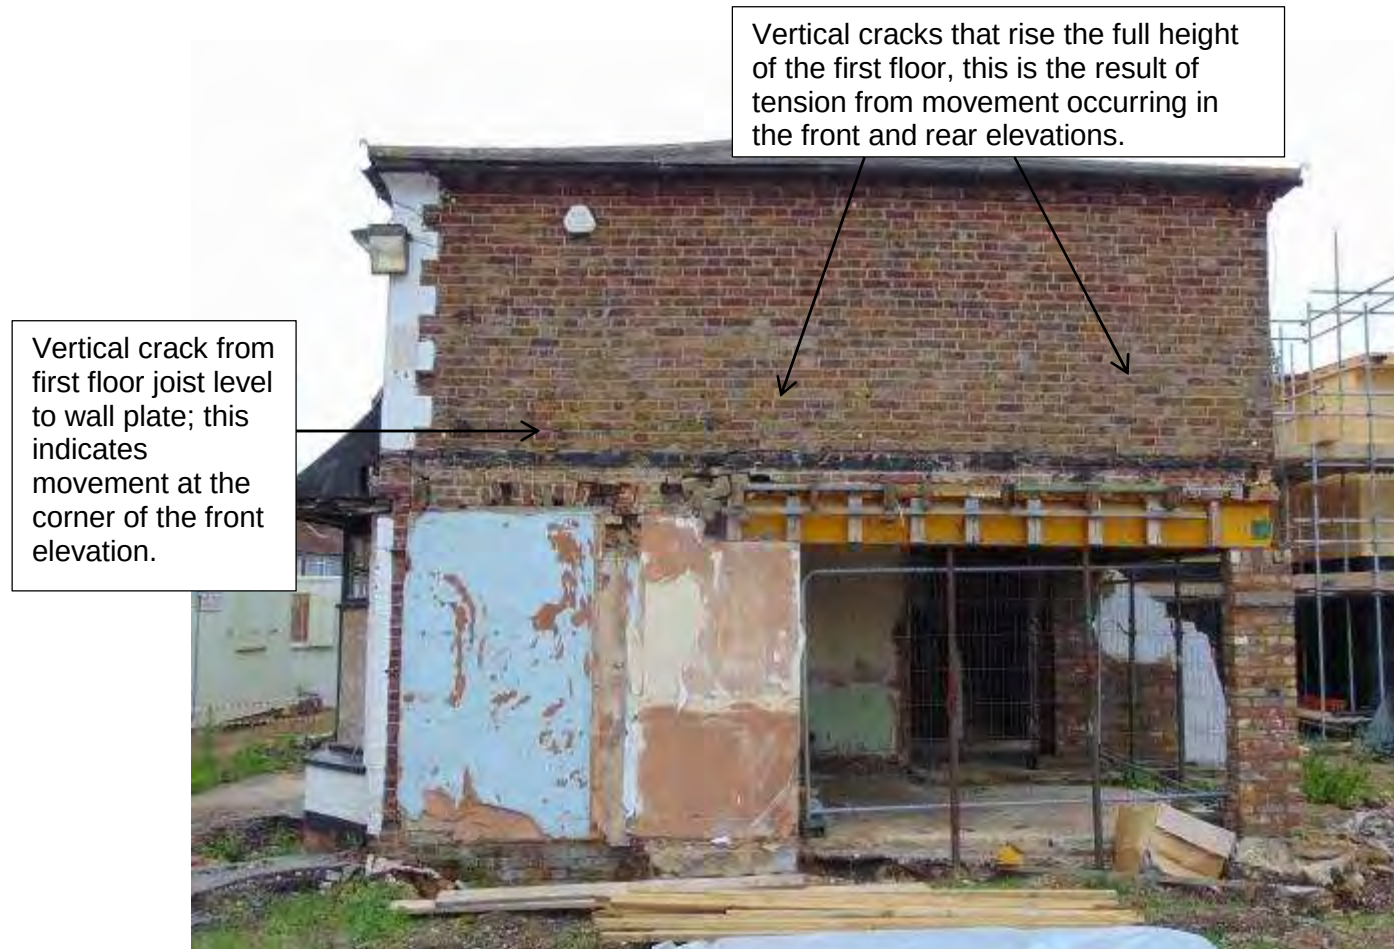
**Figure 11 Showing the West elevation**

The ground floor of the west elevation has been altered and reflects the addition of an extension that has been removed, as can be seen in figure 11. An immediate concern is the loading placed on the large steel beam that supports the right hand side of the first floor. The pier that the beam rests on is undersized by current building regulation standards and is sited on a poor quality sub-standard foundation as seen in figure 16. The remainder of the brickwork at ground level on the left hand side is covered with modern gypsum plastering, due to the fact that it would have been an internal wall prior to the extensions being demolished. It was therefore impractical to ascertain the verticality or moisture content of this section of walling.

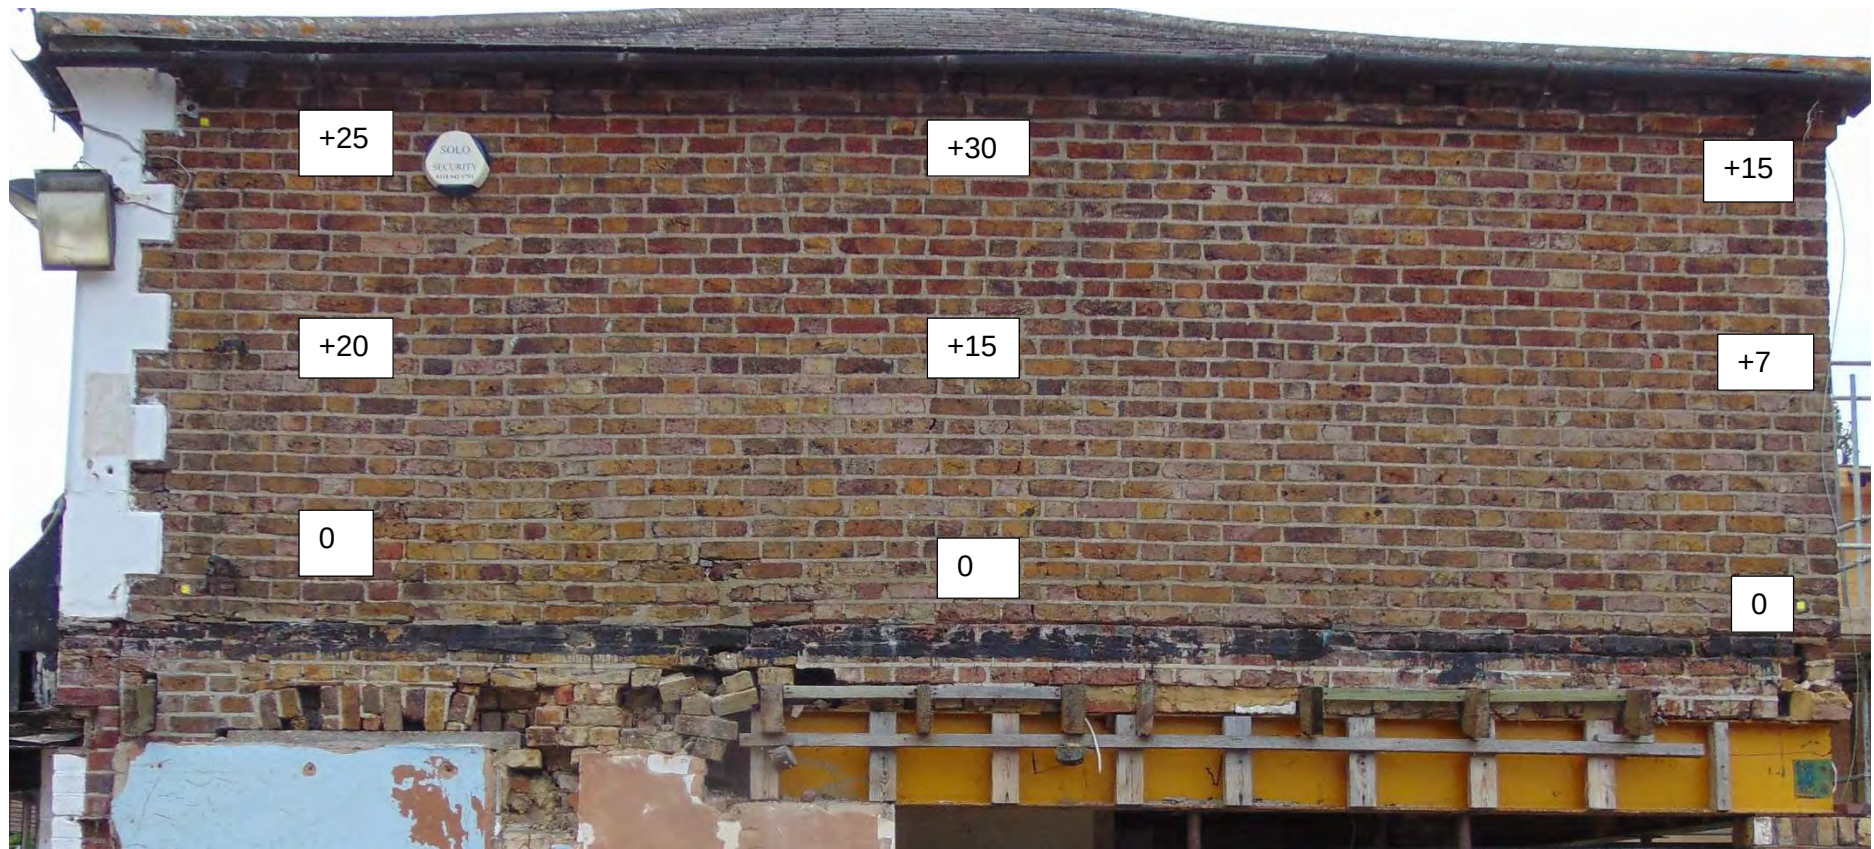
The sagging hipped roof is likely to have contributed to the lean that the masonry to the West elevation now exhibits. From figure 12 it can be seen that the first floor wall is out of vertical by between 15 – 30mm at the given points along its length. The wall is also considerably damp; a well burnt London stock that the wall is built with would expect to have an average moisture content of 5% (CIBSE). When the moisture contents are collated from figure 13, it shows us that the average moisture content of the bricks is 12.76% and the mortar that they are bedded in 21.9%. Given that we have had a prolonged period of dry weather, these figures illustrate that the wall is holding moisture; this can be attributed to the cement re-pointing of the elevation. The original lime mortar facilitates the drying of the wall by allowing the build-up of

Figure 12 Showing the verticality of the elevation, taken at three set points across the elevation from floor joist up to wall plate

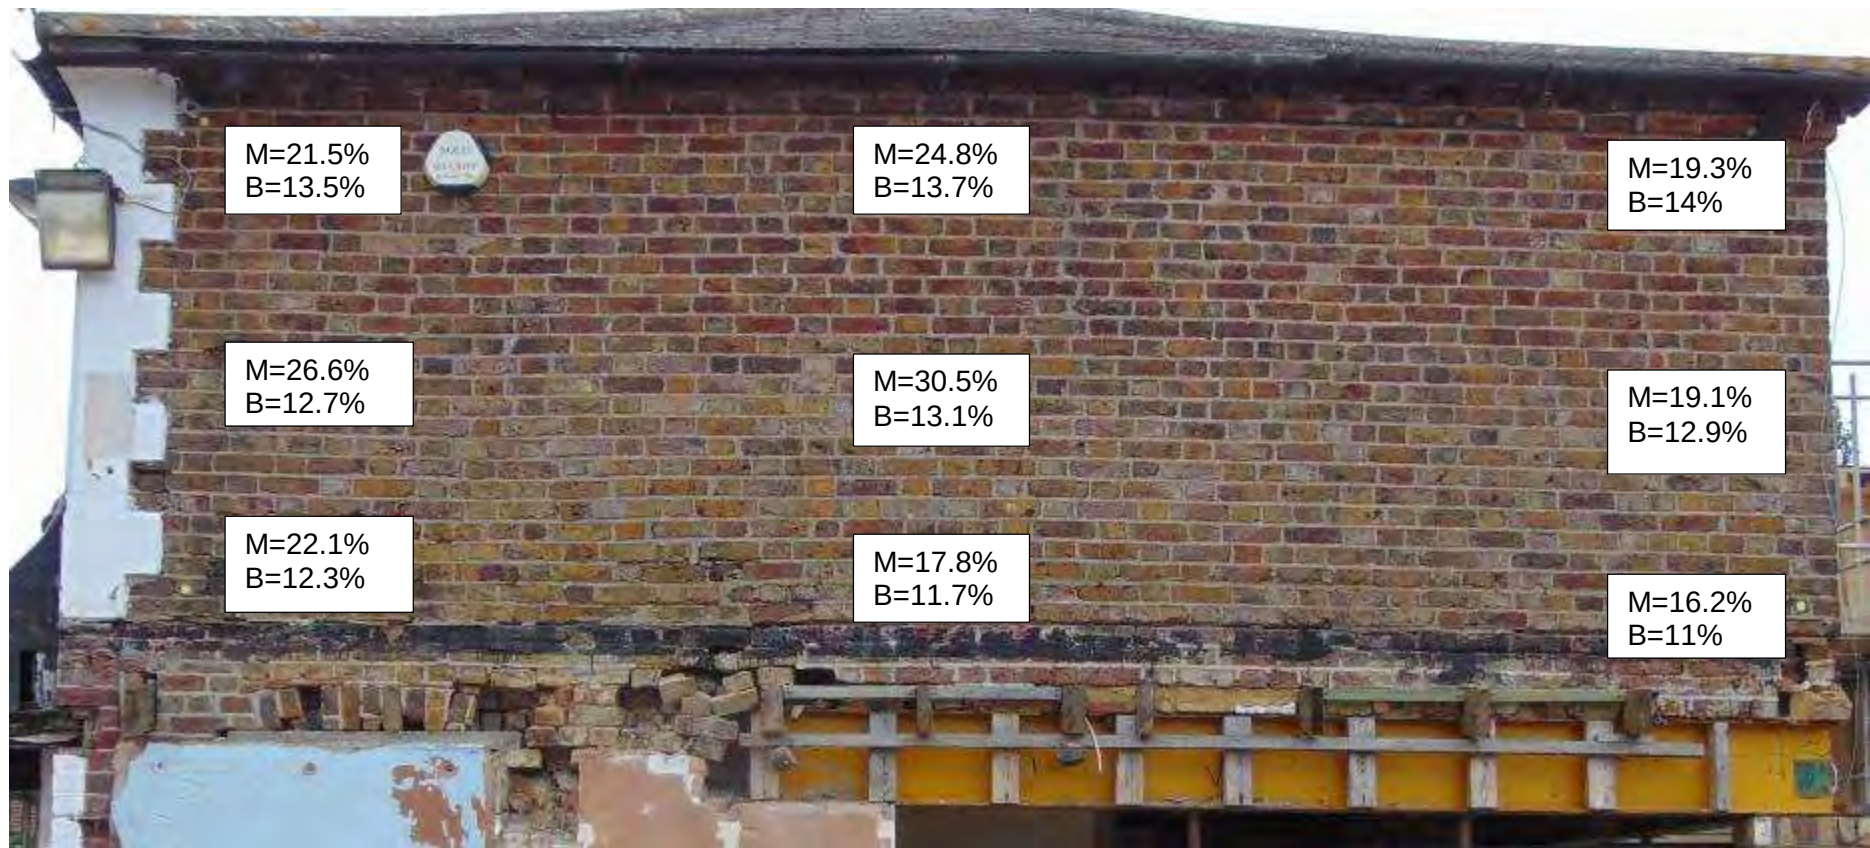
moisture within the bricks to evaporate, unfortunately the cement re-pointing has provided a barrier to that evaporation process resulting in the moisture being locked into the core of the wall. Should we start to receive some very cold periods during the winter, this will manifest itself into the spalling and eventually degradation of the bricks.

Figure 13 showing moisture content in the mortar (M) and the bricks (B) at set points across the elevation

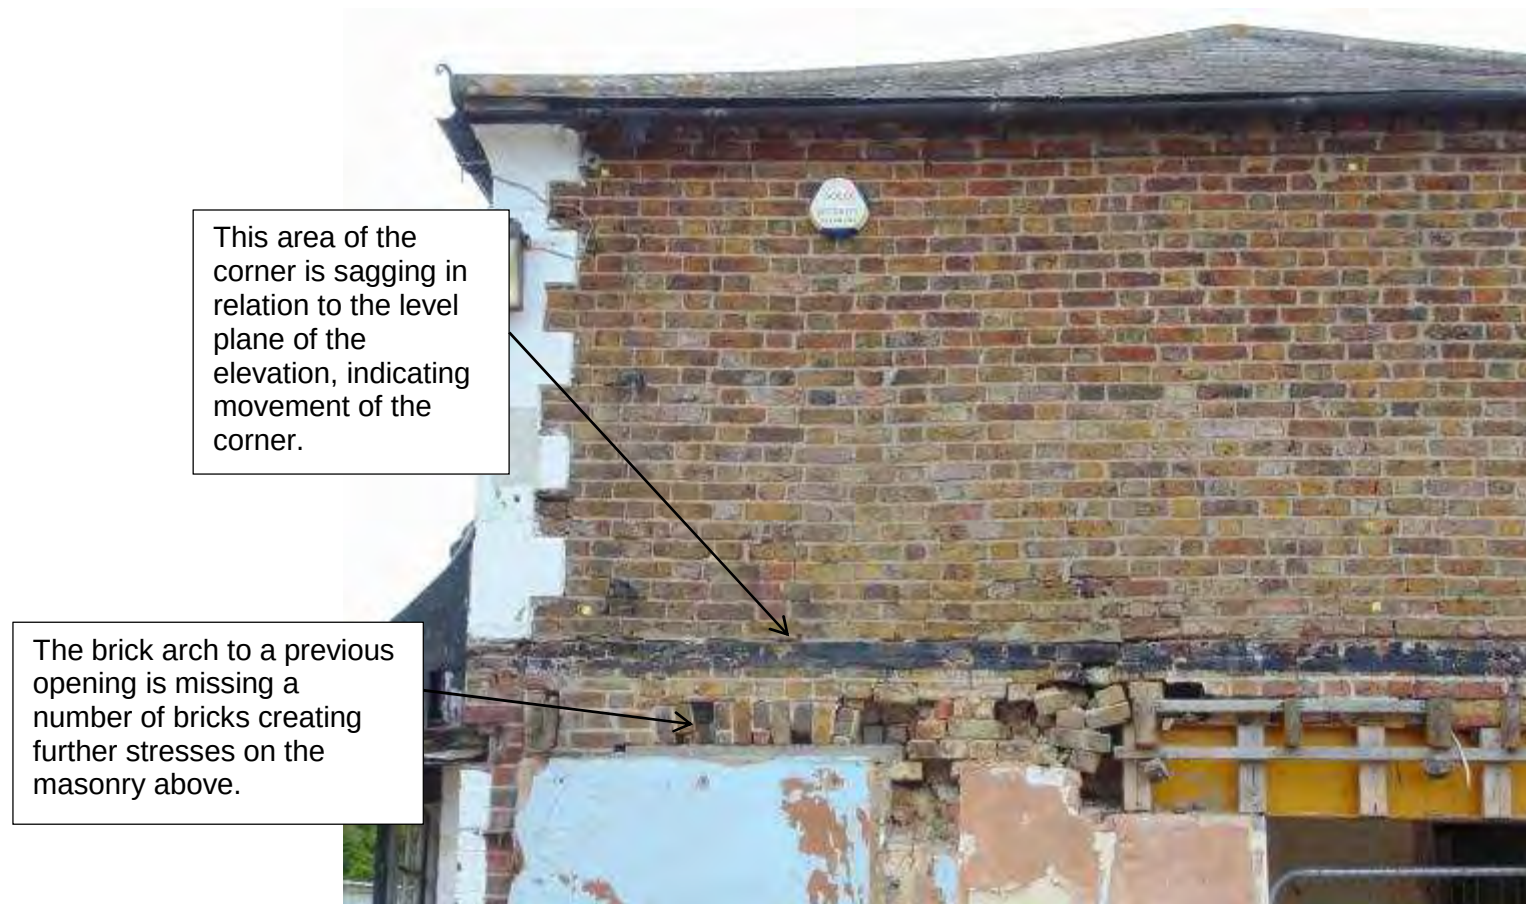
The upper section of this wall is constructed in the original London stock brick, built in a Flemish bond pattern and bedded in lime mortar. The entire section of walling has been repointed in a hard cement mortar. From figure 14 it can be seen that the left hand side of the elevation has dropped, the likely cause of this is differential settlement caused by the various alterations/additions to the elevation. There are several vertical cracks in the brickwork along the length of the wall indicating movement has occurred, see figure 19. This is further exemplified by the left hand corner of the elevation; it can be seen from figures 17 and 18 that the corner is out of alignment with the main wall of the elevation indicating rotation of the corner. It is important to note that the hipped roof above the West elevation is sagging, thus indicating that the roof timbers are not functioning as they were intended.

This area of the corner is sagging in relation to the level plane of the elevation, indicating movement of the corner.

The brick arch to a previous opening is missing a number of bricks creating further stresses on the masonry above.

**Figure 14 Showing key indicators that movement has occurred within the masonry of the West elevation**

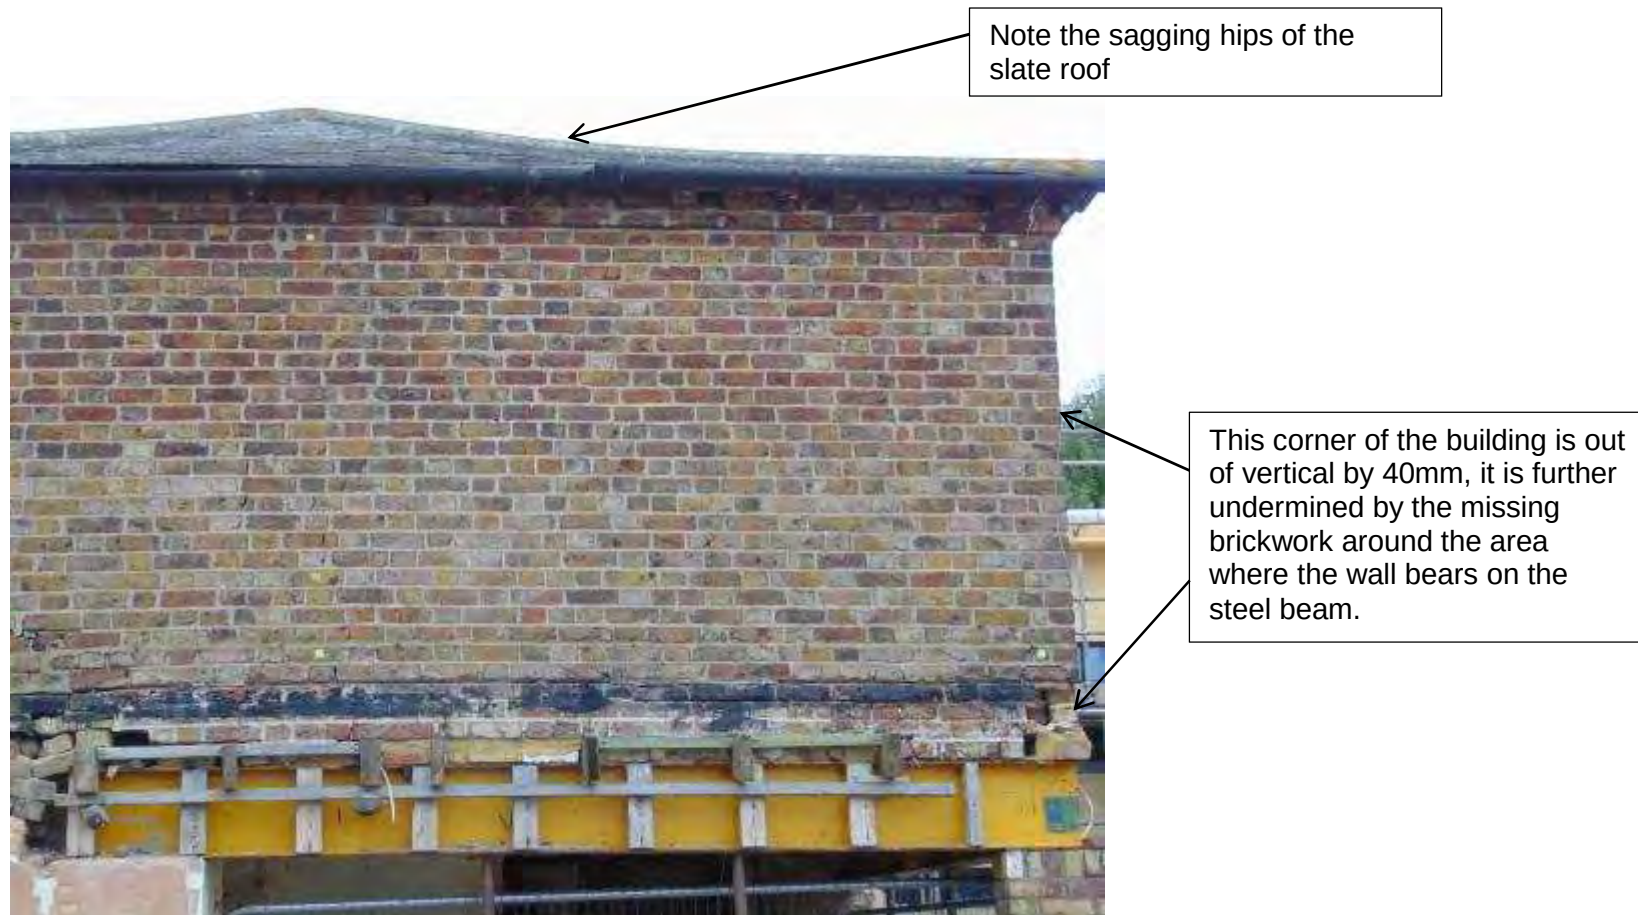
**Figure 15 Showing sagging hipped roof to the West elevation**

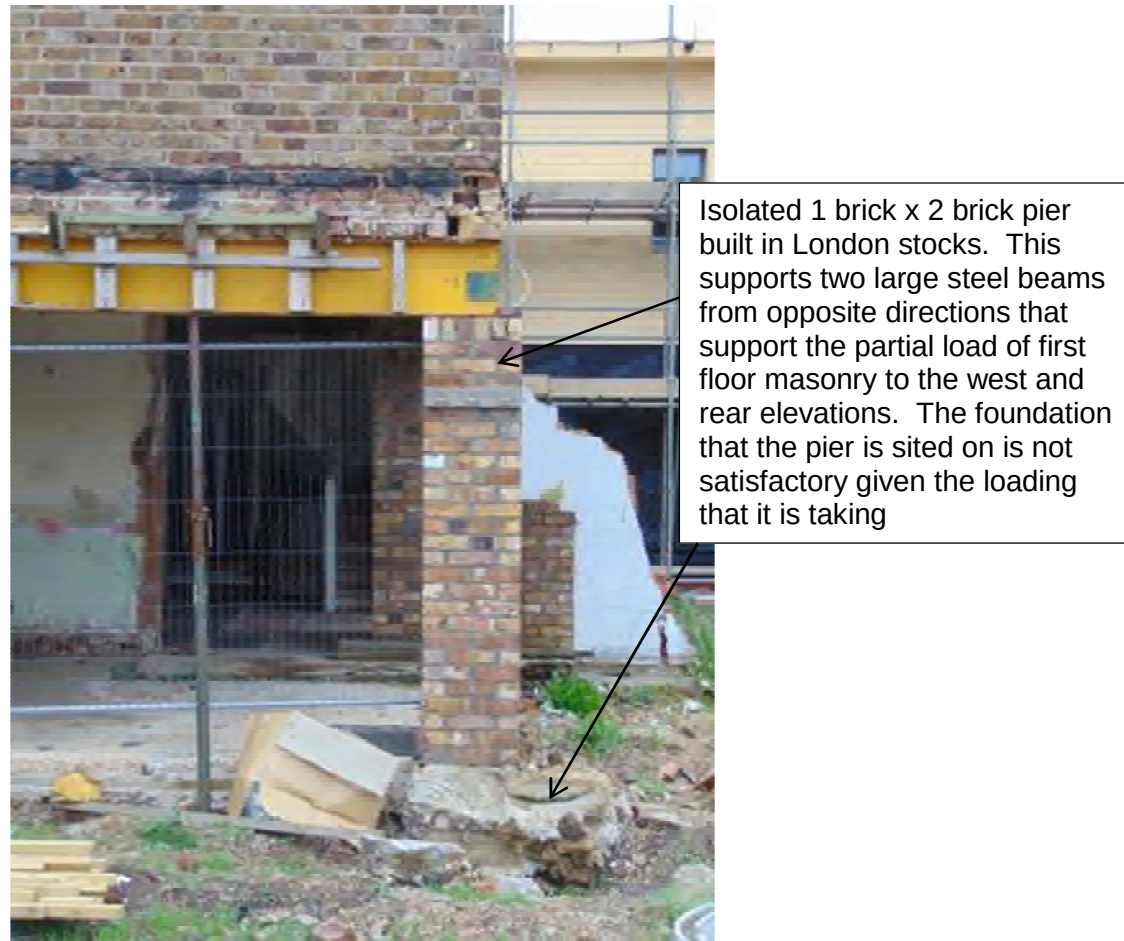
**Figure 16 showing the isolated brick pier that supports steel beams to the West and rear elevations**

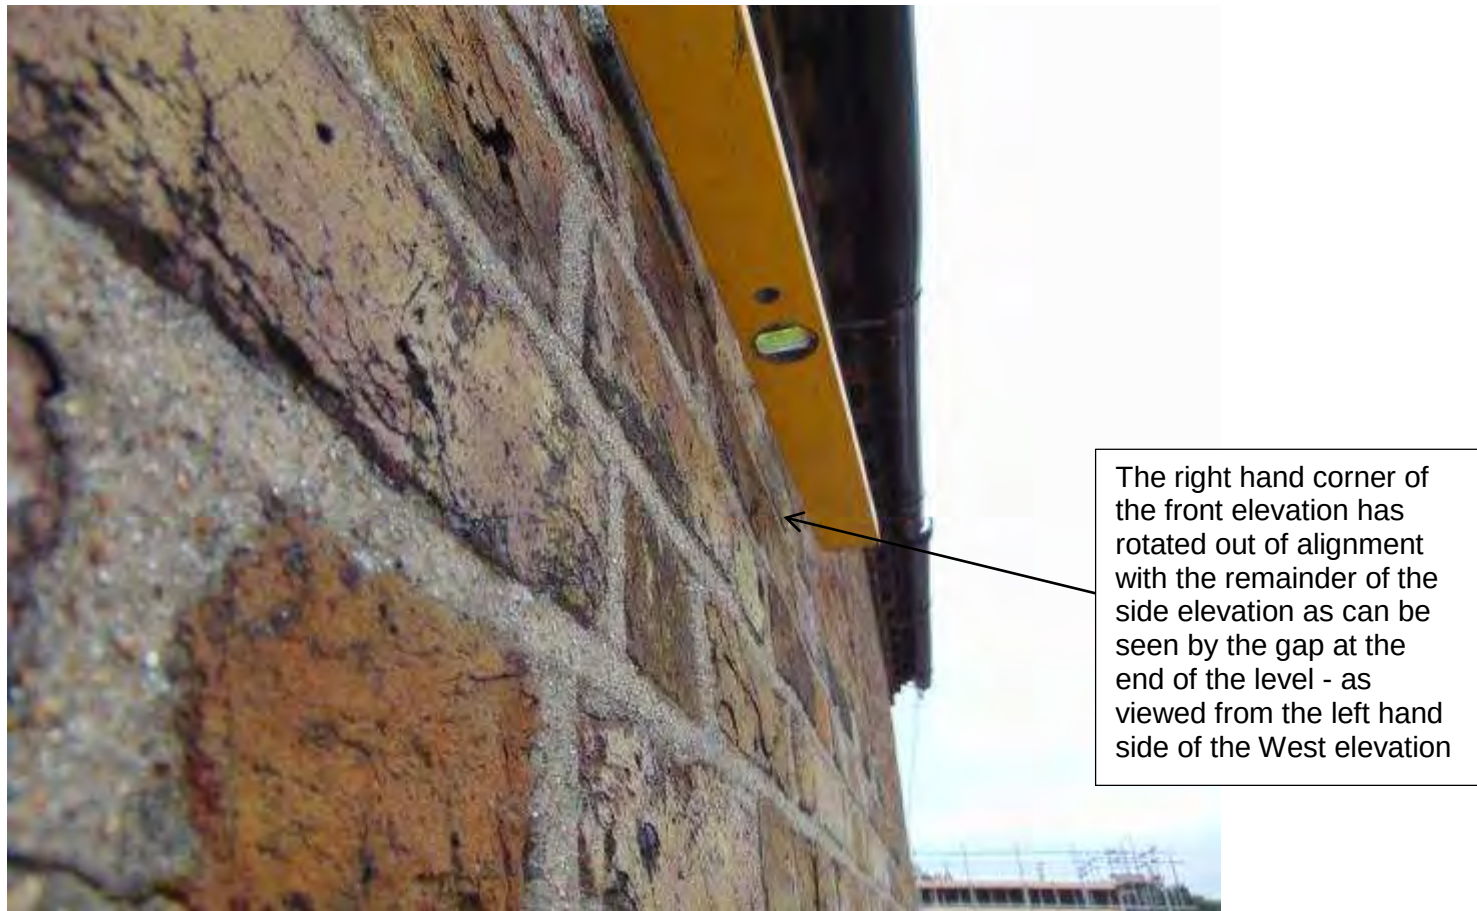
**Figure 17 showing how the left hand corner of the West elevation wall has rotated out of alignment with the remaining wall**

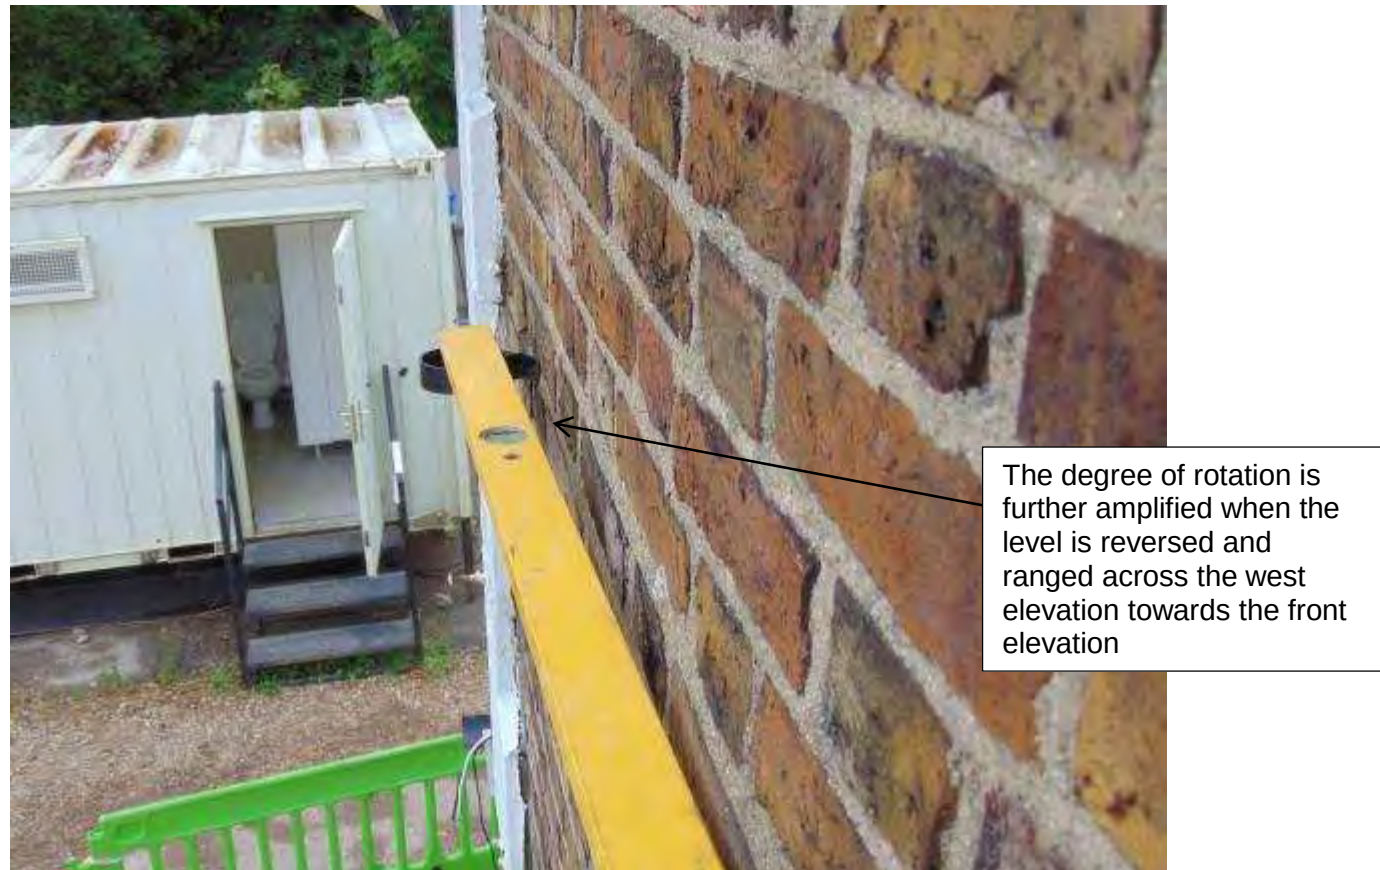
**Figure 18 Further example of the degree of rotation shown by ranging across from the right hand side of the West elevation**

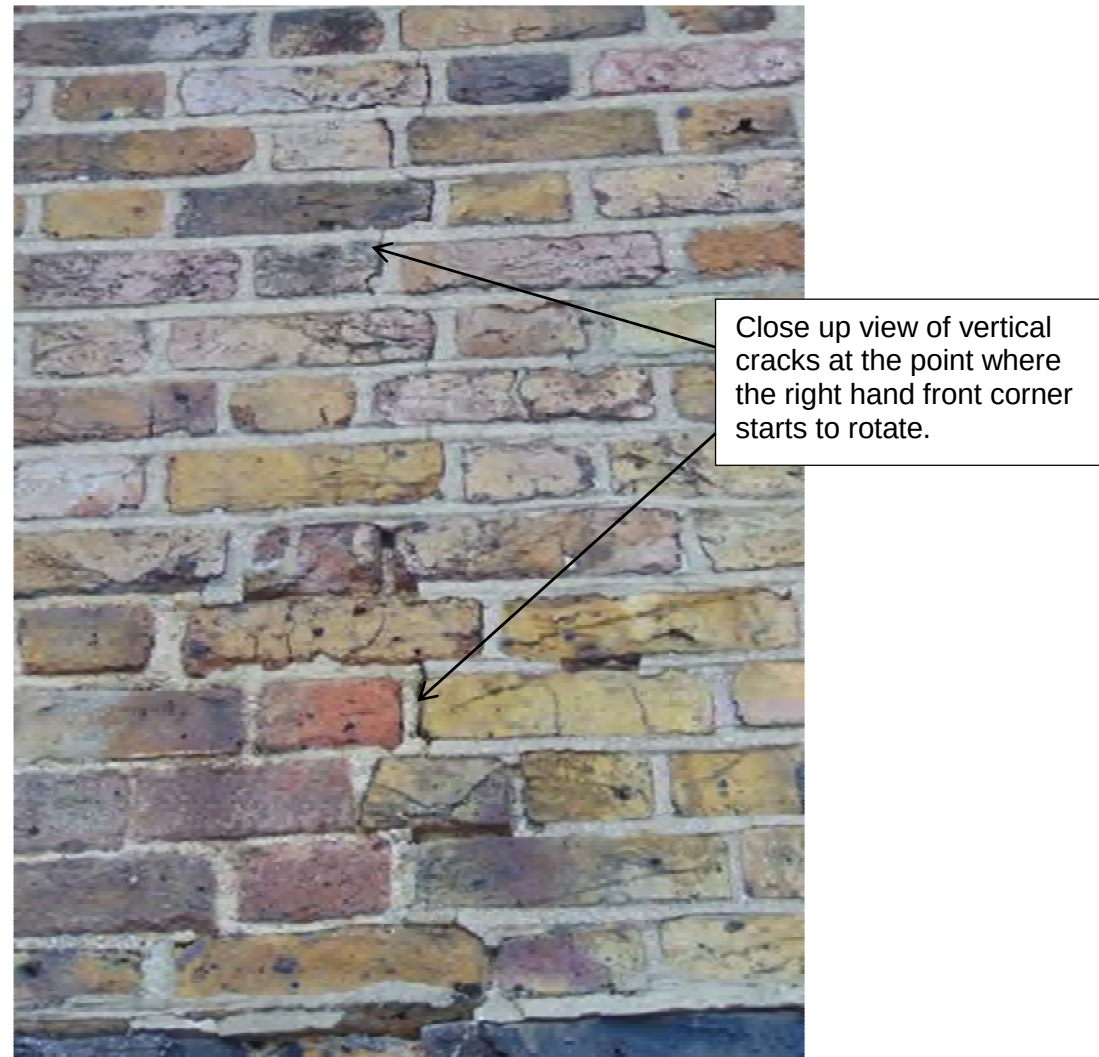
Figure 19 showing vertical cracks that appear in several places along the West elevation masonry

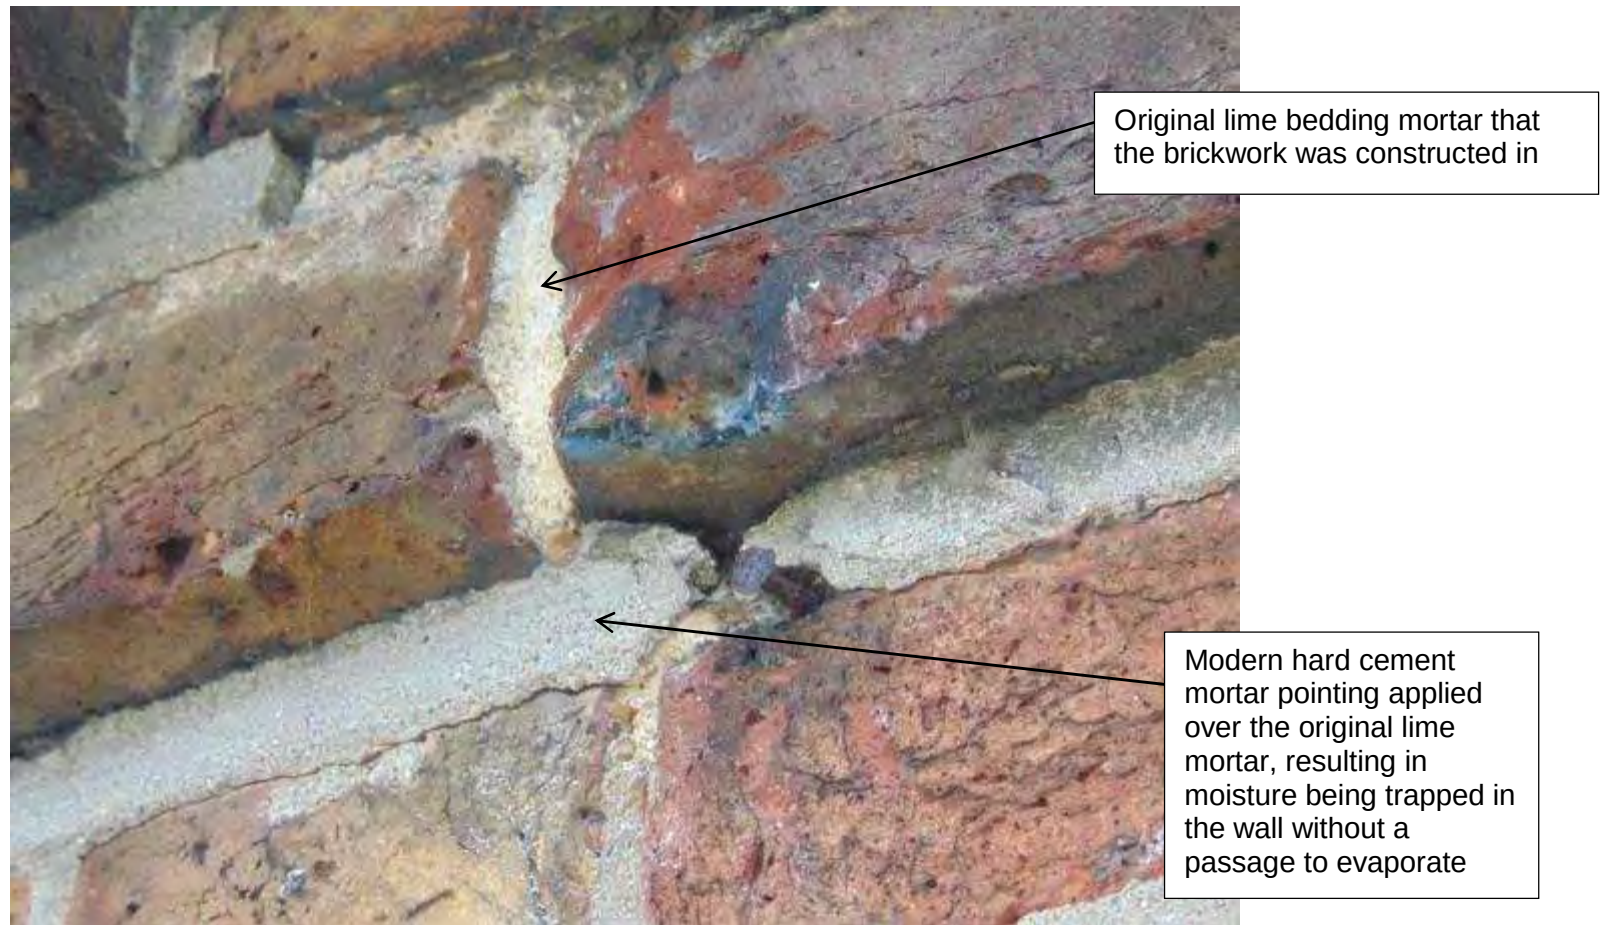
**Figure 20 Close up showing the original lime bedding mortar that the building was built in that has been overlaid with a hard cement pointing**

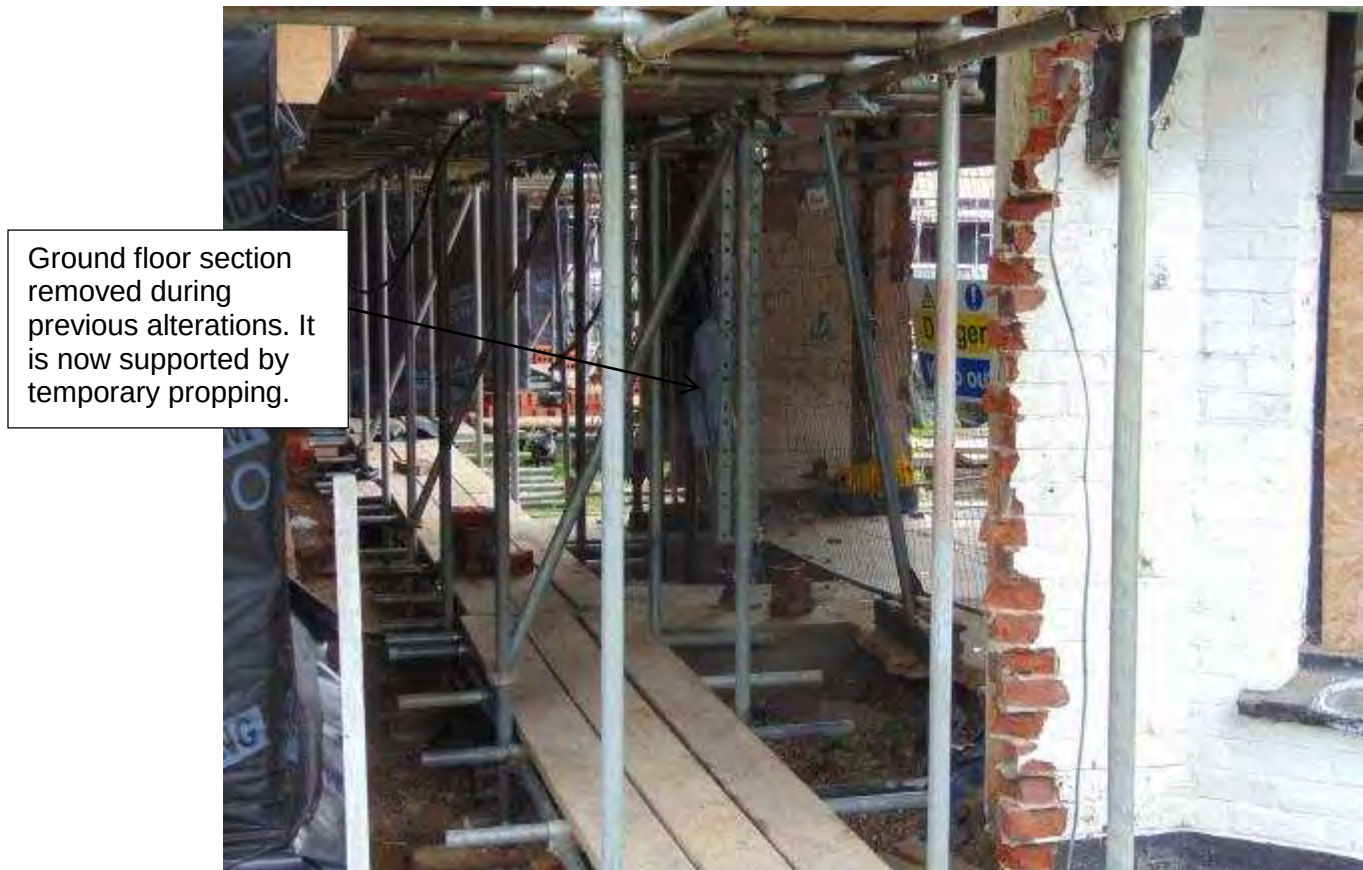
The first floor of the East elevation of the building is supported by a large steel beam that is being held up with temporary propping. Once again this is a result of the previous side extension being demolished as can be seen in figures 21 and 22. The first floor elevation is a combination of original London stock brickwork with cement rendering above and exhibits the same moisture problems as the West elevation as can be seen in figure 23 and 24. It is worth noting that the structural report by Peter Dann Consulting Engineers raises concerns regarding the structural stability of the wall if the elevation is not restrained by another structure.

**Figure 22 Showing how the first floor of East elevation is supported by temporary propping**

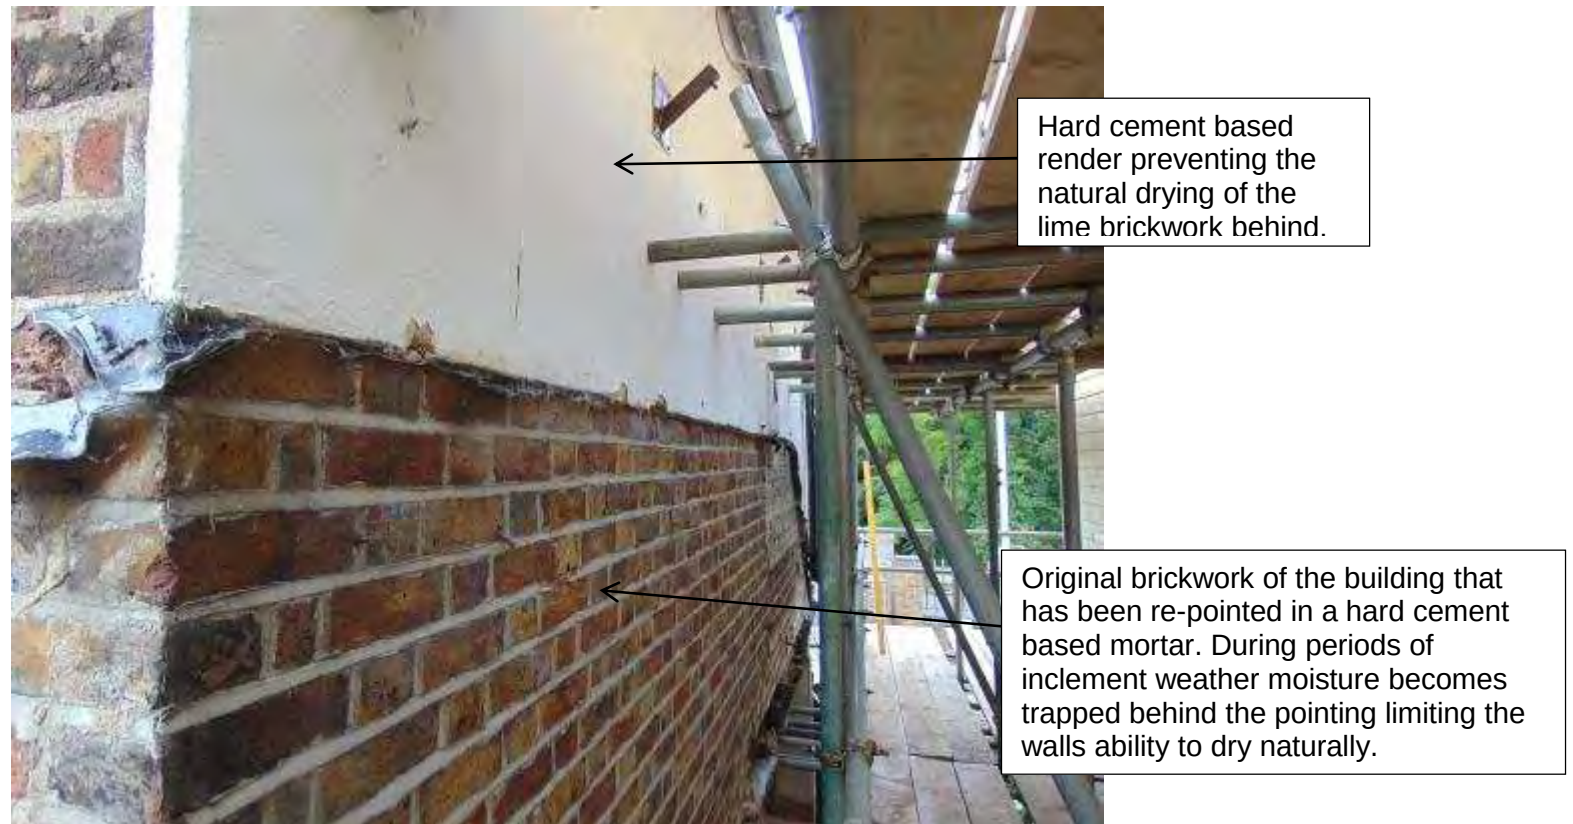
**Figure 23 showing the original brickwork of the building with a modern cement render above**
