# **Former Anglers Retreat Public House, Cricketfield Road, West Drayton**

## **Level 1 Historic Building Record**

Project Ref: 33116 | Rev: AA | Date: December 2017

# **Masonry Condition Report**

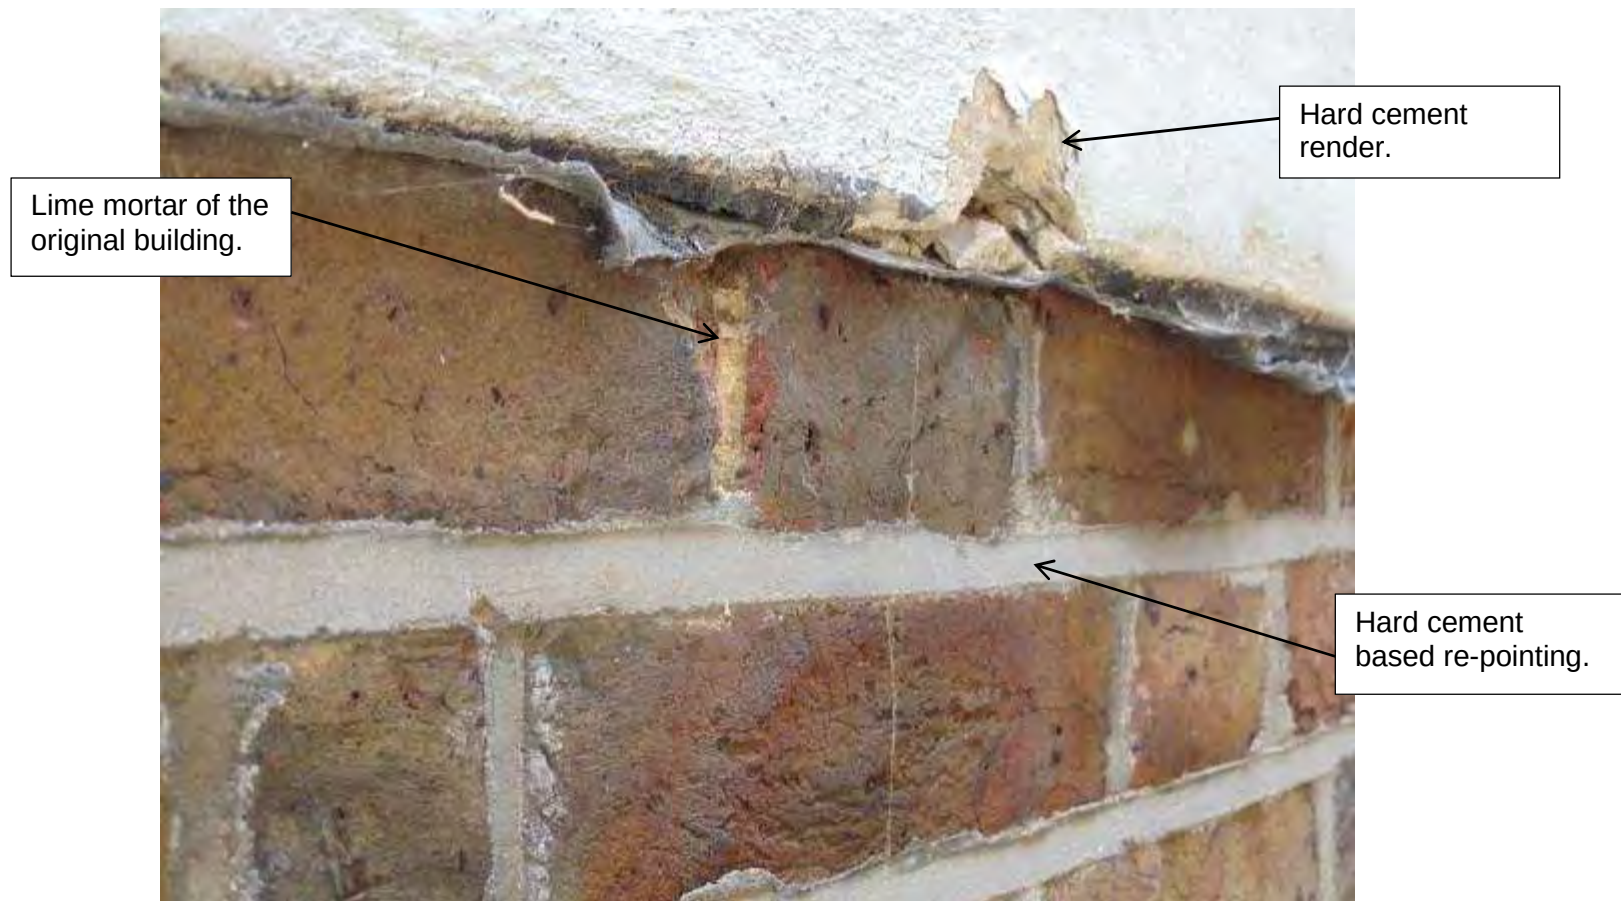
**Figure 24 Close up of the original brickwork bedded in lime mortar and re-pointed in a hard cement mortar**

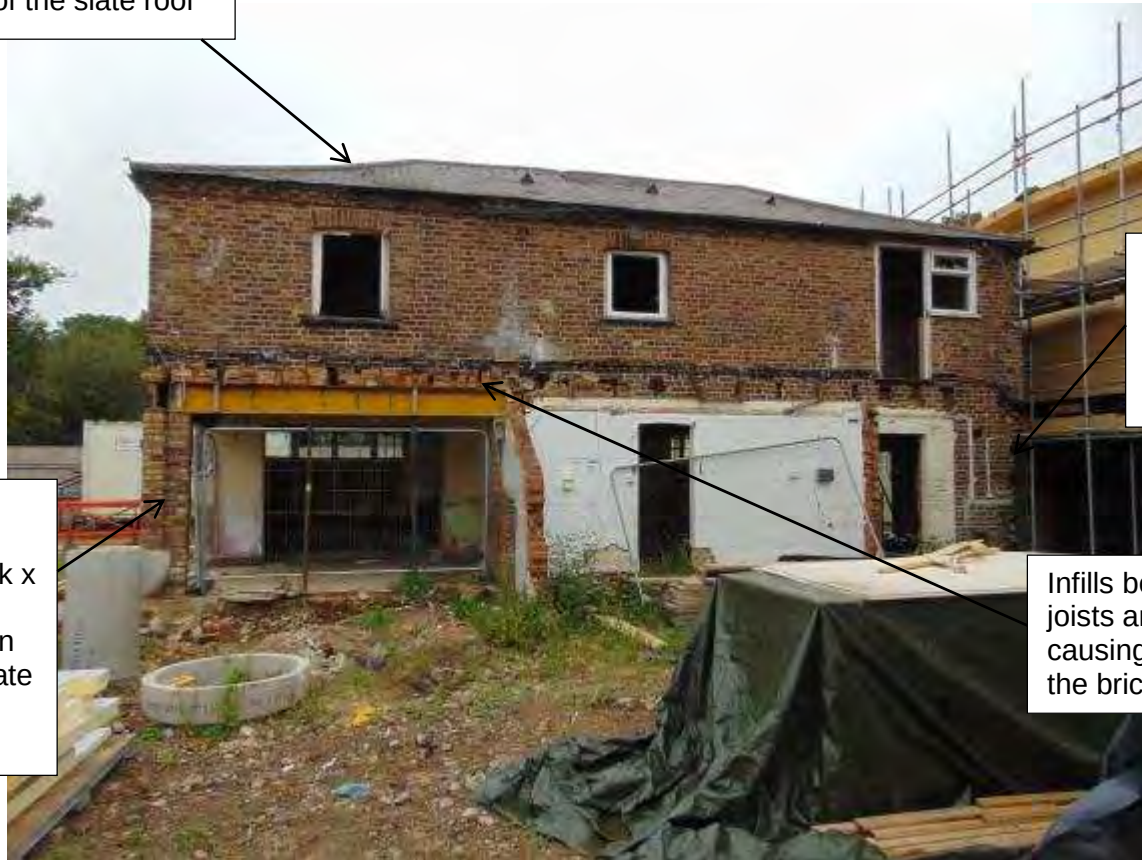
**Figure 25 The rear elevation as it stands today**

The rear elevation is a cause for concern. Figure 25 illustrates numerous areas of masonry that are either missing or failing. The lower section at ground level has two clear areas of concern; the first is to the left hand side where a large spanning steel beam that supports a third of the elevation is supported by a pier and foundation that do not conform to current building regulations. The second is the far right hand corner. This is not complete and is starting to fall away at ground level, undermining the structural integrity of the wall above.

Sagging in the hip  
end of the slate roof

Whilst the first floor is  
supported on temporary  
propping, the brickwork  
below is in a precarious  
condition.

Left hand elevation is  
supported by a large steel  
beam supported on a 1 brick x  
1 brick pier built in London  
stock bricks. The foundation  
beneath is less than adequate  
and does not conform to  
current building regulations.

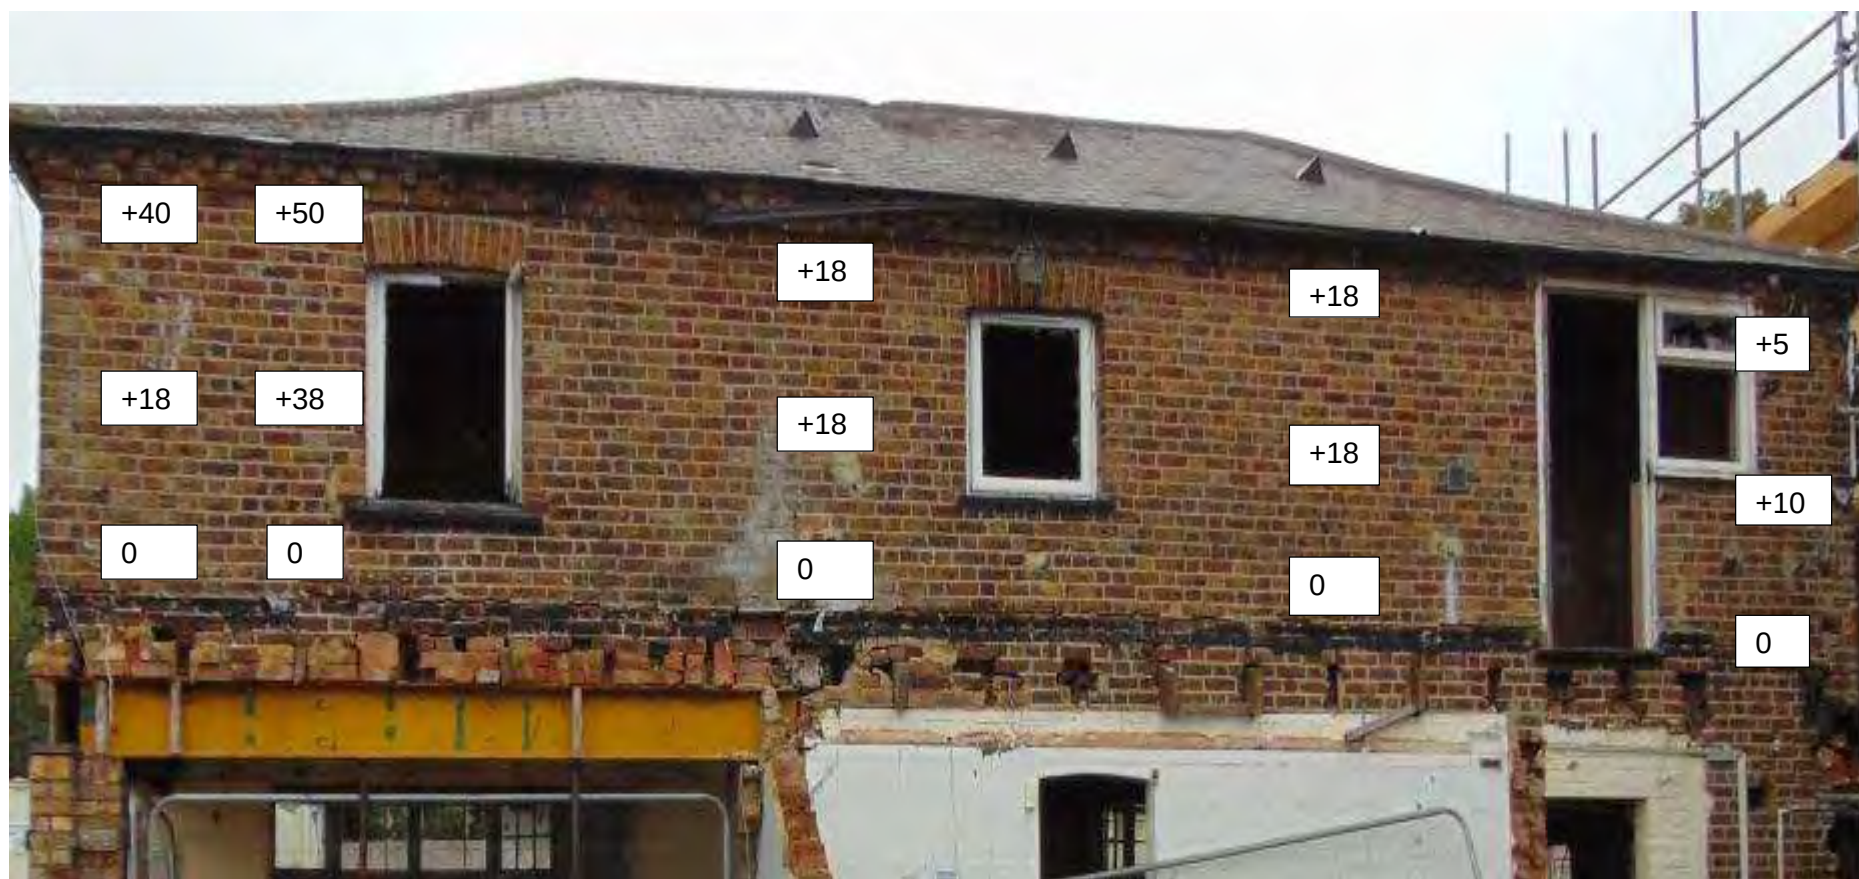
Figure 26 Showing the verticality of the elevation, taken at five set points across the elevation from floor joist up to wall plate

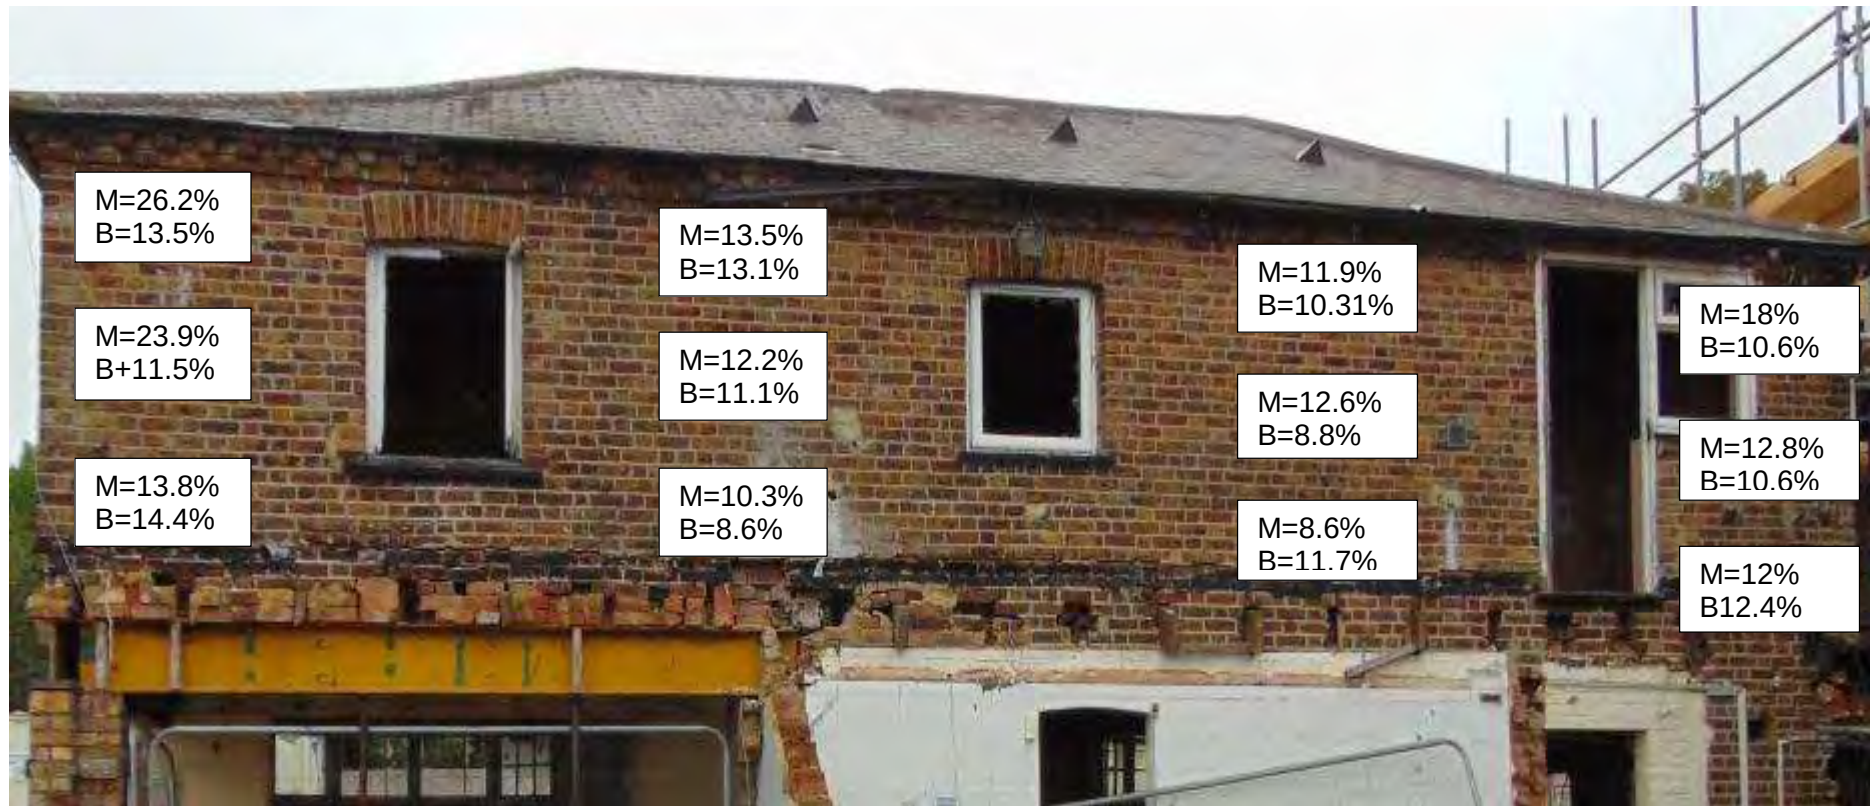
Figure 26 illustrates the moisture content within the bricks and the mortar joints. These average 11.38% and 14.6%, well above what would have been expected given the dry weather that we have had over an extended period.

Figure 27 Showing moisture content in the mortar (M) and the bricks (B) at set points across the elevation

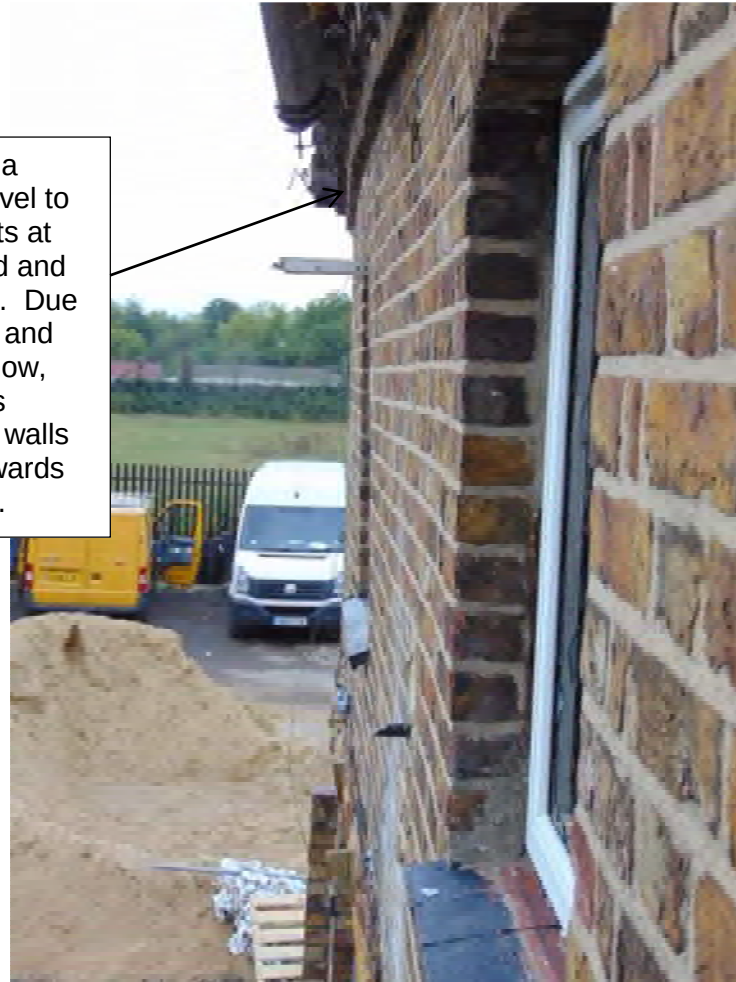
This part of the elevation has a large bulge from windowsill level to wall plate. Internal ceiling joists at wall plate level are undersized and have been spliced using nails. Due to inadequate/altered timbers and imposed loadings, such as snow, the roof no longer triangulates between the wall plates. The walls at this point have rotated outwards under the increased pressure.

**Figure 28 showing the degree of bulge in the rear masonry wall**

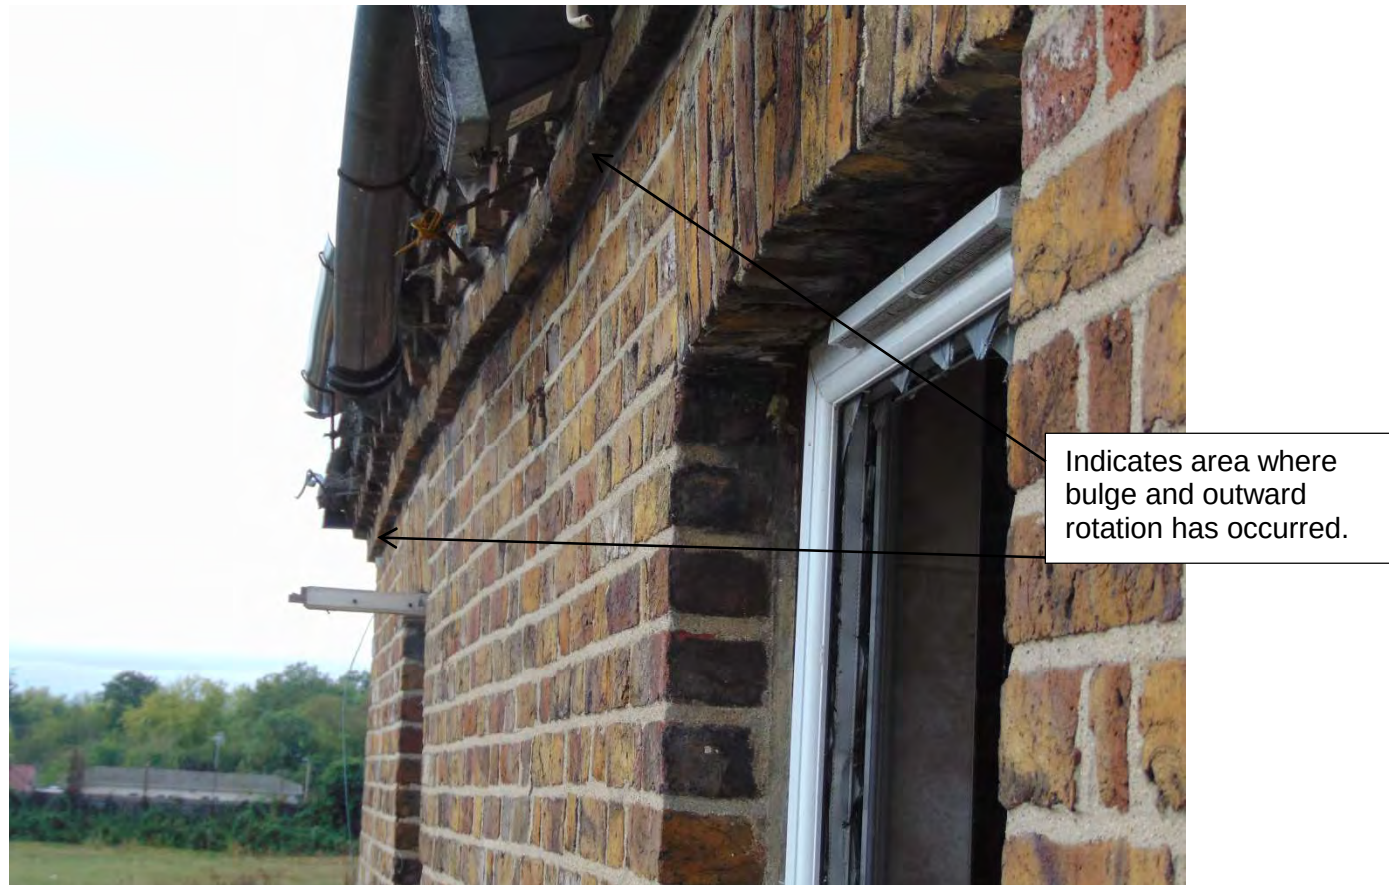
**Figure 29 showing the distance that the masonry wall to the rear bulges outwards**

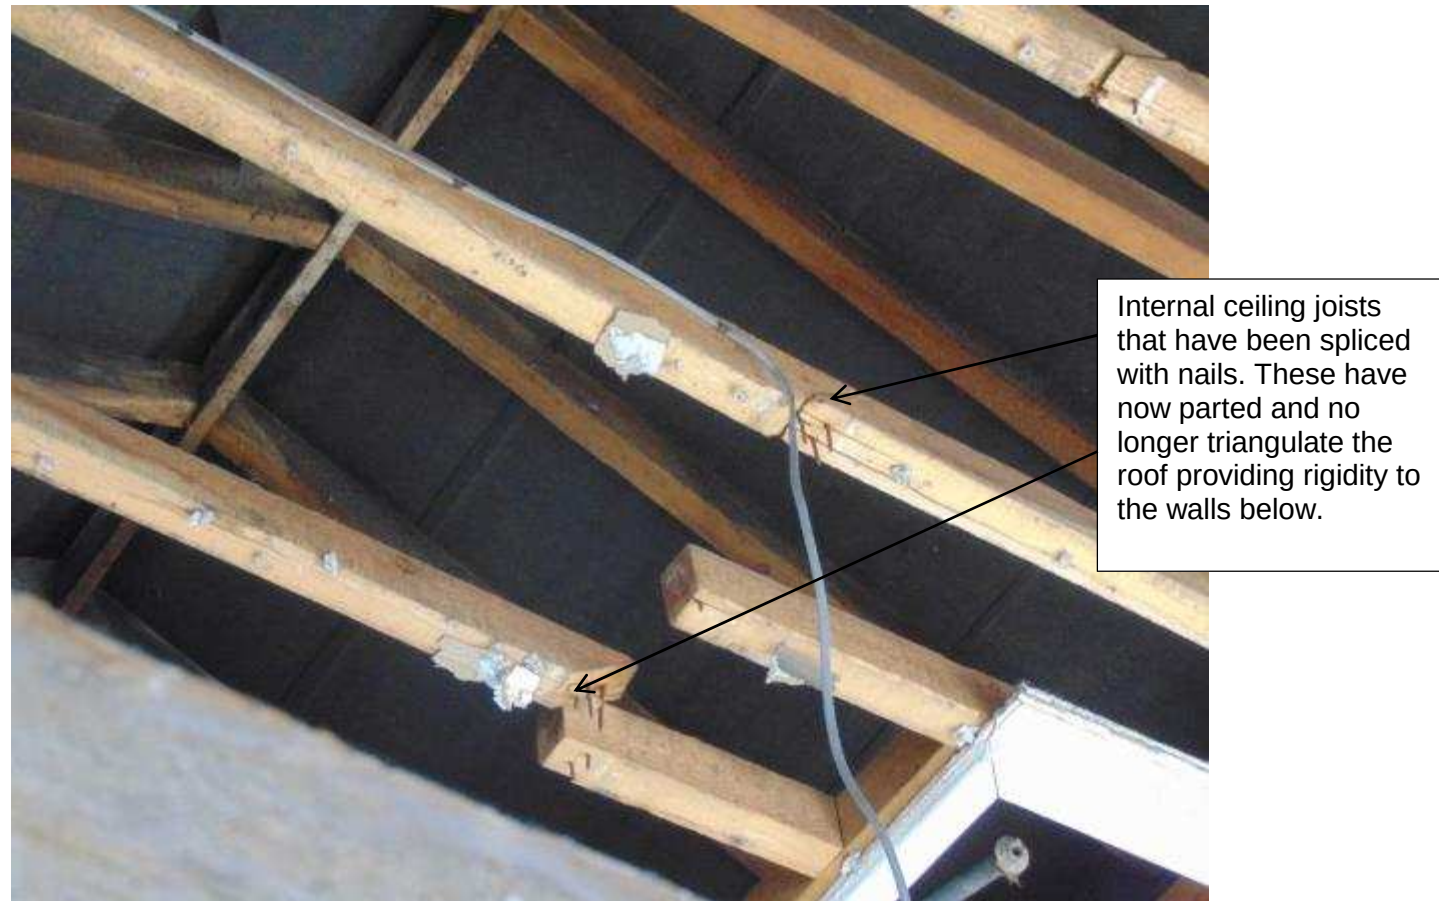
**Figure 30 Close up of the spliced timber ceiling joists**

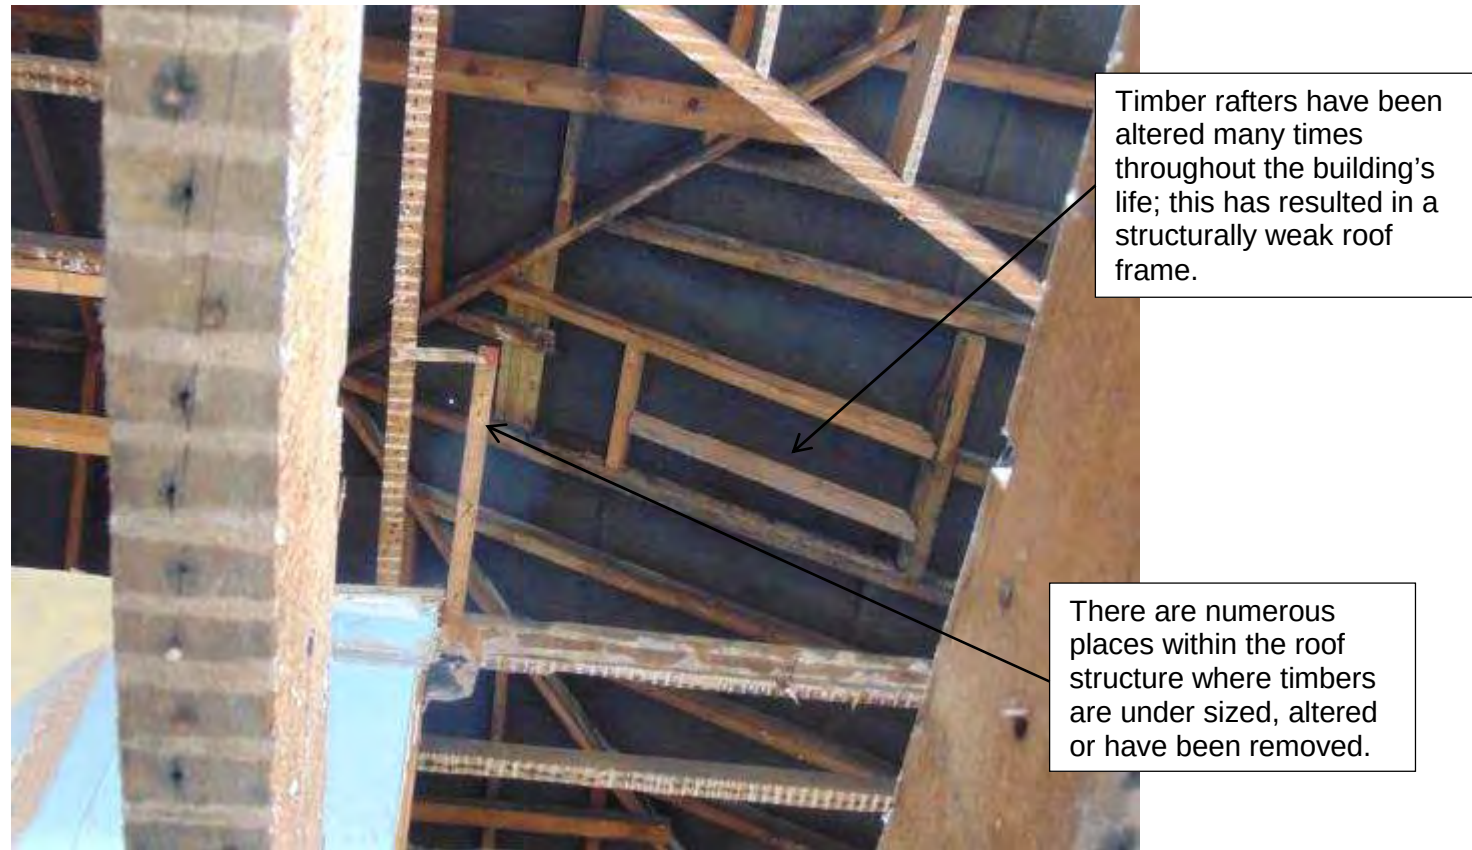
Figure 31 further exemplifies how the rafters have been altered; where the original chimney stacks have been removed the rafters have not been replaced or trimmed correctly. This has resulted in deflection of the roof above and applied loading to the walls below.

**Figure 31 Close up of under sized and altered/missing joists and rafters**

Large sized timbers have been used in several locations to triangulate the rafters with the wall plate. The remaining timbers have been placed at right angles limiting the rigidity of the roof to the walls below.

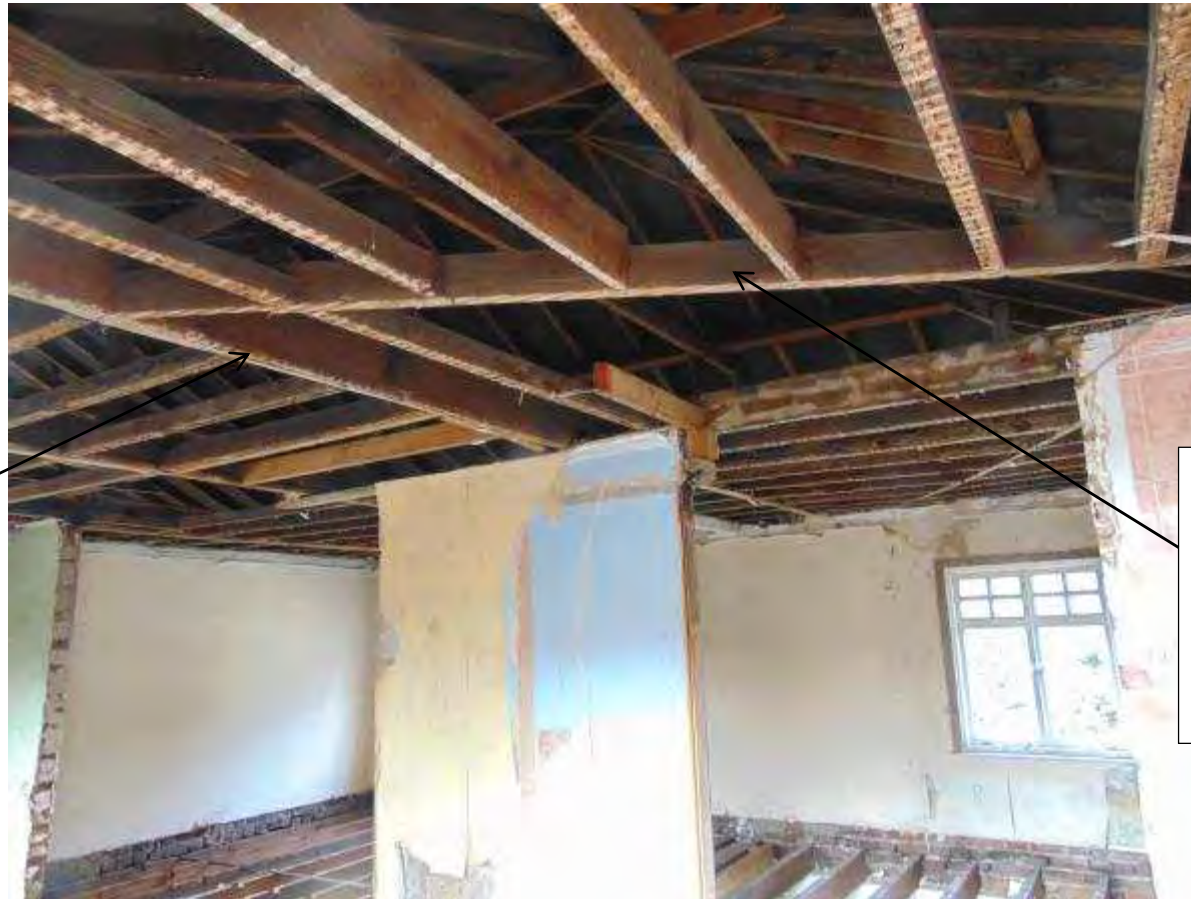
The configuration of the ceiling joists has been adapted throughout the life cycle of the building. In two sections the joists have been spliced into a diagonal beam, often with timber members missing.

**Figure 32 Close up showing configuration of ceiling joists**
