Project
CEDAR HOUSE, 2 VINE LANE,
UXBRIDGE UB10 0NF

Client
GOLD CARE HOMES

Title
LANDSCAPE PLAN / PROPOSALS

Job No. PR277	Drawing No. PR277-01	Rev. C
------------------	-------------------------	-----------

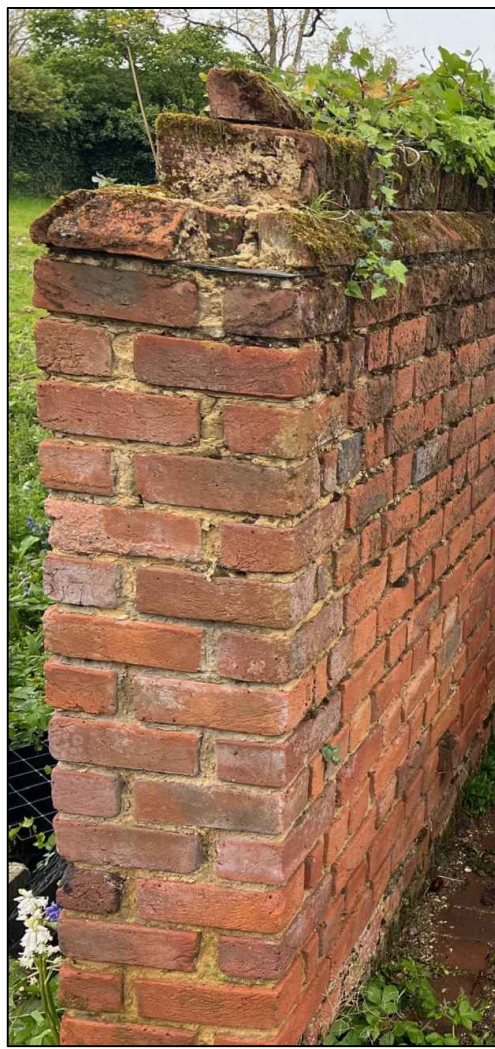
1). Repair required to brick pier with age appropriate bricks and mortar

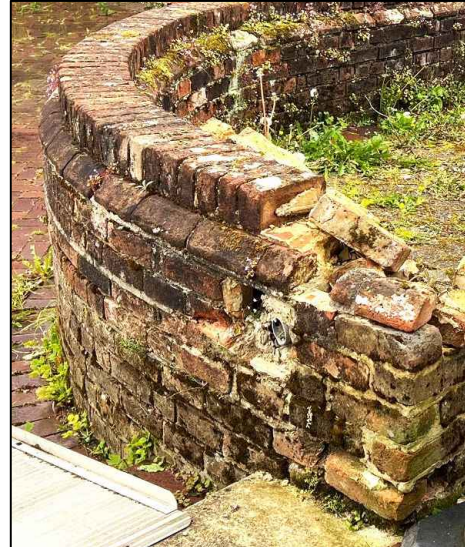
4). Repair required to brick coping with age appropriate bricks and mortar
