RE: 69 Copse Wood Way, Northwood, HA6 2TZ

Further to my recent site visit, below I have outlined the pruning I propose in order to manage the growth of the trees in the front and rear garden of the above property, to maintain them in context with the soon to be built house. This work is proposed to manage the trees crowns without detracting from their landscape value.

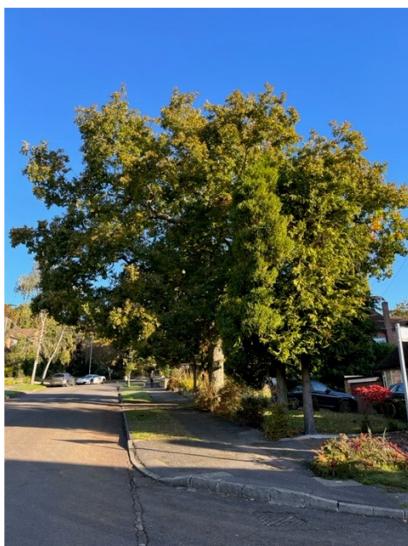
T1 Oak

Survey comments: No notable defects. Tree crown unbalanced. Heavy and low limbs on road side which are beginning to obstruct road.

Photo: T1 overhangs Copse Wood Way

- Reduce eastern crown laterally from 7m to 6m
- Reduce southern crown laterally from 9m to 7m
- Reduce western crown laterally from 9m to 7m
- Crown lift to give a ground clearance of 6m over site and road. This must be done pruning only secondary limbs, and none greater in diameter than 100mm.

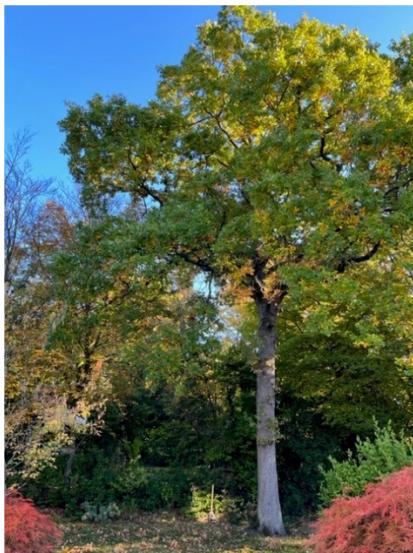
T7 Oak

Survey comments: No notable defects. Crown in close proximity to approved house outline and requires lateral pruning to manage growth. Works to this tree also noted as part of planning application report.

Photo: T7

- Reduce southern crown laterally from 6m to 6m
- Reduce western crown laterally from 7m to 4m
- Crown lift to give a ground clearance of 6m over site. This must be done pruning only secondary limbs, and none greater in diameter than 100mm.

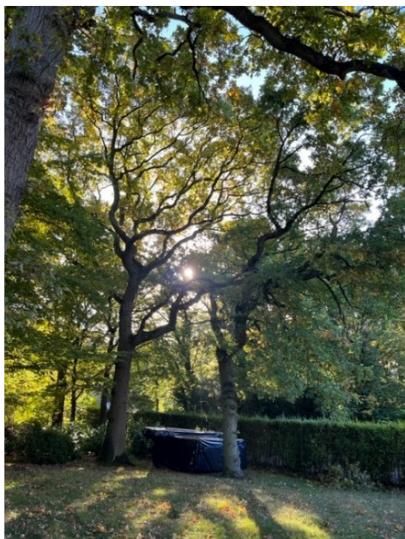
T8 Oak

Survey comments: Tree heavily suppressed and one sided due to presence of T9. T9 a much better tree and if T8 removed, T9 will fill gap and continue to grow as a quality specimen.

Photo: T8 and T9 – note T8 (right hand tree) being suppressed by T9

- Fell to ground level.

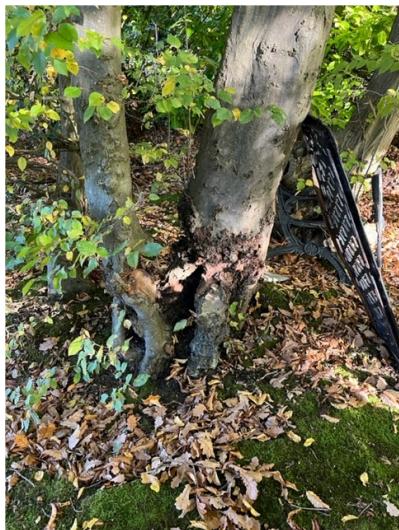
G10 Hornbeam (only section shown on plan)

Survey comments: Basal decay at ground level due to past coppicing.

Photo: decay at base of G10

- Reduce height from 20 to 10m.
