BS5837:2012 TREE SURVEY AND ARBORICULTURAL IMPACT ASSESSMENT: 15 Woodside Road, Northwood, HA6 3QE

Dated: 10th March 2026

Our reference: GHA/DS/160278:26

Location: 15 Woodside Road, Northwood, HA6 3QE
Our reference: GHA/DS/160278:26
Client: Seabrook Architects
Dated: 10th March 2026
Prepared by: Glen Harding MICFor, MSc (Forestry), MArborA
Date of Inspection: 27th January 2026

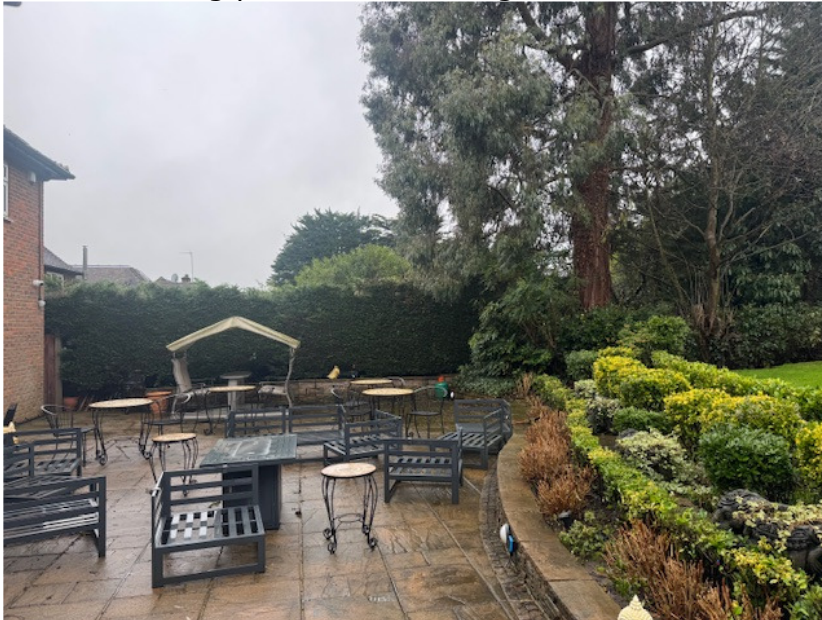
- 6.6 There is a small encroachment into the RPA of T1; this encroachment equates to 3% and is therefore assessed to be within acceptable levels. This is a healthy tree which will tolerate this small amount of root loss and recover quickly, especially when considering there are large areas of open ground to the other sides of the RPA for compensatory root growth to develop.
- 6.7 The area in question currently exists as a patio and is a well-engineered structure with an assumed sub base in excess of 300mm as shown in the photo below; given the existing patio and retaining wall, it is highly unlikely there are any significant roots from this tree in the area where the new basement will sit.

Below: existing patio and retaining wall
