Arboricultural Appraisal Report

Subsidence Damage Investigation at:

6 Windrush Close
Ickenham
Uxbridge
UB10 8EJ

CLIENT: Davies Group Ltd
CLIENT REF: 72229022
MWA REF: SUB230724-13845
MWA CONSULTANT: Andy Clark
REPORT DATE: 03/10/2023

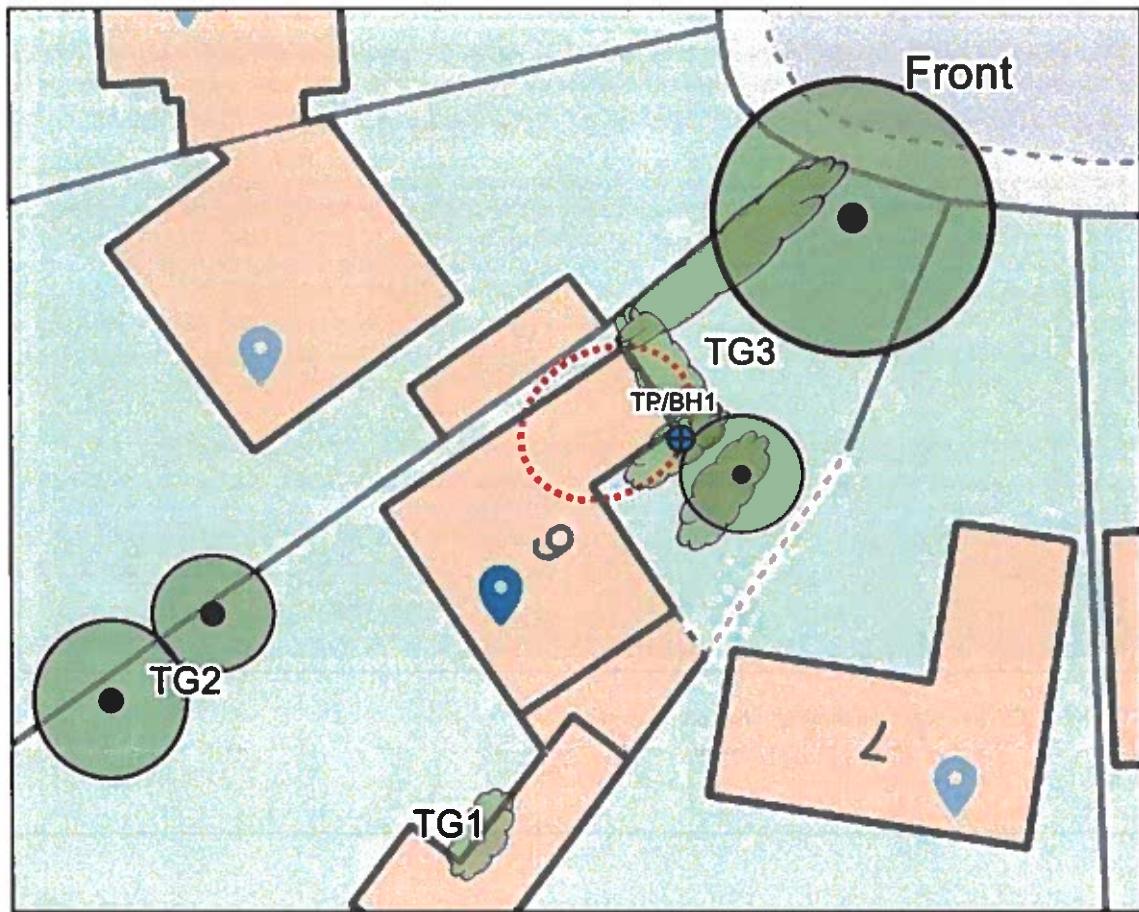
Site Plan

Approximate areas of damage

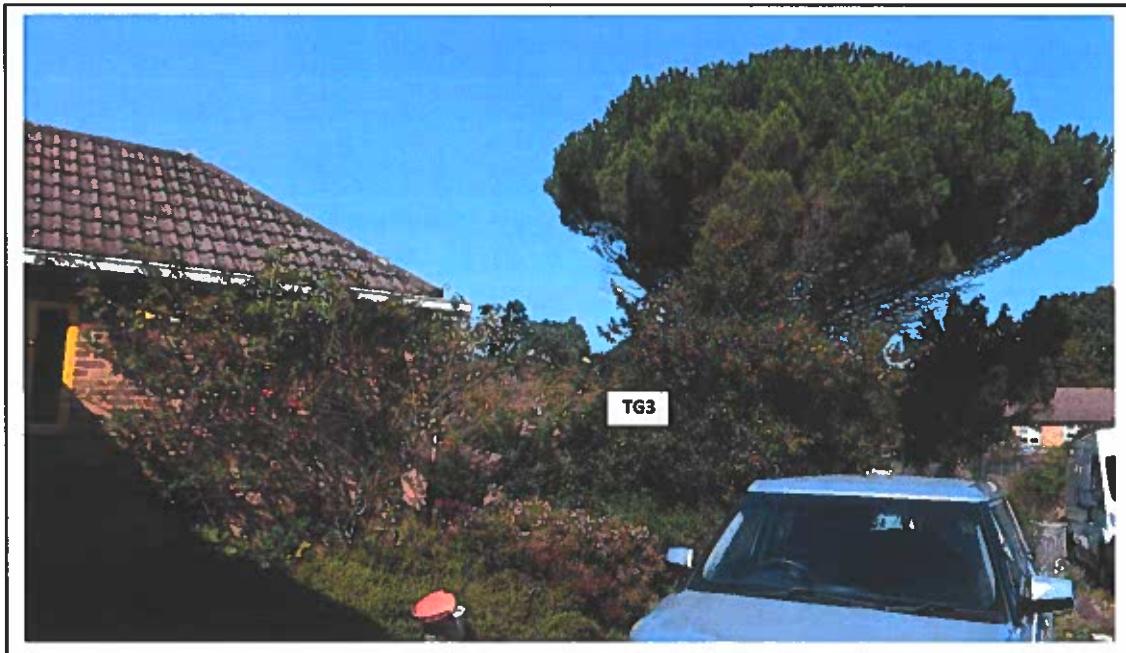
View of TG3 Pine, Holly and shrub group at property frontage

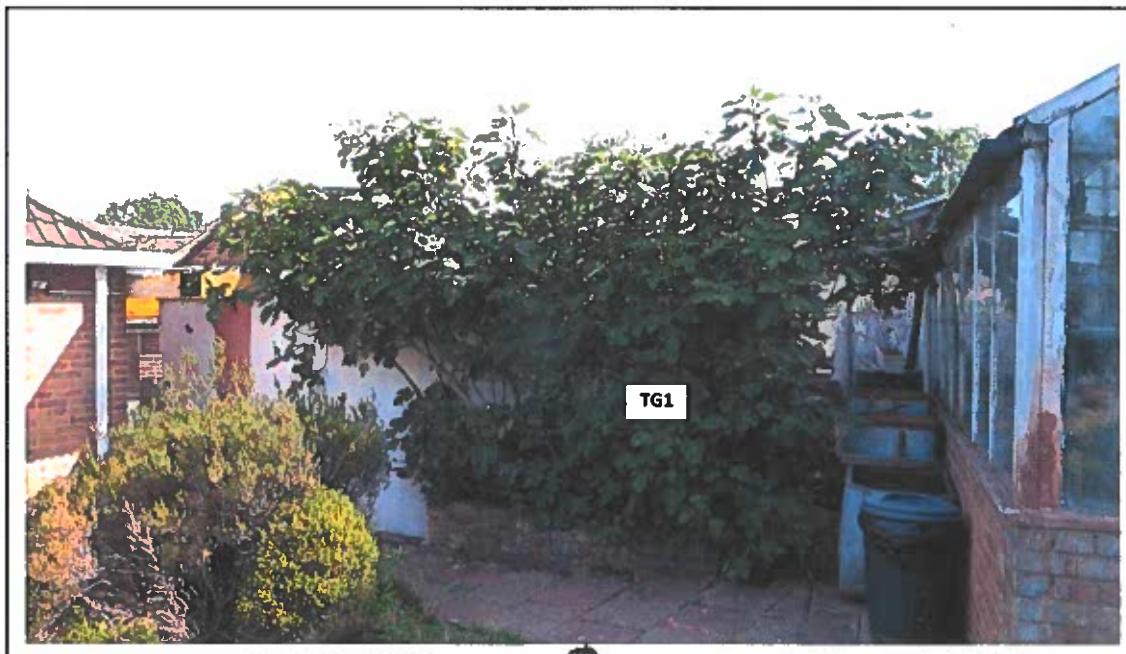
View of TG1 Fig group

X FIG IN FREE STANDING
CONCRETE BOX - ie NOT IN GROUND

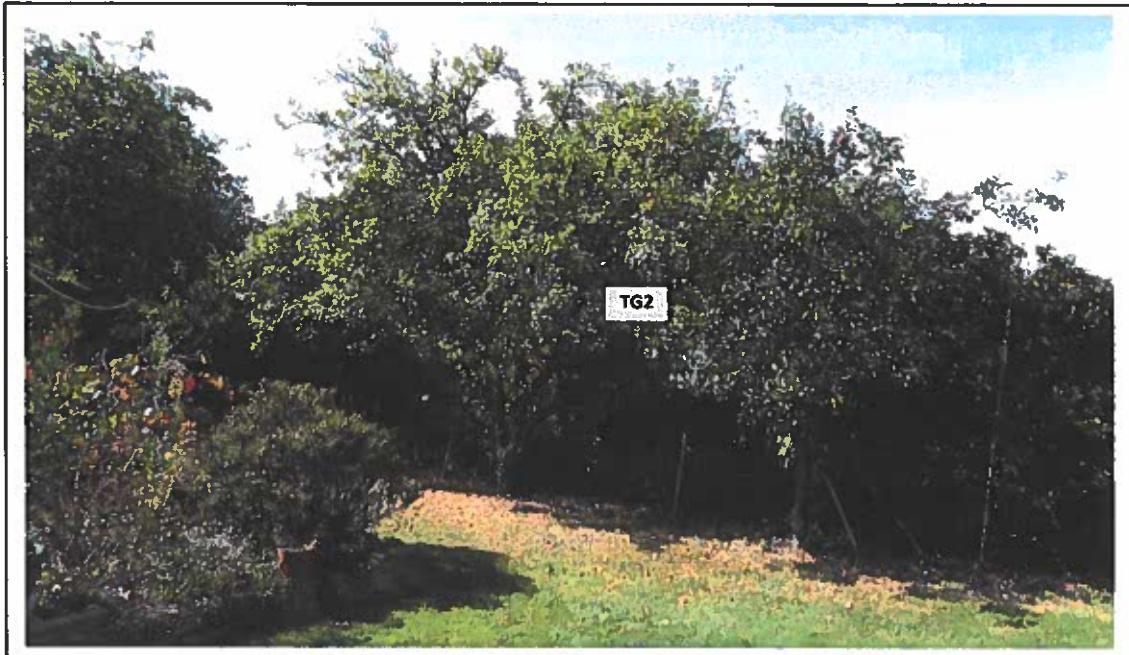
View of TG2 Apple group
