# Arboricultural Appraisal Report

## Subsidence Damage Investigation at:

6 Windrush Close  
Ickenham  
Uxbridge  
UB10 8EJ

CLIENT: Davies Group Ltd  
CLIENT REF: 72229022  
MWA REF: SUB230724-13845  
MWA CONSULTANT: Andy Clark  
REPORT DATE: 03/10/2023

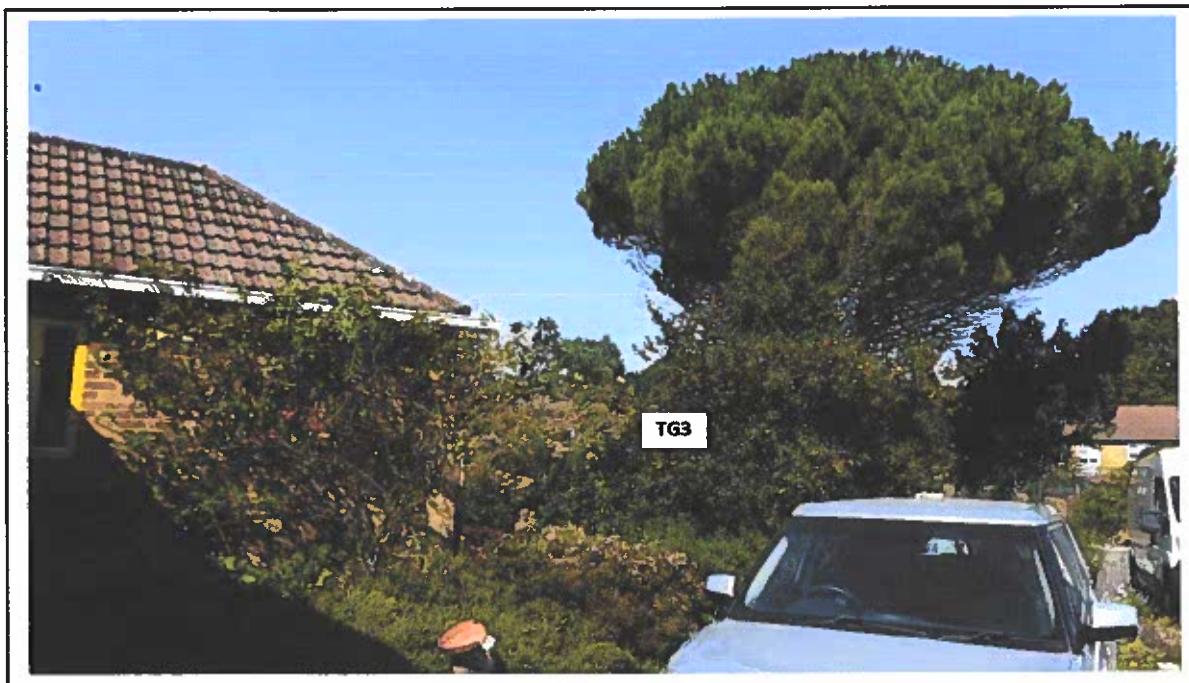
**Roots were observed to a depth of 2.5m bgl in TP/BH1 and recovered samples have been tentatively identified (using anatomical analysis) as possibly Rosoideae gp., similar to Caprifoliaceae spp. and similar to either Cedrus spp. or Pinus spp.; the origins of which will be the nearby shrubs and the Pine of TG3 group at the property frontage, confirming their influence on the soils below the foundations.**

**Based on the technical reports currently available, engineering opinion and our own site assessment we conclude the damage is consistent with shrinkage of the clay subsoil related to moisture abstraction by vegetation.**

View of TG3 Pine, Holly and shrub group at property frontage

**If an arboricultural solution is to be implemented to mitigate the influence of the implicated trees/vegetation we recommend that the nearby shrubs and the Pine of TG3 group are removed. Other vegetation recorded presents a potential future risk to building stability and management is therefore recommended. Recommended tree works may however be subject to change upon receipt of additional information.**

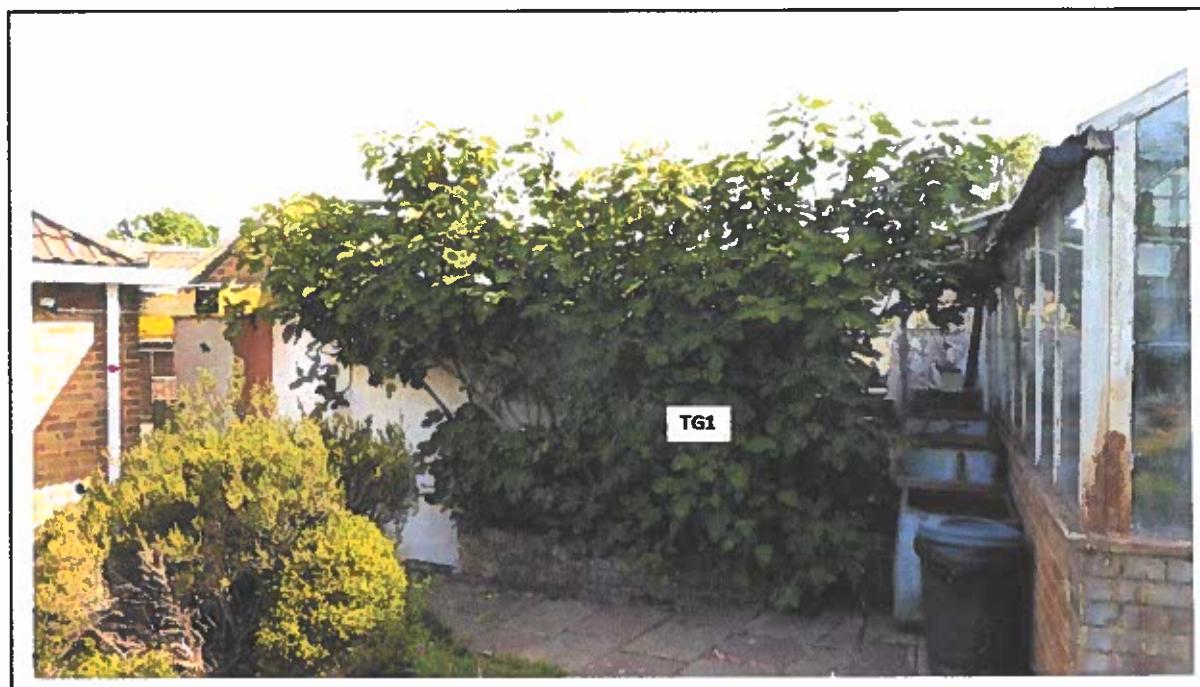
View of TG1 Fig group

Tree No.	Species	Ht (m)	Dia (mm)	Crown Spread (m)	Dist. to building (m)	Age Classification	Ownership
TG1	Fig group	2.5	40 Ms *	4.5	4.0	Younger than Property	Policy Holder
Management history		Subject to past management/pruning - appears regularly pruned.					
Recommendation		Remove (fell) to near ground level and treat stumps to inhibit regrowth.					
TG2	Apple group	5.5	180 Ms	6.5	9.5	Younger than Property	Policy Holder
Management history		No significant recent management noted.					
Recommendation		Maintain broadly at no more than current dimensions by periodic pruning.

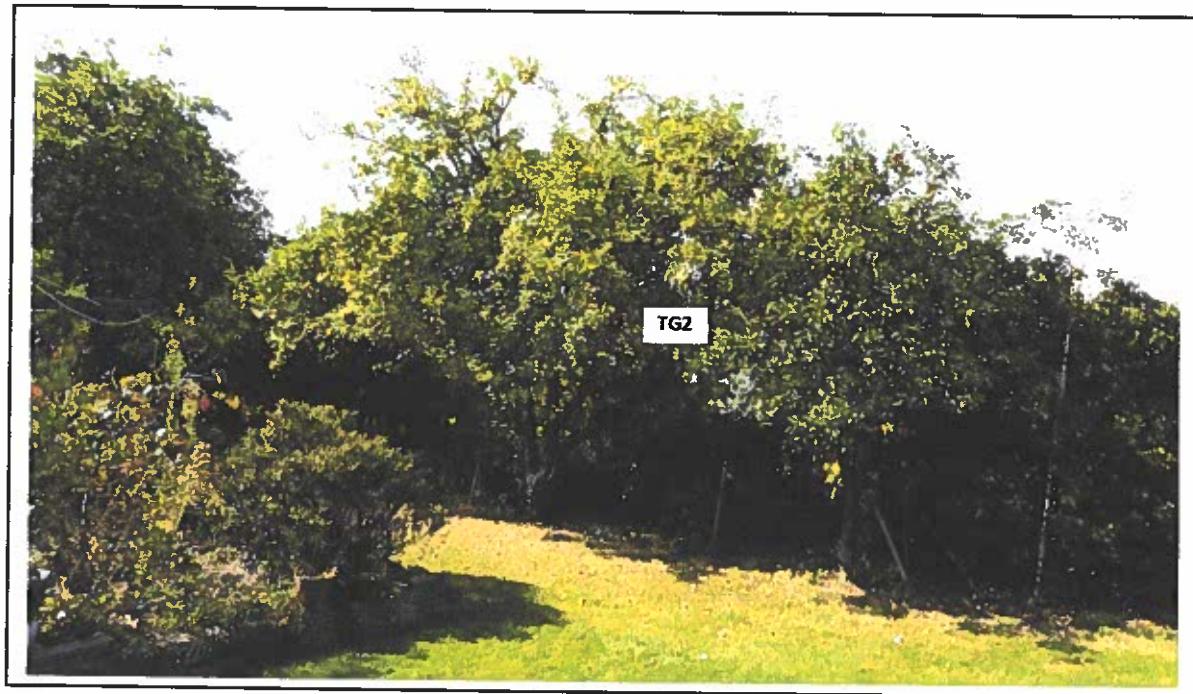
View of TG2 Apple group
