ADDENDUM TECHNICAL REPORT
Retained

We refer to previous correspondence in respect of the above from which insurers will be aware that we are dealing with subsidence damage affecting a 3 bedroom detached, domestic dwelling comprising mainly brick, elevations beneath a pitched, tiled, roof. The property is a bungalow and is believed to have been constructed in 1958 and built by Mr Ridler. It has been well maintained over the years.

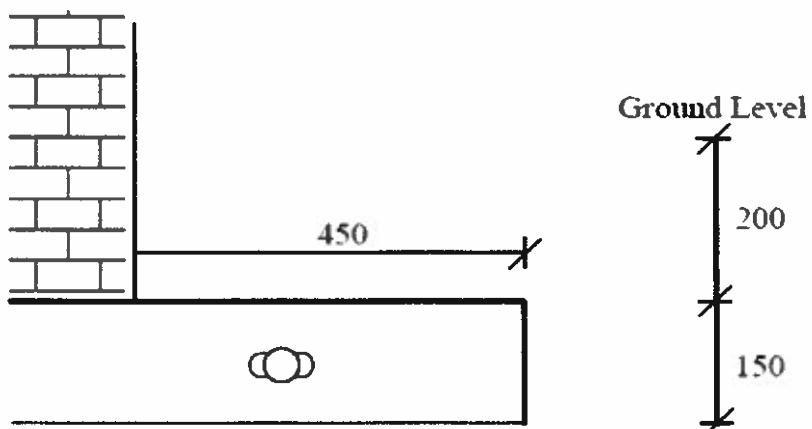
Figure 2 Foundation detail from trial pit.

The foundations to the front of the property are a brick on a concrete strip 0.35m deep and bears onto firm light brown clay. Details of the foundation can be seen in figure 2.

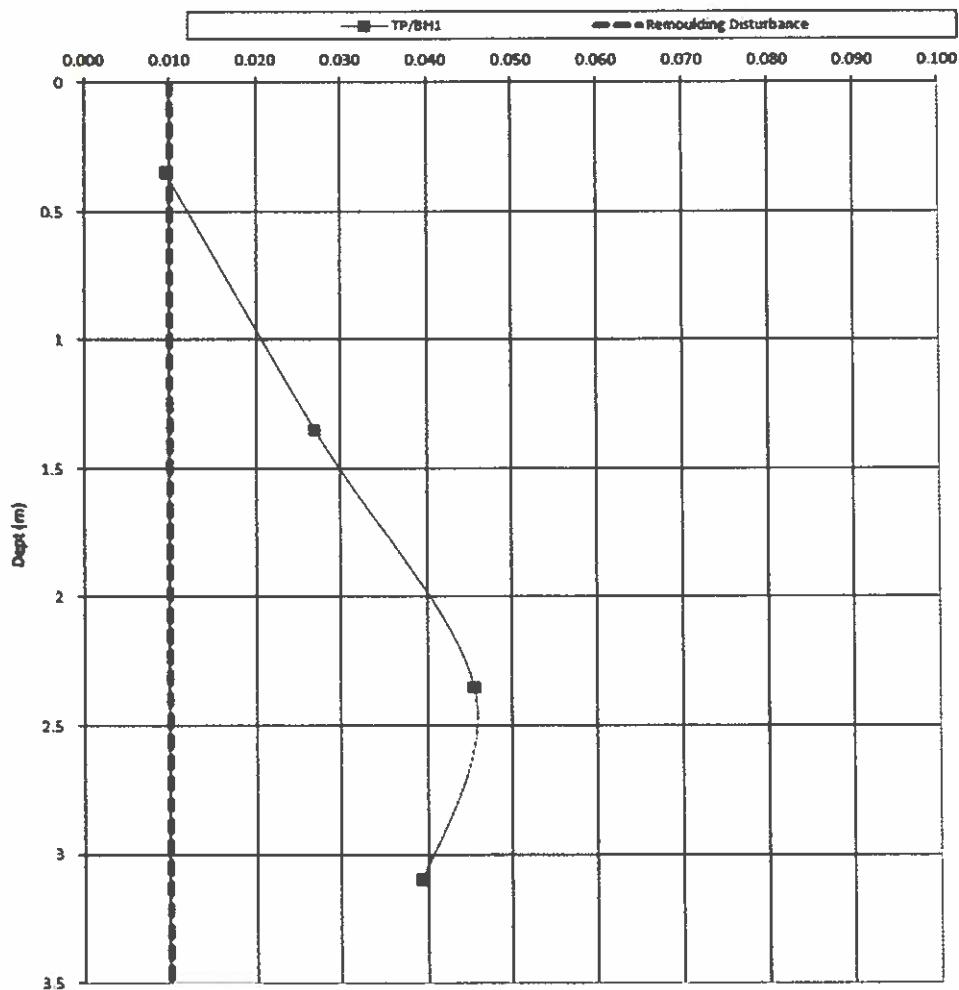
Figure 3 Oedometer strain graph.

The degree of clay shrinkage has been determined using the Oedometer Swell Strain Test method of measuring soil values. In short, the greater the strain value, the drier the sample of clay. On this basis we have determined that there is significant clay desiccation to the front of the property in the area of damage. The depth of clay shrinkage has implied that the nearby vegetation is the prime cause of clay dehydration. The oedometer results can be seen in figure 3.

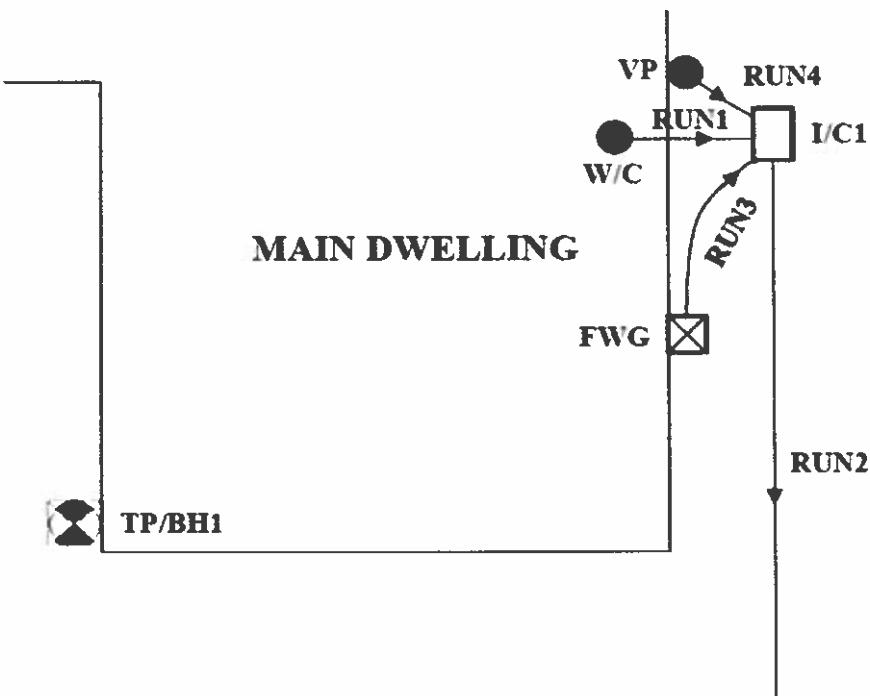
Figure 4 Drainage site plan.

The only issues with the drains are to run 2, there are mulitple cracks and root increase down the run.

There are some drainage issues to run 2 which need to be rectified however this would not be the sole cause of movement.

It is recommended that drains are repaired as soon as possible.

There are some drainage issues to run 2, insurers will need to confirm to us if we can repair them under the current claim or an additional AD claim.
