INITIAL TECHNICAL REPORT

DATE OF ISSUE:	8 th December 2022
OUR REFERENCE NO:	72229022
YOUR REFERENCE NO:	540588175
Ageas PO Box 2958 Stoke on Trent ST4 9EY	Mr Ridler 6 Windrush Close Ickenham Uxbridge UB10 8EJ

General view of property

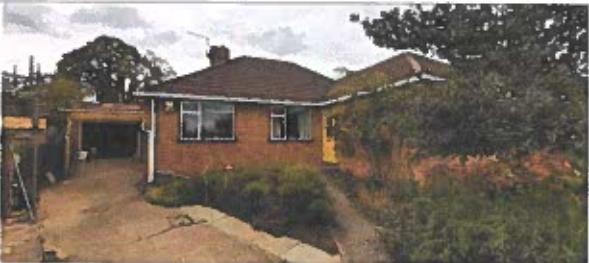
<p>Photograph 1 Front elevation.</p>

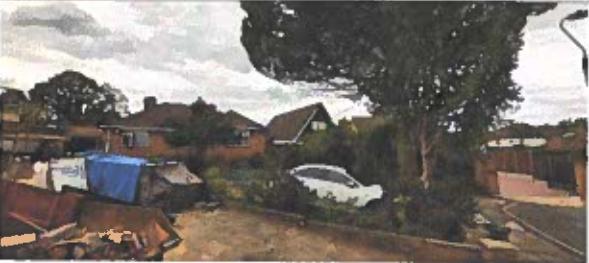
The damage could be attributable to clay shrinkage subsidence, which has been exacerbated by the moisture extraction influence of the surrounding vegetation. The primary vegetative influence is considered to be the policyholder's.

<p>Photograph 2 View of the vegetation to the front.</p>

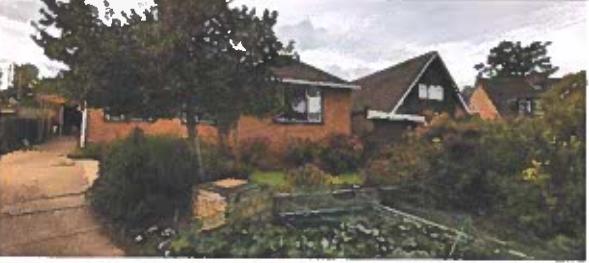
<p>Photograph 3 View of the vegetation to the front.</p>

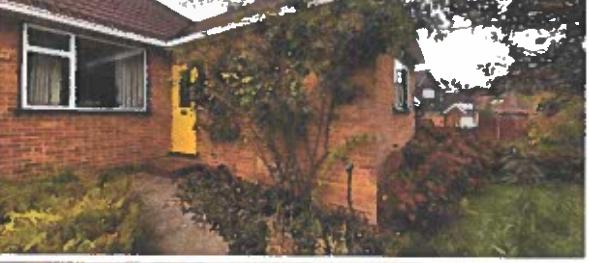
<p>Photograph 4 View of the rose bush</p>

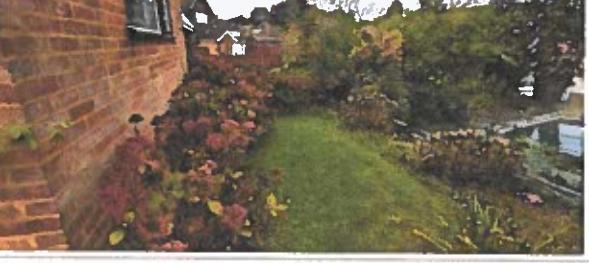
<p>Photograph 5 View of the vegetation to the front. Also showing the front elevation.</p>

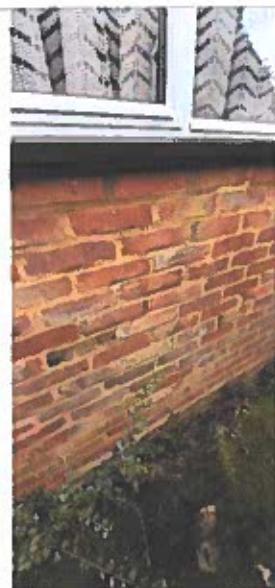
- On the front elevation, beneath the window there is an area of brickwork which has been repointed.
- In the right corner there is a vertical crack totalling 1.25 linear metres and ranging from 1 – 9 mm wide.

Photograph 6
View of the cracking beneath the front bedroom window.

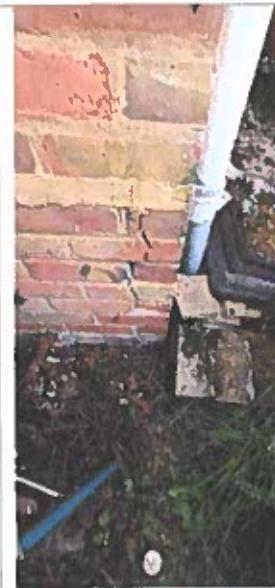
Photograph 7
View of the low-level cracking to the front right corner on the front elevation.

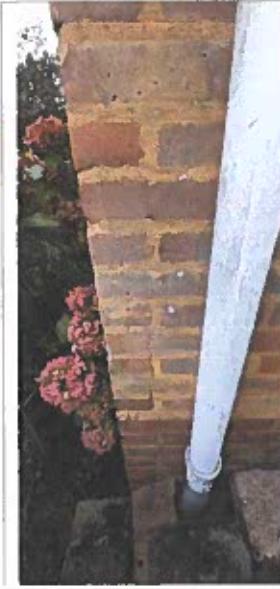
- On the right elevation of the front projection, there is a vertical crack to the corner totalling 1.25 linear meter and ranging from 1 – 5 mm wide.
- Beneath the bathroom window there is a stepped and vertical crack totalling 2 linear metres and ranging from 1 – 2 mm wide.

Photograph 8
View of the cracking to the front right corner on the right elevation.

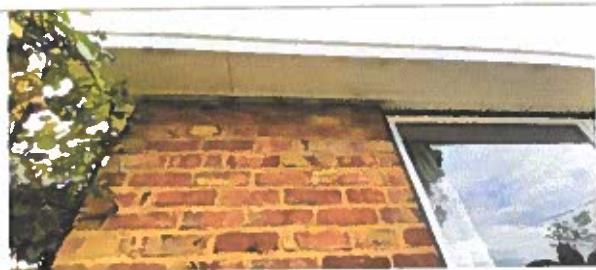
- Above the front bedroom window there is a stepped crack leaving the front bedroom window and leading to the roof level totalling, 1 linear metre and ranging from 1 – 2.50 mm wide.

Photograph 9
View of the stepped cracking to the front left corner of the front elevation, at high level.

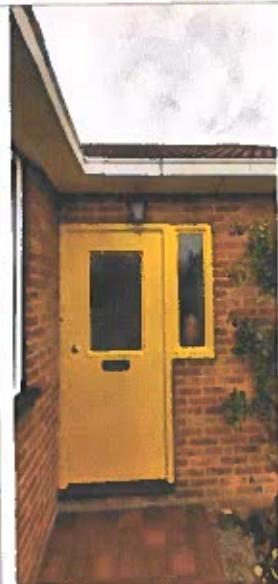
- Above the front door there is an area of repointed bricks.
- Above the door there is a stepped crack leaving the door and leading to the roof level and the crack has also damaged the soffit totalling 1 linear metre and ranging from 5 – 9 mm wide.

Photograph 10
View of the front door and cracking above the door.

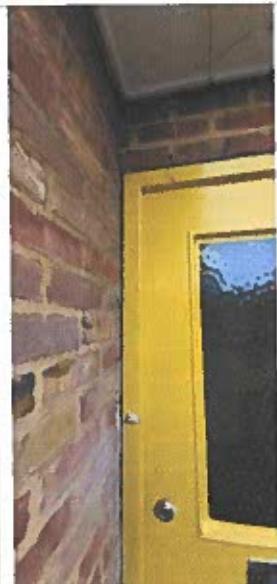
- The door frame has distorted and there is a vertical separation between the door and brickwork totalling, 2 linear metres and ranging from 1 – 9 mm wide.

Photograph 11
View of the vertical separation crack to the front door.

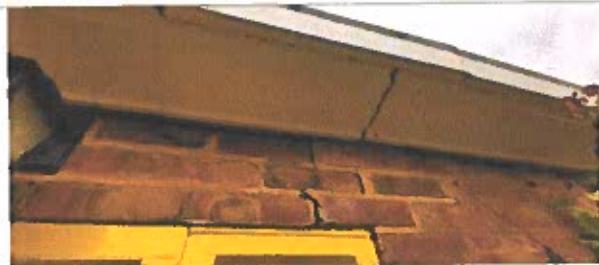
Photograph 12
View of the cracking above the front door.

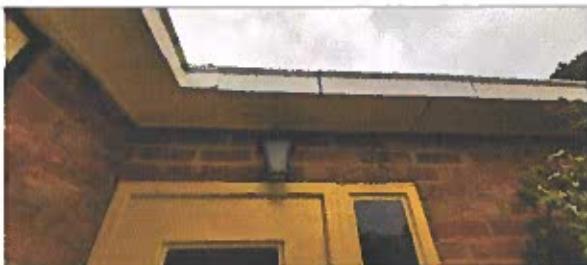
Photograph 13
View of the cracking above the front door and showing the different colour mortar.

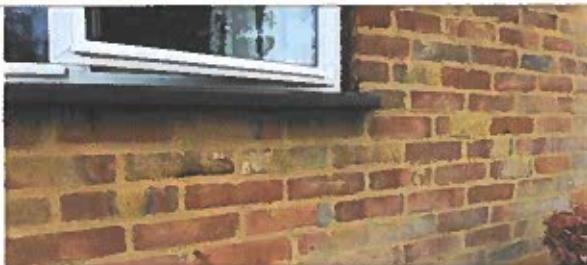
Photograph 14
View of the minor cracking beneath the front bedroom window.

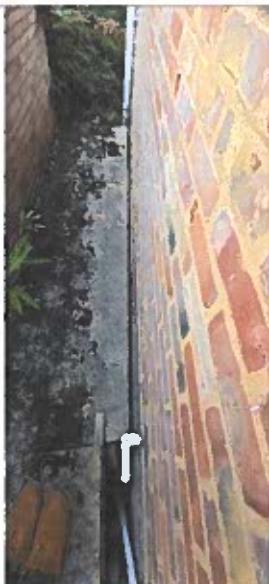
Photograph 15
View of the path to the right side of the property showing the path moving away from the main building.

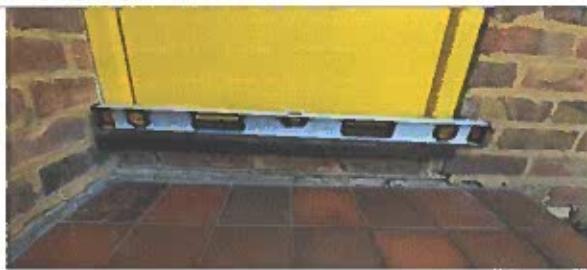
Photograph 16
View of the drop to the door.

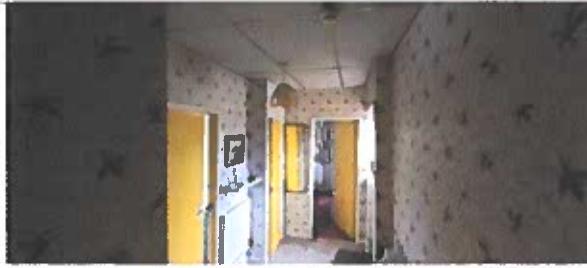
Photograph 17
General view of the hallway.

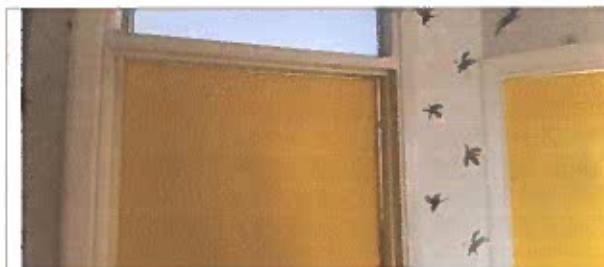
Photograph 18

View of the distortion to the door frames and showing the internal doors not closing properly.

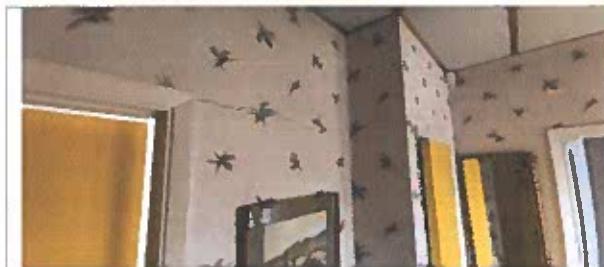
Photograph 19

- Between the front door frame and wall there is vertical separation crack totalling 2.40 linear metres and ranging from 1 – 11 mm wide.
- Leaving the door opening there is a crack leading forwards totalling, 1 linear metre and ranging from 1 – 5 mm wide.
- Above the front door there is a stepped crack totalling 2 linear metres and ranging from 1 – 3 mm wide.
- There is a horizontal crack leaving the bathroom door and leading to the cupboard totalling 1 linear metre and ranging from 1 – 4 mm wide.
- Above the door serving the front bedroom there is a vertical crack leaving the opening and leading to the ceiling totalling, 1.25 linear metres and ranging from 1 -4 mm wide.

View of the cracking to the internal walls in the hallway.

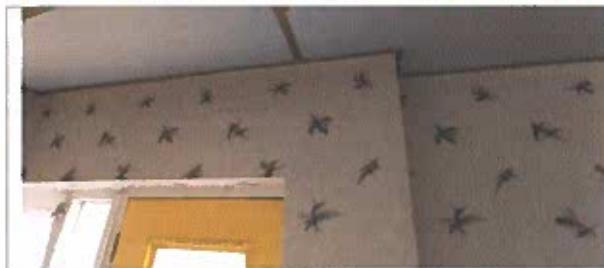
Photograph 20

View of the cracking to the internal walls in the hallway.

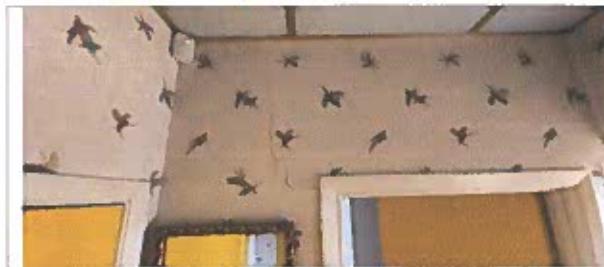
Photograph 21

View of the cracking to the internal walls in the hallway.

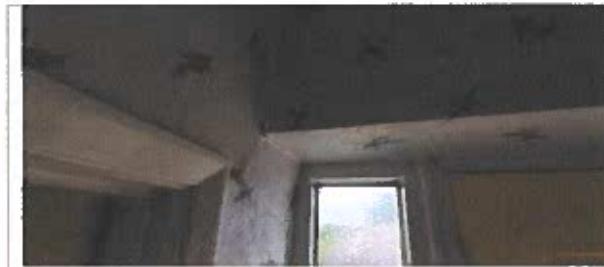
Photograph 22

View of the cracking above the front door.

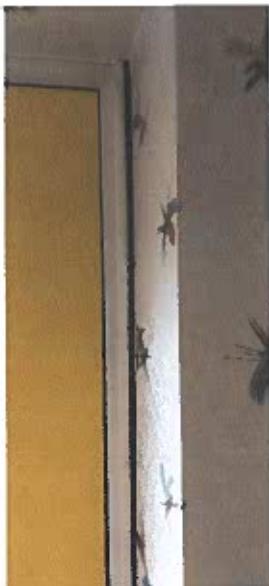
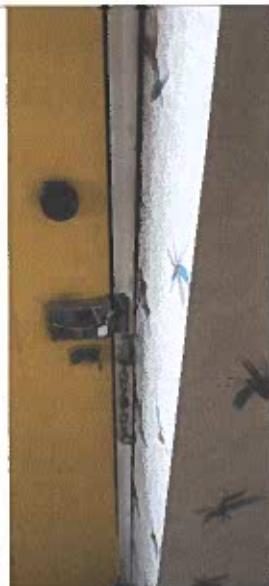
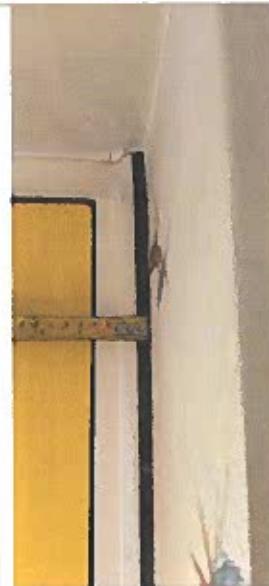
Photograph 23
View of the separation between the wall and door frame.

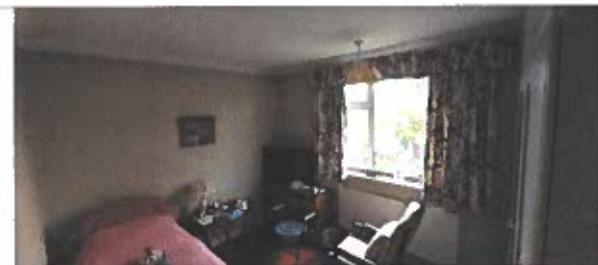
Photograph 26
View of the front bedroom.

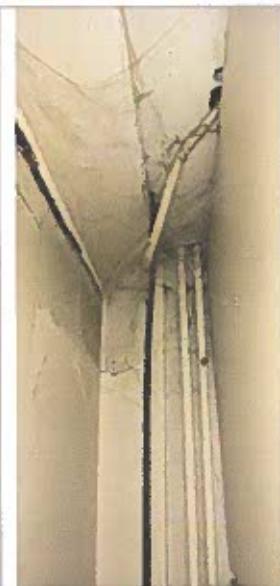
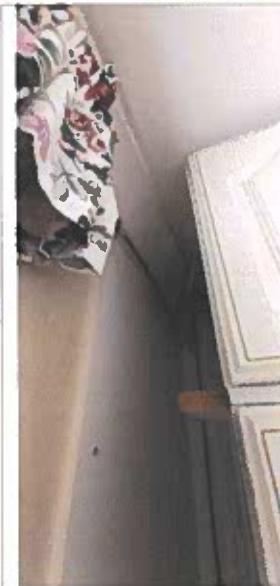
- There is a crack leaving the door opening totalling 0.50 linear metres and ranging from 1 -3 mm wide.
- In the front left corner, there is a separation crack between the front and coving totalling 3 linear metres and ranging from 5 – 11 mm wide.
- In the front right corner, there is cracking and displacement to the coving and internal wall totalling 1 linear metre and 2 mm wide.

Photograph 28
View of the high-level cracking to the front bedroom in the front left corner.

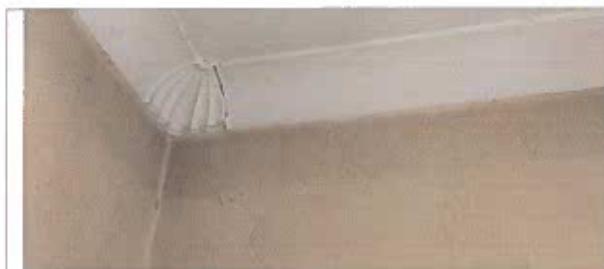
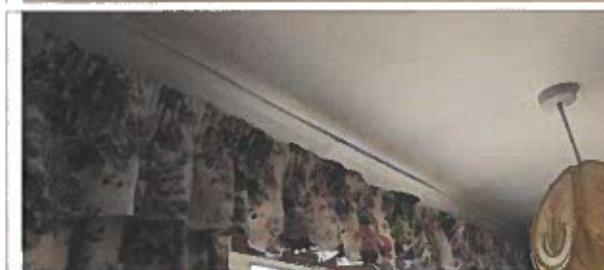
Photograph 30
View of the high-level cracking to the coving in the front bedroom.

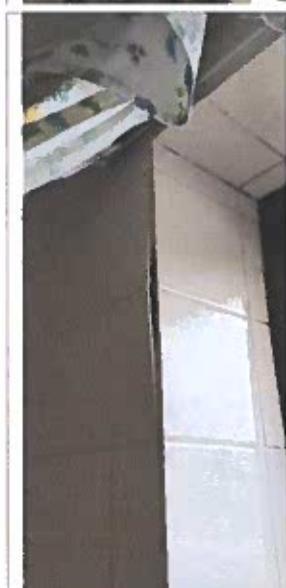
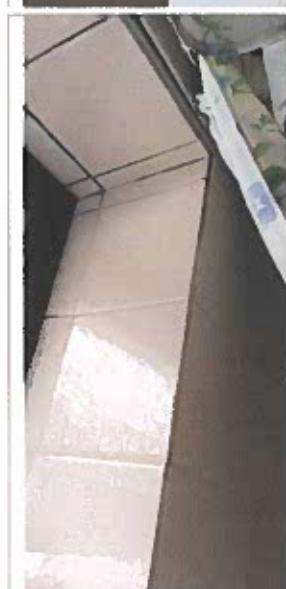
Photograph 32
View of the cracking and displacement to the bathroom tiles on the external wall.

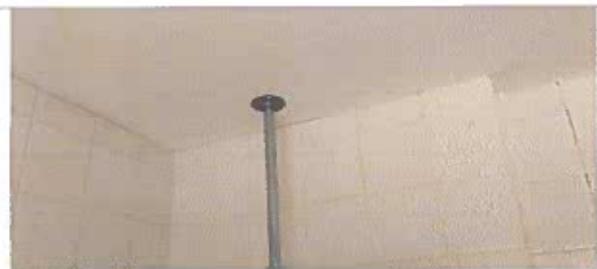
- On the internal wall there is a horizontal crack mirroring the hallway and totalling 1.25 linear metres and ranging from 1 – 4 mm wide.
- There is a separation crack to the ceiling and internal wall totalling 2.50 linear metres and ranging from 1 – 3 mm wide.
- There are two cracks wither side of the window reveal totalling 1 linear metre and 4 mm wide.
- There is a crack between the floor and walls totalling 3 linear metres and ranging from 1 -3 mm wide.

Photograph 34
View of the cracking to the wall and ceiling junction in the bathroom.

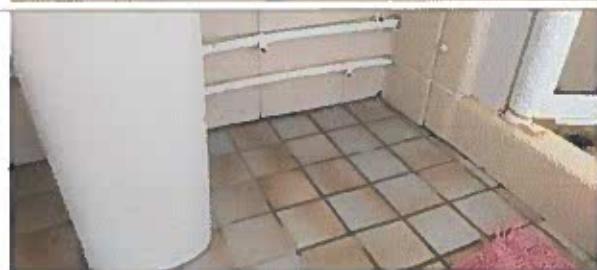
Photograph 35
View of the drop and gap between the floor and wall tiles in the bathroom.

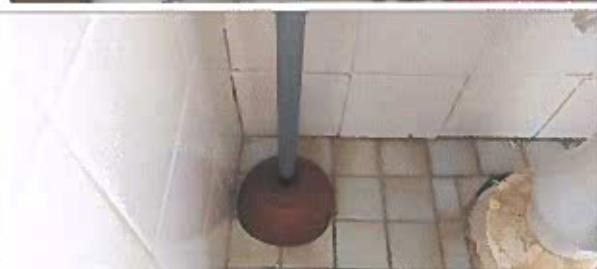
Photograph 36
View of the gap between the floor and wall tiles in the bathroom.
