SITE INVESTIGATION FACTUAL REPORT

Client: The Davies Group

Our Reference Number: HH/23/70036

Site Crew	P. Chapmas / D. Jones
Site Address & Postcode	6 Windrush Close, Ickenham, Uxbridge, UB10 8EJ
Date	07/02/2023

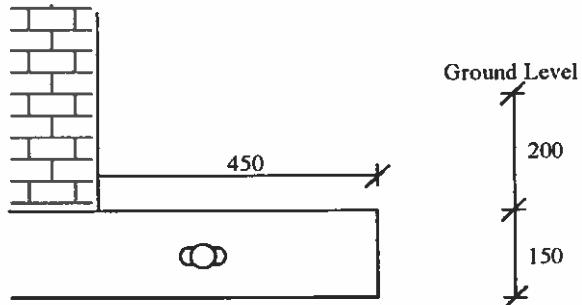
TP/BH1 FOUNDATION DETAIL

For strata information, please refer to borehole log TP/BH1.

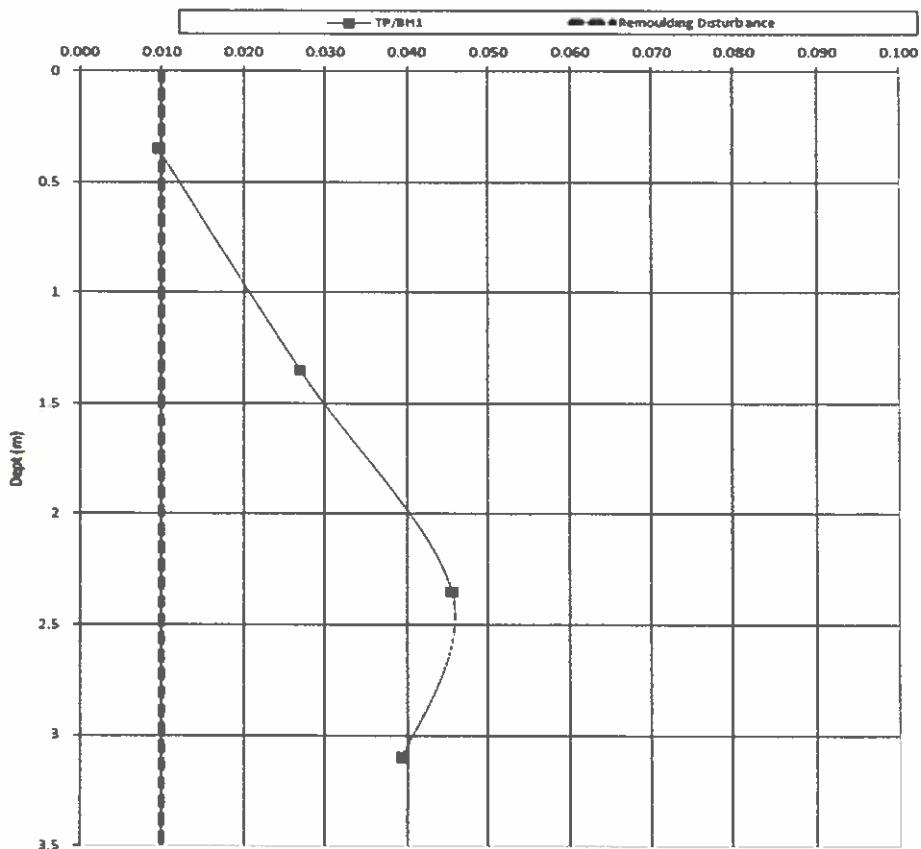
One Dimensional Swell / Strain test - In House Method

Moisture contents in TP/BH1 are approaching or below both the plastic limit and 40% of the Liquid limit. It is therefore likely that the ground has attained desiccation in this area. Oedometer strain test results are indicative of this showing potential heave of 52.6mm.
