## **SCHEDULE OF WORKS**

**Repairs**

**The Southlands Arts Centre**  
The Green, West Drayton, UB7 7PW

**Hillingdon Borough Council**

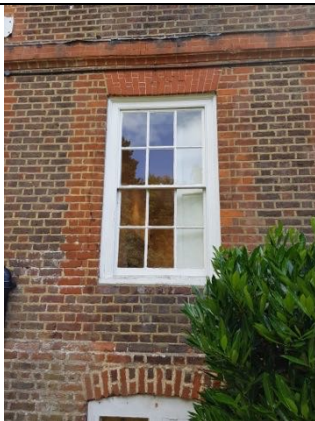
| Item | description | Photo | Heritage impact | works |
|---|---|---|---|---|
| 3.1 | <p>Above window G1, there is slight opening of brick joints to the string course. To the left reveal of this window there is a vertical crack through the brickwork that is widest at approximately 8 brick courses up from the cill, probably being a couple of millimetres (2mm to 3mm). To the left hand corner of window G1, there is an area of removed pointing and recessed joints to brickwork. Beneath the cill of G1 some of the mortar is slightly loose where it forms a fillet between the cill and brickwork.</p> | | Neutral | <p>Allow for re pointing 0.25 m<sup>2</sup> brickwork in 1:2 Lime putty /sharp sand mortar. As specification FX1 &amp; 2 in Appendix 4. Replace loose sections of mortar fillet.</p> |

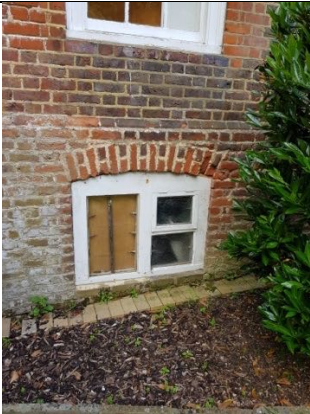
| Item | description | Photo | Heritage impact | works |
|---|---|---|---|---|
| 3.2 | At cellar level to C1 the brickwork is damaged and eroded, particularly to the right hand corner. However, around this area it would appear that rather crudely applied lime mortar has been used in the past | | Neutral | Cut out and replace 2 no. bricks to the right hand side of the arch, laid in 1:2 lime putty / sharp sand mortar. |

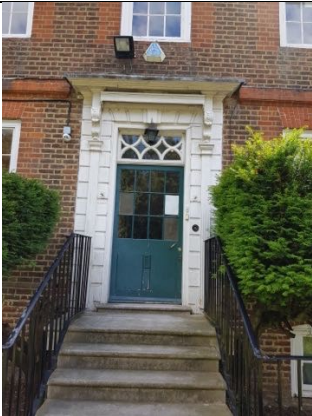
| Item | description | Photo | Heritage impact | works |
|---|---|---|---|---|
| 3.6 | From ground level there is some evidence to suggest that there might be splits in the lead capping in places, and this needs to be patch repaired as necessary. | | Neutral | Leadwork to be checked and re-dressed where necessary, particularly above entrance door. Allow a provisional sum for replacing 6 no. sections of capping, 150mm long in code 5 lead. |

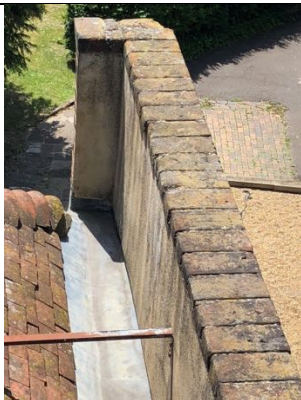
| Item | description | Photo | Heritage impact | works |
|---|---|---|---|---|
| 3.10 | The parapet coping bricks appear to be sound but pointing between is failing. | | Neutral | Rake out mortar joints to a depth of 20mm and re point in 1:2 Semi Hydraulic lime (NHL5) / sharp sand. |

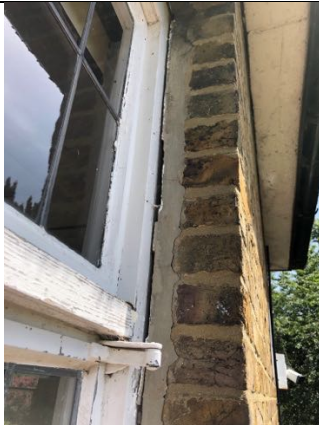
| Item | description | Photo | Heritage impact | works |
|---|---|---|---|---|
| 4.5 | Mortar fillet to F6 is falling away | | Neutral | Rake out and replace in in 1:2 Semi Hydraulic lime (NHL 3.5) / sharp sand mortar. |

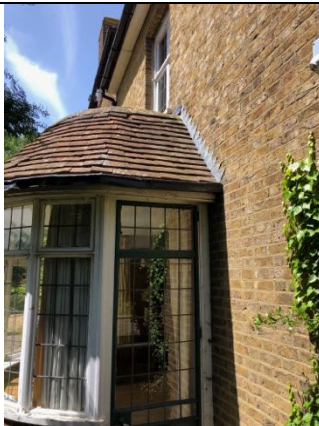
| Item | description | Photo | Heritage impact | works |
|---|---|---|---|---|
| 4.6 | The leadwork at the abutment of the bay with the main building appears sound. The felt over the bay roof appears sound at present. However, the mortar fillet around its perimeter is cracked and in poor condition. There is past evidence of roof leaks here, possibly by wind driven rain. | | Positive | Ideally the felt roof covering would be replaced in lead, however in this remote position, with some history of lead theft we recommend replacing the felt with a GRP roof covering incorporating rolls to take the appearance of lead as "Topseal simulated lead, topseal GRP" installed in accordance with manufacturers recommendations with simulated lead rolls as, Appendix A-3.0 or similar. |

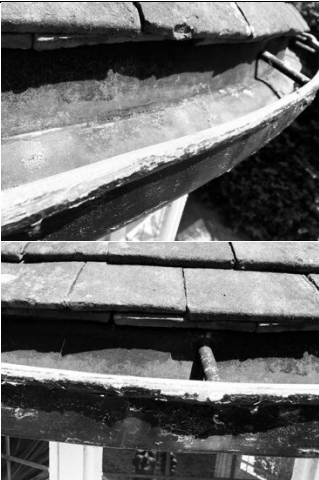
| Item | description | Photo | Heritage impact | works |
|---|---|---|---|---|
| 4.8 | The lead gutter to the bay is poor with splits and damage.<br>To the left hand section, there is no connection between the gutter and the downpipe. | | Neutral | The lead gutter will need to be completely replaced to match the existing details in code 7 lead, including for iron spacer bars. Allow for forming outlet to connect into existing downpipe and re connected to the downpipe. |

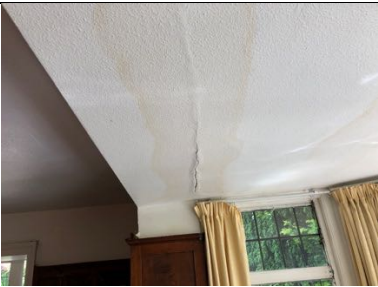
| Item | description | Photo | Heritage impact | works |
|---|---|---|---|---|
| 4.10 | Garden room bay window ceiling. | | | Repair staining by removing lining paper, clean down and fill cracks. Apply stain block and re finish with heavy duty lining paper. Re decorate in 1mist coat and 2 full coats emulsion paint |

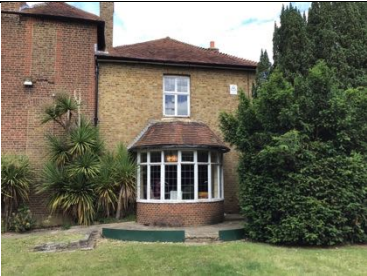
| Item | description | Photo | Heritage impact | works |
|---|---|---|---|---|
| 4.11 | To the cast iron gutters, there are one or two of the joints which appear slightly distorted and need to be properly opened, cleaned and re-formed and left sound. | | Neutral | Provide access to inspect gutter joints and provisionally allow for dismantling, cleaning down and re forming 4 no. joints |

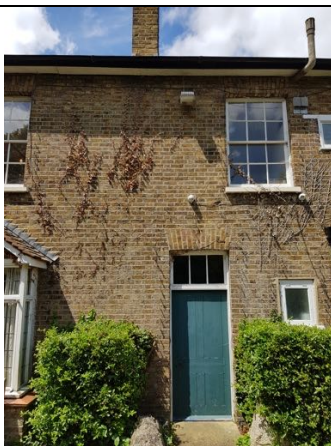
| Item | description | Photo | Heritage impact | works |
|---|---|---|---|---|
| 5.3 | The elevation has had some climbing plants up it in the past, but these do not appear to have caused any major problem. | | Neutral | The dead remnants need to be completely cleared and allowance made in case some localised patch repair is needed. Provisionally allow for a total of 3m <sup>2</sup> re pointing in areas of not less than 0.2m <sup>2</sup> each, in 1:2 lime putty / sharp sand mortar |

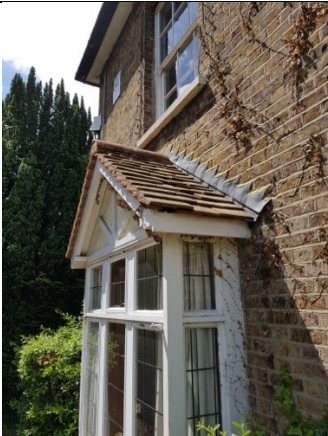
| Item | description | Photo | Heritage impact | works |
|---|---|---|---|---|
| 5.6 | To the bay, the ridge tiles are loose and need to be re-bedded. There are a couple of misaligned tiles and general overhaul of the roof is required. | | Neutral | Re fix loose and misaligned tiles and re bed ridge tiles in 1:2 Semi Hydraulic lime (NHL5) / sharp sand |

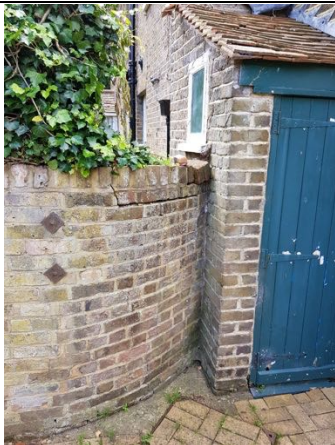
| | tile missing. Ideally, there should be a lead detail between the wall and this ridge. | | | |
|---|---|---|---|---|
| 5.10 | Where the garden wall adjoins this lean-to under G11 the brickwork is loose and open jointed | | Neutral | Re build 0.5m <sup>2</sup> of wall using existing bricks where possible made up with re claimed brick to match laid in 1:2 lime putty / sharp sand mortar.<br>Allow for an additional 1m <sup>2</sup> re pointing |

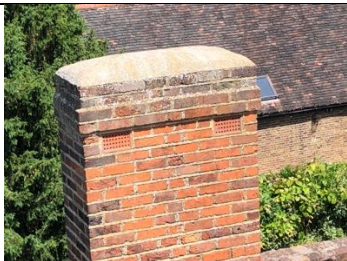
| <b>6.0</b> | <b>North Elevation</b> | | | |
|---|---|---|---|---|
| 6.1 | At high level the chimney over the older part appears sound and has been repointed in with the rest of the elevation. It would appear to have been completely repointed or perhaps even rebuilt. The top does have air bricks for ventilation | | Neutral | No work |

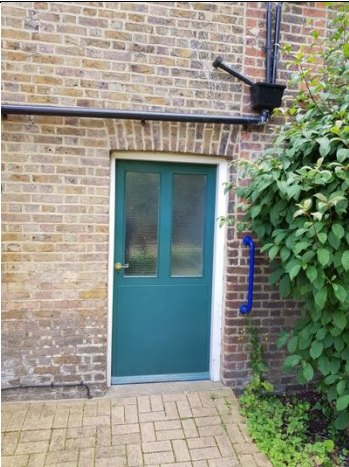
| Item | description | Photo | Heritage impact | works |
|---|---|---|---|---|
| 6.2 | The hopper above door G13 has staining below it, suggesting it might be leaking or has been leaking in the past. Where this downpipe from the hopper turns from almost horizontal to vertical in the corner by the kitchen lean-to, there is staining at a joint that again suggests leaks. | | Neutral | Dismantle joint and re seal. |

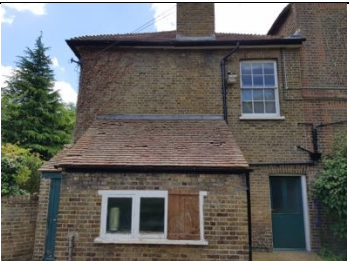
| Item | description | Photo | Heritage impact | works |
|---|---|---|---|---|
| 6.4 | To the top of the kitchen lean-to roof the leadwork has been partly ripped away and the leadwork needs to be replaced. Where someone has clambered over the roof, there are a number of damaged tiles | | Neutral | Replace 1m length of flashing in code 5 lead detailed as existing and replace 50 roof tiles to match existing. |

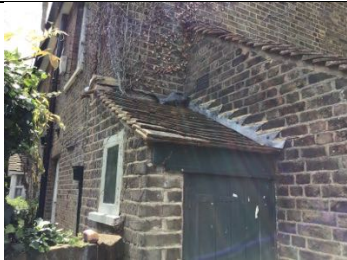
| Item | description | Photo | Heritage impact | works |
|---|---|---|---|---|
| 6.5 | Where the shed lean-to adjoins the building, the leadwork has again been ripped up and needs to be completely re-formed. | | Neutral | Replace entire top edge flashing in code 5 lead detailed as existing. |

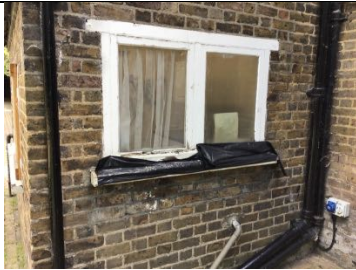
| Item | description | Photo | Heritage impact | works |
|---|---|---|---|---|
| 6.8 | Window G12 has a rotten cill and bottom section. These are planted timbers in front of the original frame. The bottom of the frame is probably capable of being repaired, but the whole of the cill and bottom section needs to be rebuilt. As the window is in a later lean-to add-on, it has limited historic value and total replacement will be a more economical solution. | | Neutral | Replace entire window in treated softwood with hardwood cill, as drawing 05, glazing to be 4mm toughened glass, putty fixed. |

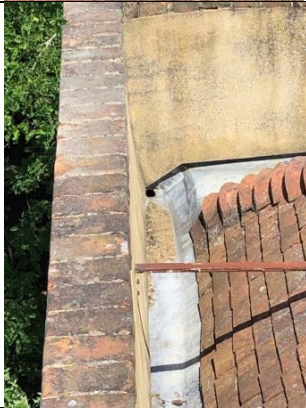
| Item | description | Photo | Heritage impact | works |
|---|---|---|---|---|
| 7.6 | The lead lined gutter behind the west parapet appears to be in sound condition, although there is evidence that the gutter has leaked at the 1 <sup>st</sup> step from the left. There is some debris in the gutter and the outlet is small, the likelihood is that in very heavy rain, water may not discharge through the narrow outlet at a sufficient rate and therefore, is backing up and leaking through the step in the gutter | | Neutral | Strip out end section of lead valley and re form in code 5 lead with 100mm diameter outlet chute. Include for stripping back 3 courses of tiles and re laying and re forming the drip to the render to the parapet wall with stainless steel bead and making good render in 1:2 Semi Hydraulic lime (NHL5) / sharp sand with stainless steel drip bead. |

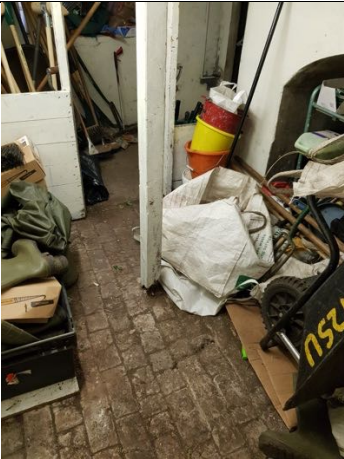
| 8.1 | Post in room 07 has some localised rot at the base | | Neutral | Provide temporary support, cut off bottom 150mm of post and replace with Hardwood with ½ lap joint on to existing post. |

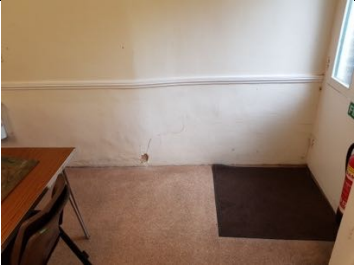
| Item | description | Photo | Heritage impact | works |
|---|---|---|---|---|
| 9.1 | <p>To the chimney breast there is blistering paint and plaster at low level. There are also high readings in search mode and it is suspected that dampness is trapped in the old fireplace recess at the base of this chimney. There is no ventilation, etc. to this area and externally the chimney seems to be open.</p> <p>Along the internal wall with room 02, there is some damaged plaster at low level. Again, the wall gives readings in search mode. It would appear that there has been some past replastering and it is a modern dense plaster. The moisture meter gives no readings in WME mode. It is suspected that this wall may have been treated in the past or at least tanked.</p> | | Neutral | <p>Remove the damaged areas of plaster up to dado rail along the whole length of the wall and chimney breast and re plaster in 2 coats as:-<br/> 1<sup>st</sup> 1:3 (lime putty, coarse sand)<br/> 2<sup>nd</sup> 1:3 (lime putty, fine sand)<br/> Re decorate in 3 coats distemper.</p> <p>Fit 215 x 215mm terracotta air brick in Chimney breast.</p> |

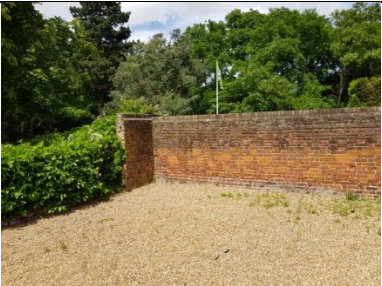
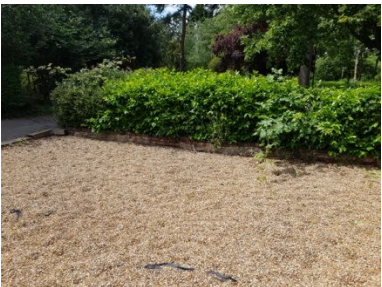
| Item | description | Photo | Heritage impact | works |
|---|---|---|---|---|
| 11.4 | <p>Front walled garden - The boundary walls are generally plumb with no major deterioration. There is surface spalling to individual bricks but nothing of significance at present. Past repointing in cement mortar has been carried out and this might explain some of the spalled bricks. However, at present it is more a matter of monitoring the situation rather than any repair.</p> <p>To the south side of the front garden wall, the south wall has some areas of open jointed brickwork, but nothing that needs urgent attention at present. This should be monitored, and patch repair undertaken in due course. Where the wall appears to have been truncated the end of the wall could be improved by better finishing, but this is not urgent. Under the laurel hedge to the front the low level wall is poor and uneven with some loose brickwork. This requires localised repair. There is a wall running east-west from the northeast corner of the building. This has a gate within it. Again, it appears sound. Towards the eastern end, the wall is cracked and displaced due to past movement, probably due to the yew trees nearby. The eastern section leans over slightly because a yew tree is pressing upon it. The movement appears to be historic and at present there is no immediate need for work, but the situation should be monitored. Looking at the same wall from the north side, the displacement does appear to be due to the tree. If the tree is to remain, the wall will eventually need to be rebuilt, but at present it is not unsound with no evidence of any imminent problem.</p> | | Neutral | <p>Allow for rebuilding 3m<sup>2</sup> of wall using existing bricks where possible, made up with re claimed brick to match laid in 1:2 Semi Hydraulic lime (NHL 5) / sharp sand mortar.</p> <p>Allow for an additional 3m<sup>2</sup> re pointing</p> |

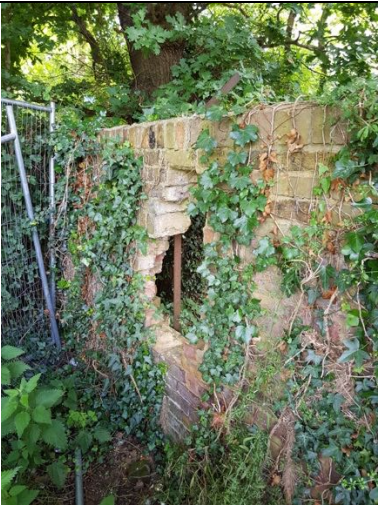
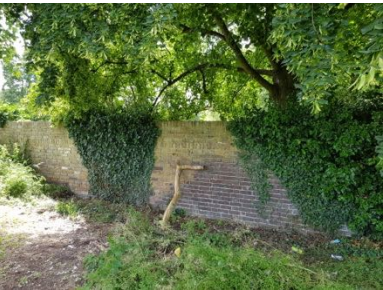
| | The main length of the wall appears to be sound from the north side. | | | |
|---|---|---|---|---|
| 11.5 | <p>Eastern most wall behind the yew trees - The top section has been heightened with additional brickwork and this is all in sound condition. Just below this, the older brickwork and the chamfered areas have some loose sections and in fact some missing sections of chamfer.</p> <p>Some localised patch repair of pointing and repair, particularly to the loose sections of chamfer, would be sensible. At the northeast corner there is a slight differential movement crack, but nothing of substance at present. The north wall has surface spalling to it in places, but the upper sections have been repointed in the past and at present show no sign of any particular problem. The western section appears slightly older, but much of it is disguised by vegetation. Towards the western end the top section does appear to be loose with the capping having a horizontal crack to it. However, there does not appear to be an imminent problem.</p> <p>In the northeast corner are a series of three yew trees. There is very minor displacement of the wall but nothing significant. However, in the northeast corner itself the wall is cracked and some local repair is required. The west wall does have a crack through it due to slight movement because of the trees, but again it is not significant to warrant any immediate concern. Partway along this wall on the west side, is I think, an ash tree that is</p> | | Neutral | <p>Prior to undertaking any work clear all plant growth from the wall and cut back to allow a clear working area 1m wide to either side of the wall (excluding any trees with a trunk diameter exceeding 75mm at a height of 1.5m)</p> <p>Allow for rebuilding 3m<sup>2</sup> of wall using existing bricks where possible made up with re claimed brick to match laid in 11:2 Semi Hydraulic lime (NHL 5) / sharp sand mortar in areas of not less than 0.25m<sup>2</sup> each.</p> <p>Allow for an additional 10m<sup>2</sup> re pointing in mortar as above.</p> <p>Allow for re bedding 6m of coping bricks in mortar as above in lengths of not less than 300mm</p> |

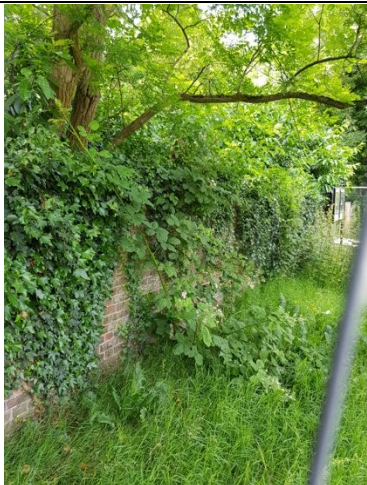
| | almost leaning against the wall and could pose a problem in due course. | | | |
|---|---|---|---|---|
| 11.6 | North wall to east of entrance - There is an area fenced off with Heras fencing and this is thought to be hazardous. It is difficult to get close access behind the Heras fencing because of vegetation, but there is access on the far side to the green. The wall is clearly leaning. The lean is not yet likely to result in imminent collapse, but it would be sensible to buttress this wall where it is at present to prevent the risk of further lean and collapse. The cause of the leaning is probably the trees and vegetation on the subject site side of the wall. | | <b>Negative</b><br>but works essential to prevent total collapse | <p>Prior to undertaking any work, clear all plant growth from the wall and cut back to allow a clear working area 1m wide to either side of the wall including a Hawthorn tree at the east end. Remove one branch overhanging the wall from the Force Acacia tree in the centre of the wall.</p> <p>Build buttresses as drawing 04 in bricks reclaimed from Fallen wall at item 11.8 laid in 1:2 Semi Hydraulic lime (NHL 3.5) / sharp sand mortar on concrete footing.</p> <p>Allow for 3m<sup>2</sup> re pointing in 1:2 Semi Hydraulic lime (NHL 3.5) / sharp sand mortar</p> <p>Allow for re bedding 3m of coping bricks in mortar as above in lengths of not less than 300mm</p> |

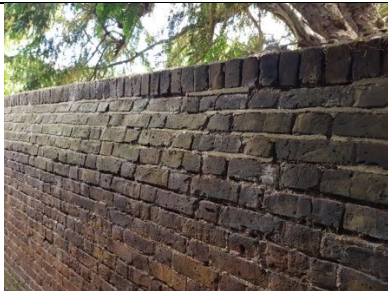
| | almost leaning against the wall and could pose a problem in due course. | | | |
|---|---|---|---|---|
| 11.7 | On the public footpath side of the north wall, there are some areas of open jointed brickwork, but this is relatively minor and is mainly where past cement pointing has fallen out and applies primarily to the western section. The eastern section appears to be in generally better condition and is thought to be a later construction anyway. | | <b>Neutral</b> | <p>Strip all ivy growing on the wall. Allow for 3m<sup>2</sup> re pointing in 1:2 Semi Hydraulic lime (NHL 3.5) / sharp sand mortar</p> |

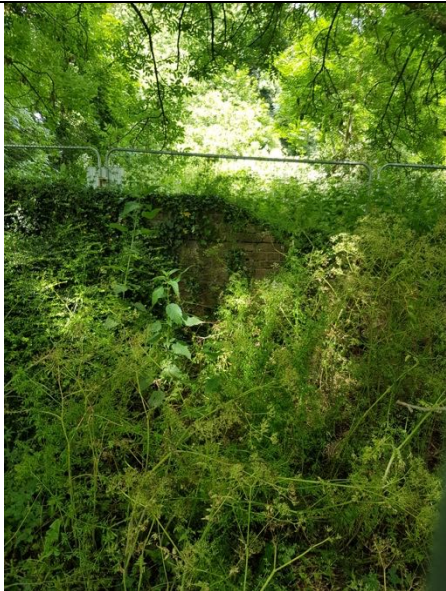
| Item | description | Photo | Heritage impact | works |
|---|---|---|---|---|
| 11.8 | <p>Section of the wall by the overflow car park - This again runs east to west. The north side of the wall is completely inaccessible, but there is some Heras fencing. On the south side, the Heras fencing prevents access together with vegetation, etc. However, at the eastern end it is clear that part of the wall has collapsed, and the problem here seems to be that the wall has virtually collapsed along the length, meaning that it really needs to be completely reconstructed. There are odd sections remaining at the east and west ends, but these are covered with vegetation and the vegetation needs clearing, the wall needs to be taken back to sound and then rebuilt as appropriate. It might be best to assume that the wall needs to be taken down almost to ground level and then rebuilt up to an appropriate height.</p> | | <p><b>Positive</b></p> | <p>Prior to undertaking any work, clear all plant growth from the wall and cut back to allow a clear working area 1m wide to either side of the wall (excluding any trees with a trunk diameter exceeding 75mm at a height of 1.5m)</p> <p>Dismantle remaining sections of wall down to a sound base (assume this to be ground level )and re claim all available bricks from both the dismantled and fallen sections of the wall to be used in item 11.6. Re build wall to a height of 1.5m in 215mm thick construction in Flemish bond with brick on edge coping in Buff brick (230 x 110 x 68mm) as “Imperial handmade bricks” specification code “imperial 189/68” laid in 1:2 Semi Hydraulic lime (NHL 3.5) / sharp sand mortar. Reinstall 330 x 330mm brick pier by entrance gate and form new piers at 3m centres as drawing 04 to give additional support to wall.</p> <p>Allow an extra over price for grubbing out existing brick footings and re forming brick foundation as drawing 4 laid in 1:2 Semi Hydraulic lime (NHL 5) / sharp sand mortar over the entire length of the wall.</p> <p>Prior to construction build a Sample panel of 1m<sup>2</sup> for approval before the main re building starts.</p> |

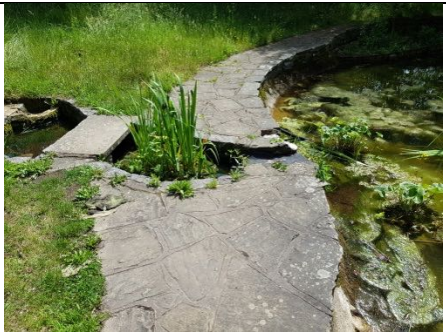
| Item | description | Photo | Heritage impact | works |
|---|---|---|---|---|
| 11.9 | <p>There is a pond on site. This has no safety rail or other safety features around it. The depth does not appear to be too great, but even without a safety rail there ought to be warning notices and safety equipment such as rings, etc.</p> <p>The paving around the pond is missing in places, loose, and potentially a trip hazard and therefore, dangerous. At present, the pond is low because of the weather, but in wetter weather it would be higher and therefore, deeper. It seems that the pond is</p> | | <p><b>Neutral</b></p> | <p>Allow 4 man days for working over the paving and re bedding loose paving and re pointing joints where necessary. (Clients to provide safety notices etc.)</p> |

| | by a public footpath or at least public access. If it is, until it is repaired and improved upon, there ought to be a restriction for access around this. There is a water feature or stream running into the pond. All this appears to be manmade. There are no safety rails or any features to protect against falling into the water. | | | |
