Arboricultural Impact Assessment

205 Harefield Road, Uxbridge, UB8 1PP

Project Number: P2906B.1.0

Date: 10 August 2025

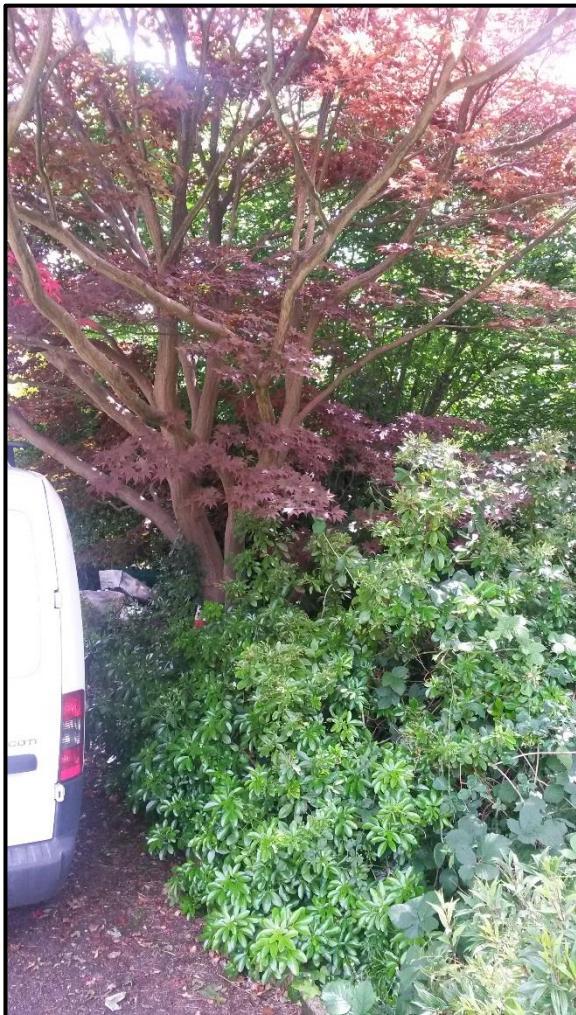
Plate 1. T1, Japanese maple, located close to the access to number 207. Note surrounding dense shrub planting.

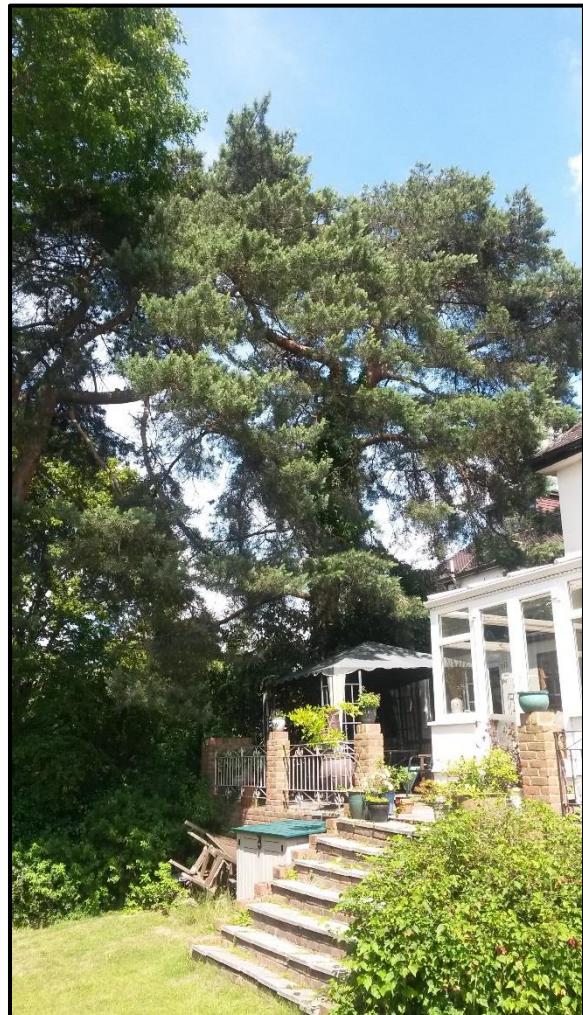
Plate 2. T3, Scots pine (centre), located alongside the patio to the rear of number 205. Viewed looking towards the north-east.

Tree No.	Species	Work Recommended Irrespective of Development	Work Required to Facilitate Development
T3	Scots pine	No work required.	Remove due to incompatibility with the proposed development.
T4	Yew	No work required.	Remove due to incompatibility with the proposed development.
T5	Scots pine	No work required.	Remove due to incompatibility with the future residential use of the site.
T6	Red oak	No work required.	Remove due to incompatibility with the future residential use of the site.
G1	Hazel Corsican pine Laurel Yew	Remove dead tree within one year of survey date.	Remove due to incompatibility with the proposed development.
G2	Ash Yew Hawthorn	No work required.	Remove due to incompatibility with the proposed development.

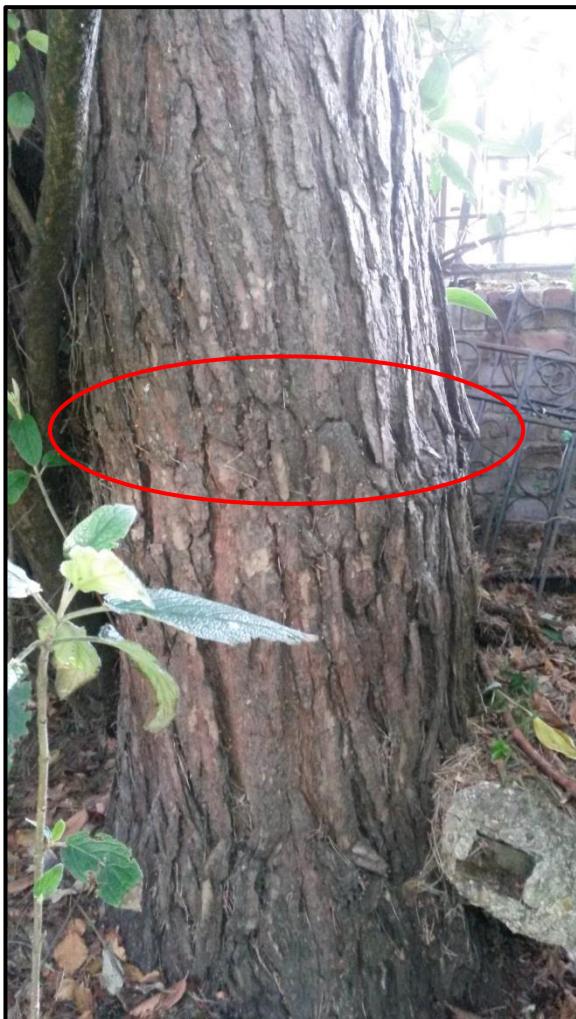
Plate 3 (left). T3, Scots pine, showing concrete embedded at the base and buckling of the main stem (circled).

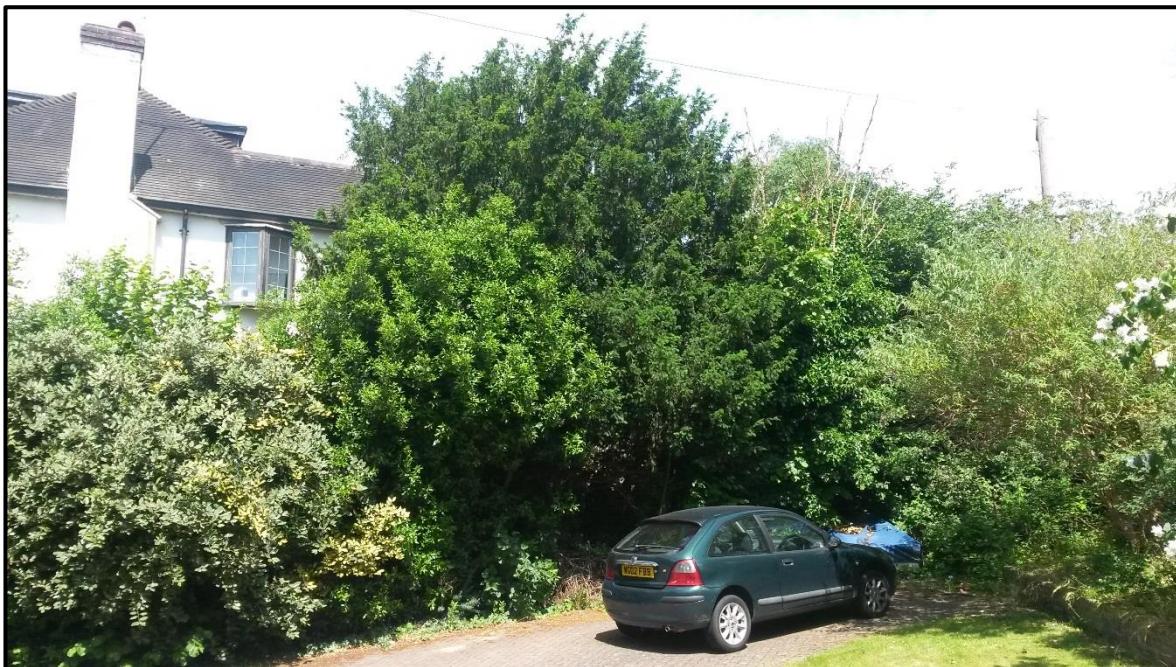
Plate 4 (below). T4, yew (centre) located within G1, mixed species, showing proximity to number 207. Viewed looking towards the north-east.

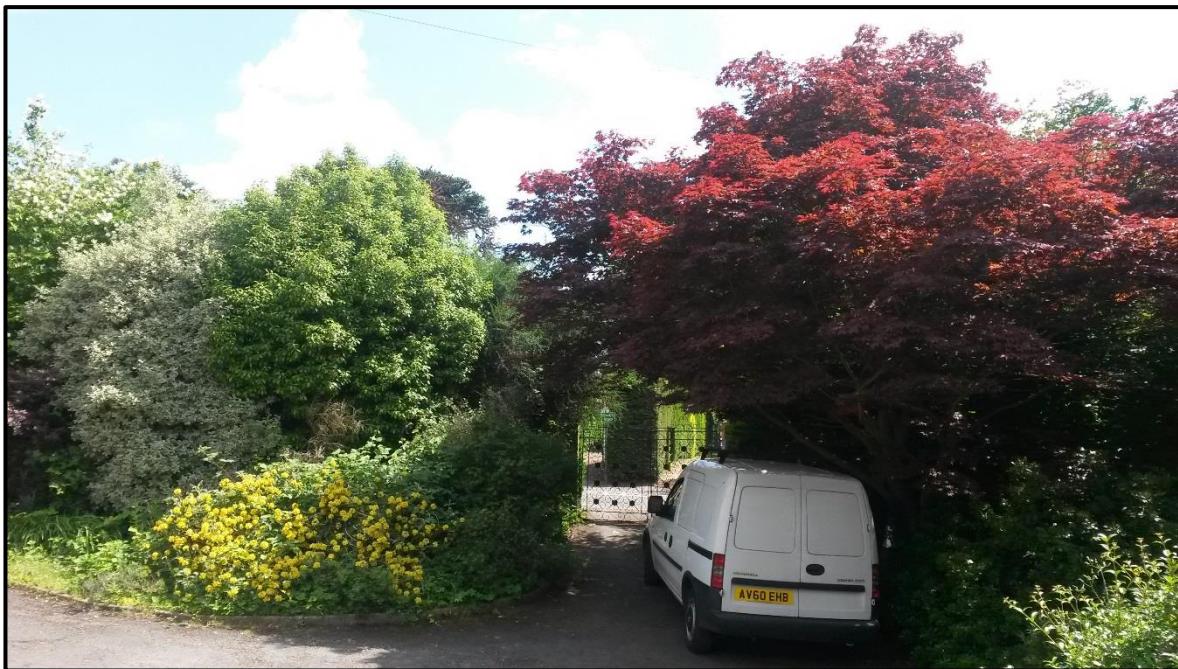
Plate 5 (above) Section of G1, mixed species (centre right) located to the southern boundary.

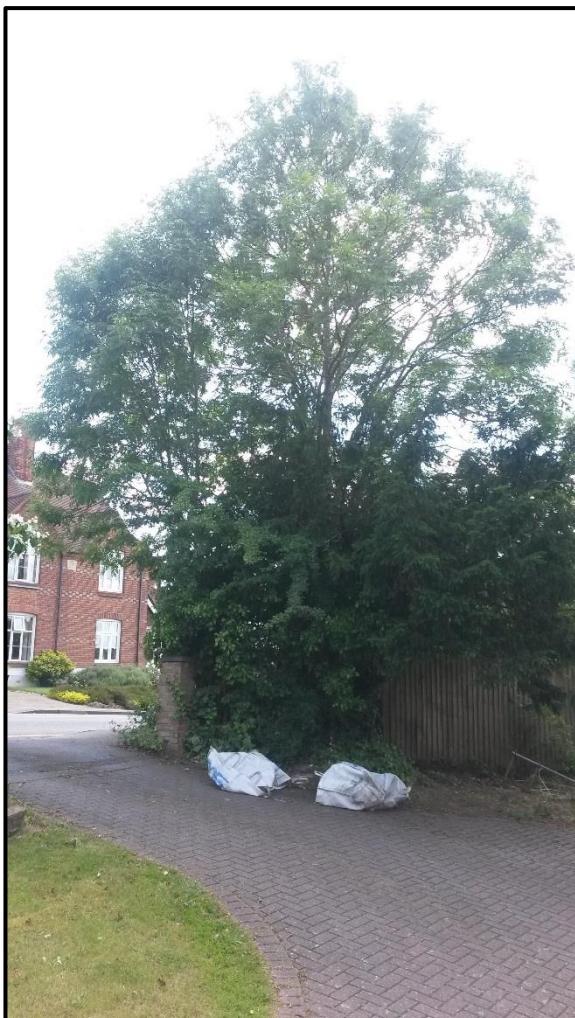
Plate 6 (left). G2, ash, yew and hawthorn, located to the south of the access drive. Viewed looking towards the south.

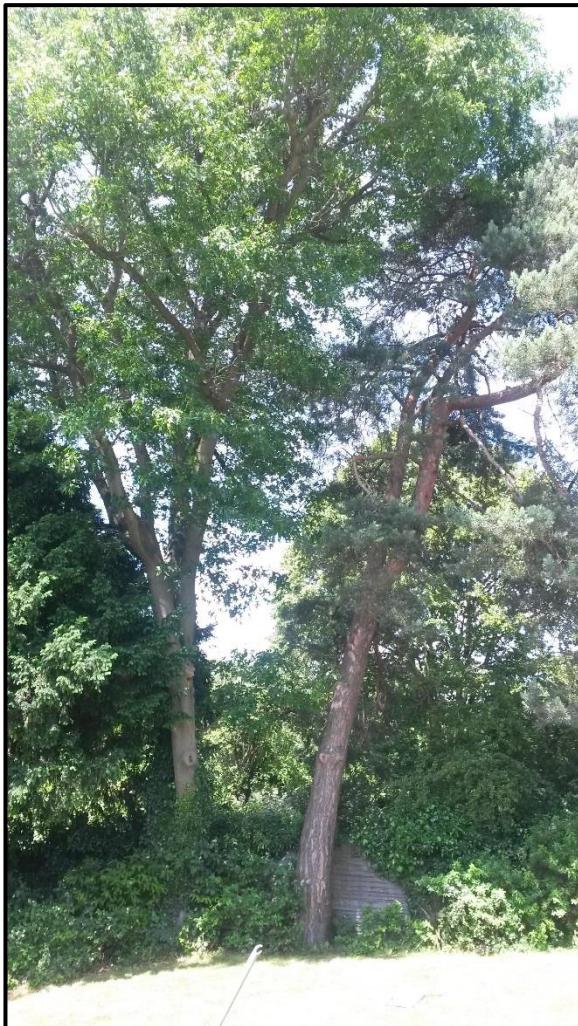
Plate 7. T5, Scots pine, (centre-right) and T6, red oak (centre left), located on the nothern boundary of number 205.

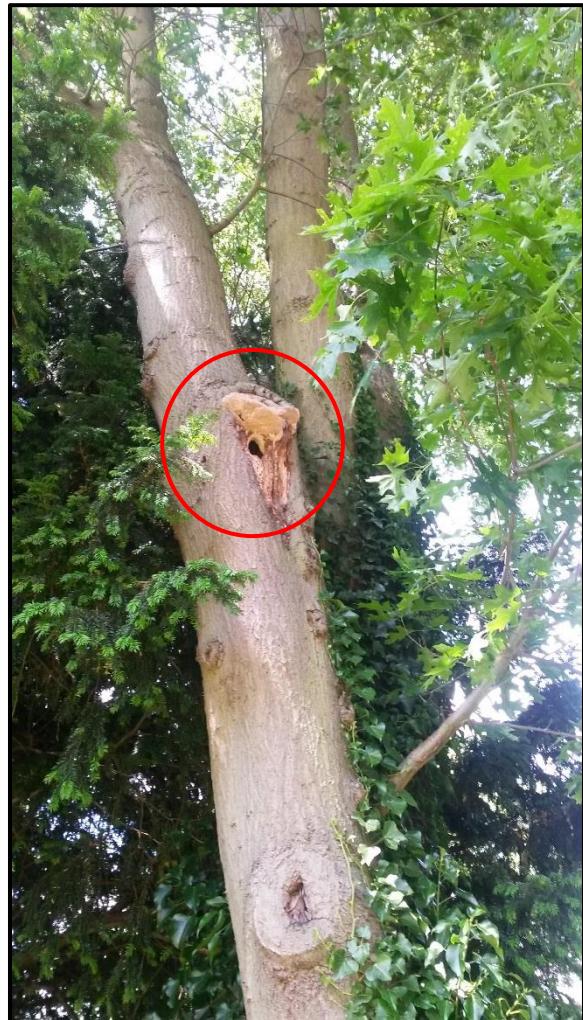
Plate 8. Close up of T6, red oak, showing fungal fruiting body (FFB) with cavity just below (circled). Note partially occluded pruning wound below. Viewed looking upwards towards the north-west.

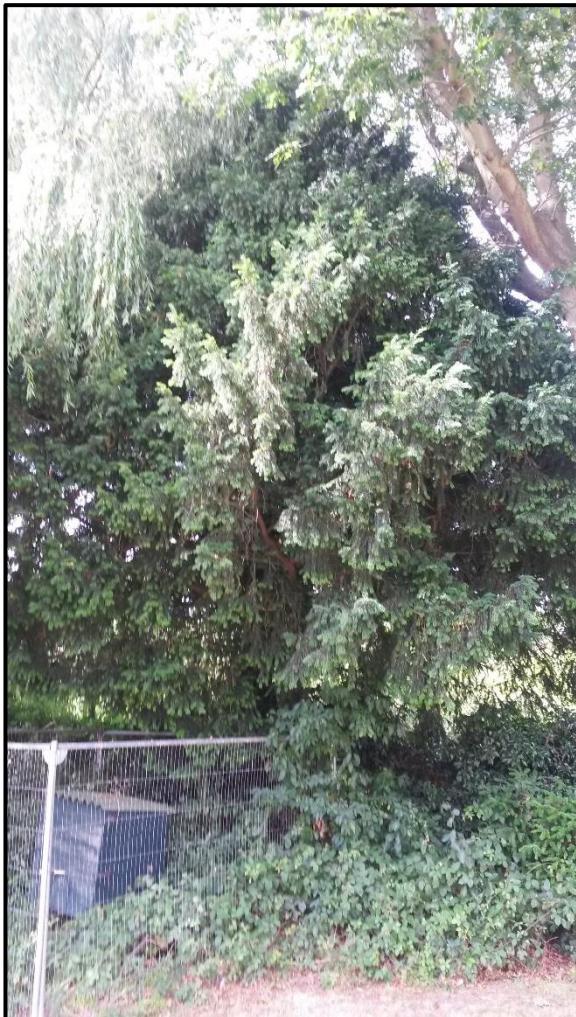
Plate 9. T7, yew, situated in the centre of the garden.

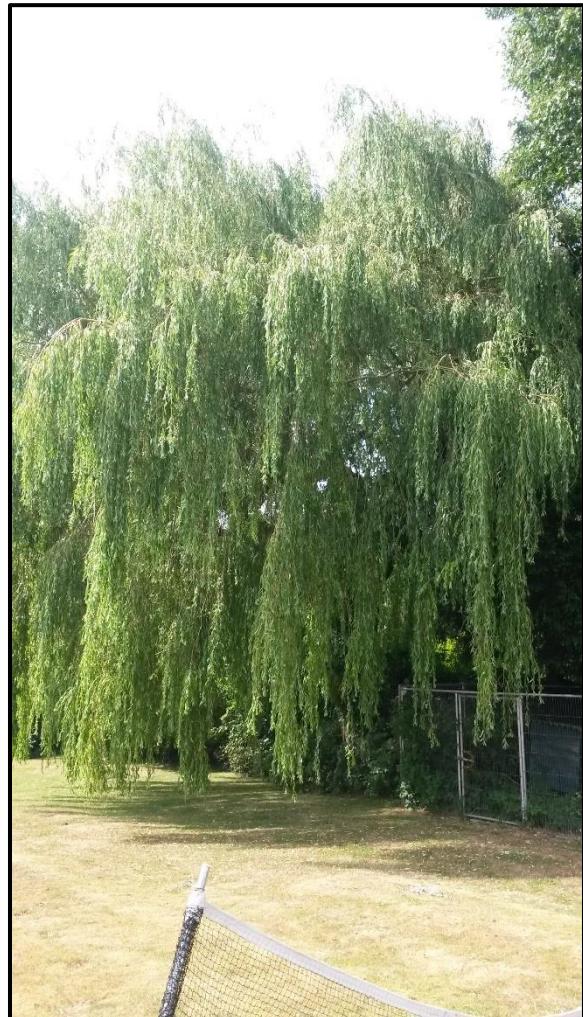
Plate 10. T8, weeping willow. Viewed looking towards the north-west.

Ivy and vegetation is recommended form the base of T8, weeping willow, to allow a more detailed inspection.

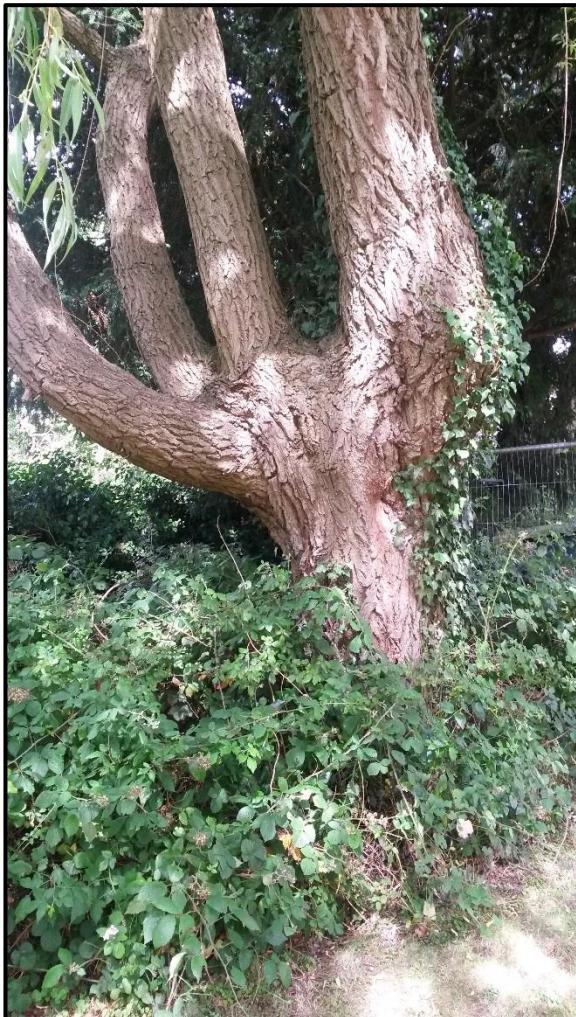
Plate 11. T8, weeping willow, showing large dimensions of main stems and multiple branches. Viewed looking towards the north-east.

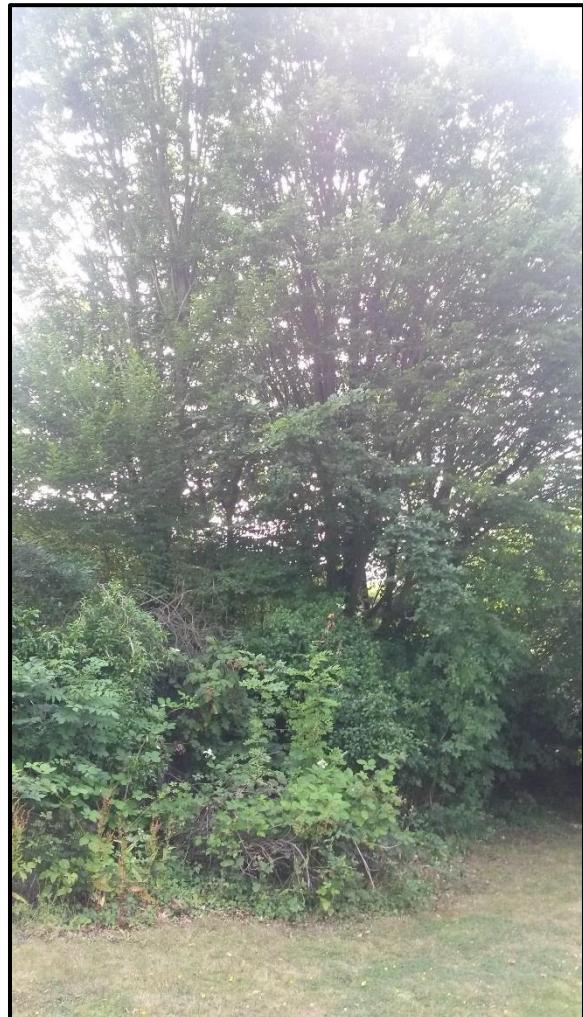
Plate 12. G3, beech, hazel, ash and apple, located in the far west corner of the garden. Viewed looking towards the south west.

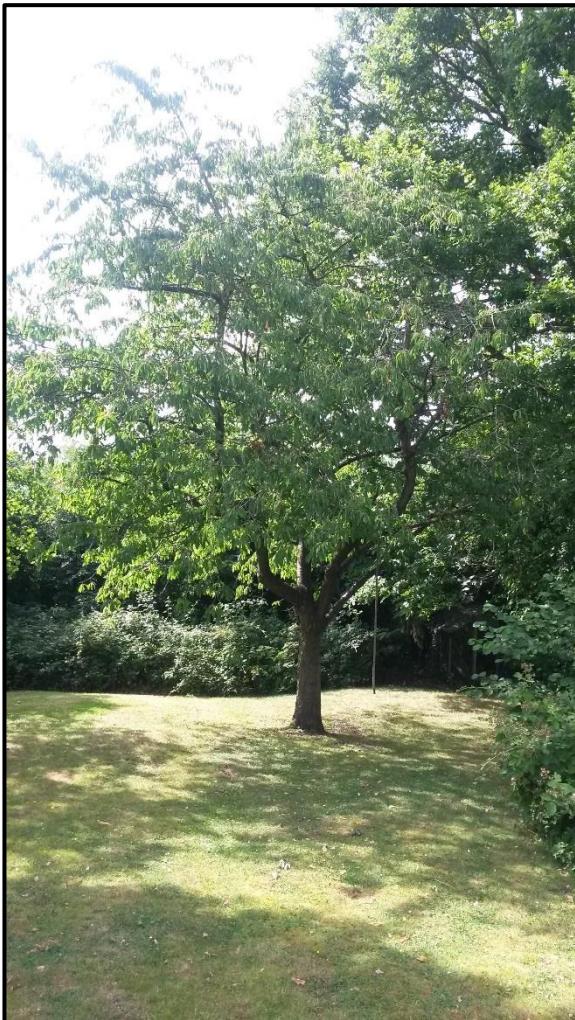
Plate 13. T9, cherry, located in the centre of the east end of the garden. Viewed looking towards the west.

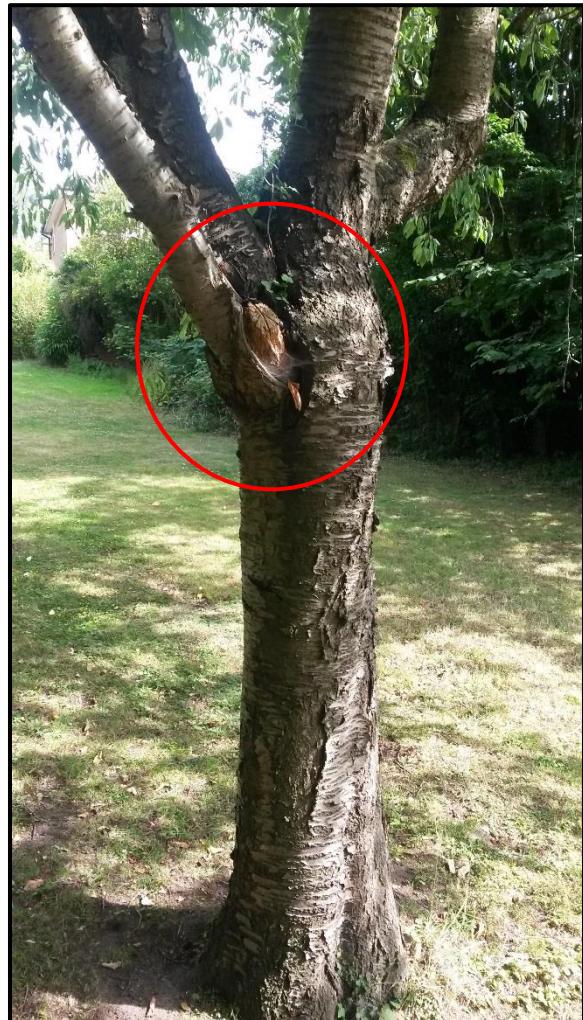
Plate 14. T9, cherry, showing major deadwood with decay at the branch union (circled).

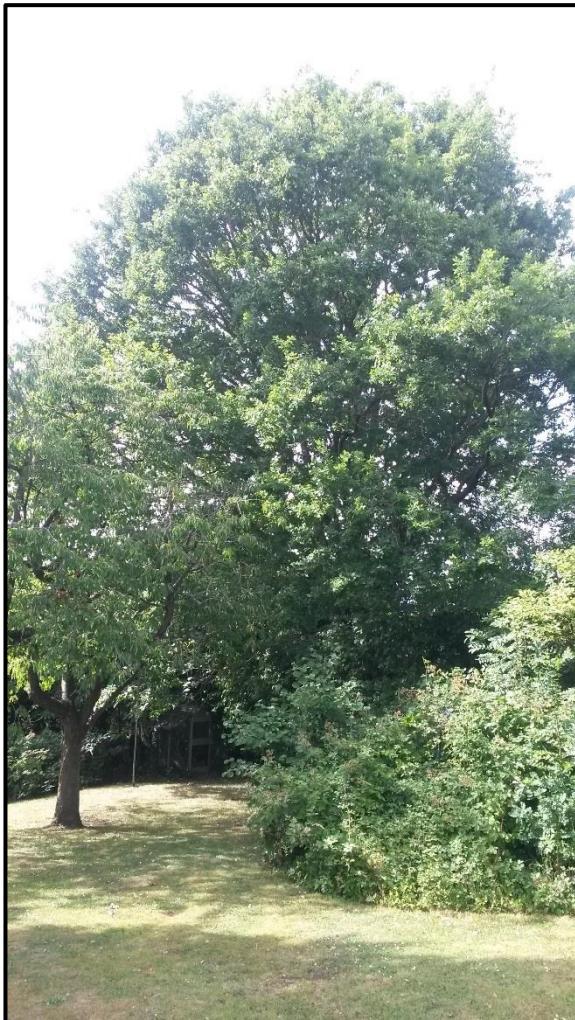
Plate 15. G4, oak, sweet chestnut and hawthorn, showing dominant oak within group, on the boundary between the two gardens.

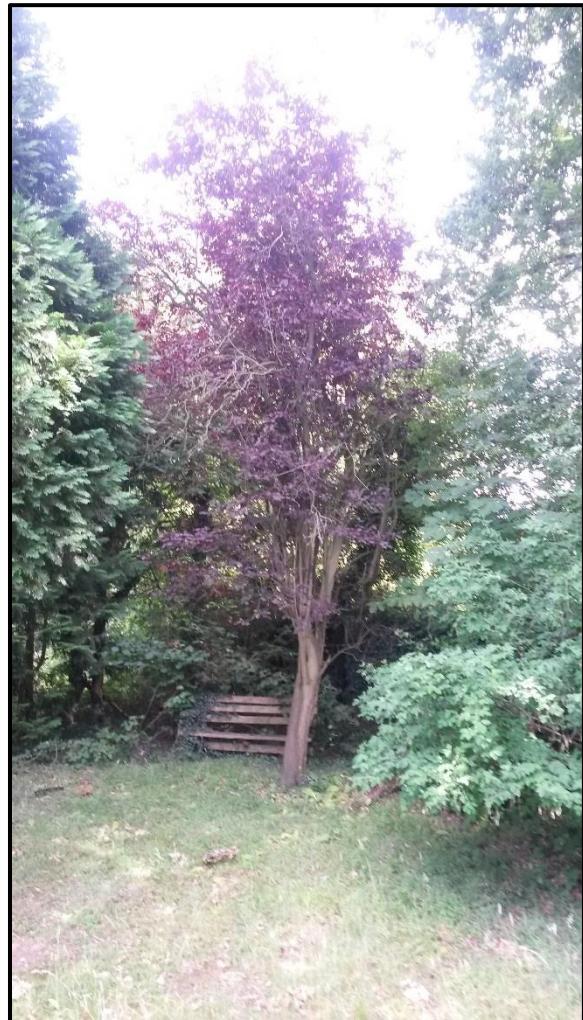
Plate 16 (left). T11, myrobalan plum, showing fair condition of crown. Viewed looking towards the east.

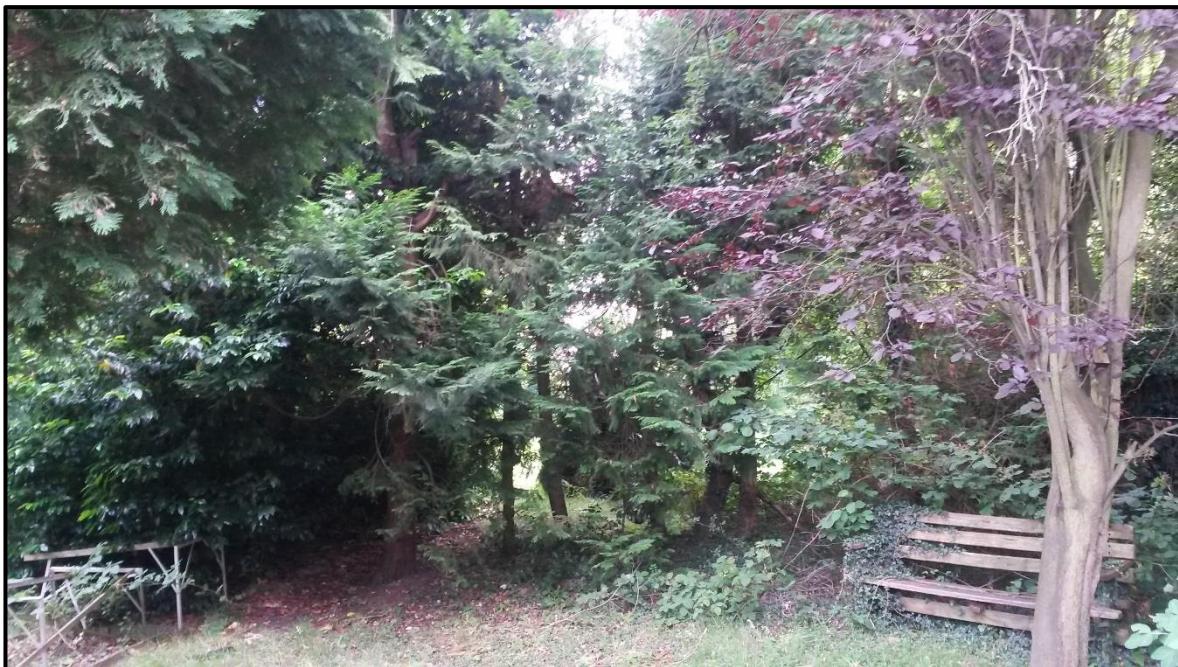
Plate 17 (above). G5, Leyland cypress and laurel, forming and overgrown hedge in the garden of number 207.
