## FORMER POWERGEN SITE, BULLS BRIDGE, HAYES PERS AUDIT

FM Conway Ltd

December 2012

## PERS Audit

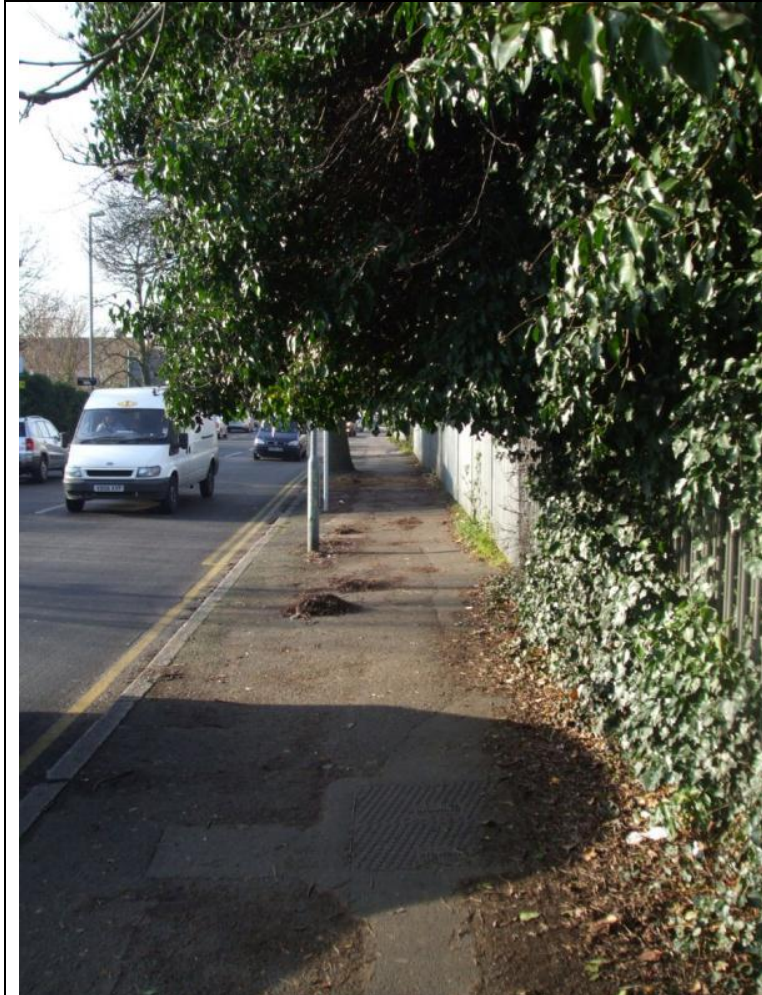
**Photograph 1:**

- 3.2.1 As shown in Photograph 1 below, foliage has overgrown above the footway, and may cause an obstruction for some pedestrians. Consideration should be given to increasing the frequency of pruning by the local authority, however as the pinch point is over a short distance it is not considered to be a significant obstruction.

North Hyde Road (north side), facing west

Obstruction caused by low-hanging branches

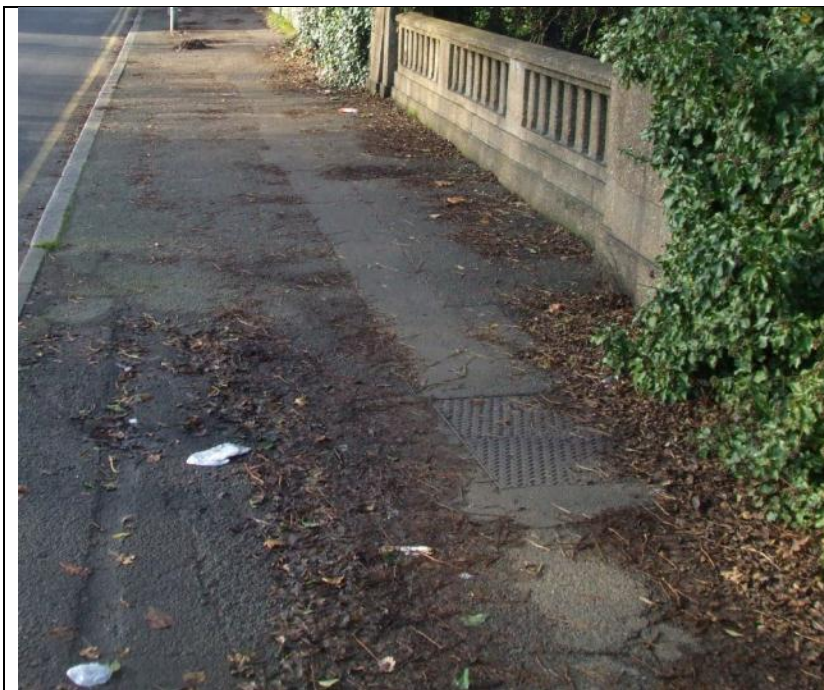
**Photograph 2:**

- 3.2.2 As shown in Photograph 2 below, leaf litter, wet weather causing mulch to form and general ponding have combined to reduce the attractiveness, or conviviality, of the footway. Consideration should be given to increasing the frequency of highway maintenance visits; however it is likely that the leaf litter is not seen as a barrier by pedestrians.

North Hyde Road (north side) facing west

Pinch point caused by ponding and leaf litter

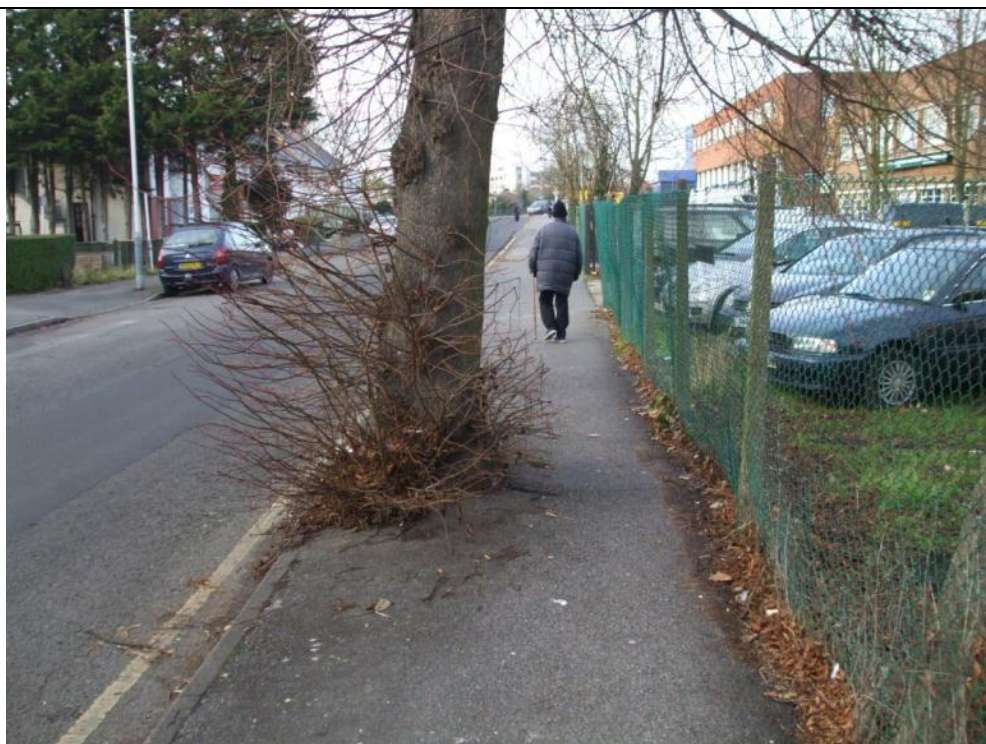
**Photograph 3**

- 3.3.1 Occasional pinch points with a temporarily reduced footway width are caused by trees at several sites along the route. In addition, the roots of the same trees have caused some heaving in the footway, shown in Photograph 3 below. Where possible, consideration should be given to re-grading the footway on the approach to the trees and footway widening where possible, however it is possible that any re-grading would ultimately require the removal of the tree which would in turn reduce the attractiveness and residential nature of the link.
- 3.3.2 Notwithstanding this, it should be noted that the review of Personal Injury Accident Data review (undertaken within the Transport Assessment) did not highlight any accidents on Nestle's Avenue involving pedestrians which cited footway condition as a contributory factor.

Nestles Avenue, north side, facing west

Pinch point and heaving caused by the tree

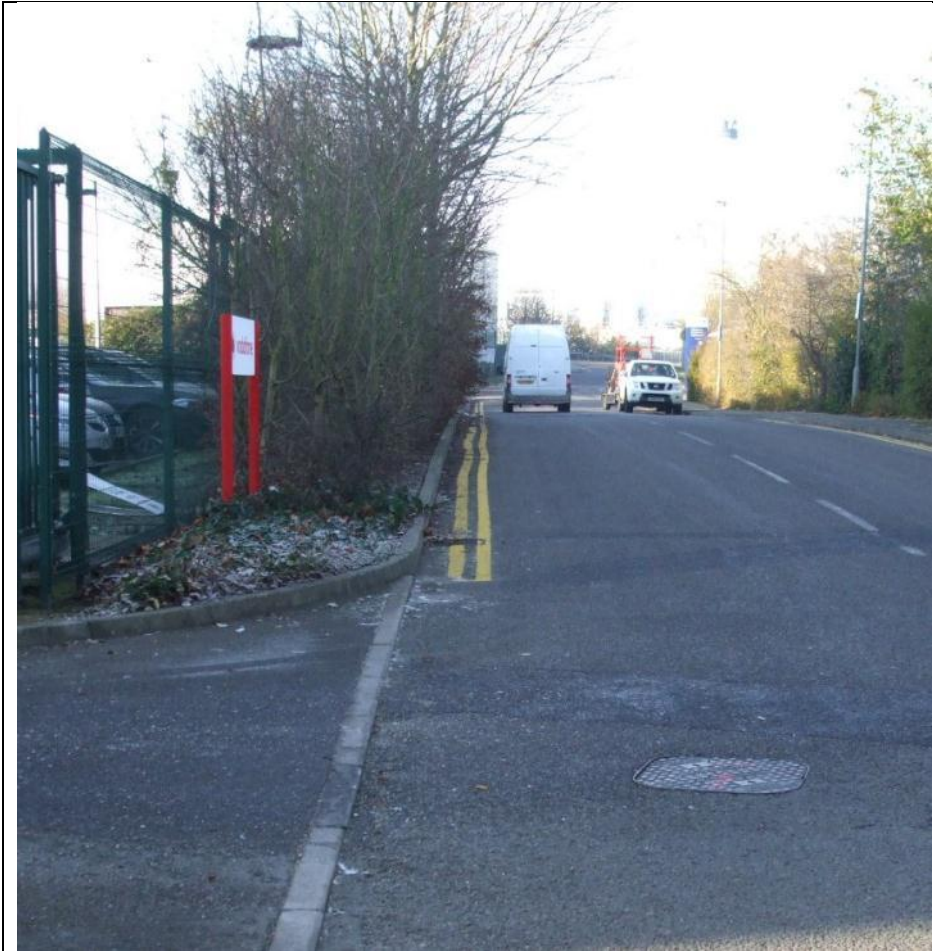
**Photograph 4**

- 3.4.1 As shown in Photograph 4 below, no formal footway is present on the south and east sides of North Hyde Gardens; however the route is infrequently used by pedestrians. However the existing footway on the opposite side of the road is considered to be an acceptable alternative. Consideration could be given to providing a crossing point in the form of dropped kerbs to facilitate ease of passage.

North Hyde Gardens, south side, facing west

No footway present on south side

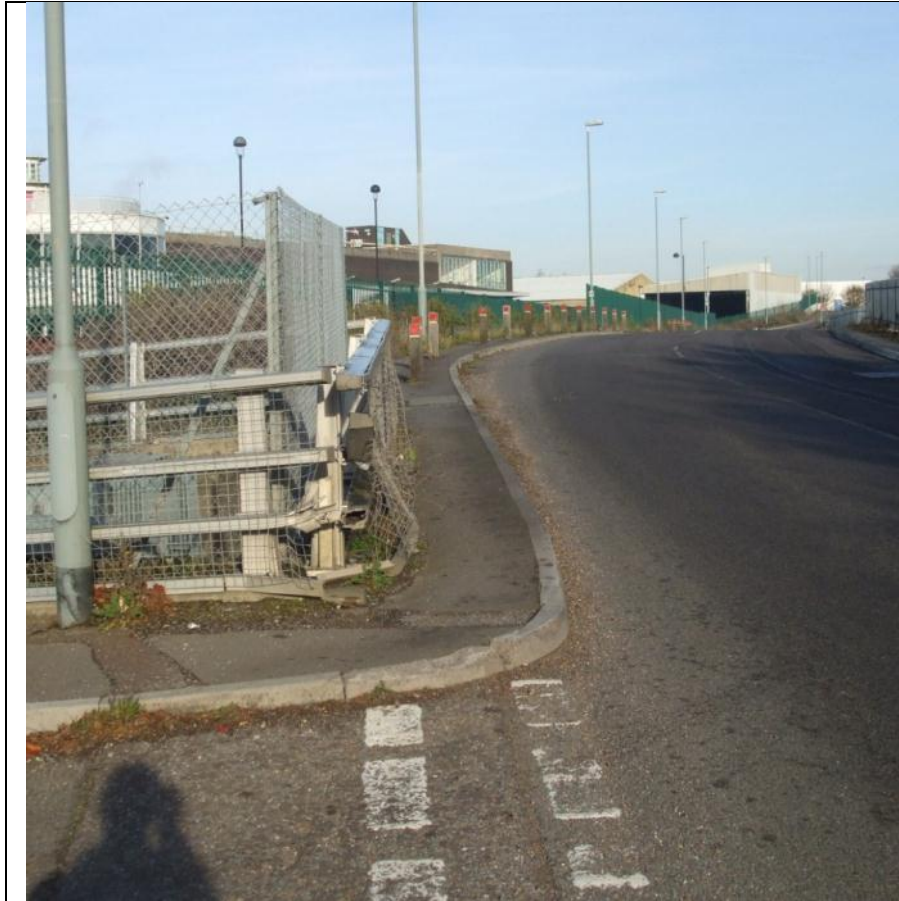
**Photograph 5**

- 3.5.1 Towards the southern end of North Hyde Gardens, the western footway narrows slightly while adjacent to an area of (assumed) electrical plant, as shown in Photograph 5 below. However during the site visit by WSP, no pedestrians were observed deviating from the footway and it does not appear that the area causes any problems for the typical pedestrian users.

North Hyde Gardens, west side, facing north

Pinch point in footway

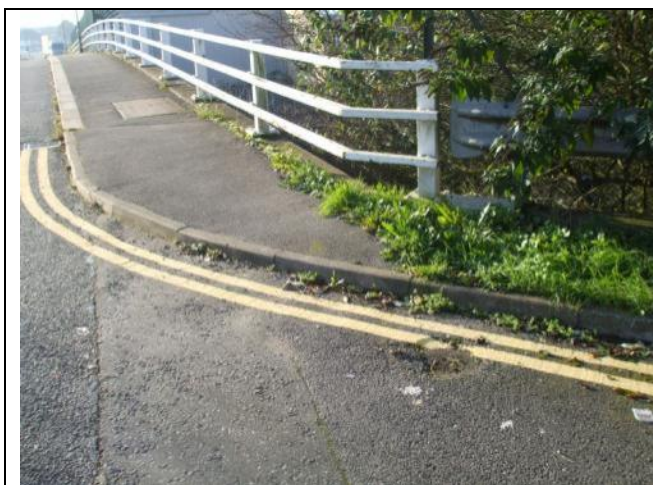
**Photograph 6**

- 3.5.2 Dropped kerbs are not provided where the footway crosses an access road, just north of the canal and dropped kerbs are sub-standard at the access to British Airways Engineering, shown in Photographs 6 and 7 below. Dropped kerbs could be introduced to facilitate ease of crossing.

North Hyde Gardens, west side, facing south  
No dropped kerb adjacent to canal bridge

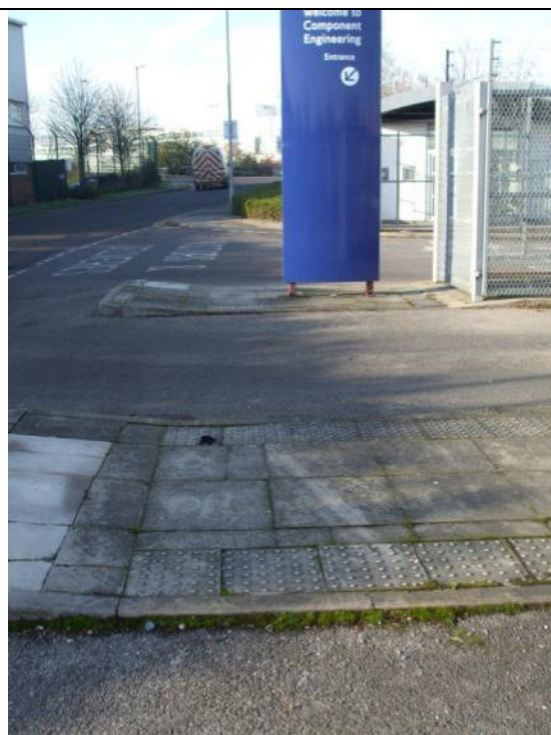
**Photograph 7**

North Hyde Gardens, north side, facing west  
Dropped kerbs with minor upstand (shown where moss has grown) and obstruction caused by the sign

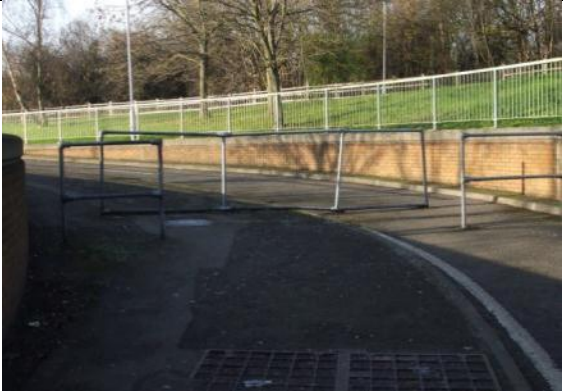
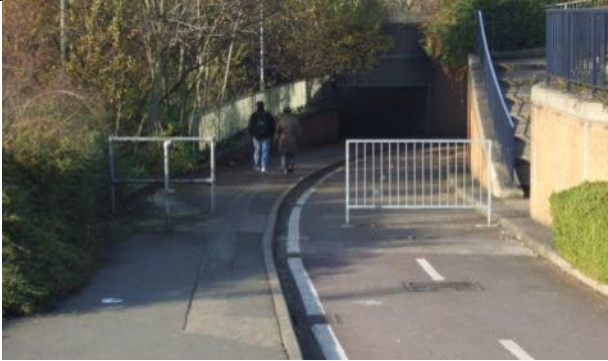
- 3.6.1 As shown in Photographs 8 and 9 below, two sets of metal railing chicanes, on both approaches to an underpass form minor obstructions to cycle movement. Whilst these act as a deterrent to cyclist movement it is not recommended that any change is made as this is likely to generate an adverse impact on pedestrians through increased cyclist speed through the underpass.

| <p><b>Photograph 8</b></p> <p>Shared footway, facing west</p> <p>Chicane on west side of underpass</p> | <p><b>Photograph 9</b></p> <p>Shared footway, facing west</p> <p>Broken chicane on east side of underpass</p> <p>Evidence of 'black hole effect' at entrance to underpass.</p> |

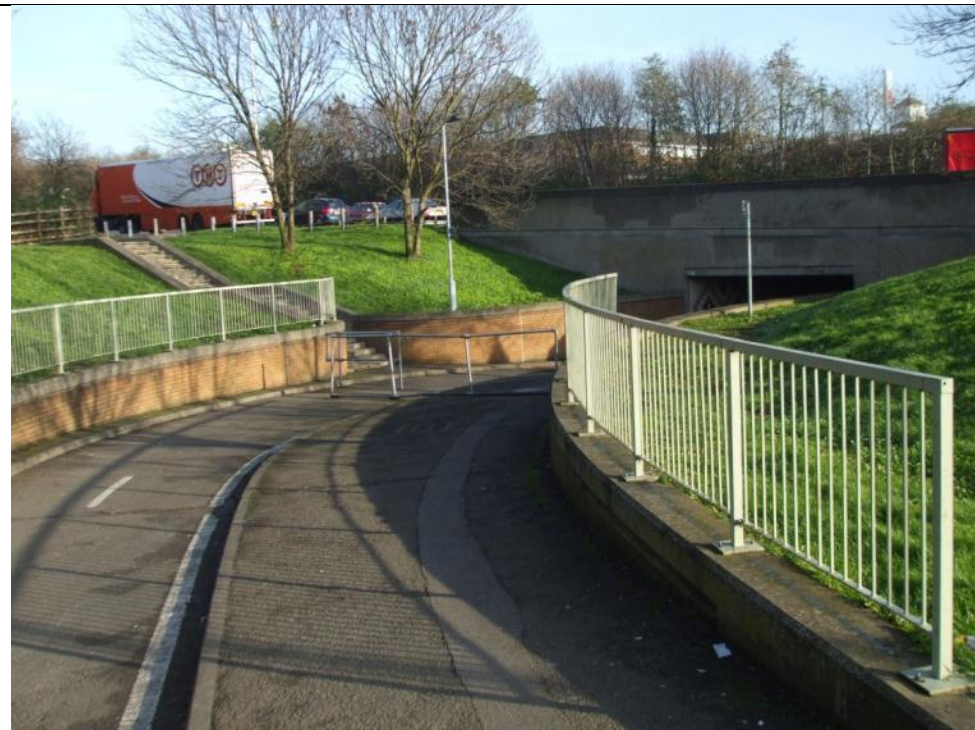
**Photograph 10**

- 3.6.2 A degree of poor inter-person visibility between pedestrians in the underpass and those on the approach is caused by horizontal deflection on the approach to the underpass, shown in Photograph 10 below. In addition, the provision of increased lighting at the tunnel entrances could be considered in order to counteract a potential 'black hole effect'.

Shared footway facing east

Poor inter-person visibility on approach caused by sharp horizontal deflection

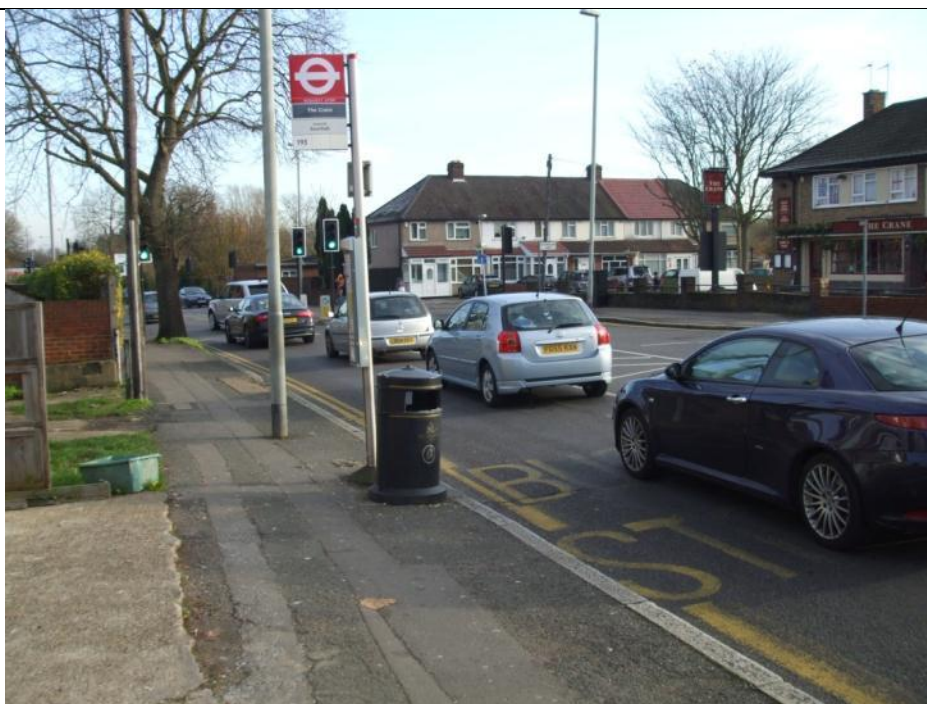
**Photograph 11**

- 4.1.2 Within each of the assessed PTWAs, there were specific items that could benefit from further attention, outlined below.
- 4.1.3 Consideration should be given to re-locating the east bound stop on North Hyde Road to avoid the potential for conflict between residents accessing their private driveways across the footway adjacent to the bus stop, shown in Photograph 11 below.

North Hyde Road, north side, facing east

Bus stop with no shelter and adjacent to private driveway accesses

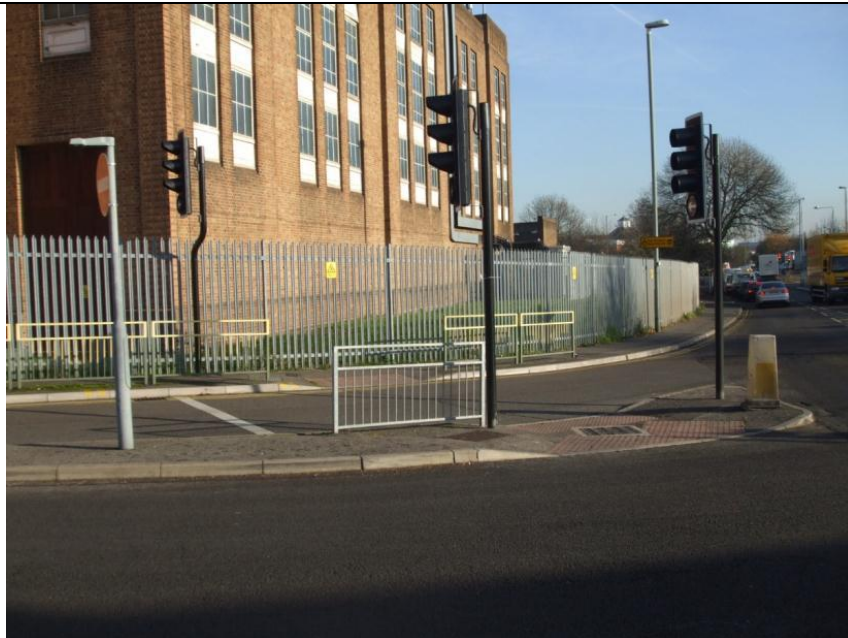
**Photograph 12**

5.2.1 The provision of red coloured tactile paving is not appropriate at this crossing as there is no pedestrian phase associated with the traffic signals. The highway authority should consider replacing the tactile paving with any other colour apart from red to comply with national and local guidance.

North Hyde Road, north side, facing east

Red tactile paving suitable for controlled crossings only - no pedestrian phase exists here

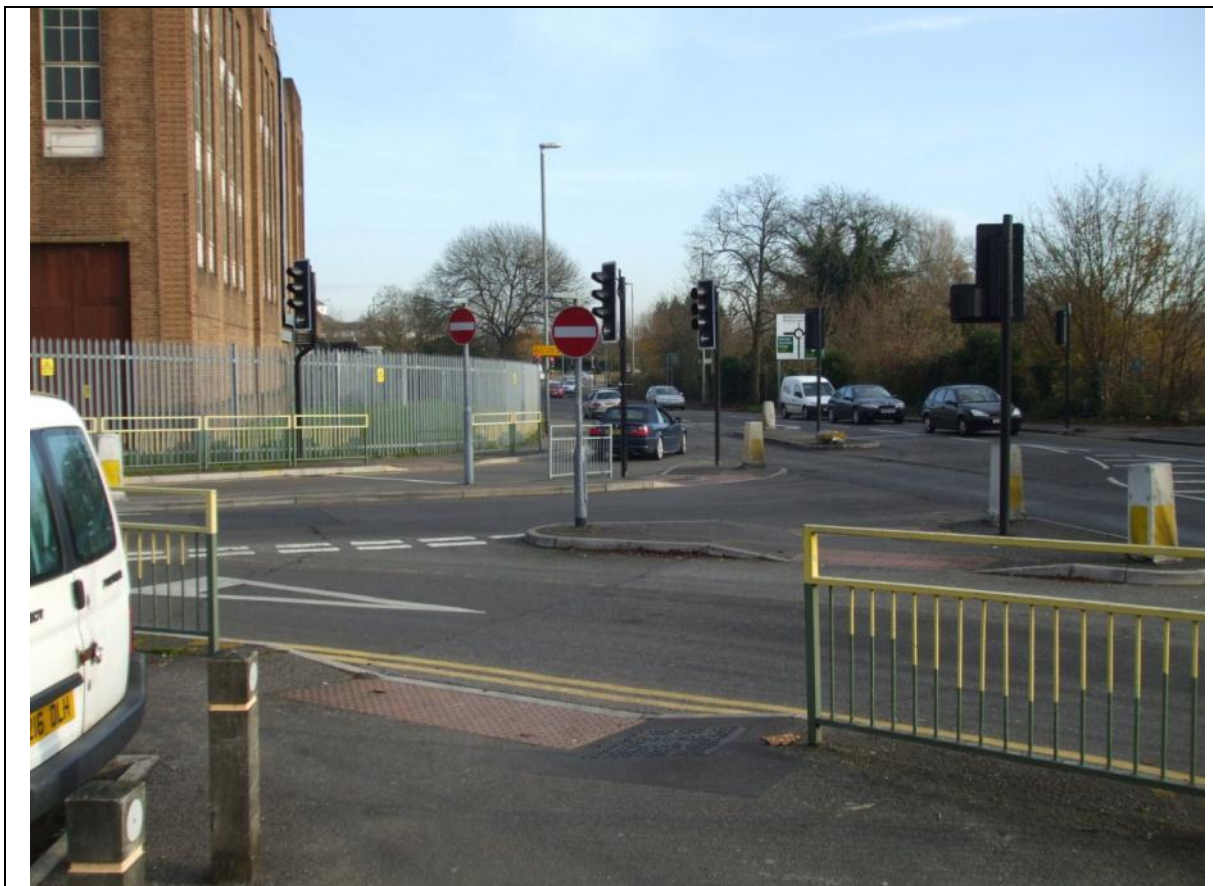
**Photograph 13**

- 5.2.2 There is a degree of confusion caused by the junction layout – pedestrians cross in three separate movements, and do not appear to intuitively look the correct way (specifically at traffic moving westbound on North Hyde Road turning north into North Hyde Gardens). The situation should be monitored and if necessary, consideration should be given to the provision of Look Right and Look Left road markings, as appropriate, at the crossing.
- 5.2.3 Notwithstanding this, the analysis of Personal Injury Accident Data undertaken for the Transport Assessment Report, confirms that during the study period (1 November 2006 – 31 October 2011), there were no accidents involving pedestrians recorded at the North Hyde Road / North Hyde Gardens junction.

North Hyde Road, north side, facing east

Pedestrian crossing movement in three stages. Pedestrians noted to look to their left at the second stage of the crossing (proceeding eastbound) rather than towards on-coming traffic from the right.

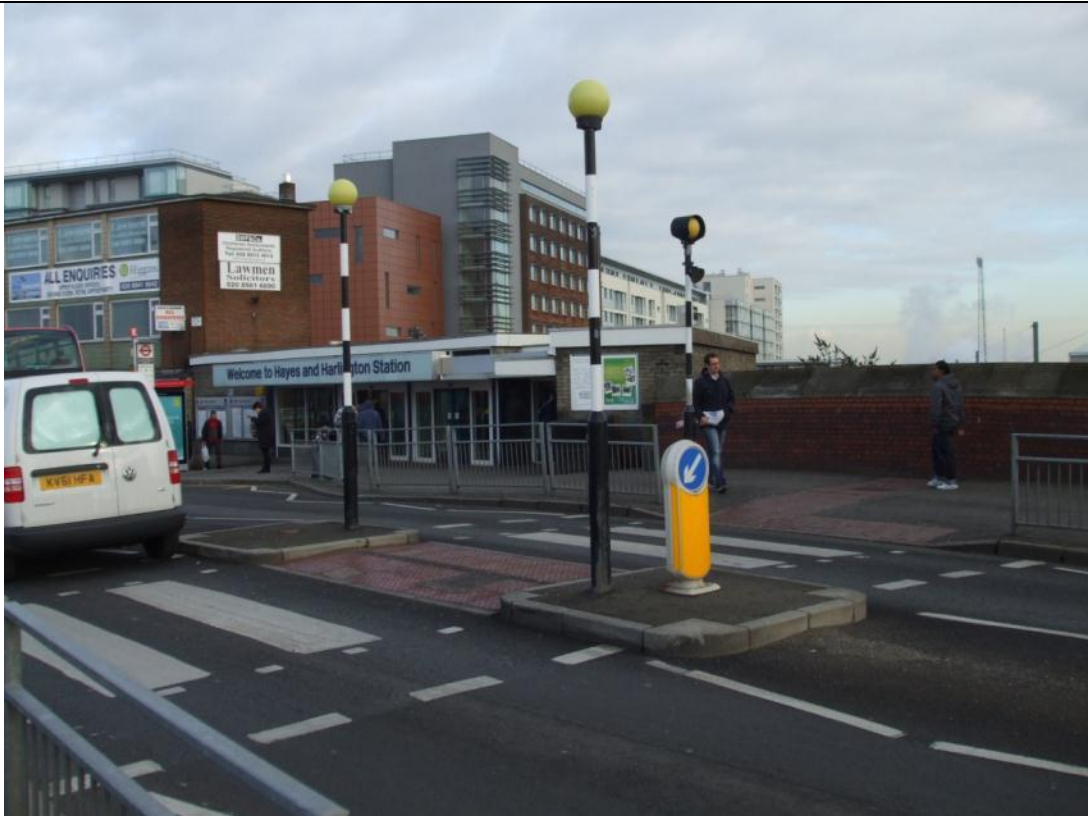
**Photograph 14**

- 5.3.1 This zebra crossing has a central island, which is less convenient for pedestrians. The central island also causes a degree of confusion between pedestrians and vehicles as to who has priority. The provision of a central island on a 'straight across' crossing is not recommended by the 'Design and Assessment of Pedestrian Crossings' guidance. However, the hesitation causes the pedestrian and vehicle driver to make eye contact and a therefore a conscious decision has to be made whether to proceed or not. It is recommended that the highway authority give consideration to removing the central island, after longer-term monitoring of the operation of the crossing.

Station Road, west side, facing north-east

Zebra crossing at narrow carriageway with refuge island provided.
