## Segro Park Hayes

C14074 - Nestle Avenue Railing Dilapidation Report

Tuesday, 20 October 2020

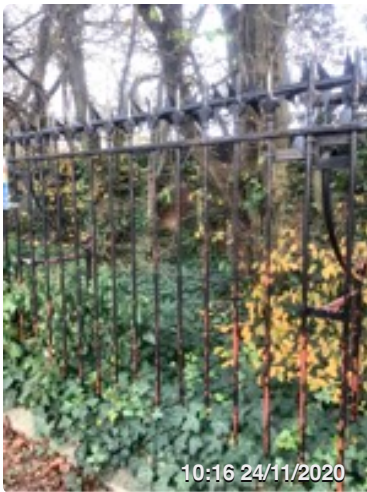
### **Bay 25**

Missing fin

Welding to next panel

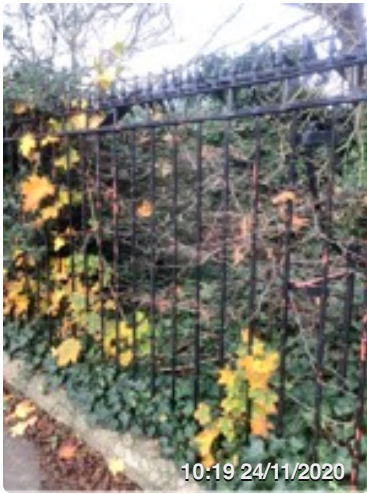
### **Bay 30**

Bend railing upright

Note, grind down previous fin locations?

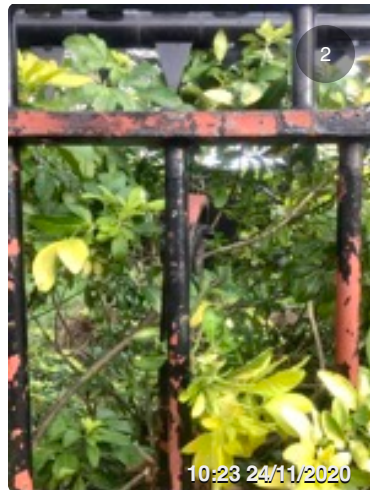
### Bay 38

Bend feature

Note, grind down previous fin locations?

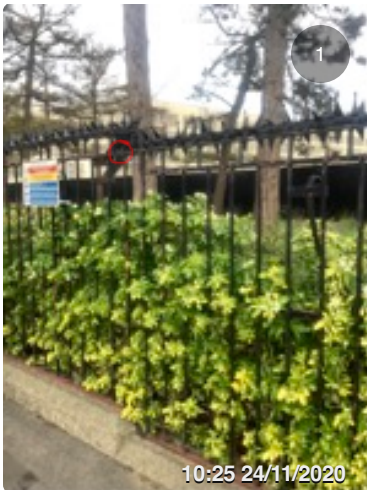
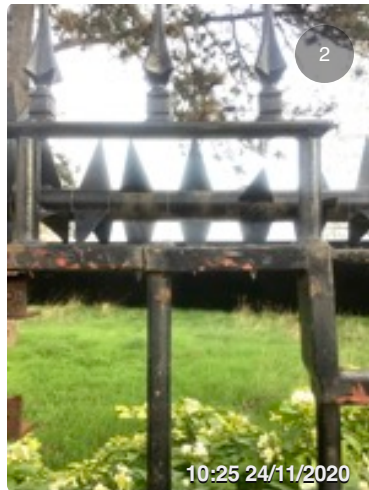
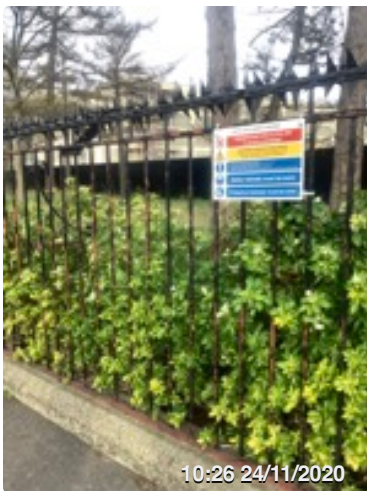
## Bay 50

Cracked railing

Note, grind down previous fin locations?

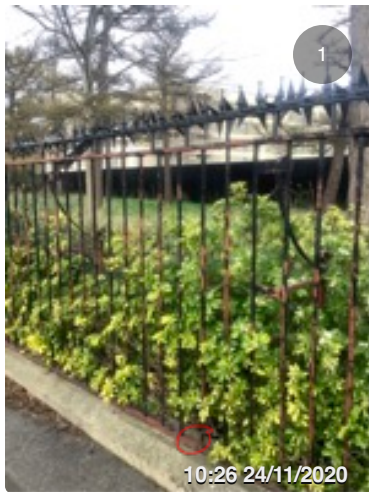
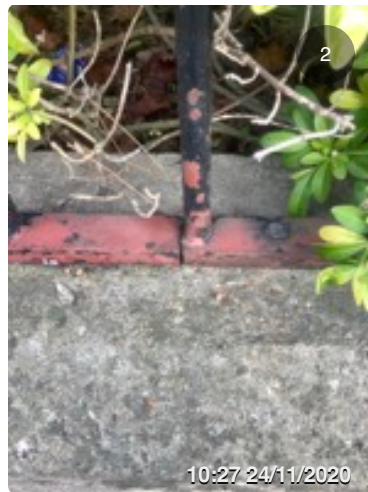
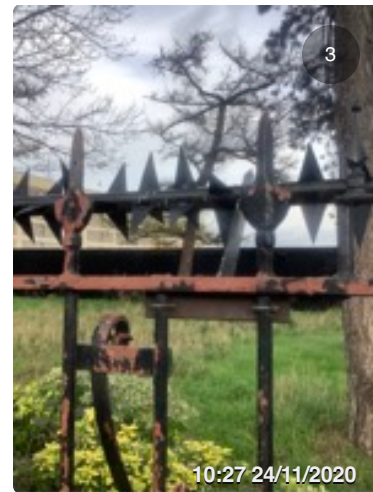
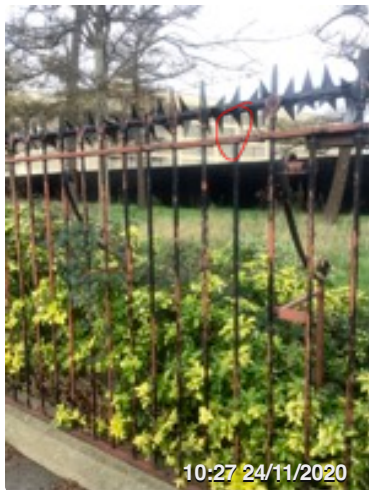
## Bay 52

Crack railing

Missing fin

Note, grind down previous fin locations?

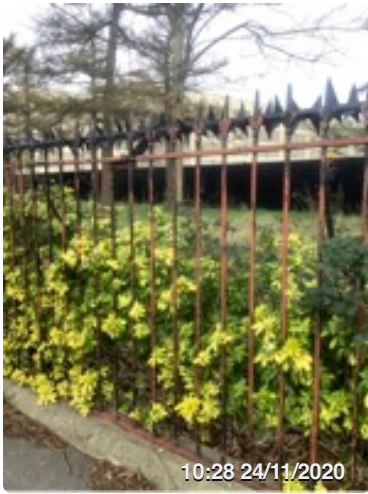
## Bay 53

Missing fin

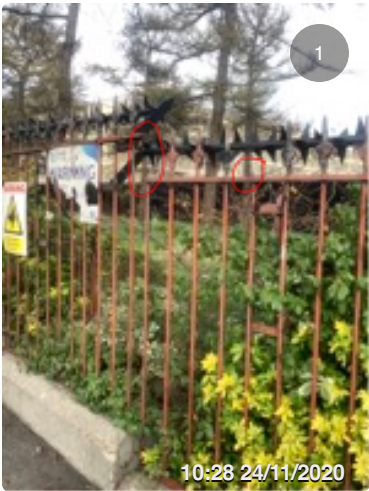
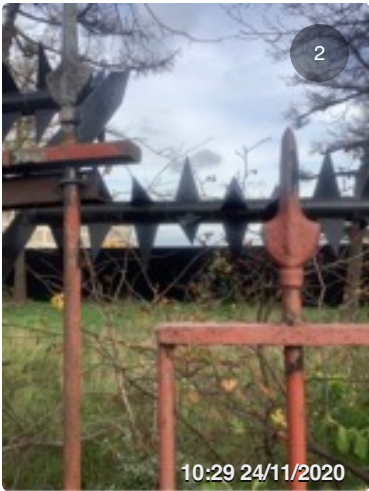
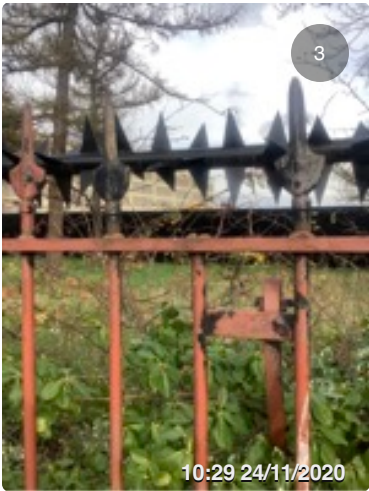
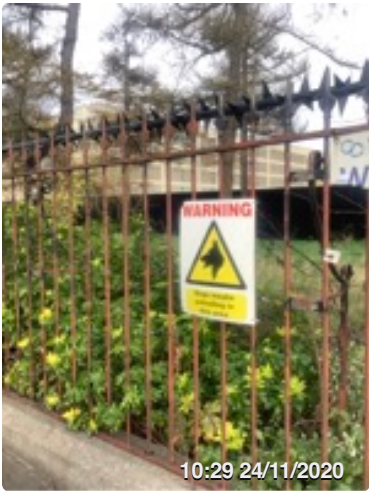
**Bay 57**

Missing fin

Missing panel upright connection

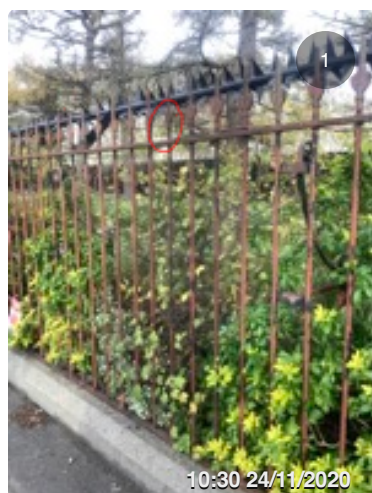
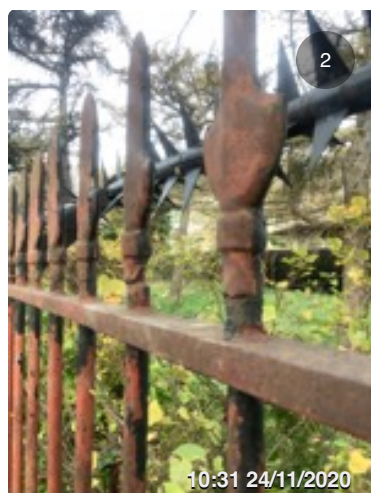
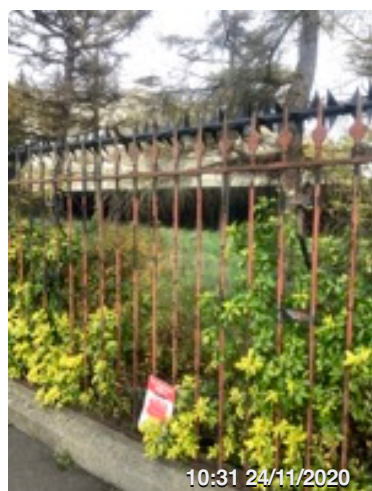
## Bay 60

Back of fin damage

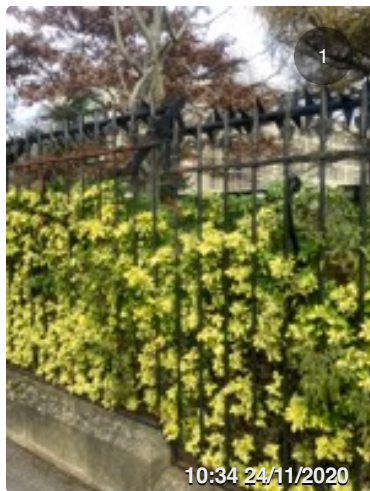
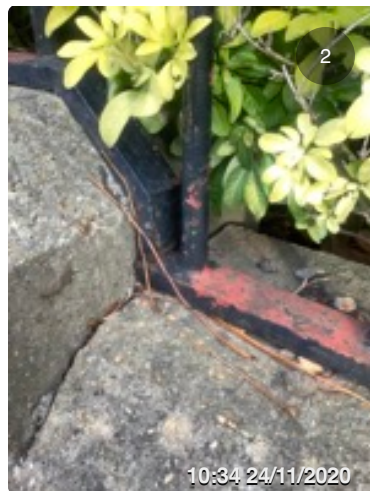
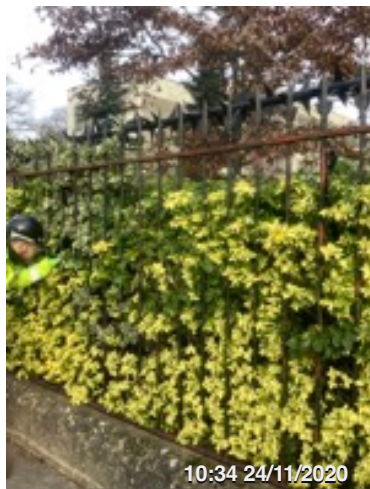
## Bay 69

Snapped welding

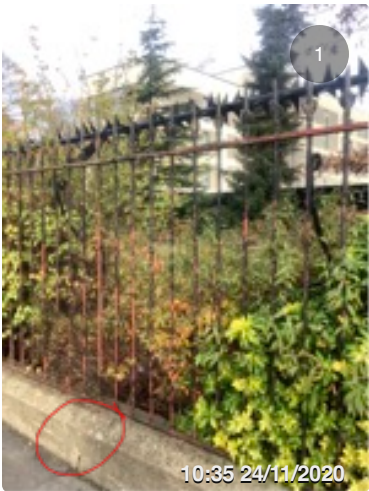
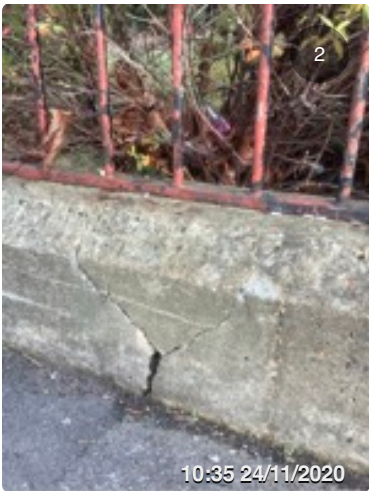
**Bay 72**

Concrete wall damage

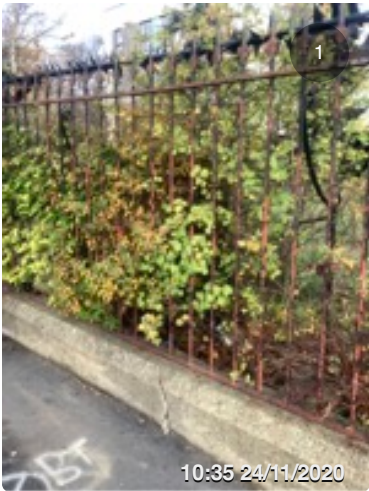
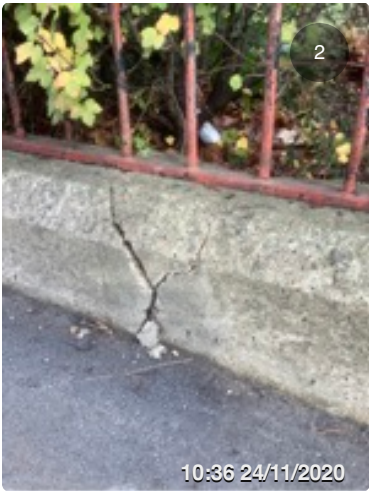
**Bay 73**

Concrete wal damage

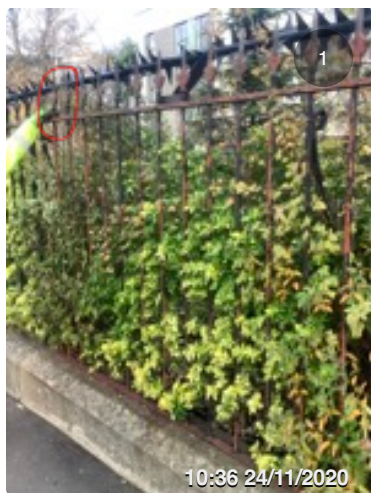
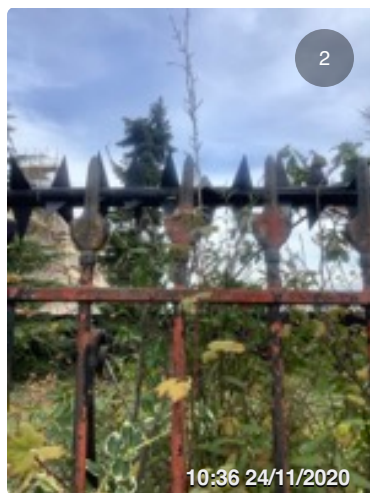
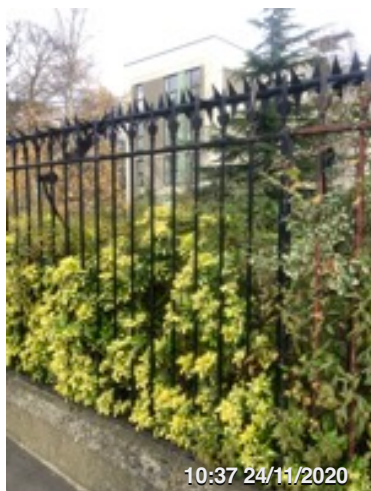
## Bay 74

Fin of plumb

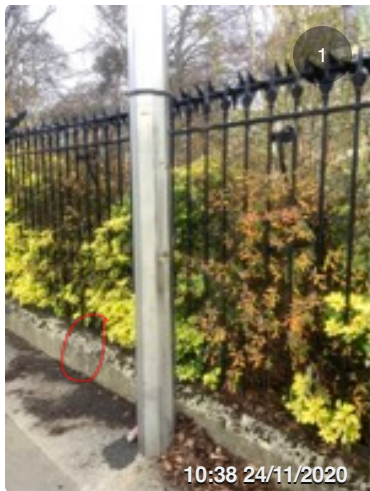
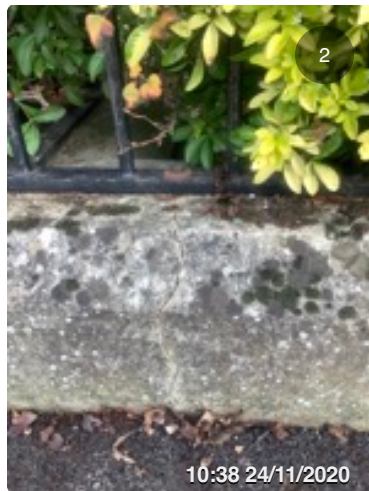
## Bay 81

Concrete wall damaged

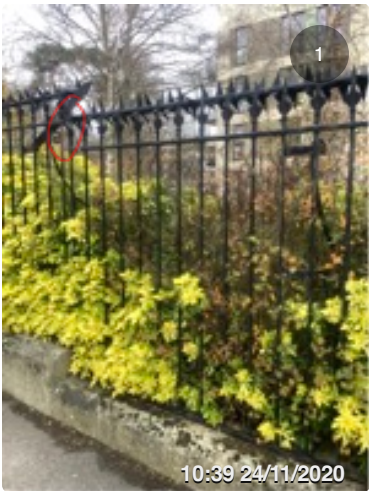
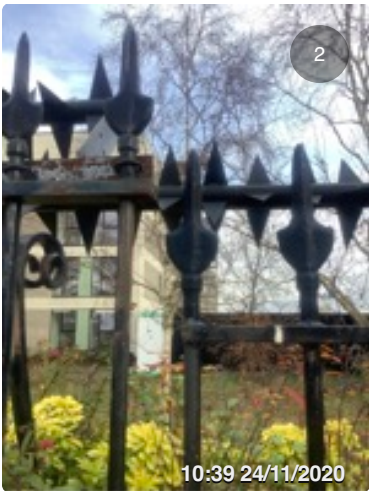
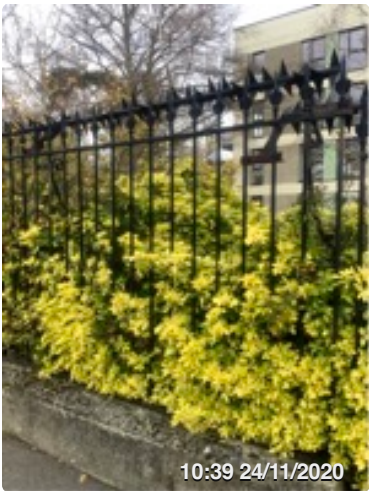
**Bay 82**

Missing drop connecton
