# CANTEEN BUILDING NESTLE HAYES

22878

Tuesday, 10 November 2020

Prepared For Barratt West London

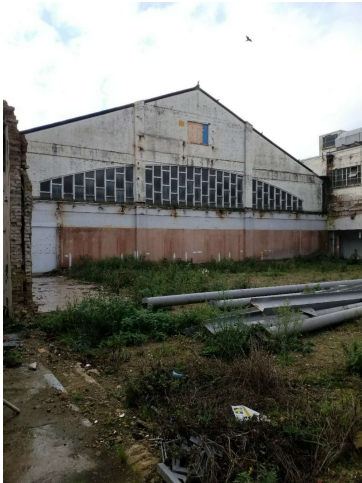
## Rear Access To Canteen

Heras fencing to site compound  
 Scaffold for access will need 2 lifts 1 into ridge line due to height difference  
 Loading bay in centre to store waste sheets before loading to skips also new sheets loaded to here for install  
 Crush to soil to aid access route for lorries by Barratts  
 Hoist required to carry from loading bay to skip and new sheets to loading bay by Barratts  
 40 yard skip required for asbestos waste only  
 Decontamination unit required to segregate workers and washing facilities  
 Non notifiable under HSE due to asbestos cement sheets

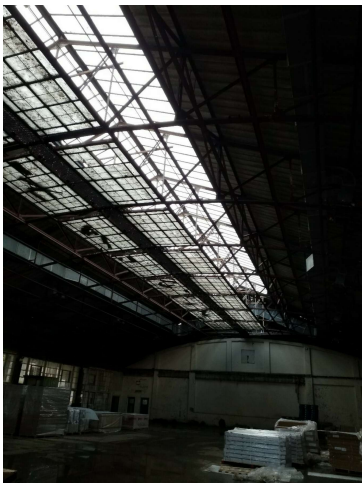
## Main Roof Internal

Roof sheets have been identified as containing asbestos and therefore require removal to specialist asbestos skips, removed by asbestos awareness trained operatives with appropriate PPE  
 Some roof sheets contain cracks and holes, these are common signs of defects for a roof of this age and material.  
 Cleaning and/or coating is not a suitable method to repair or waterproof this roof as the sheets must be in a stable condition prior to application.  
 The steels are showing signs of light corrosion however are deemed safe by a structural survey, propping to trusses required.  
 Safety netting will be installed to the purlins to provide fall protection  
 Scissor lift may be required for rescue plan  
 Scaffold to RHS & LHS for internal crash deck and gutter inspection  
 Internal storage area to be cleared and cleaned, no material or access to be provided to any other traders during works due to operatives working overhead, risk of falling materials.

On completion cleaning will take place to remove any remnants of asbestos, however this will not be extended to the cleaning of pigeon excrement.

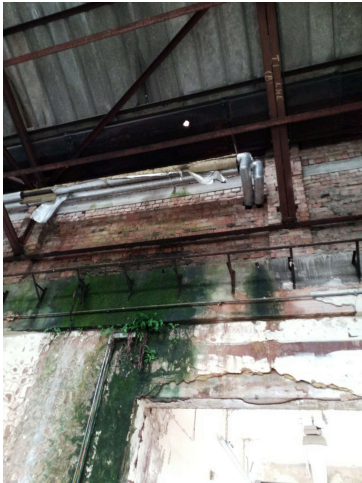
### Gutter Internal

Metal gutters are showing moderate to severe signs of corrosion and are the main cause of water ingress into the canteen building.

Scaffolding is required to underside of gutter for inspection prior to works taking place and also to be used as a crash deck incase of its fragile condition.

Gutter brackets require close inspection to confirm new waterproofing can be installed. Axter excel HRS to be installed into gutters with Hyranger TS underlay. App 1

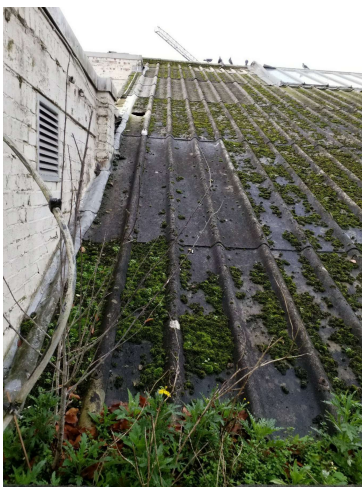
### Main Roof External

Roof sheets have a large amount of moss build up, growth from surrounding walls also showing dampness contained within, holes in sheets allowing water ingress

Roof sheets have been identified as a trafford sheet , unfortunately these are no longer available however a similar profiled sheet can be installed as a like for like, Joris steel profiled sheeting JIC 32.167.1000, once access afforded to measure peak and trough of existing sheet and match. Standard colour to be goose wing grey. App 2

We could not guarantee any repairs to this roof and would not recommend overlaying it due to risks of condensation and the additional weight to existing structure therefore we recommend removing and reinstalling in its entirety.

Additional safety requirement for working on fragile roof when removing sheets - Youngmans with hand rail and lanyard hooked on to harness.

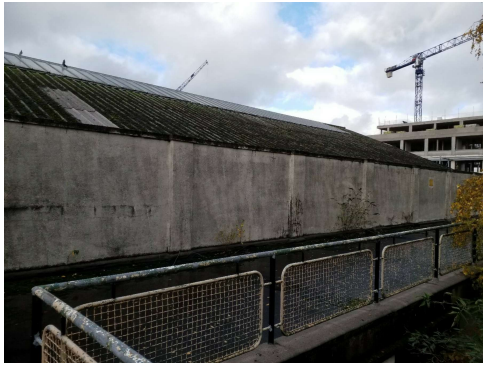
### Right Hand Elevation

No works required to felt flat roof.

Single lift scaffold to be erected for access onto roof over parapet wall.

4 boards wide used for walkway.

Access through building to be closed.

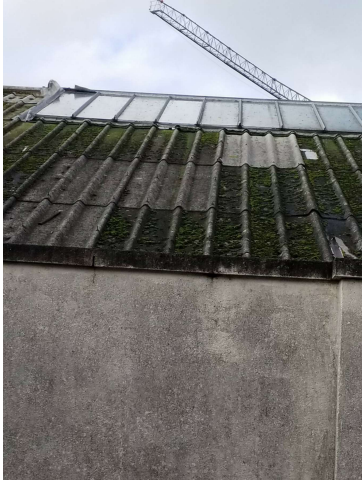
### Rooflight

Where flashings have already come away to sides of rooflights and the bottom where they join the new metal sheets a new flashing will be installed. App 3

No works to be carried out to rooflights

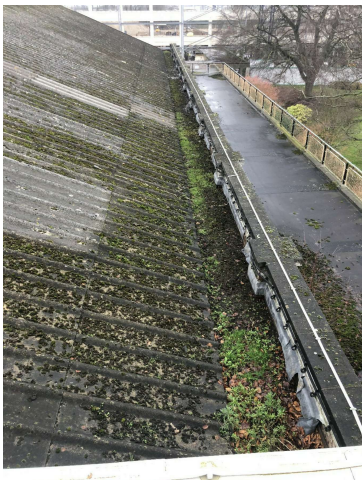
### Gutter External

The gutters are blocked with debris and moss build up.

Gutters require thorough cleaning to inspect condition closely.

Options to supply and install a purpose built lightweight gutter liner, if gutter brackets are in a sound condition, these may need to be replaced or repaired.

Alternatively gutters can be re-lined with a liquid or felt membrane, dependent upon condition.
