Nestle Railings – Planning Conditions  
LBH Ref: 1331/APP/2017/1883

Our ref: HILL 1220/P8026

05/07/2018

## Protection Method Statement & Schedule of Repairs and Management Plan

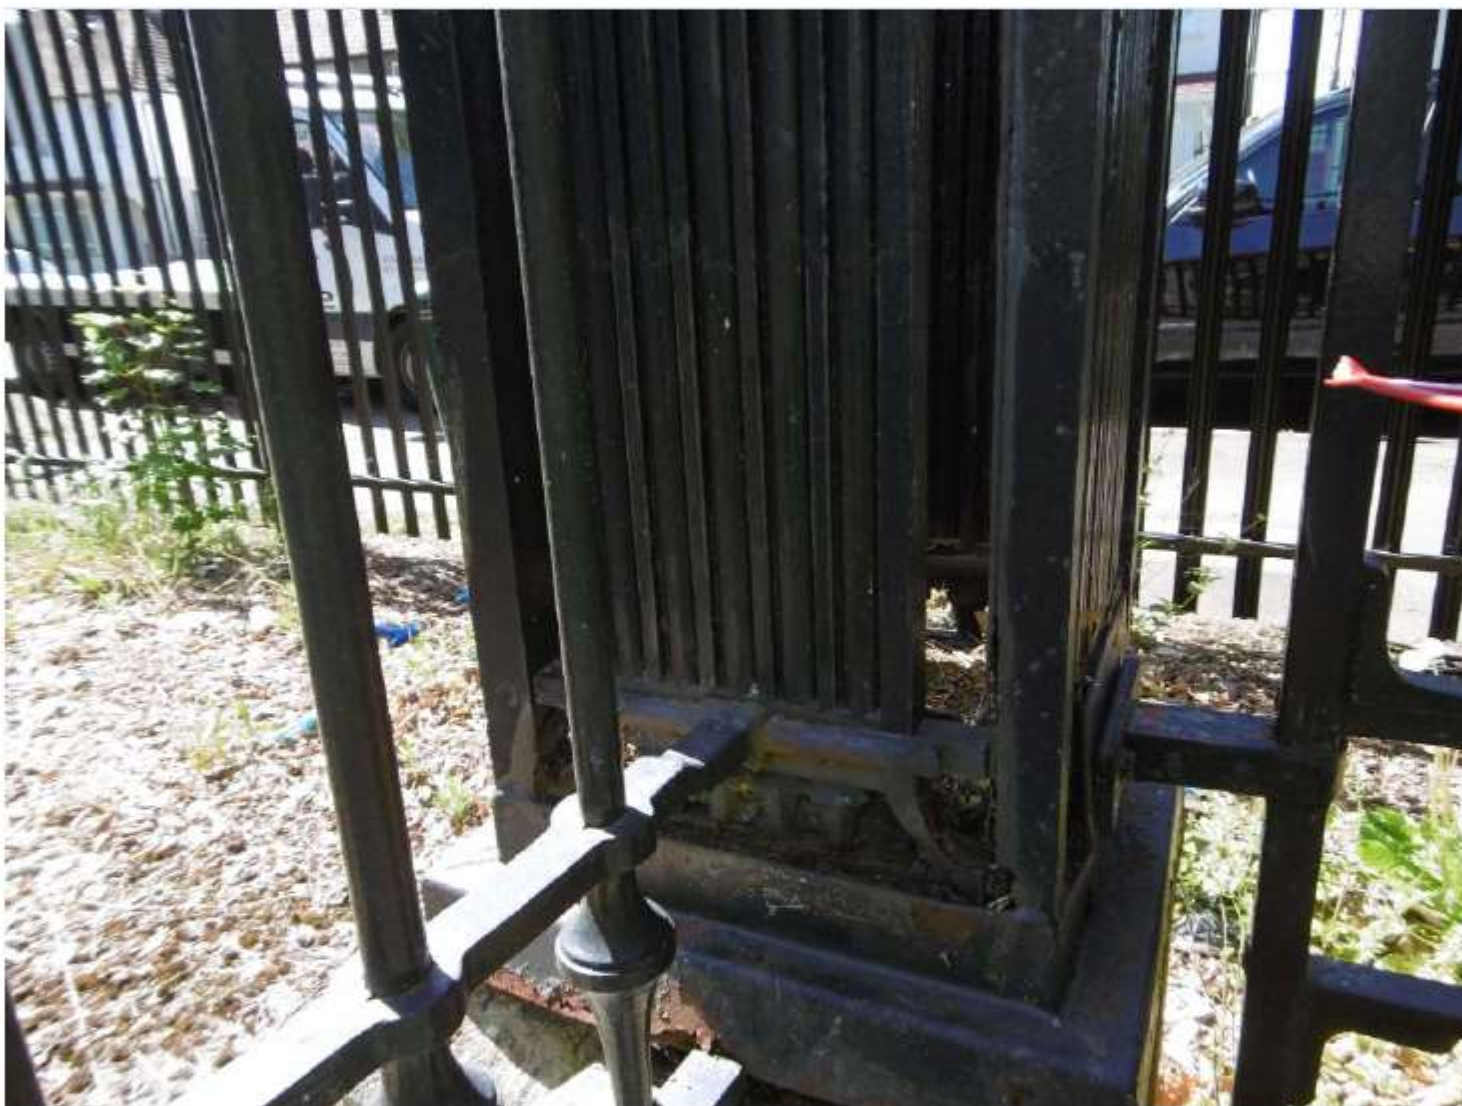
*Fig 2: Central gate corner post looking south, base showing exposure and corrosion*

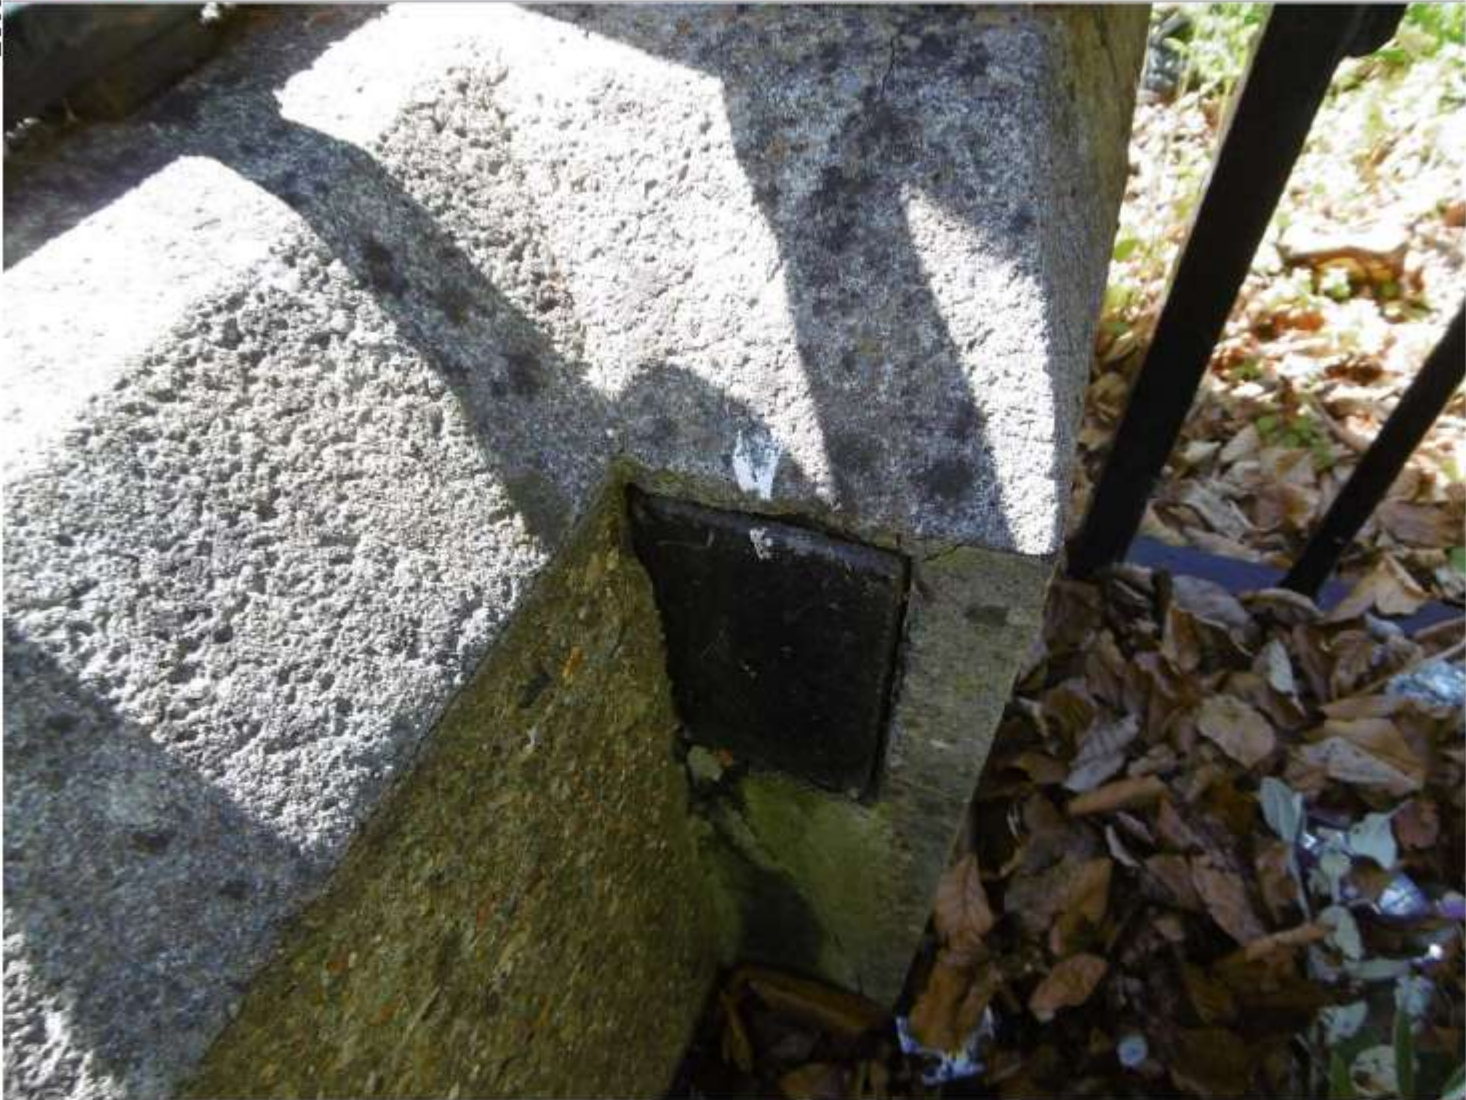
*Fig 3: Central gate corner looking south, exposed metal frame in concrete base*

leaves with berries beneath the capitals. Railings and gates are topped with “spearhead” finials, 100 wide and 275 high, all of which are intact. A small panel of metalwork was exposed beneath the concrete base at a corner, suggesting exposure of the frame through erosion (Fig 3). Paint has stripped away in places exposing the railings and posts to rust in localised areas; with the bases of posts being most visibly affected (Figs 2, 4, 7). All posts on this elevation are capped with trapezoid “capitals”, each with a simple appearance of being constructed from plate and contrasting slightly from the more ornate appearance of the posts upon which they are located. A single decorative finial resembling an acorn rests atop the post capital on the east side of the curved railings. It is unclear whether this represents a single surviving remnant of a regular decorative feature on all of the posts or not.

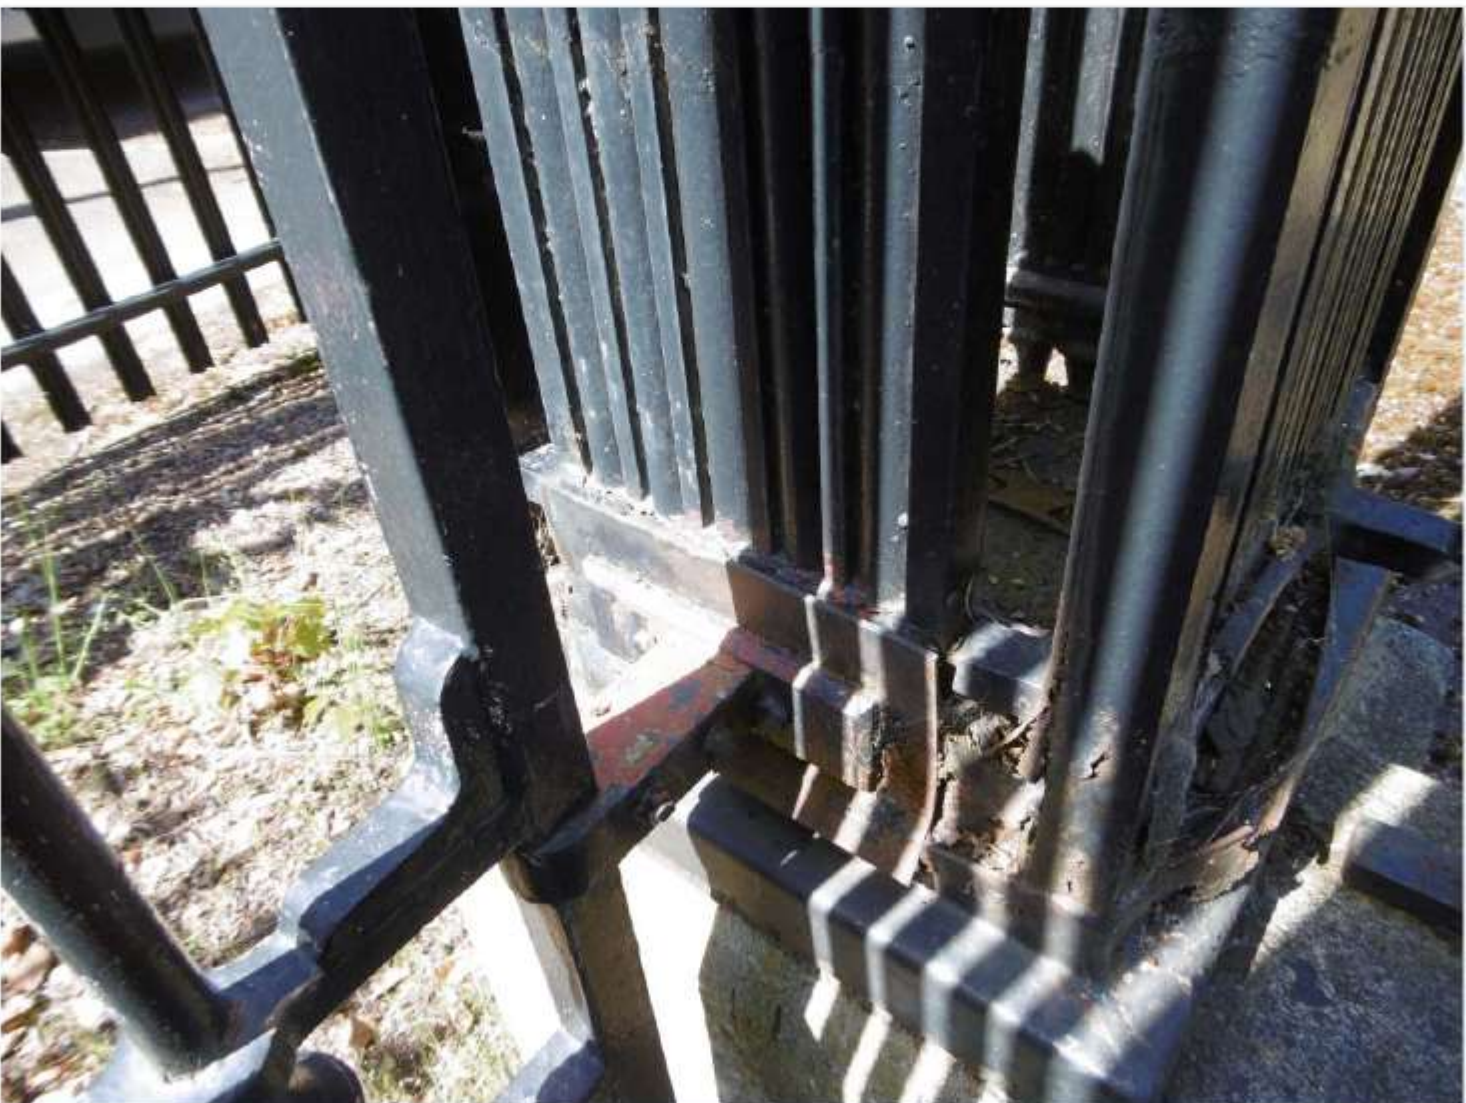
*Fig 4: Central gate, corner post base showing exposure and corrosion*

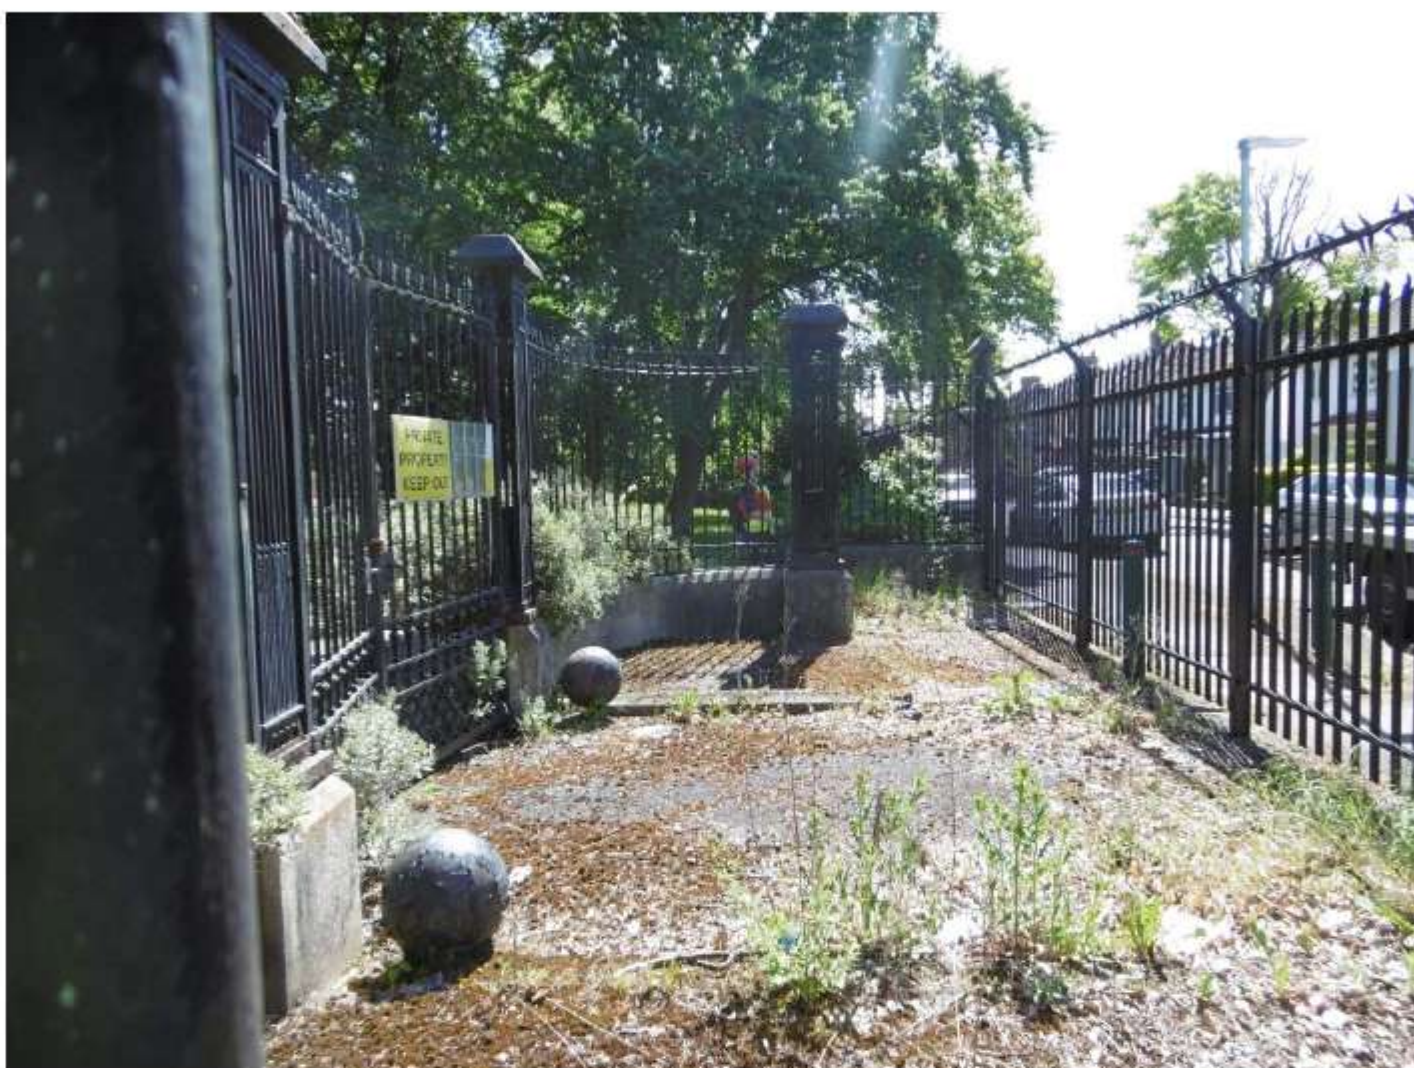
*Fig 5: Central gate, looking south-east – general untended condition*

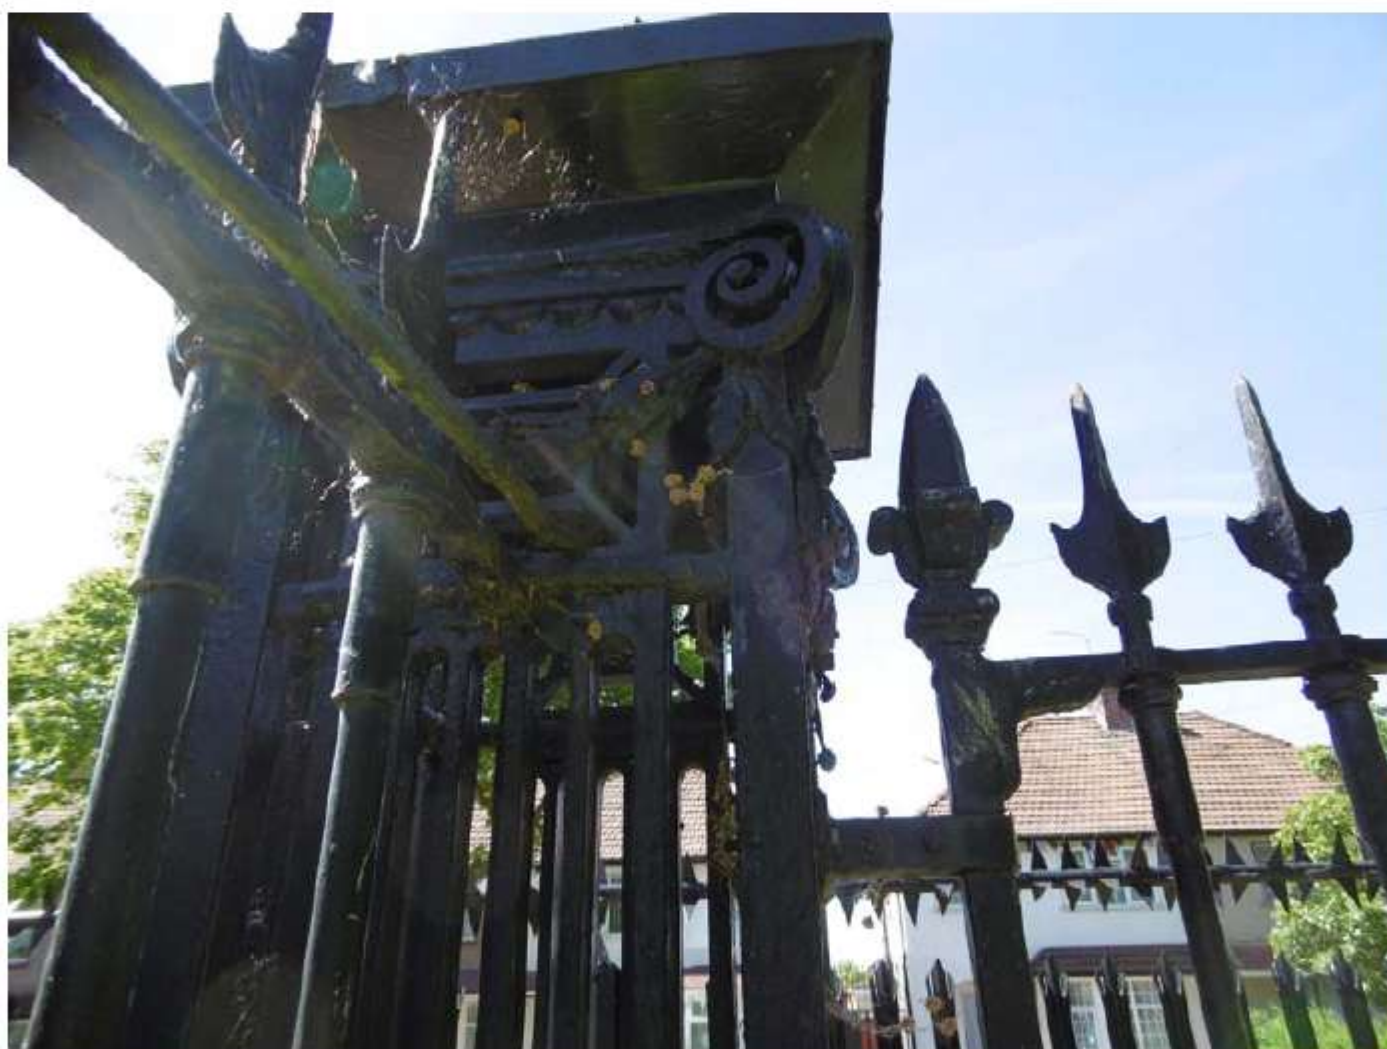
*Fig 6: Central gate, corner post, looking south. Note redundant pipe/trunking.*

| Table 1 | | |
|---|---|---|
| Lighting | Not found | Check conduit/pipe for wiring. Decision to replace rests with the Client.<br>If replaced, fit to manufacturer's specification. |

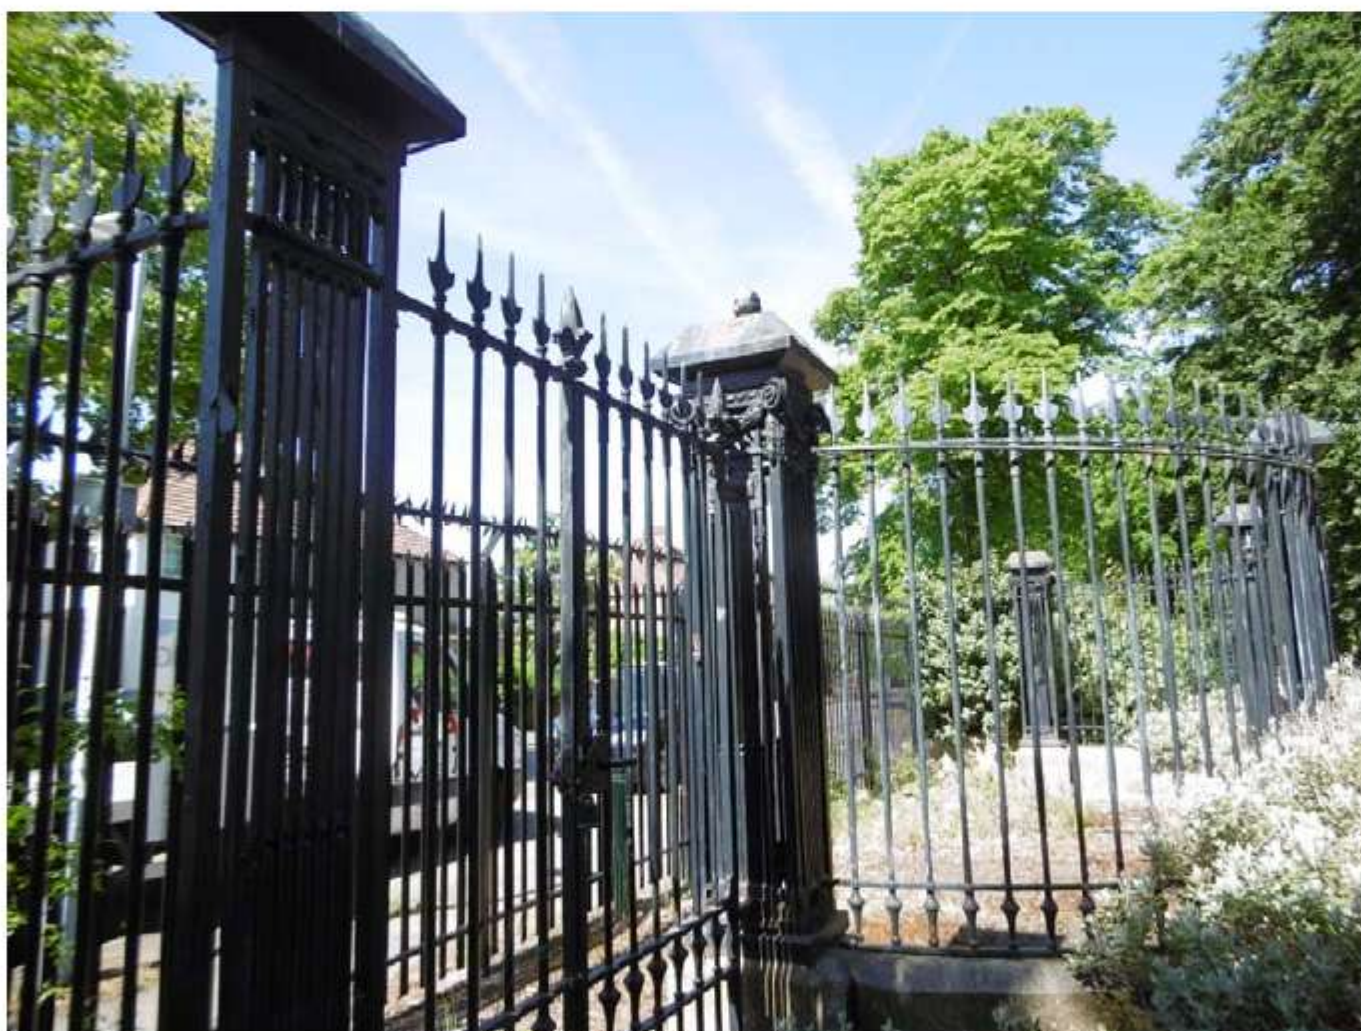
*Fig 8: Central gate, looking west; decorative finial atop corner post capital*

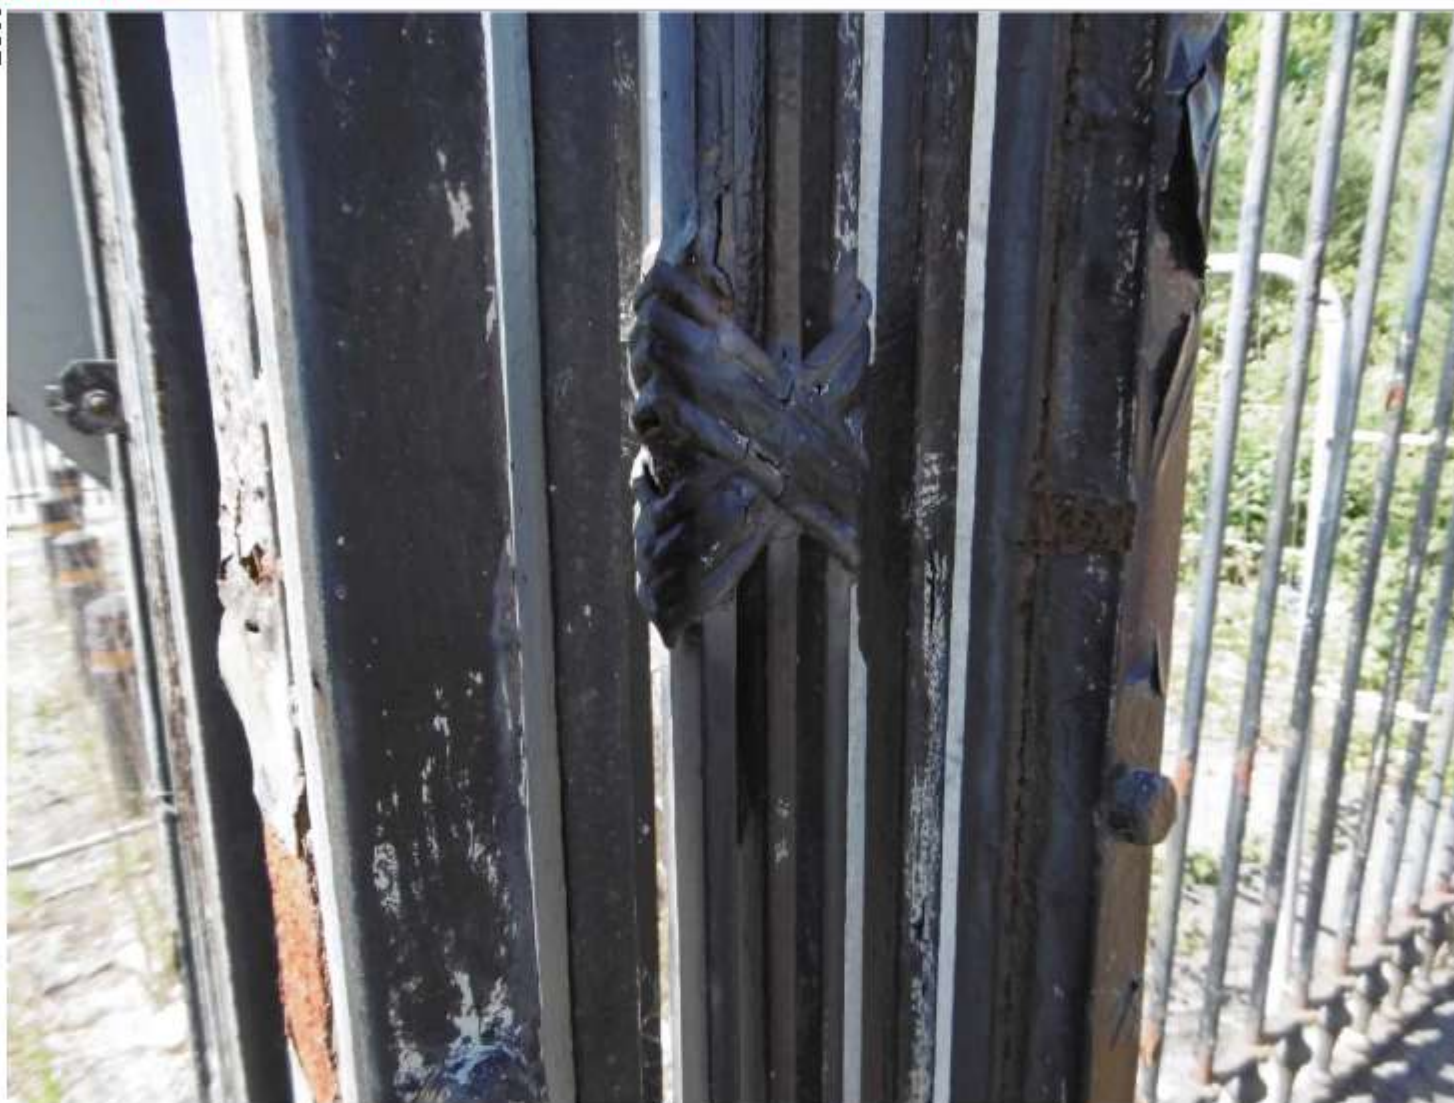
*Fig 9: Western gate, looking south-west*

corrosion was also visible in some of the posts here (Figs 9, 11). The two posts flanking the central gates were supported with braces set in concrete blocks, of more recent appearance than the rest of the concrete plinths and bases (Fig 12). Decorative detailing cast leaves with berries was visible at corner posts as in the case of the eastern gate (Fig 13). The posts around these gates were all topped with circular plastic lamps, (the bowls of which at least are a later addition) though these were not measured (Figs 10, 14).

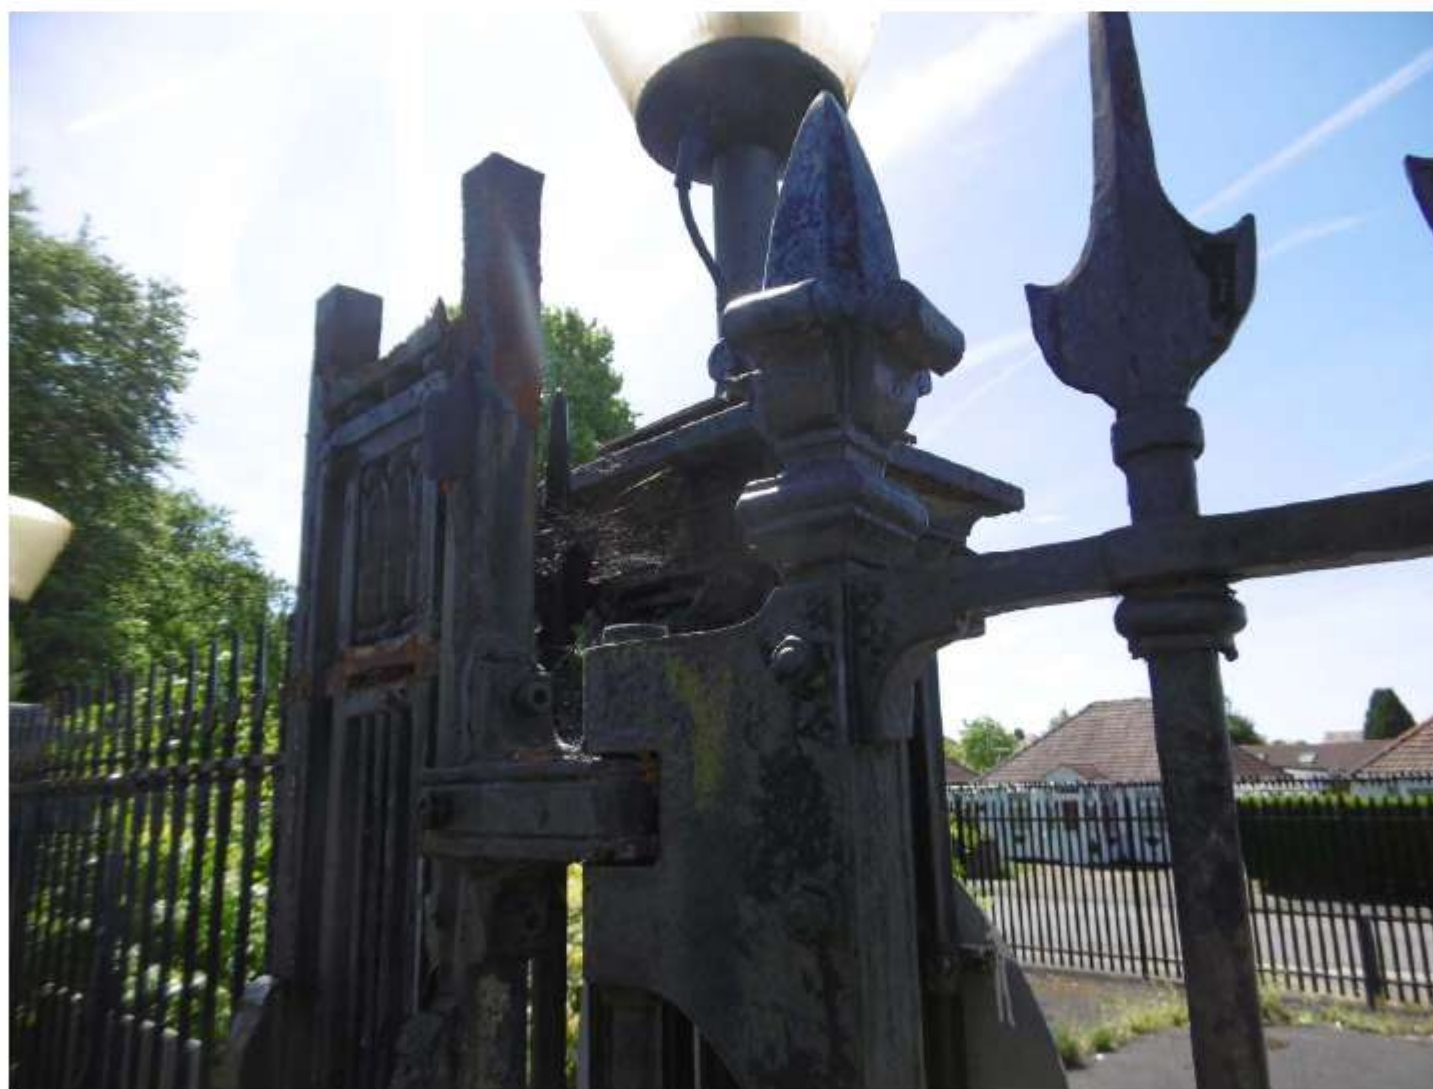
*Fig 10: Western gate looking south-east, post and gate frame with mounted lamp*

| Element | Situation | Action/Recommendation |
|---|---|---|
| Lighting | Intact but untested | <p>Check lamp heads for condition and fitting.</p> <p>Check function and refurbish wiring, connections etc.</p> <p>Rub back and Paint upstands with suitable water-based paint system (to Manufacturers' specification; see below)</p> |

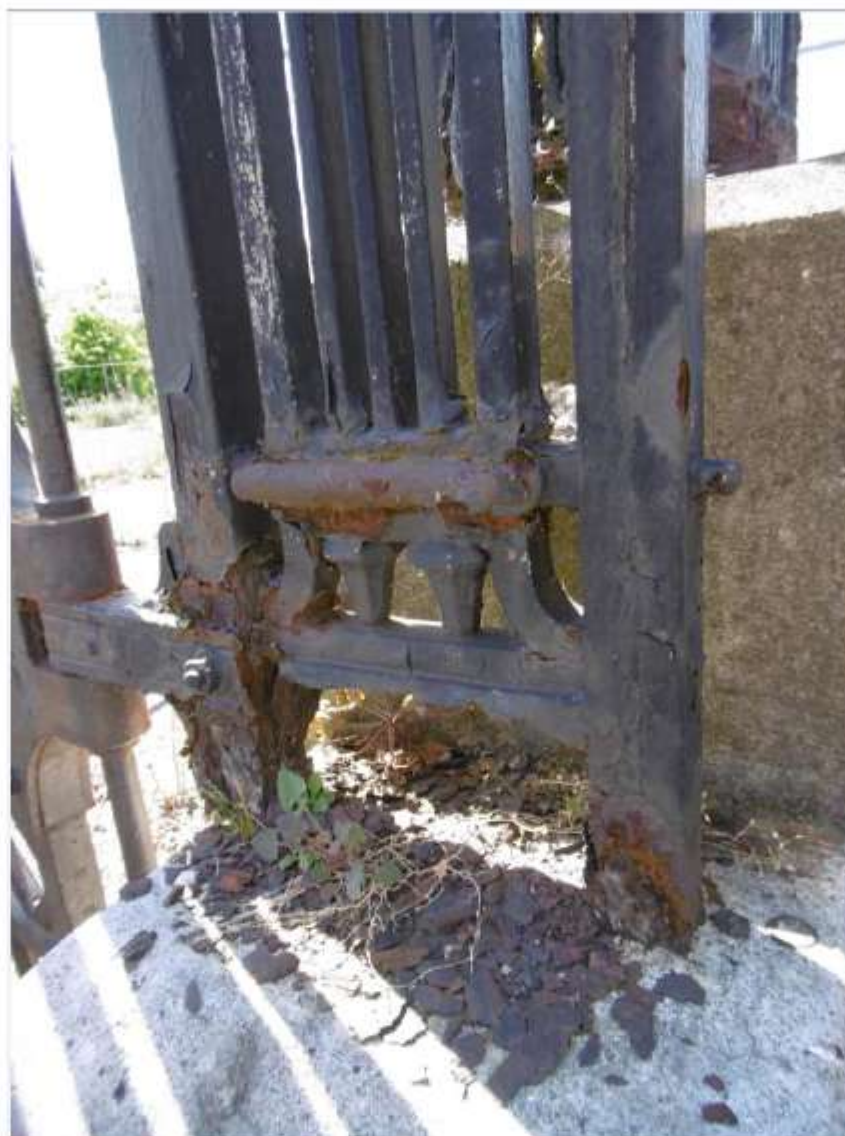
*Fig 11: Western gate corner post, corrosion exposed*

| Metalwork – inner pillars | Fair condition overall, some rust/deterioration of fine detail | <p>The metal work has been over-painted possibly on a number of occasions. All paint should be stripped off using a proprietary method to manufacturers' specification) (NB No chemicals should be allowed to enter the surface water system or escape onto the public highway).</p> <p>Detailed inspection after stripping will reveal the extent of deterioration of fine detail and where moisture has caused problems. Repair and reinstatement of this detail will need to be done by a suitably specialist contractor.</p> <p>The means by which joints are sealed at present should be inspected post-strip and made good.</p> <p>Metalwork to be repainted in a suitable breathing system to manufacturers' specification.</p> |

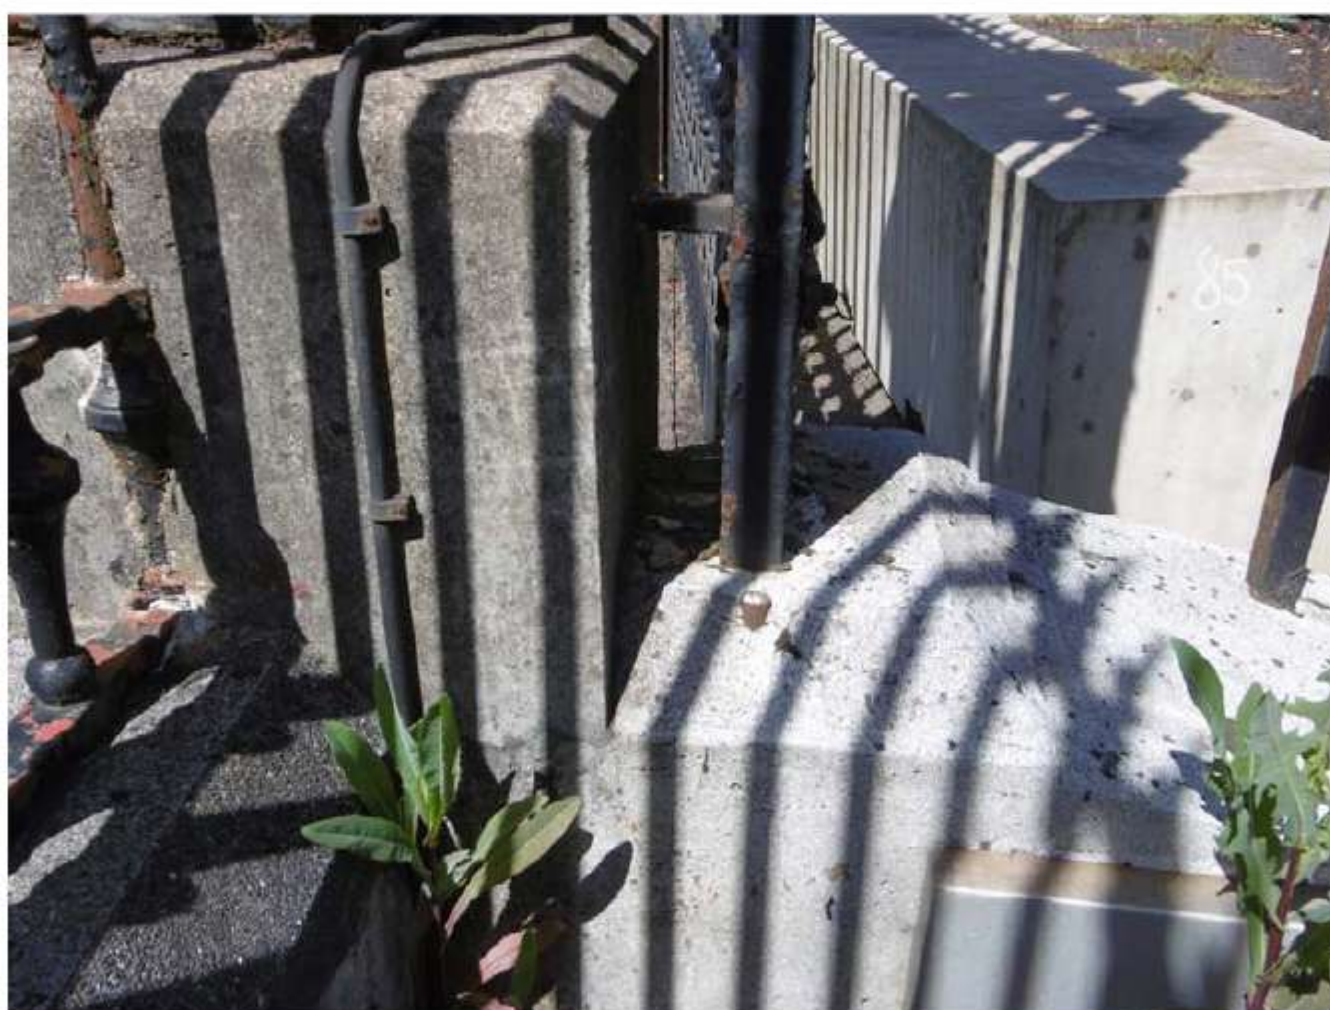
*Fig 12: Western gate corner post with accompanying concrete support*

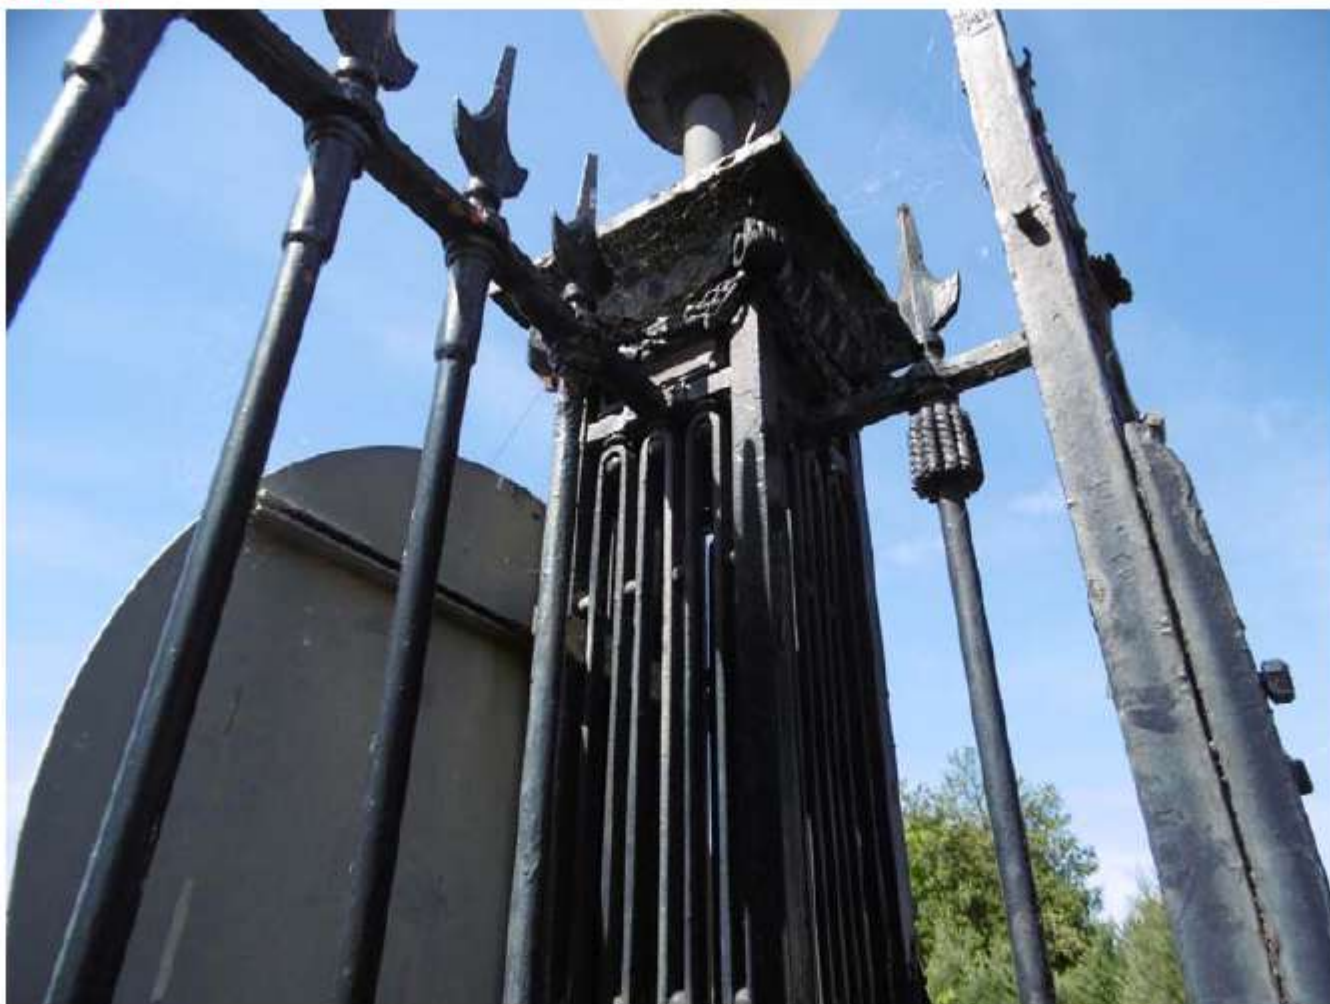
*Fig 13: Western gate corner post with lamp and decorative detail, looking west*

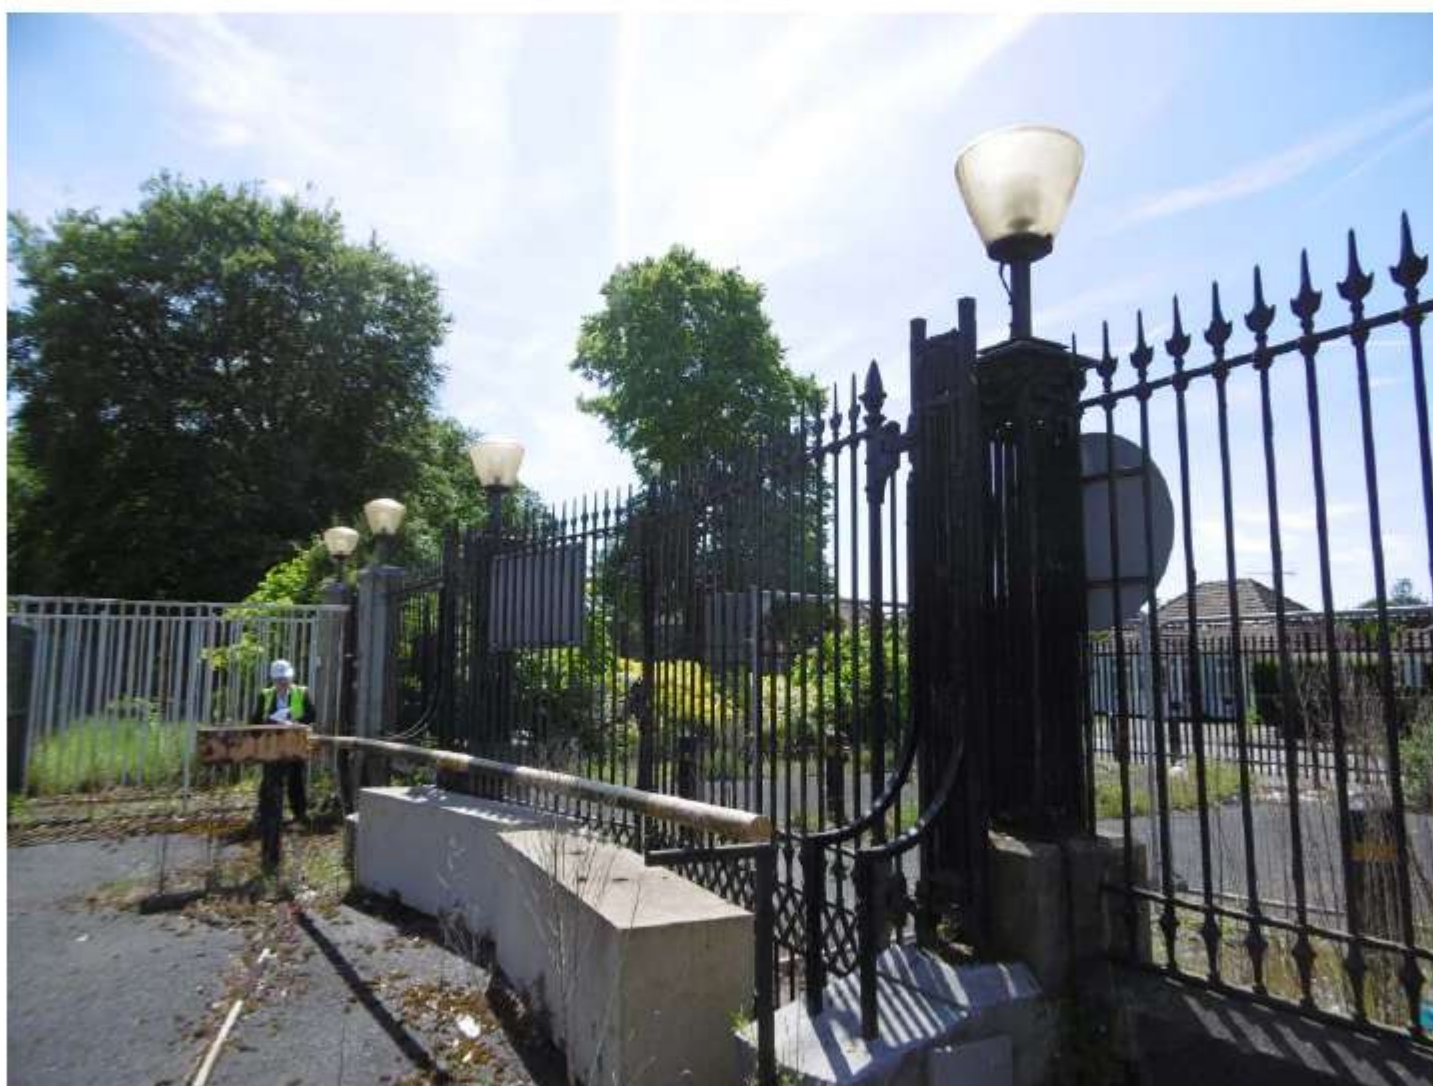
*Fig 14: Western gate looking south-east*
