**Former Nestle Canteen Building, Hayes**

**Report on the Investigation of Certain  
Façade Steel Frame Elements**

**Final Report – 5049**

**Barratt London**

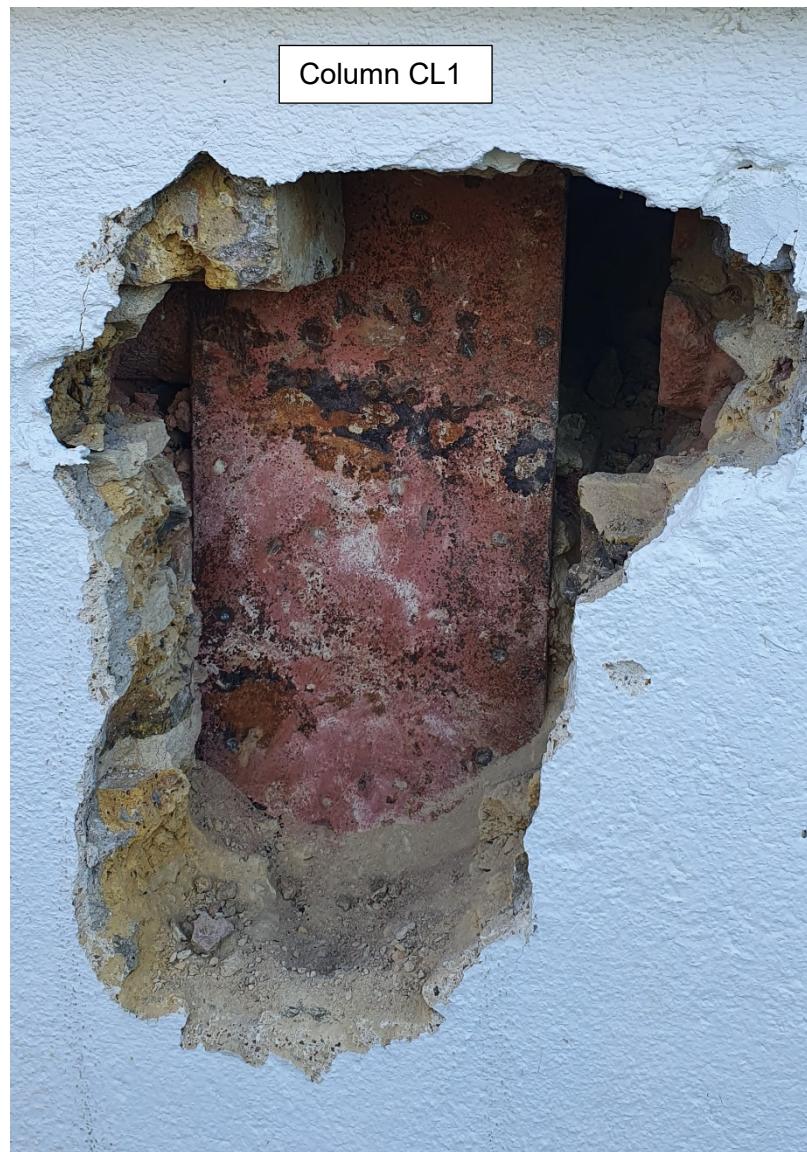
The steel columns locally exposed above ground level on the western façade (CL1 and CL2) exhibited no more than light surface corrosion.

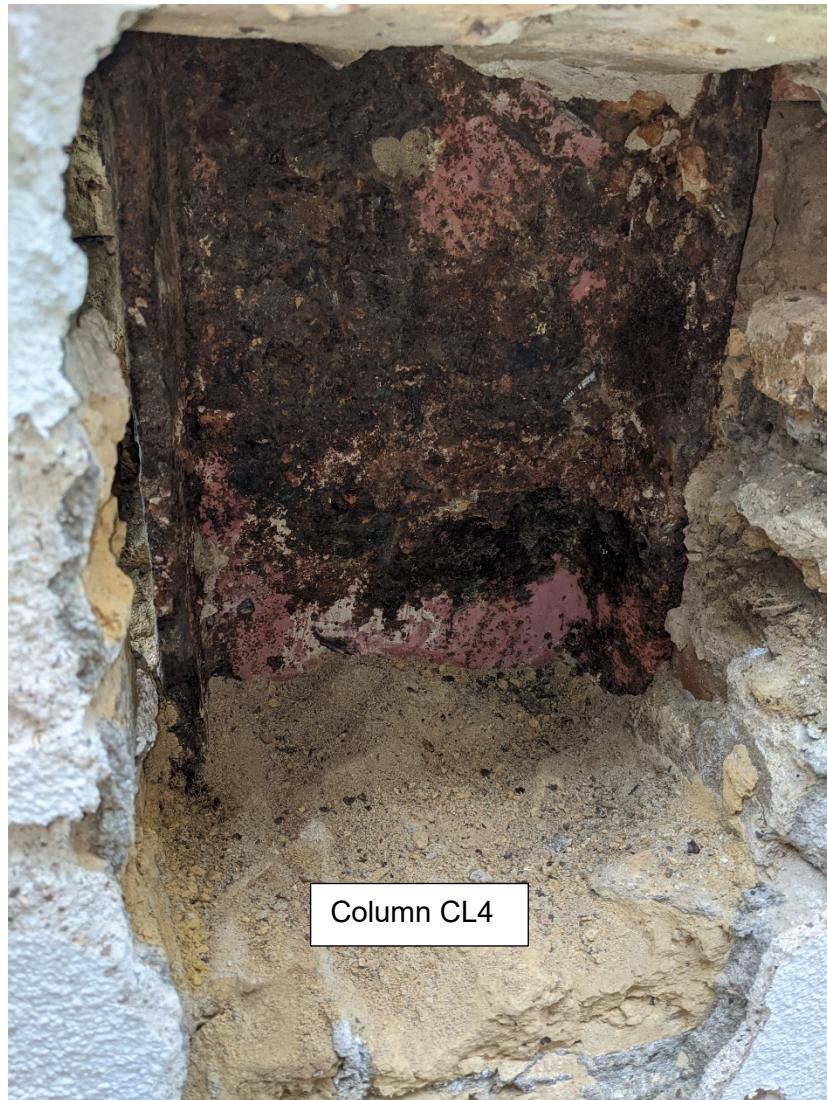
On the southern façade, the steel column locally exposed above ground at CL3 exhibited moderate surface corrosion (further developed surface corrosion, but no measurable section loss), whilst the column locally exposed at CL4 exhibited moderate to heavy surface corrosion (heavy corrosion deposits and flaking evident, with onset of section loss, <10%).

The residual capacity of the columns that exhibit heavy surface corrosion should be assessed by the Client's Structural Engineer.

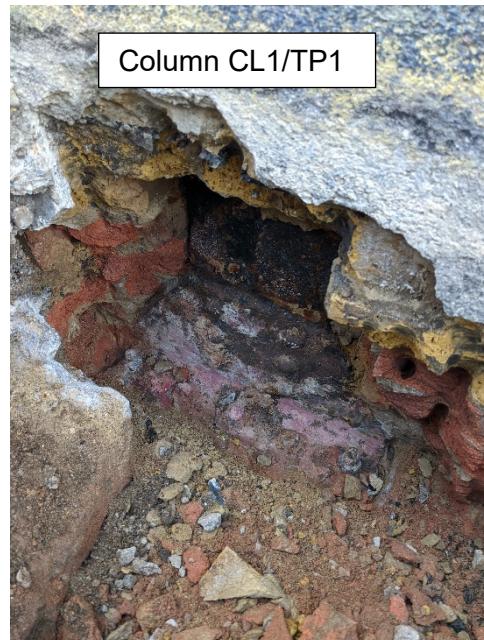
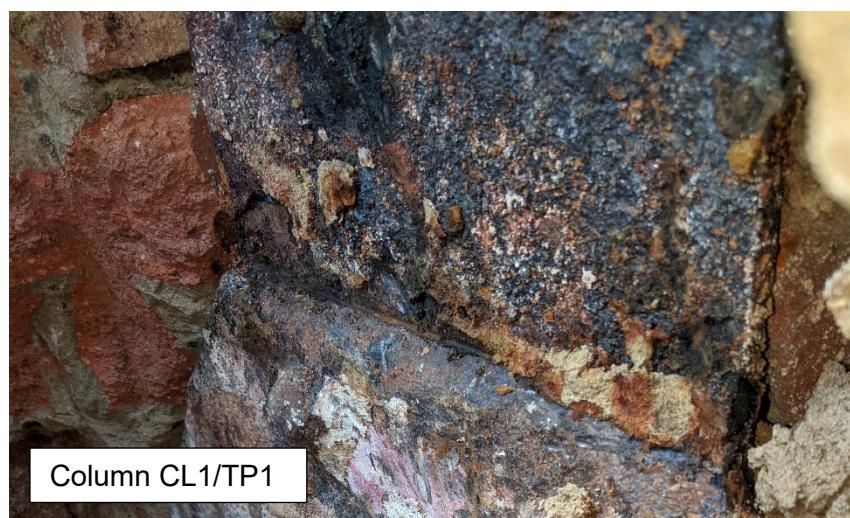
At each of the four locations the gusset plates/angles and connecting rivet and bolt heads exposed (typically encased in concrete) exhibited no more than light surface corrosion. However, the base of the column sections typically exhibited moderate surface corrosion (further developed surface corrosion, but no measurable section loss). The base of the column section at location CL1 exhibited heavy surface corrosion (heavy corrosion deposits and flaking evident, with onset of section loss, <10%).

Given the variability in the condition of the small sample of steel column sections investigated at low and below ground level (where encased in masonry), it should be expected that there are other low level areas around the façade where the columns exhibit heavy surface corrosion, or potentially more severe corrosion. It is therefore recommended that, prior to any repairs, the lower portions of the columns and the column bases below ground level are opened up and similarly inspected. Any significantly corroded sections will need to be cleaned and repaired/protected and/or strengthened as directed by the Client's Structural Engineer, prior to any encasement repairs.

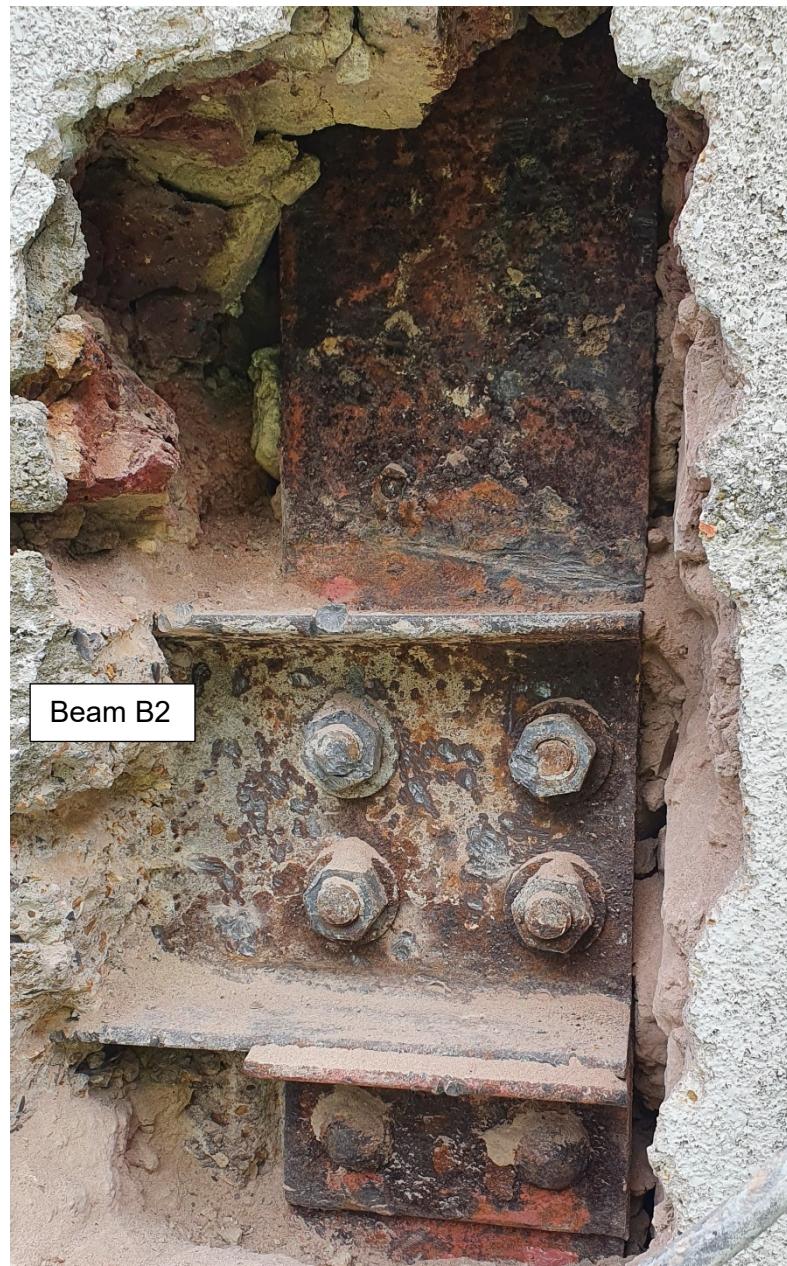
The steel beams locally exposed (B1 and 2) exhibited no more than light surface corrosion.

The steel columns should also be exposed for inspection at higher levels where cracking is evident to the external render/masonry (following the line of the column). It would also be prudent to inspect any steel beam locations where cracking is identified to the concrete encasement (following the line of the beam), although the steel beams are expected to be in better condition throughout where encased in concrete.

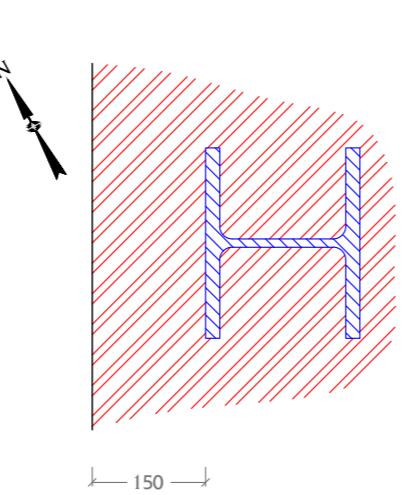
FIG.1a: PART PLAN SHOWING COLUMN CL1 CONSTRUCTION DETAILS AND CONDITION (1m ABOVE GROUND F.F.L.) SCALE 1:10

D: 252mm  
B: 204mm  
T: 18.7mm  
t: 11mm

CRACKING OBSERVED TO RENDER, STEEL COLUMN EXPOSED EXHIBITS LIGHT SURFACE CORROSION (ONSET OF SURFACE CORROSION BUT NO SECTION LOSS)

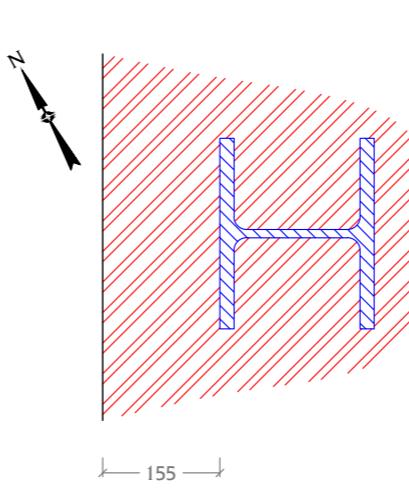
FIG.1b: PART PLAN SHOWING COLUMN CL2 CONSTRUCTION DETAILS AND CONDITION (1m ABOVE GROUND F.F.L.) SCALE 1:10

D: 253mm  
B: 207mm  
T: 19.6mm  
t: 10.6mm

CRACKING OBSERVED TO RENDER, STEEL COLUMN EXPOSED EXHIBITS LIGHT SURFACE CORROSION (ONSET OF SURFACE CORROSION BUT NO SECTION LOSS)

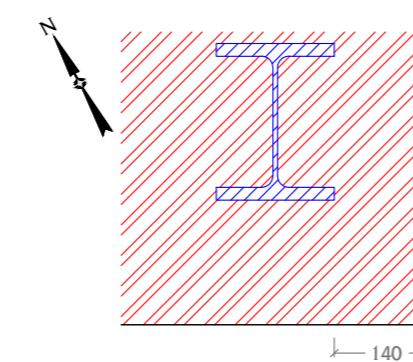
FIG.1c: PART PLAN SHOWING COLUMN CL3 CONSTRUCTION DETAILS AND CONDITION (1m ABOVE GROUND F.F.L.) SCALE 1:10

D: 207mm  
B: 156mm  
T: 16.8mm  
t: 6.2mm

CRACKING OBSERVED TO RENDER, STEEL COLUMN EXPOSED EXHIBITS MODERATE SURFACE CORROSION (FURTHER DEVELOPED CORROSION, BUT NO MEASURABLE SECTION LOSS)

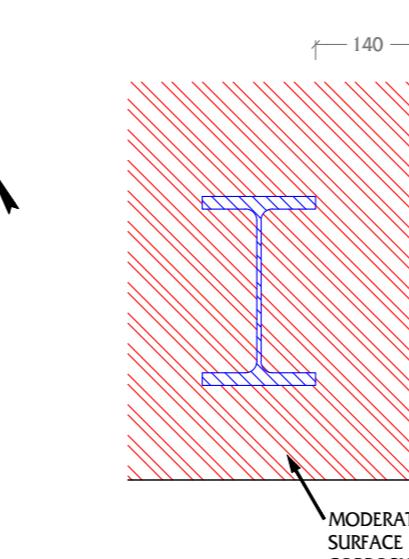
FIG.1d: PART PLAN SHOWING COLUMN CL4 CONSTRUCTION DETAILS AND CONDITION (1m ABOVE GROUND F.F.L.) SCALE 1:10

D: 250mm  
B: 150.5mm  
T: 16.7mm  
t: 5.7mm

CRACKING OBSERVED TO RENDER, STEEL COLUMN SECTION EXPOSED EXHIBITS MODERATE TO HEAVY SURFACE CORROSION (HEAVY CORROSION DEPOSITS AND FLAKING EVIDENT IN PLACES WITH ONSET OF SECTION LOSS)

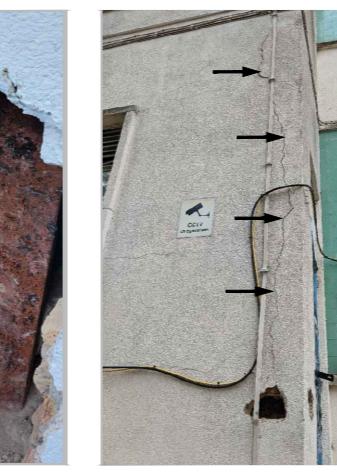
PIg: CL3 COLUMN EXPOSURE AND CRACKING
