FORMER NESTLE FACTORY, HAYES
Demolition Report – Former Canteen Block

Project: **Former Nestle Factory, Hayes**Job No: **W1965**Title: **Demolition Report – Former Canteen Block**

**Report on the Investigation of Certain
Façade Steel Frame Elements**

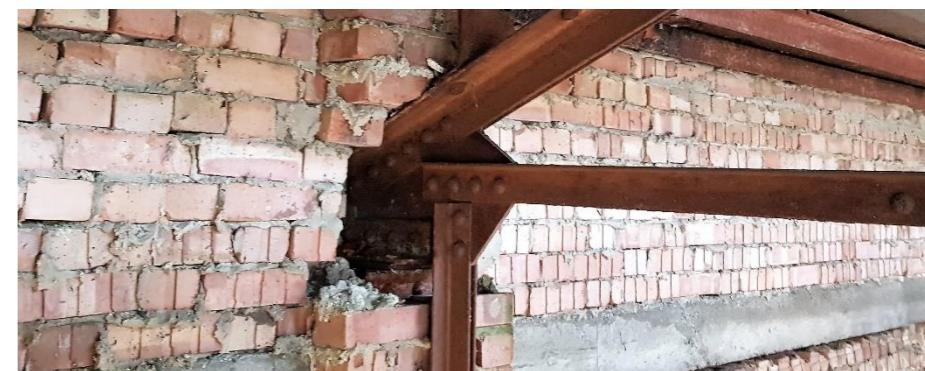
Photo 6: Canteen hall truss embedded in brickwork.

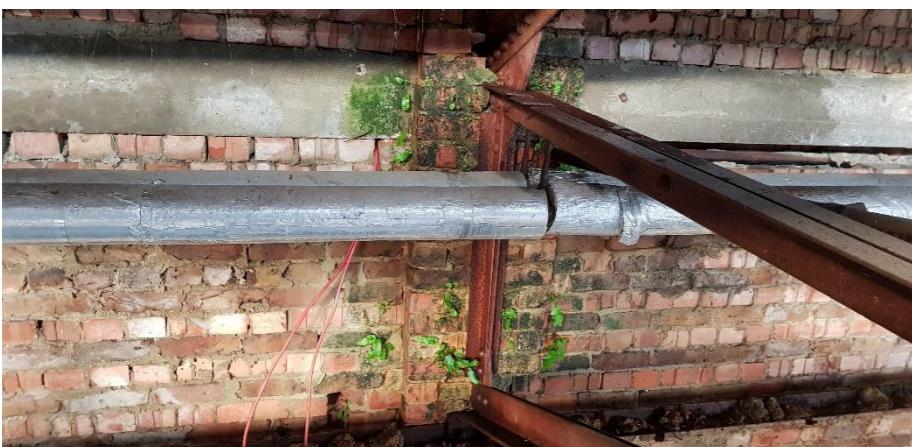
Photo 7: Roof truss embedment into brickwork.

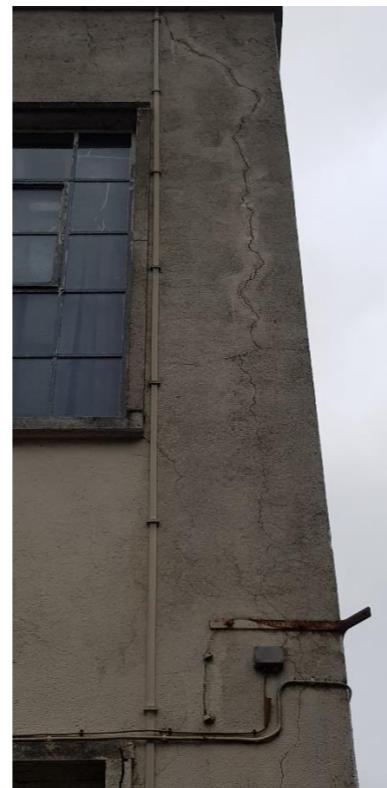
Photo 11: Crack through render on south-west corner of building

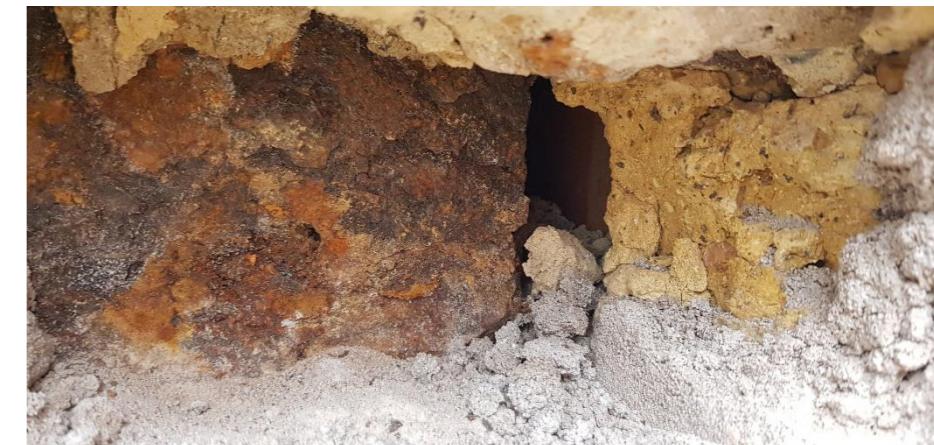
Photo 12: Steel column exposed within brick encasement.

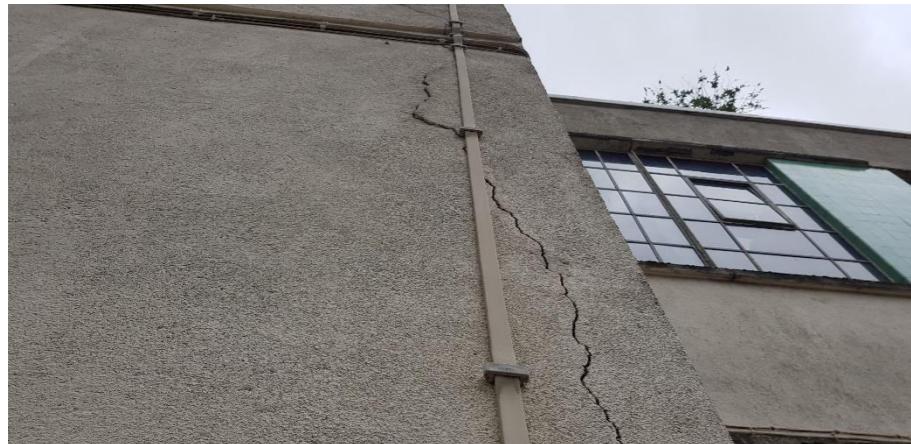
Photo 13: Crack through render on south elevation

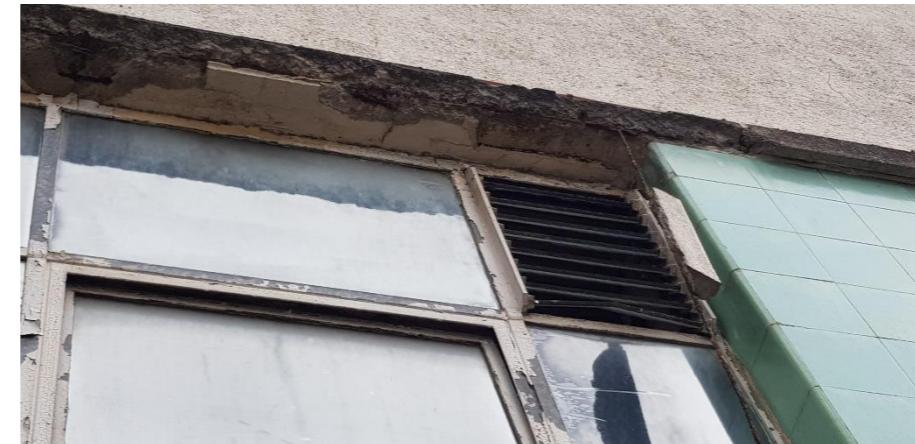
The outer leaf is supported on precast concrete lintels between the column encasements. These concrete lintels were generally in poor condition, with steel reinforcement bars exposed and corroded, and in places detached from the lintel.

Photo 14: Façade lintel spalling with reinforcement dislodged.

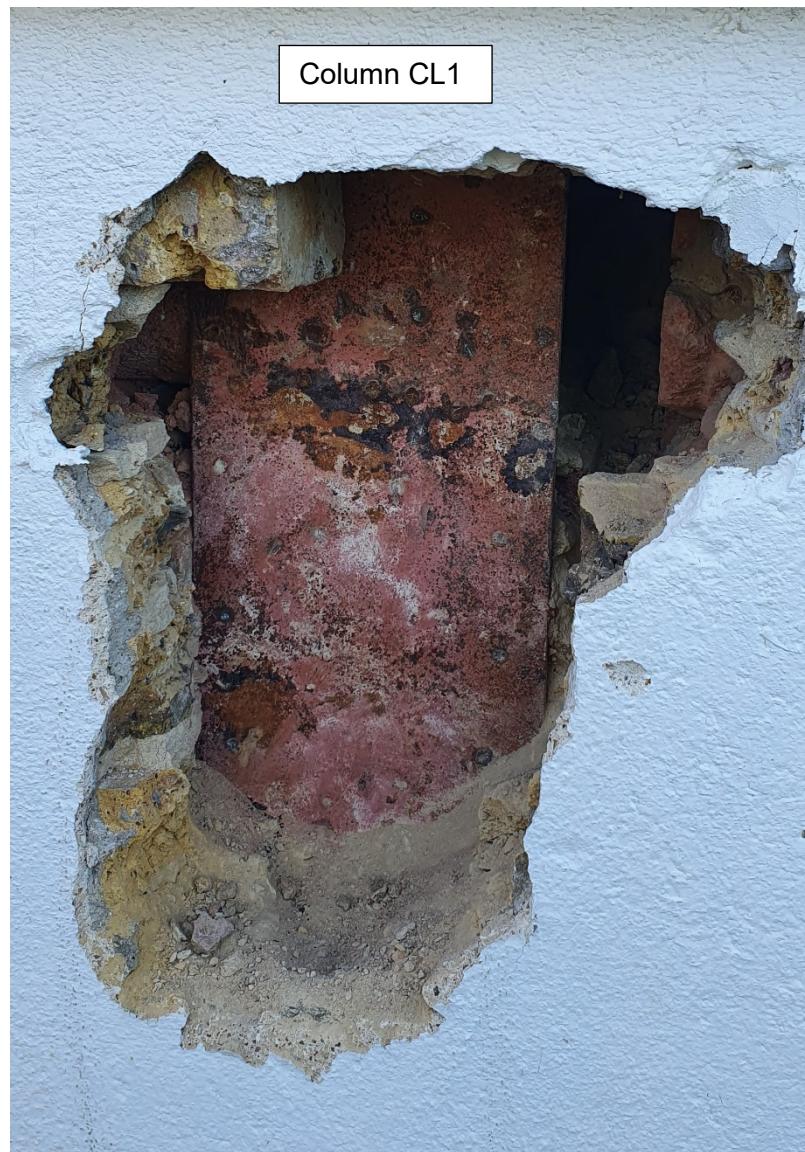
The steel columns locally exposed above ground level on the western façade (CL1 and CL2) exhibited no more than light surface corrosion.

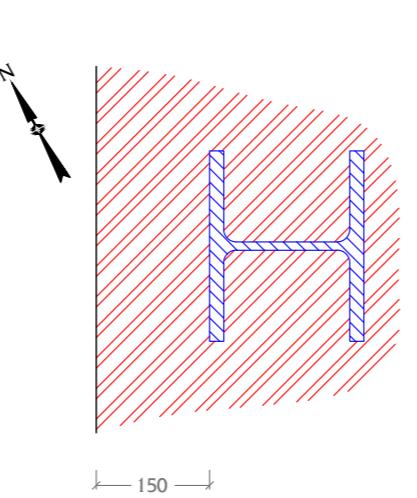
FIG.1a: PART PLAN SHOWING COLUMN CL1 CONSTRUCTION DETAILS AND CONDITION (1m ABOVE GROUND F.F.L.) SCALE 1:10

D: 252mm
B: 204mm
T: 18.7mm
t: 11mm

CRACKING OBSERVED TO RENDER. STEEL COLUMN EXPOSED EXHIBITS LIGHT SURFACE CORROSION (ONSET OF SURFACE CORROSION BUT NO SECTION LOSS)

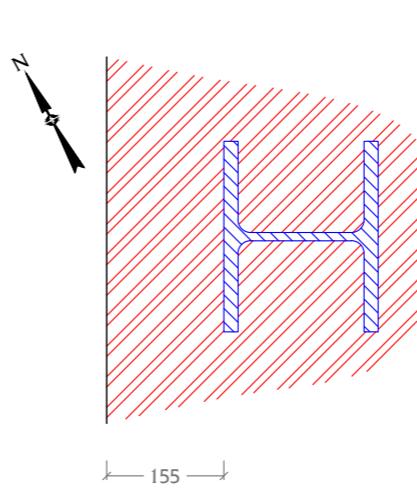
FIG.1b: PART PLAN SHOWING COLUMN CL2 CONSTRUCTION DETAILS AND CONDITION (1m ABOVE GROUND F.F.L.) SCALE 1:10

D: 253mm
B: 207mm
T: 19.6mm
t: 10.6mm

CRACKING OBSERVED TO RENDER. STEEL COLUMN EXPOSED EXHIBITS LIGHT SURFACE CORROSION (ONSET OF SURFACE CORROSION BUT NO SECTION LOSS)

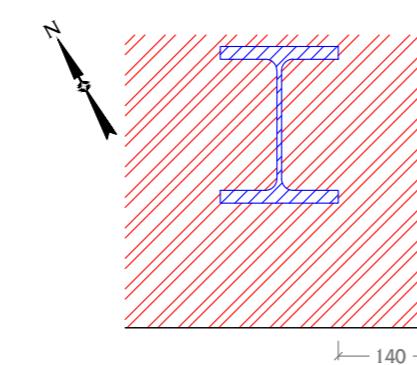
FIG.1c: PART PLAN SHOWING COLUMN CL3 CONSTRUCTION DETAILS AND CONDITION (1m ABOVE GROUND F.F.L.) SCALE 1:10

D: 207mm
B: 156mm
T: 16.8mm
t: 6.2mm

CRACKING OBSERVED TO RENDER. STEEL COLUMN EXPOSED EXHIBITS MODERATE SURFACE CORROSION (FURTHER DEVELOPED CORROSION, BUT NO MEASURABLE SECTION LOSS)

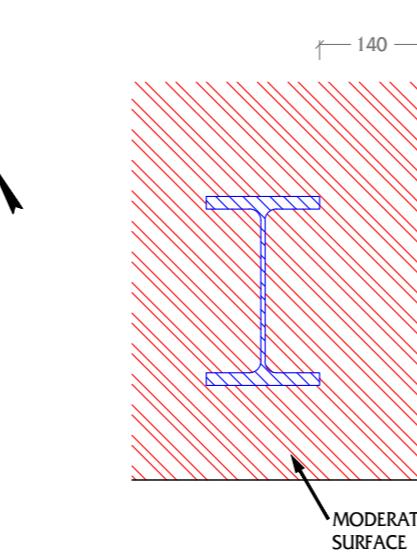
FIG.1d: PART PLAN SHOWING COLUMN CL4 CONSTRUCTION DETAILS AND CONDITION (1m ABOVE GROUND F.F.L.) SCALE 1:10

D: 250mm
B: 150.5mm
T: 16.7mm
t: 5.7mm

CRACKING OBSERVED TO RENDER. STEEL COLUMN SECTION EXPOSED EXHIBITS MODERATE TO HEAVY SURFACE CORROSION (HEAVY CORROSION DEPOSITS AND FLAKING EVIDENT IN PLACES WITH ONSET OF SECTION LOSS)

The residual capacity of the columns that exhibit heavy surface corrosion should be assessed by the Client's Structural Engineer.

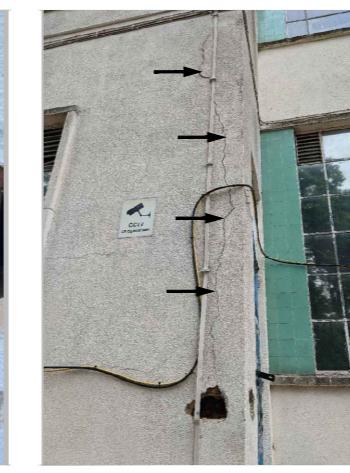
PIg: CL3 COLUMN EXPOSURE AND CRACKING

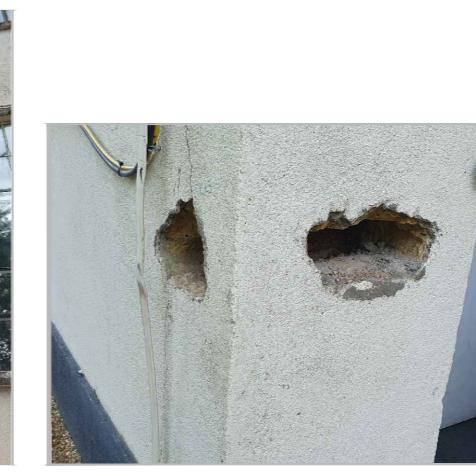
PIh: CL3 COLUMN EXPOSURE
