FORMER NESTLE CANTEEN

Facade retention study - REV A

April 2022

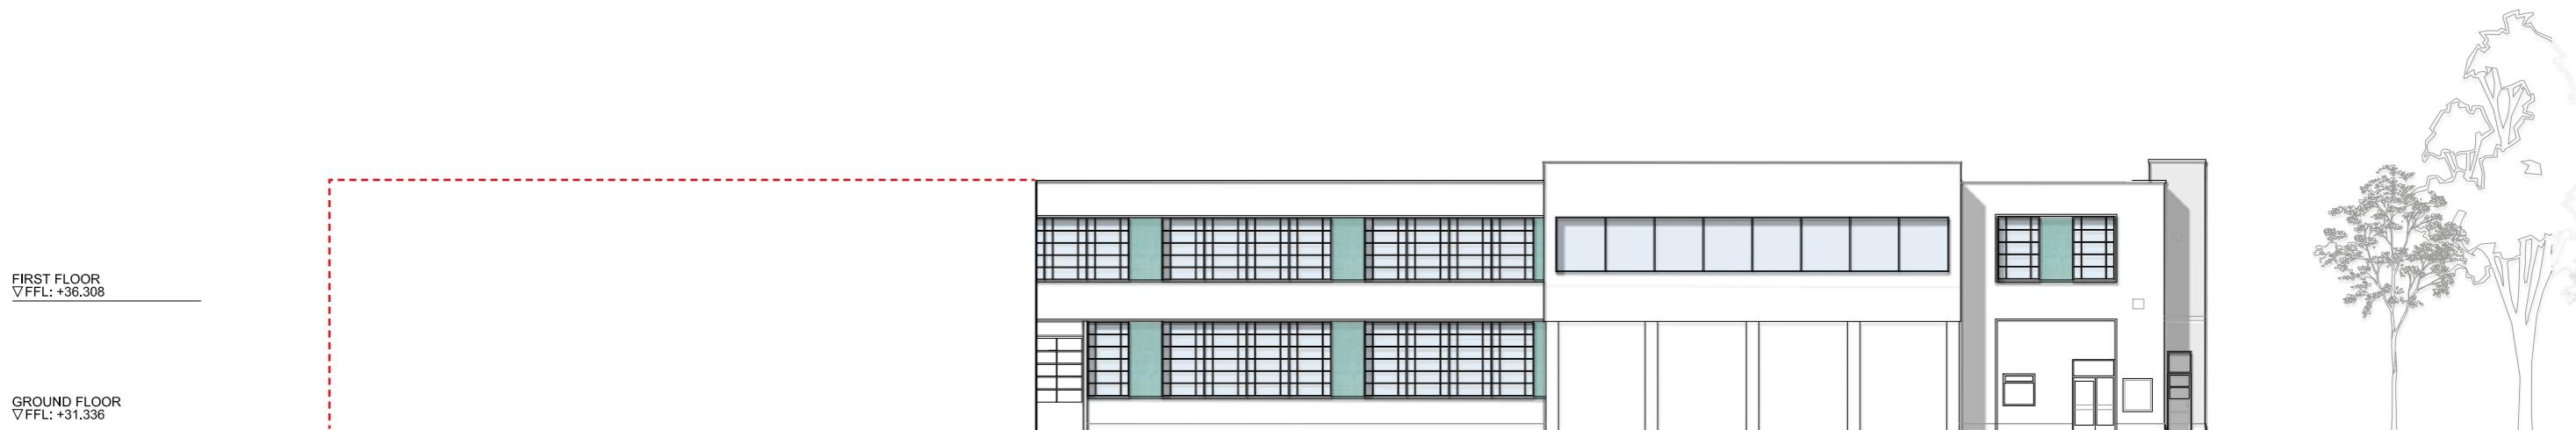
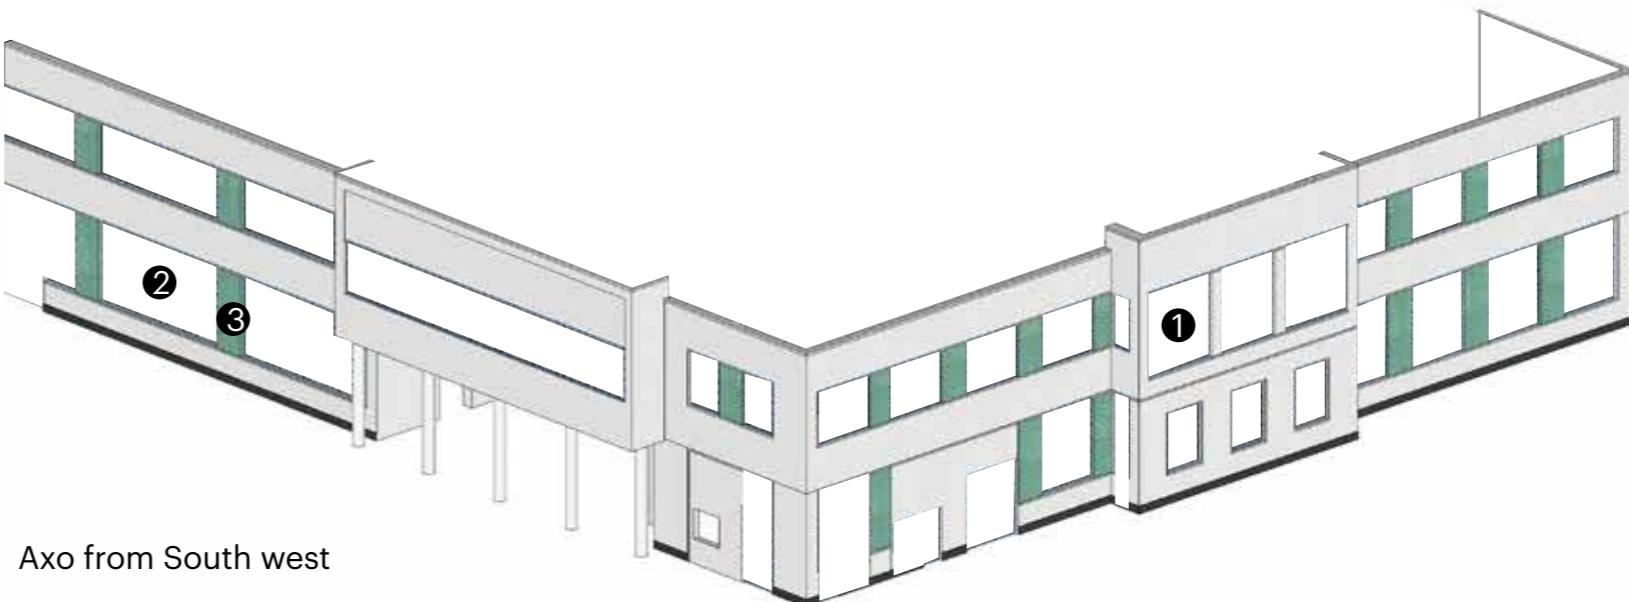
West Elevation

Single-glazed windows to be replaced

1. The existing windows are single-glazed steel framed, and need to be replaced with thermally broken double glazed in order to meet the NHS requirements of a sustainable BREEAM excellent medical centre. The proposal is for the same crittal style aluminium window frames used on blocks F1 and G, which appear in keeping with the original aesthetic.

2. To facilitate the medical centre design and room sizes, the existing window spans on the West facing elevation will need to be subdivided by half; the junction of wall to window detail draws from the original design, using a vertical green tile panel junction.

3. The existing green tiles are damaged or missing in areas; to ensure consistency with the new panels, all the tiles are to be removed and replaced with new green tiles, using the same product and supplier as the tiles used on blocks G and F1; these three buildings will complete the composition around Wallis Gardens

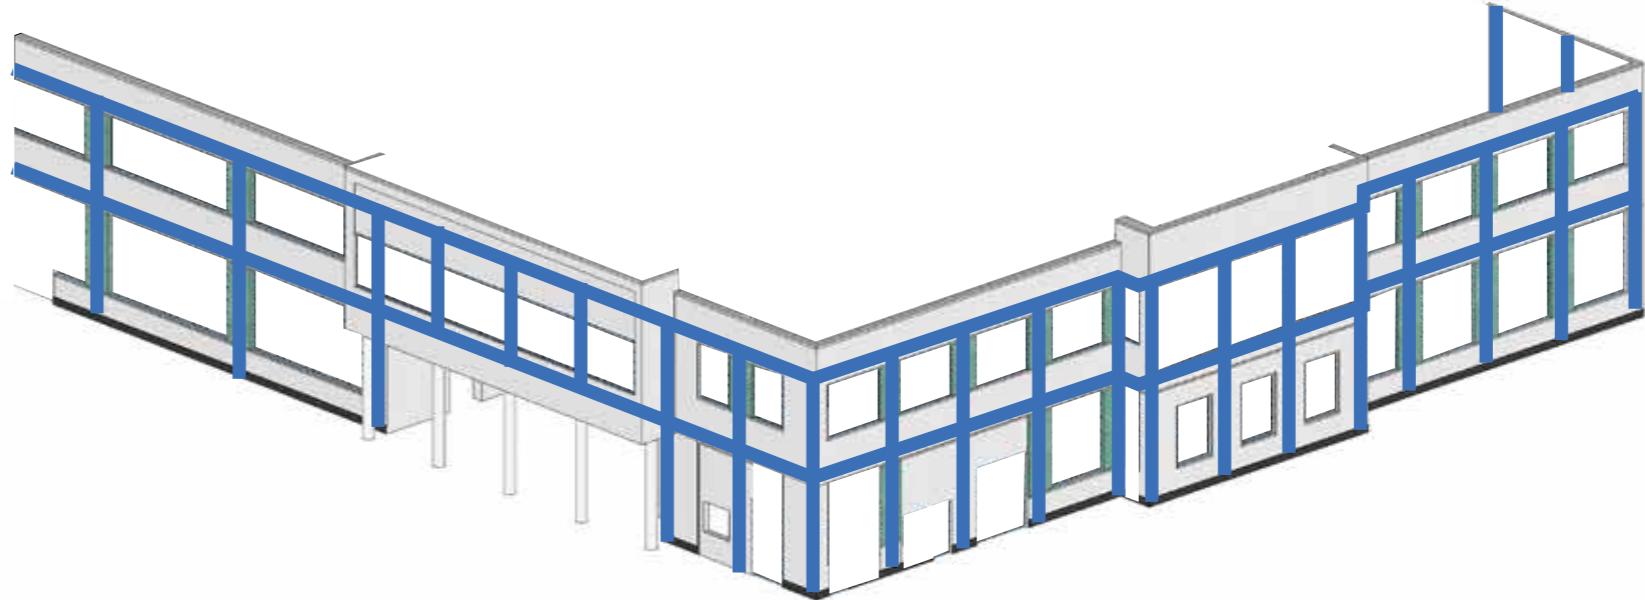
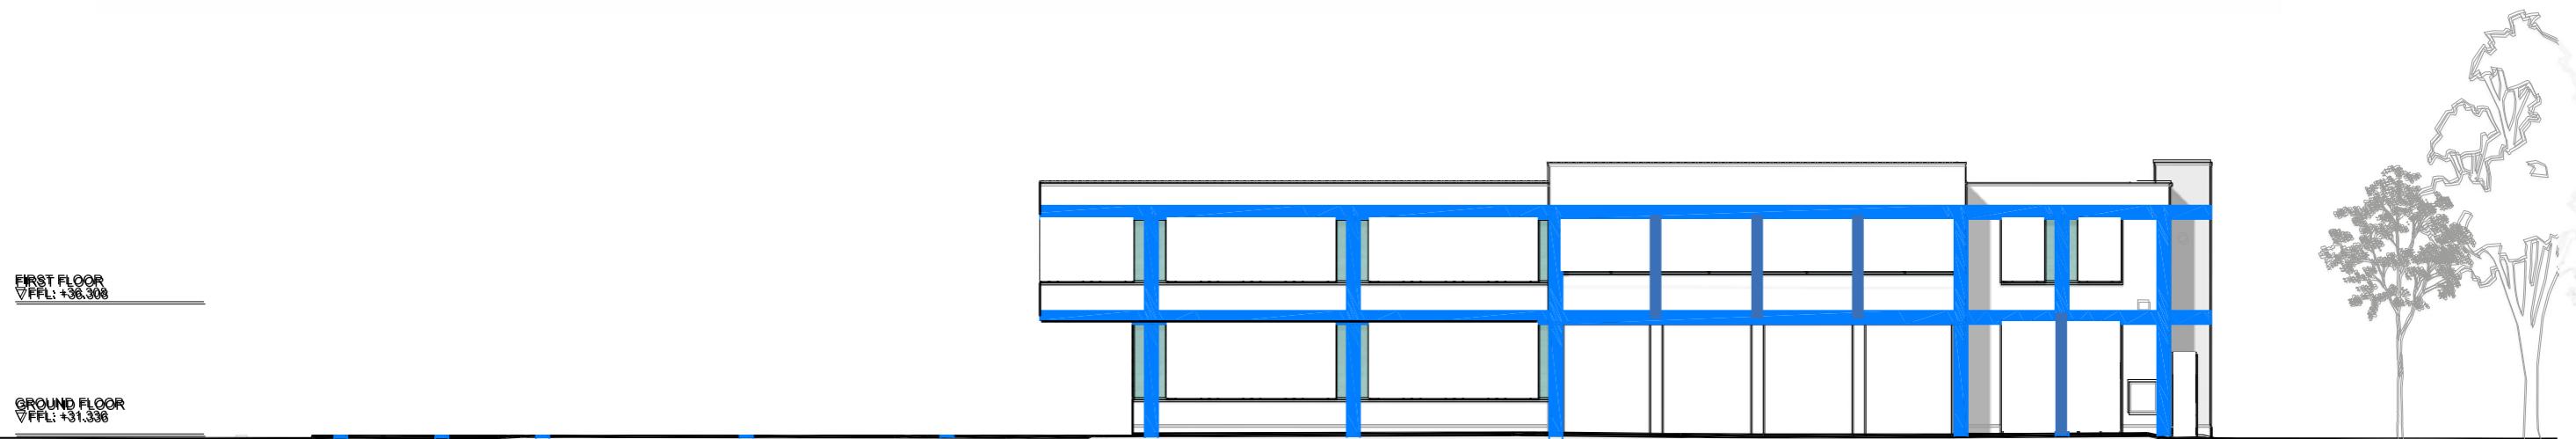
West Elevation

Corroded steel structure embedded in brick facade

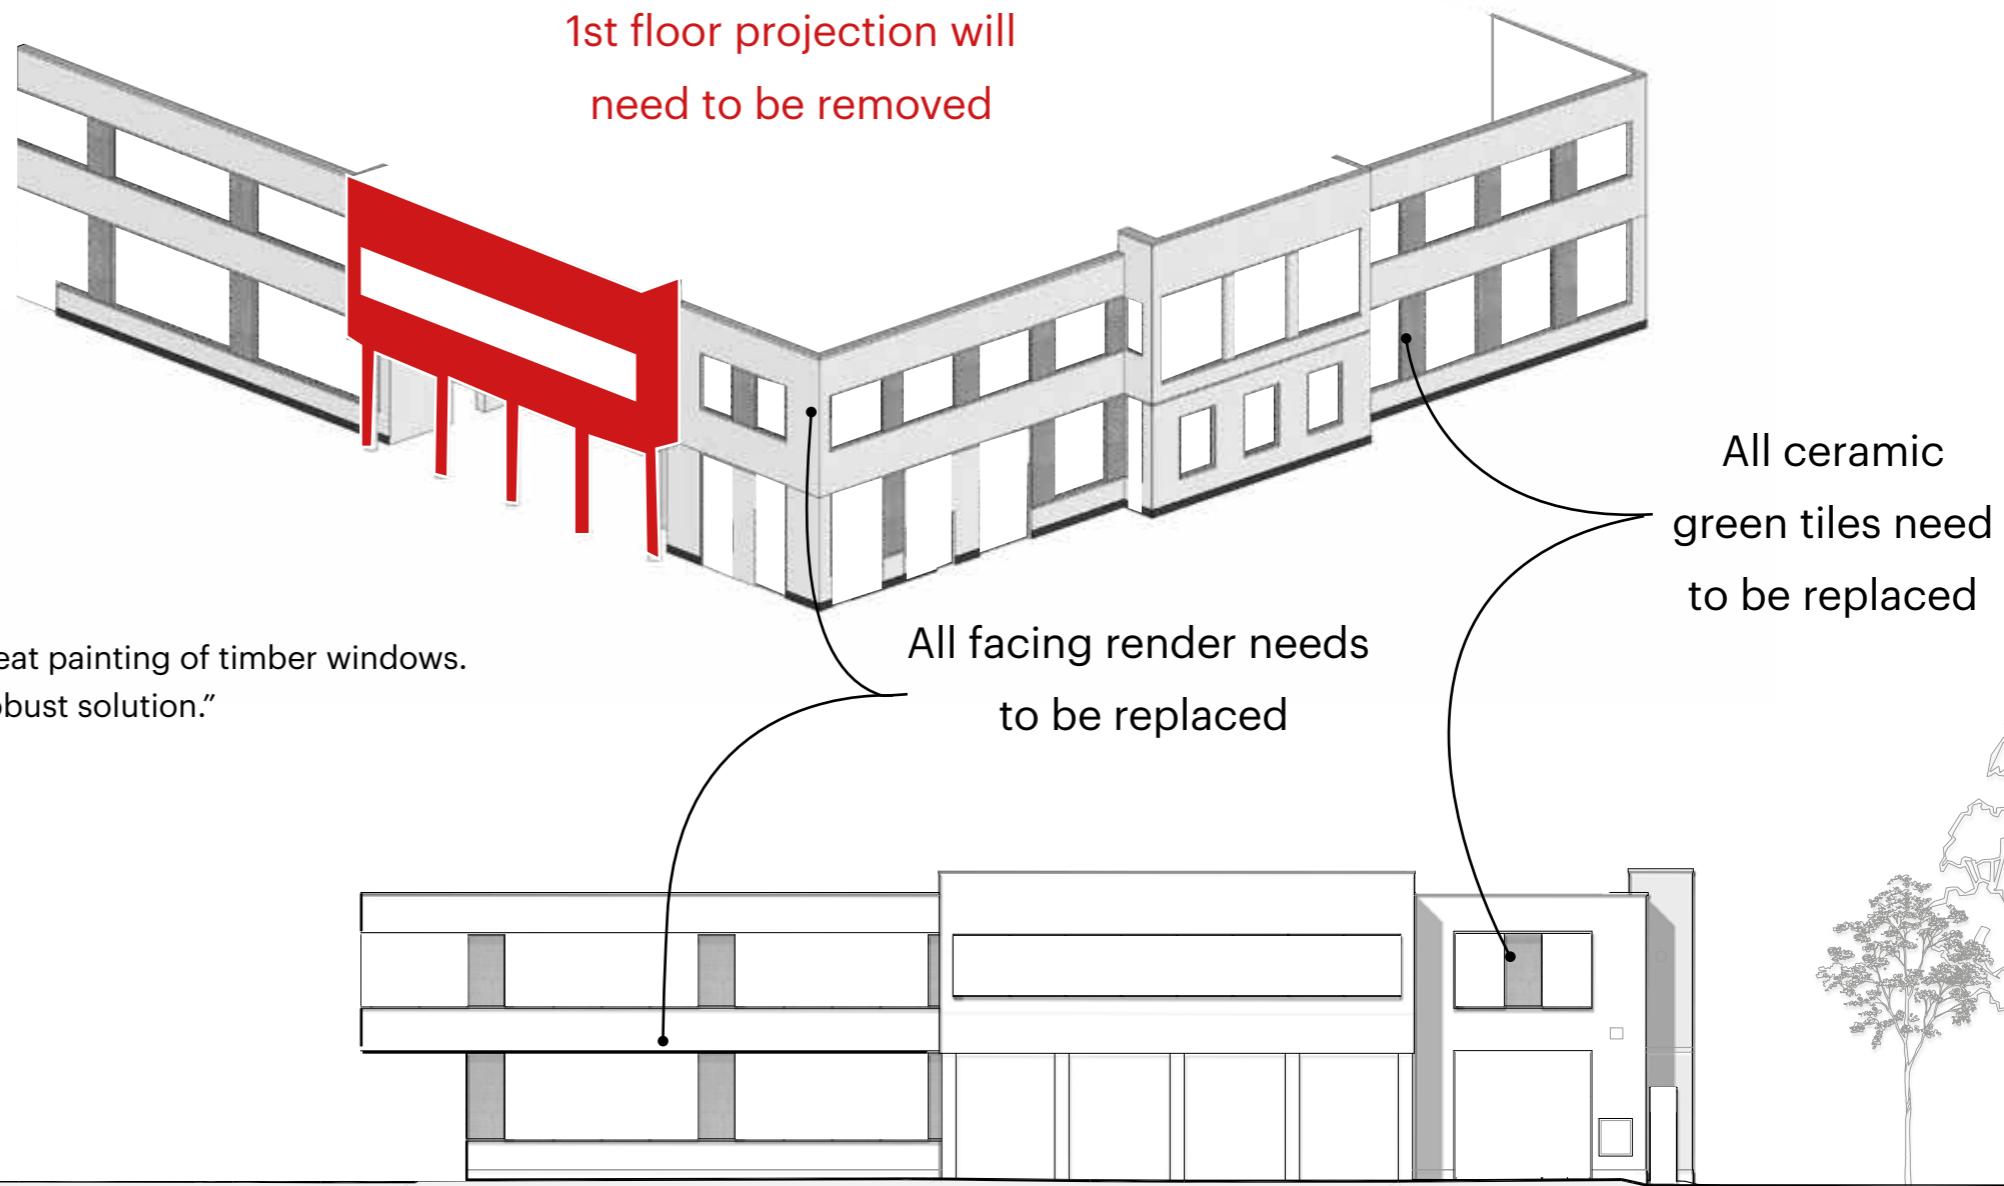
OPTION 1 - Extent of facade remaining if steels do not require treatment

The steel beams and columns are encased in brickwork. This detail was typical during midcentury construction - particularly as a way of creating a modernist concrete aesthetic - but is now understood as a poor detail due that allows water ingress to damage the steelwork, often creating structural damage referred to as 'Regents street disease.' By today's standards, any retained steelwork would be categorised as primary structural elements, and would therefore need to provide a 60 year minimum lifespan.

This option relies upon a sealant applied to the outer layers of render to prevent future moisture ingress. However, initial comments from NHBC is that relying on, "a paint-on solution requires periodical application and may affect how the building breaths (interstitial and surface condensation). Any periodical maintenance required would need to be done by operatives who are suitably trained in the product and this is likely to be part of a condition of warranty - for example similarly to the repeat painting of timber windows. Given the end user and possible cost, this is a risk and is not a robust solution."

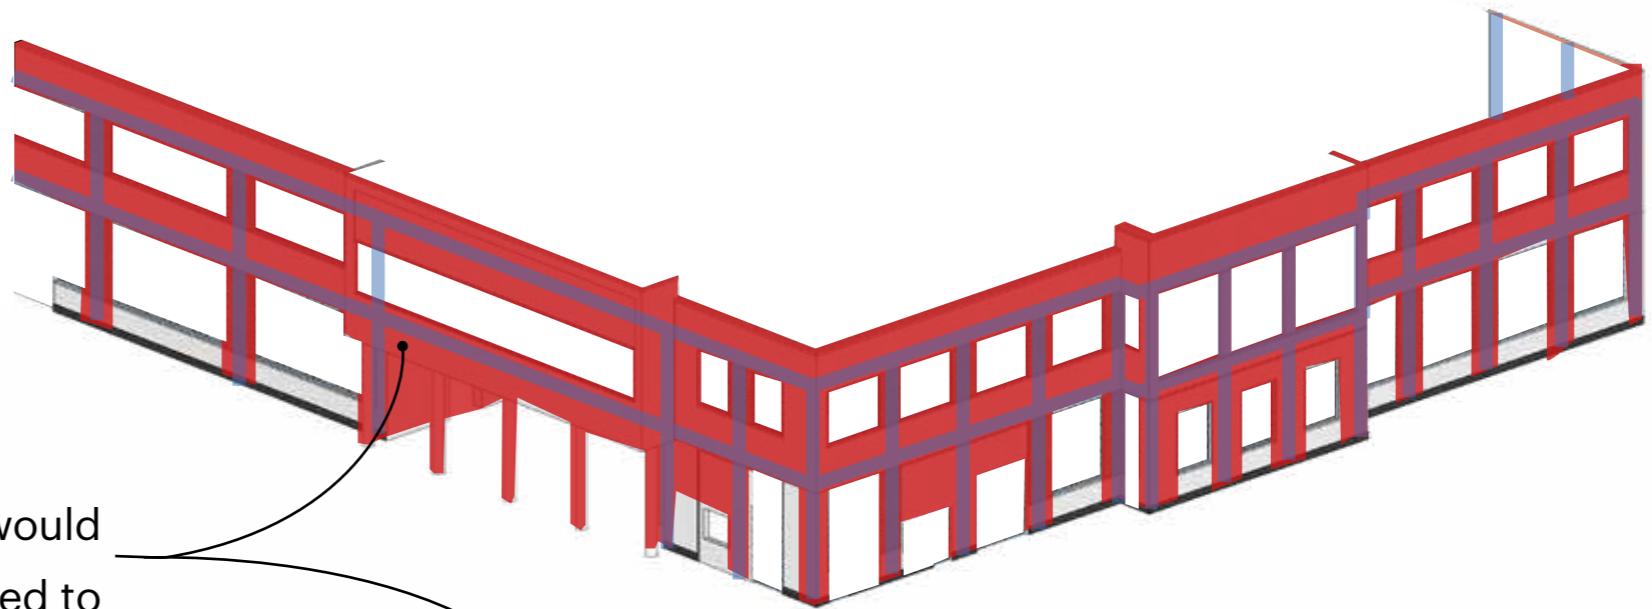
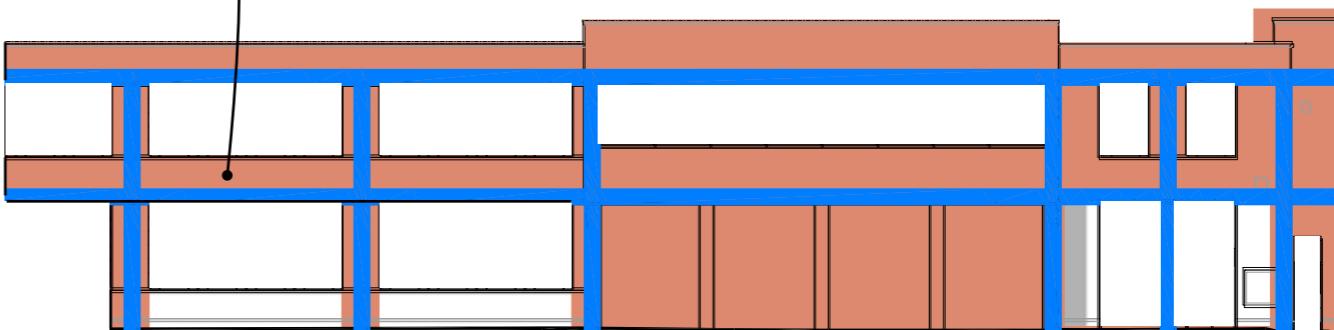
OPTION 2 - Extent of facade removed if steels require treatment

In order to achieve a robust remedial detail to retain the steels and provide a 60 year lifespan that would satisfy the NHBC warranty, it is likely that the steels would need to be fully exposed in order to provide repairs and protection from future moisture. This would require the removal of all the brickwork shown in red opposite, to be rebuilt.

By this point, for all intents and purposes, only the steel-work remains from the original fabric.

majority of brickwork would need to be removed to enable access to steels
