Tree Inspection Report

6 Pepys Close, Ickenham, UB10 8NL

25th April 2024

TI08032401

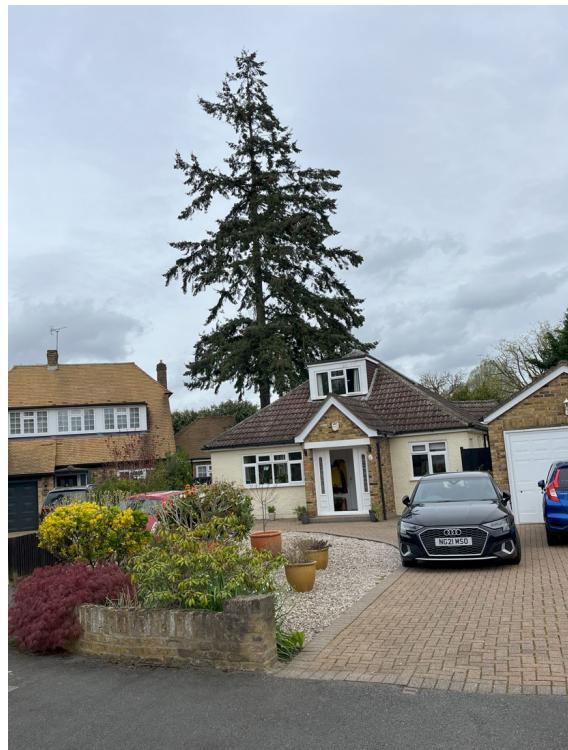
Photograph 1. *View of the tree from the road, looking north. No 6 centre of view, No 8 on the left*

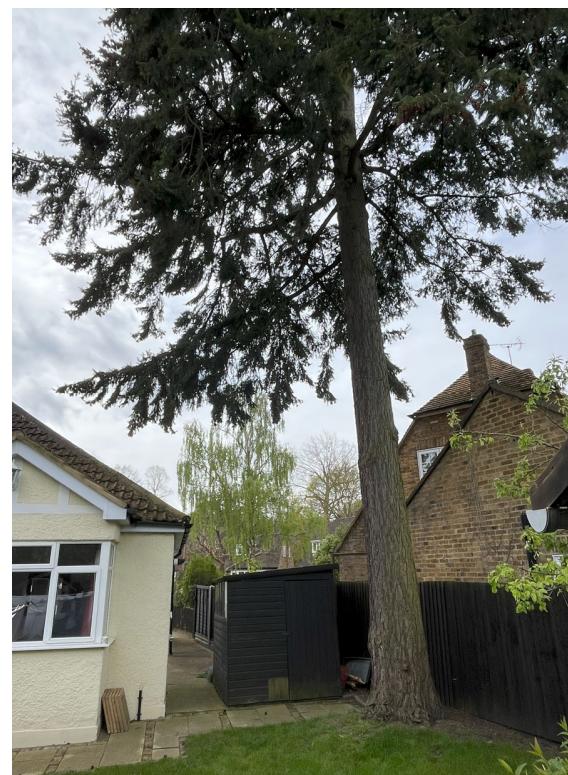
Photograph 2. *View of the tree from the rear garden of No 6. No 8 to the right of the view*

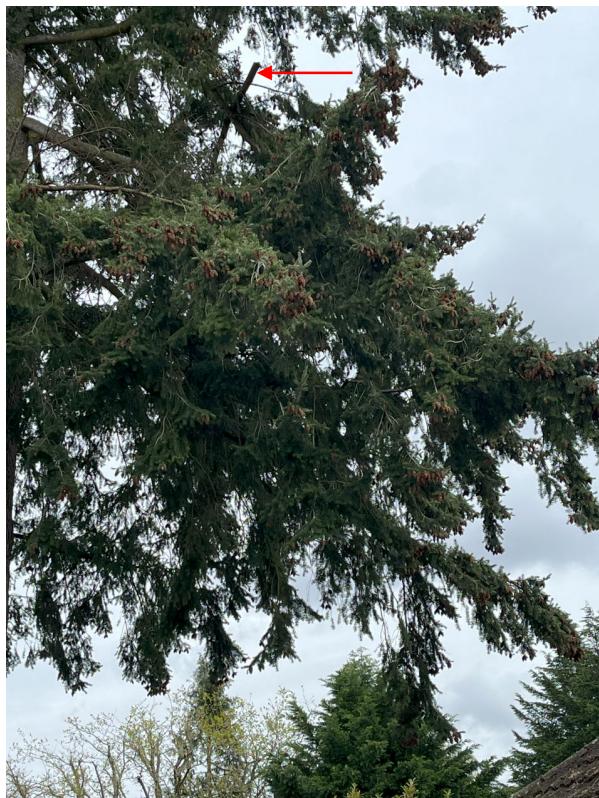
3.2.4 I observed several stubs on the stem caused by past branch failure. On the south-east side of the tree at a height of approximately 10 metres above ground level I observed a broken, hanging branch over the roof of the house at Number 6.

Photograph 3. Broken hanging branch over roof of No 6, at approximately 10m above ground level

4.1 In general terms, as a species Douglas fir trees are known to have brittle branches which are highly prone to breaking and falling, and I have seen this many times. In the Collins Field Guide*, Mitchell describes Douglas firs as having '*big crowns much broken by gales and snow*'. The tree at 6 Pepys close is clearly pre-disposed to shedding branches with six having reportedly fallen from the tree in the past three years, and a further broken branch that I observed lodged and hung-up in the crown overhanging the roof of the house (see Photograph 3).

5.3 I recommend that, within the next 3 months (sooner if possible), the broken hung-up branch overhanging the roof of Number 6 is removed.

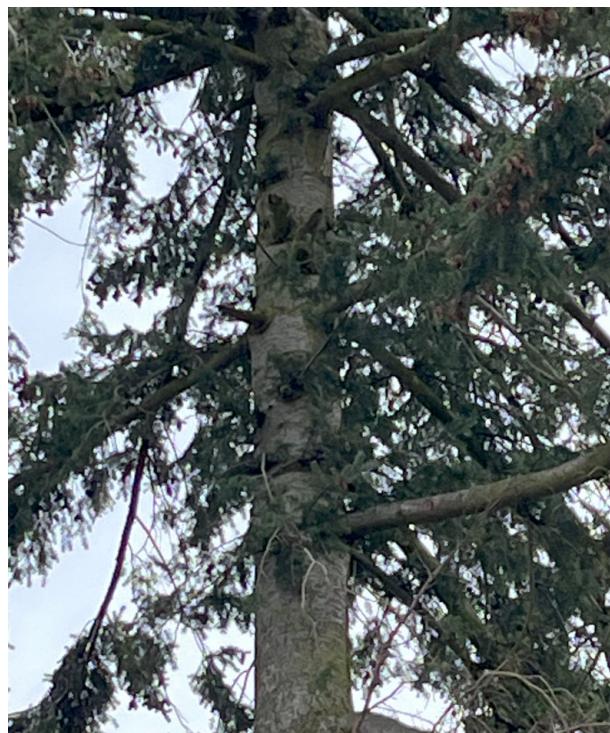
Photograph 4. Stubs on stem from past branch failures

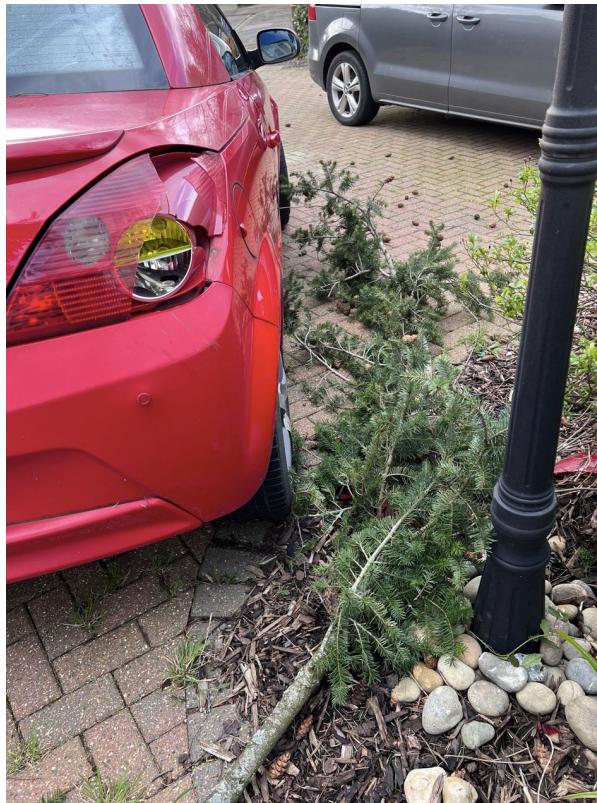
1.4.2 I am advised by the owner of 6 Pepys Close that in the three years that they have lived there, six branches have fallen from the tree of which two fell onto the roof of the house, one on a garden shed, two in the garden, and one onto the driveway of Number 8 where it caused damage to a parked car (see Photograph 5 provided to me). The most recent branch to fall from the tree did so in February 2024.

Photograph 5. Provided by the client. Recent branch failure onto the driveway of Number 8, causing damage to a parked car

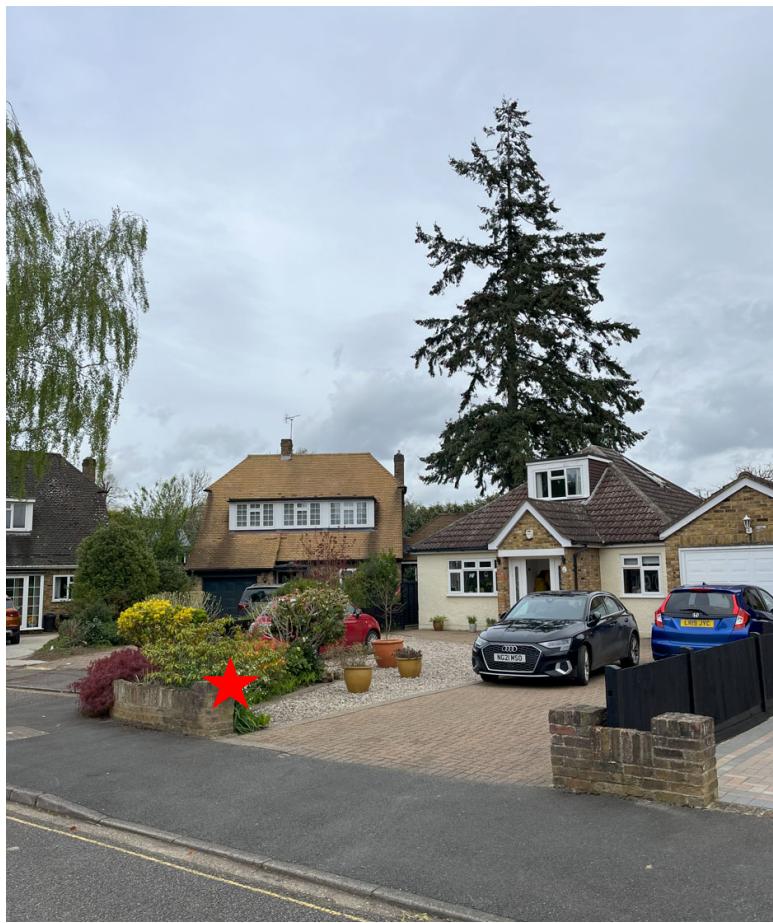
Photograph 6. Recommended location of replacement deodar cedar tree (red star)

4.7 I have looked at options for replacement tree planting, and I have identified a location at the front of the property close to the road (see Photograph 6 and the Tree Location Plan). In this position a replacement will be highly visible to a large number of houses which face towards it, and the replacement tree would be sufficiently far from the buildings that it will be a more sustainable relationship with the built environment. I recommend that the replacement tree is a deodar cedar, with this having many of the visual attributes of Douglas fir, whilst being less prone to branch failure.

5.2 I recommend that a replacement deodar cedar is planted in the front garden in the location indicated on the Tree Location Plan. The replacement tree is to be a containerised standard with a stem girth of 10-12cm.
