## Hayes Campus

### Tree Hazard Evaluation

*July 2018*

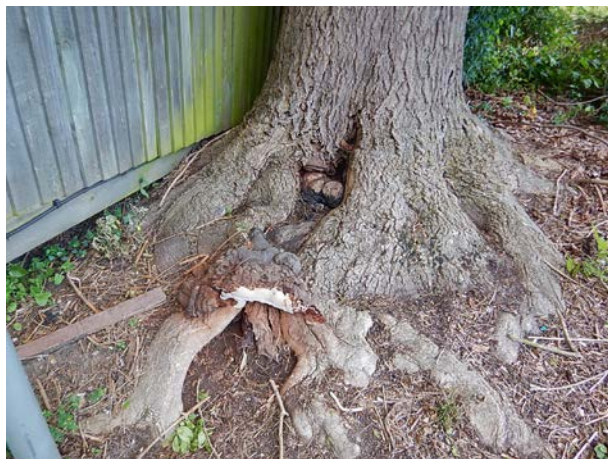
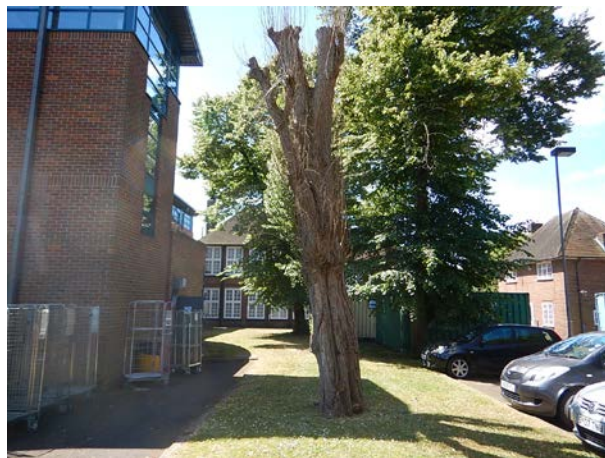
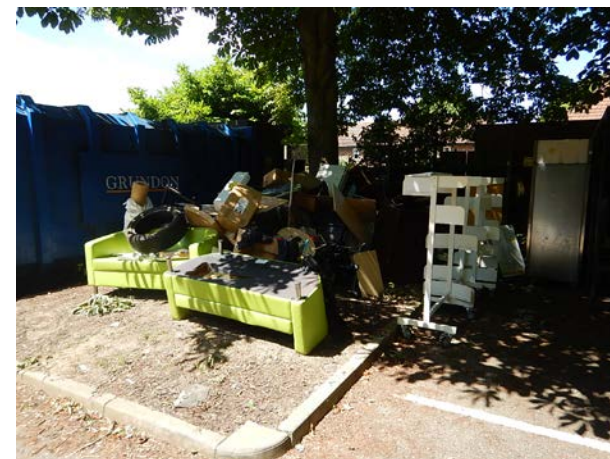
### **3.09 Poplars 755, 761 and 767**

These are prominent specimens located in the sports ground. They have extensive decay and fruiting bodies of *Ganoderma*. The condition of the trees is such that they should be removed.
