## Safety and Condition Tree Survey

Uxbridge Hayes College  
College Way  
Coldharbour Ln  
Hayes  
UB3 3BB

Date: 21<sup>st</sup> May 2025

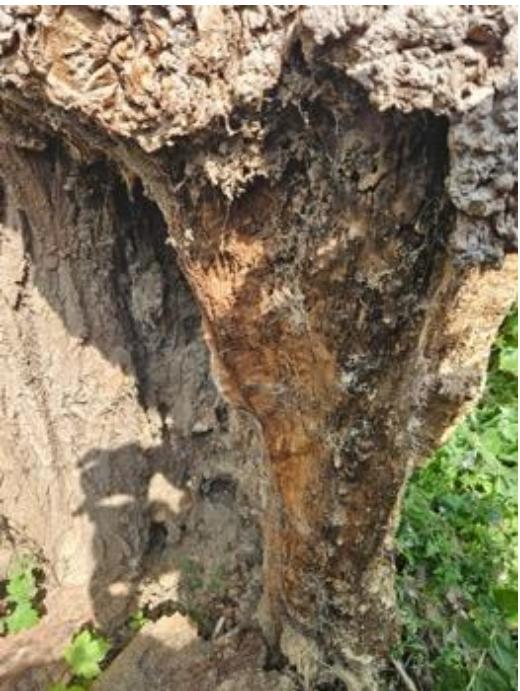
T734

727	Lombardy poplar ( <i>Populus nigra italicica</i> )	Height (m): 12 Crown Radius (m): 3	lower stem in reasonable condition Recent heavy reduction	Fair	None at time of survey
728	Lombardy poplar ( <i>Populus nigra italicica</i> )	Height (m): 13 Crown Radius (m): 3 Life Stage: Mature	Recent pollard.	Fair	None at time of survey
729	Lombardy poplar ( <i>Populus nigra italicica</i> )	Height (m): 13 Crown Radius (m): 3 Life Stage: Mature	Recent pollard.	Fair	None at time of survey
731	Common ash ( <i>Fraxinus excelsior</i> )	Height (m): 16 Crown Radius (m): 6 Life Stage: Mature	Slight bark inclusion in the main union at approximately 2.5 m this is stable.	Fair	None at time of survey
732	Lombardy poplar ( <i>Populus nigra italicica</i> )	Height (m): 8 Crown Radius (m): 2 Life Stage: Over Mature	Tree removed	Fair	None at time of survey
734	Lombardy poplar ( <i>Populus nigra italicica</i> )	Height (m): 14 Crown Radius (m): 3 Life Stage: Mature	Large open decay at ground level. Extending deep in to the main stem.	Poor	Fell to ground level. Timescale: 21-Nov-2025 (6 Months)

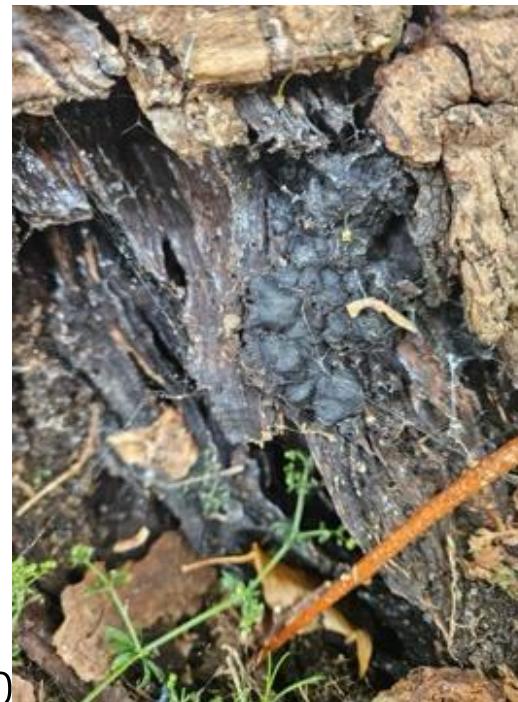
T800

800	Sycamore ( <i>Acer pseudoplatanus</i> )	Height (m): 14 Crown Radius (m): 6 Life Stage: Mature	Large open cavity on the north east side at ground level. Kretchamaria dusta noted within the decay. Significant dead wood in the upper canopy.	Fair	Remove tree. Timescale: 21-Aug-2025 (3 Months)
