Addendum Arboricultural Appraisal Report

Subsidence Damage Investigation at:

36 Blossom Way
Uxbridge
Middlesex
UB10 9LN

CLIENT: Crawford & Company
CLIENT REF: SU2102700
MWA REF: SUB210624-9153Rev01
MWA CONSULTANT: Andy Clark
REPORT DATE: 28/07/2022

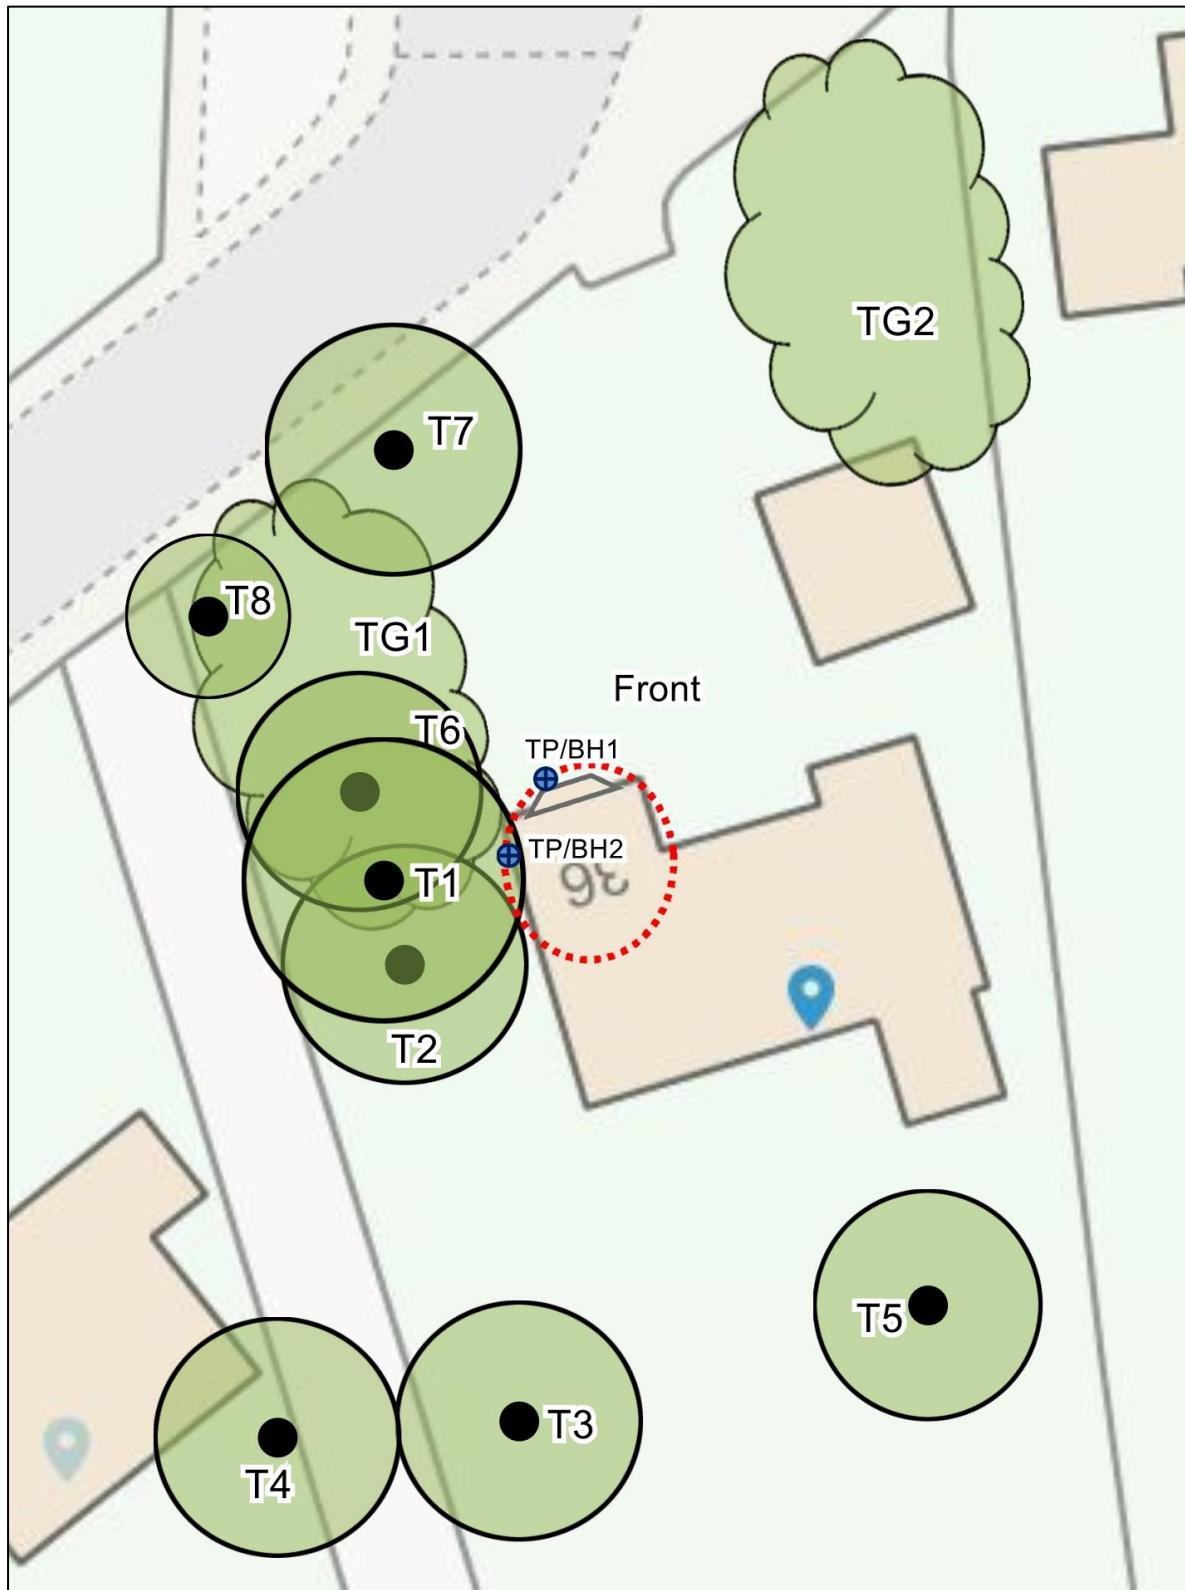
Site Plan

Approximate areas of damage

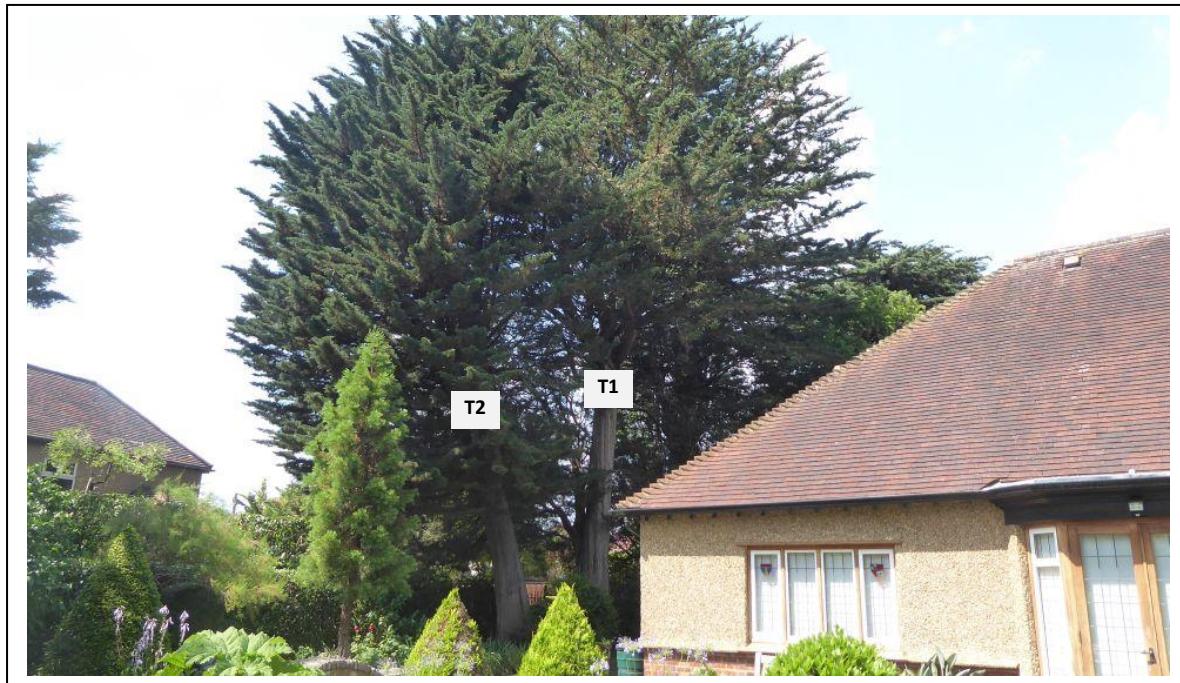
Roots were observed to a depth of 1.5m bgl in TP/BH1 and to 2.2m bgl in TP/BH2, and recovered samples have been positively identified (using anatomical analysis) as Pomoideae gp. and Cupressaceae spp.; the origins of which will be the Pyracantha elements of TG1, and the Monterey Cypresses of T1 and T2 as the most proximal related trees to the area of damage.

View from property rear of T1 and T2 Monterey Cypress trees

Tree No.	Species	Ht (m)	Dia (mm)	Crown Spread (m)	Dist. to building (m)	Age Classification	Ownership
T1	Cypress (Monterey)	20.0 *	1010	15.0	8.3	Similar Age to Property / Older than extensions	Policy Holder
Management history		Subject to past management/pruning - appears regularly pruned.					
Recommendation		Remove (fell) to near ground level and treat stump to inhibit regrowth.					
T2	Cypress (Monterey)	18.5 *	850	15.0	8.6	Similar Age to Property / Older than extensions	Policy Holder
Management history		Subject to past management/pruning - appears regularly pruned.					
Recommendation		Remove (fell) to near ground level and treat stump to inhibit regrowth.					
T8	Lombardy Poplar	20.0	800 *	5.5	16.1	Younger than Property / Older than extensions	Policy Holder
Management history		Previously crown reduced.					
Recommendation		Remove (fell) to near ground level and treat stump to inhibit regrowth.

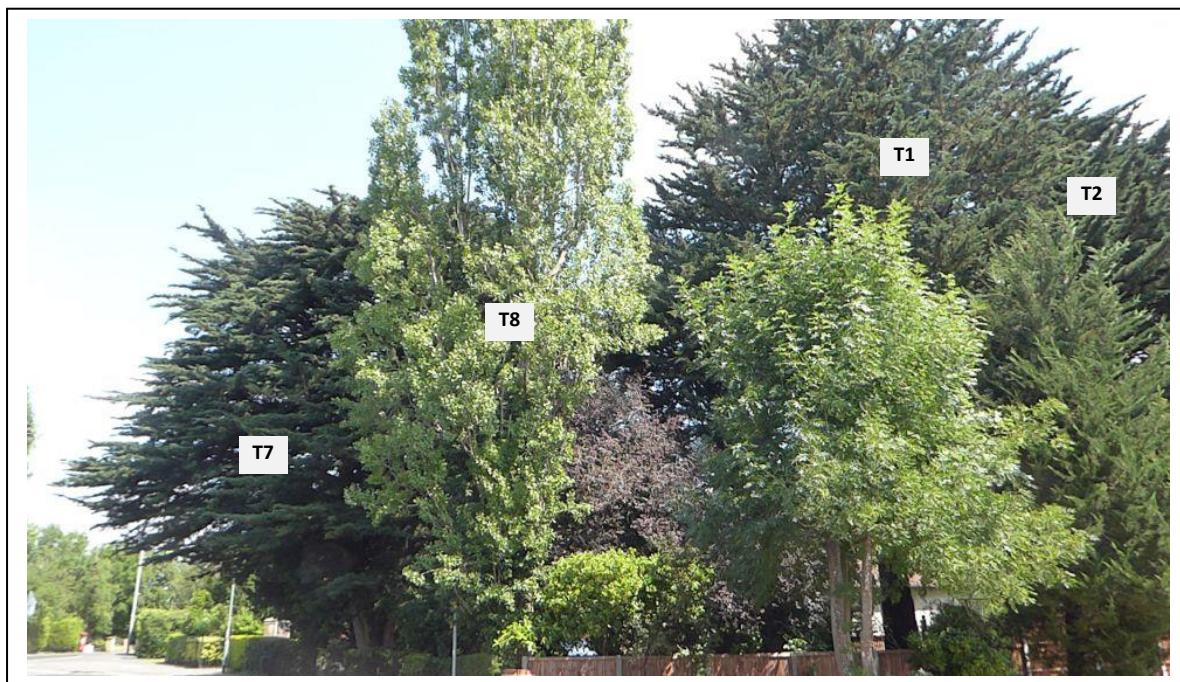
Irrespective of the identification of recovered root samples, our survey has identified vegetation within influencing distance of the building with a current potential to influence soil volumes below foundation level; the most significant of which in relation to the current damage is T8 Lombardy Poplar.

View from roadside of T8 Lombardy Poplar with T1, T2 and T7 Monterey Cypress trees visible beyond

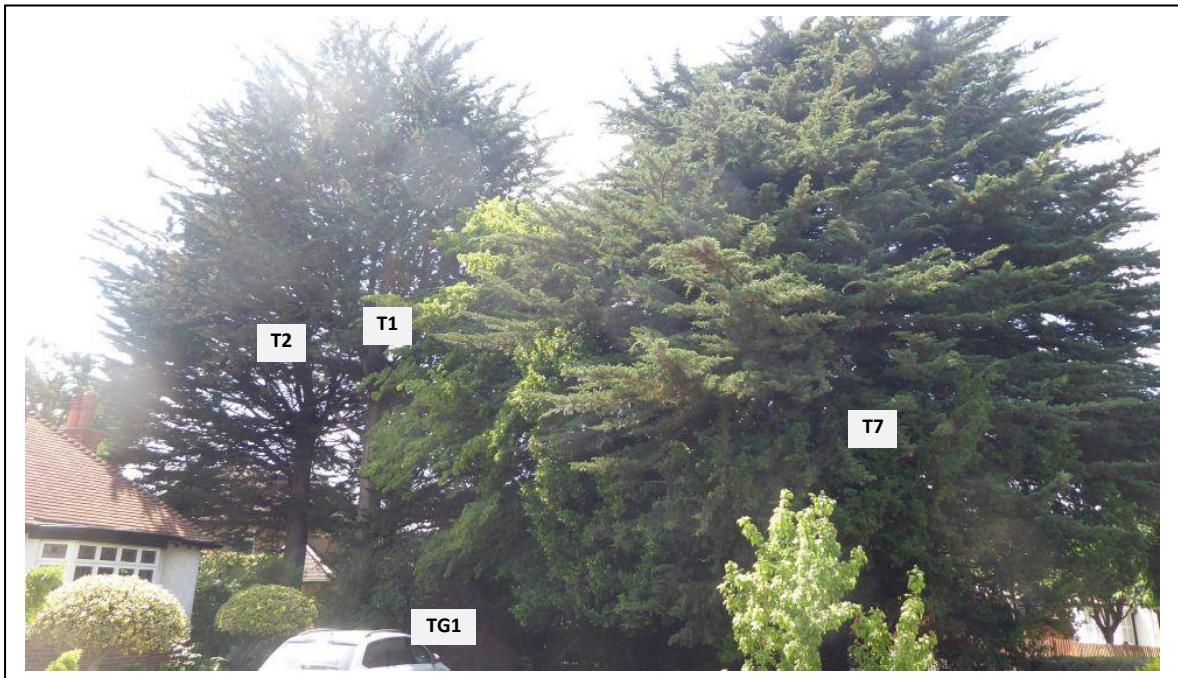
View of T7 Monterey Cypress with TG1 group understorey and T1 and T2 Monterey Cypress stems visible beyond

Management history		No significant past management noted.					
Recommendation		Do not allow to exceed current dimensions (subject to review if movement persists).					
T7	Cypress (Monterey)	18.5 *	1000 *	14.5	13.7	Similar Age to Property / Older than extensions	Policy Holder
Management history		No significant past management noted.					
Recommendation		Do not allow to exceed current dimensions (subject to review if movement persists).

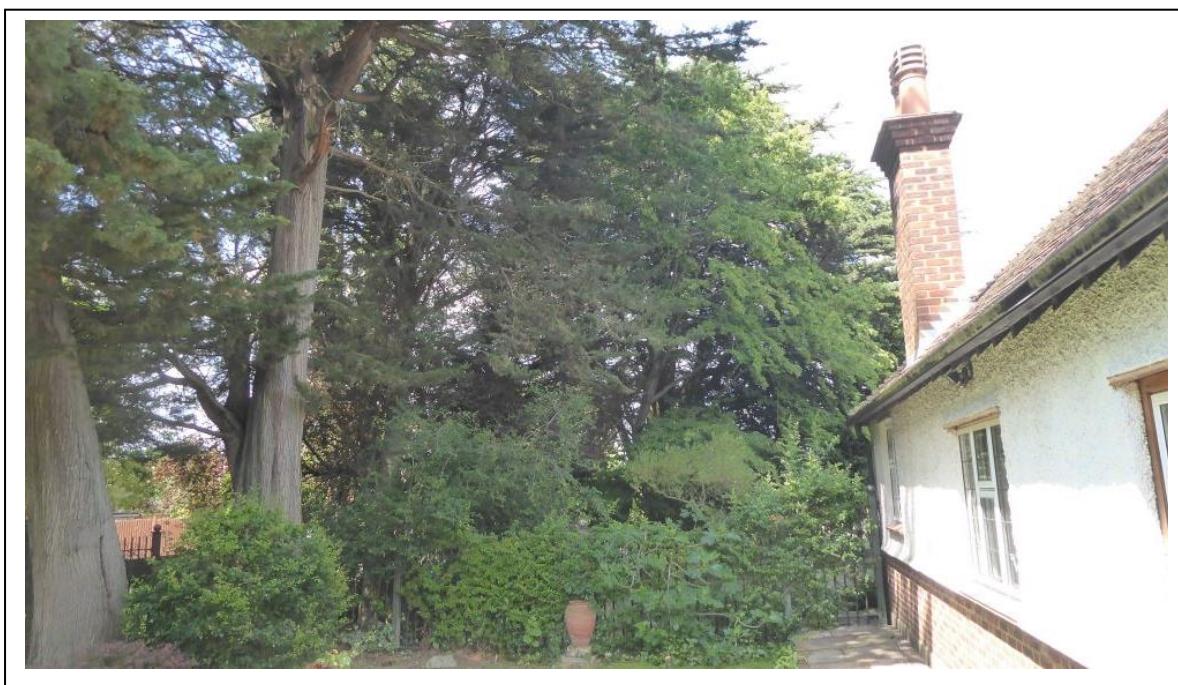
View of TG1 understorey with T1 and T2 Monterey Cypress stems visible to foreground

Tree No.	Species	Ht (m)	Dia (mm)	Crown Spread (m)	Dist. to building (m)	Age Classification	Ownership
TG1	Mixed spp. group of mostly Plum, Purple Leaved Plum, Hornbeam, Portuguese Laurel, Yew and Pyracantha	12.0	430	9.5	6.5	Younger than Property	Policy Holder
Management history		No significant past management noted.					
Recommendation		Do not allow to exceed current dimensions (subject to review if movement persists).					
TG2	Mixed spp. group of mostly Purple Leaved Plum, Laurel and Yew	7.5	200 Ms	5.0	1.5 [to garage]	Younger than Property	Policy Holder
Management history		No significant past management noted.					
Recommendation		Maintain broadly at no more than current dimensions by periodic pruning.
