CRANFORD HOUSE CELLARS, CRANFORD PARK, LONDON BOROUGH OF HILLINGDON: HISTORIC BUILDING SURVEY

AOC Project No: 34326

Date: May 2022

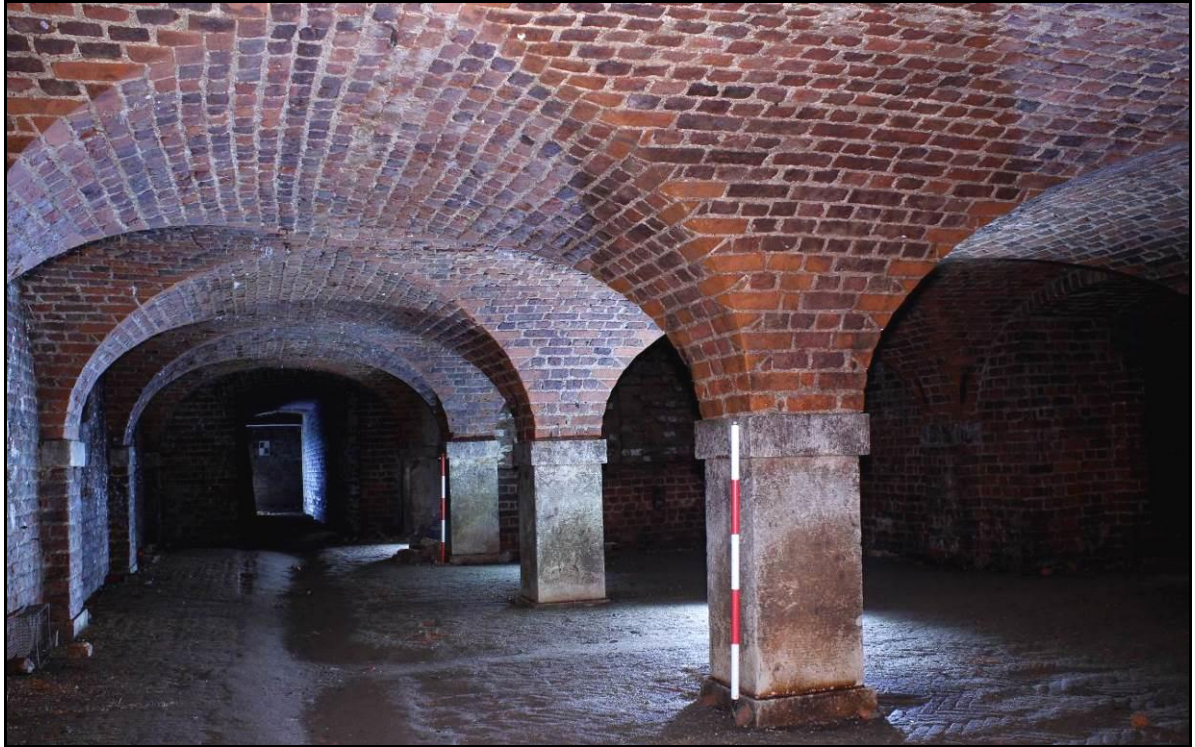
Plate 1: Room 4 Looking North

- 6.2 The two largest rooms of the cellars (Room 4 and Room 5) (Plates 1-10) appear to be the earliest part of the cellars, and are constructed in red brick laid in English bond with lime mortar. The bricks measure 210mm by 105mm by 60mm, consistent with a late 17th century date as surmised in the 1943 RCHME Survey. Room 4 measures 11.30m north-south and 6.35m east-west, while Room 5 measures 11.95m by 6.35m, both with brick vaulted ceilings supported on three piers along the spine of the rooms, also springing from piers along the wall lines. There are thus two vaulted structures oriented north-south and four oriented east-west in each room. The piers are centred 2.95m apart in Room 4 and at 3.08m apart in Room 5. Each pier of the central row is formed of a Portland stone base with a 0.48m square profile, standing 0.97m high, surmounted by a square-profile Portland stone impost of 0.15m thickness, from which the arches spring. The chiselling of the piers is apparent, with the marks chased across the faces, rather than being dressed smoothly. Along the wall line, the piers are brick, and are dressed with a Portland stone impost, like the central piers. The

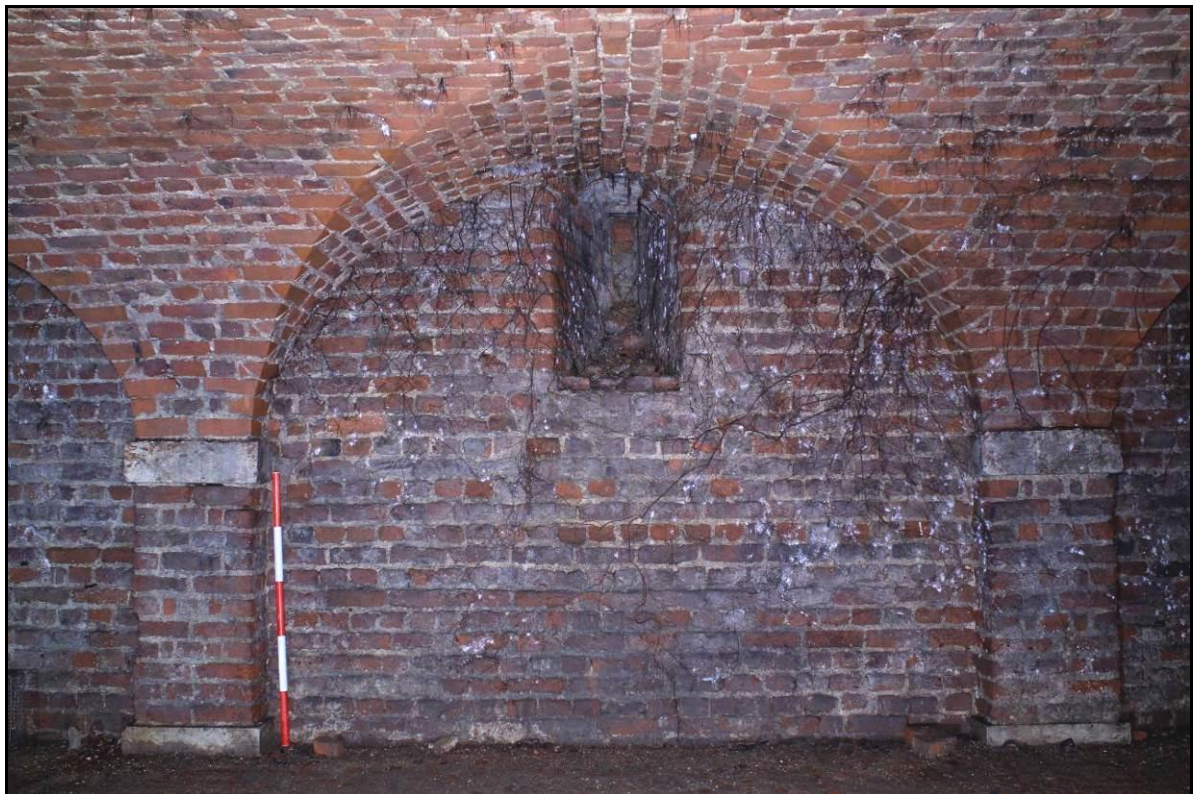
Plate 4: Tapering slit in Room 4

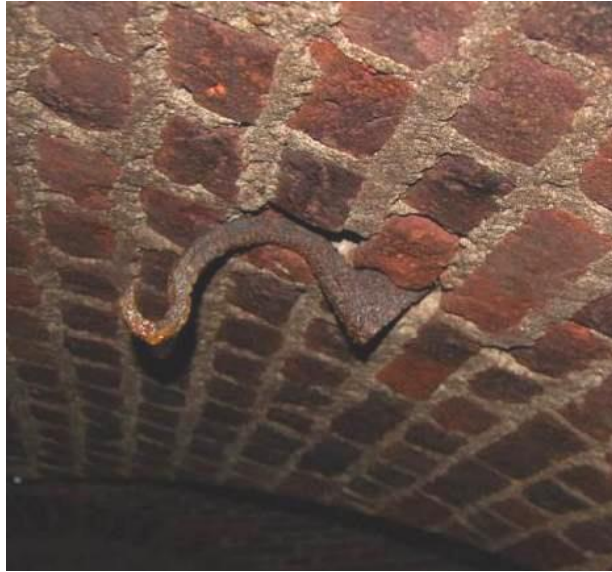
arched vault supported by the piers is a Roman vault with a true semi-circular profile. Each rib of the arches is faced with a hard-fired rubbed red brick which may have been shaped to the arch during the build rather than specially moulded. The external walls of Rooms 4 and 5 are not fully tied into the arched vaults, rather they appear to be separate but contemporary builds. Two narrow tapering slits in the west wall of Room 4 would have allowed fresh air into the cellars (Plate 4). There are two hooks in the ceiling of the central arch in Room 4, which may be attachments to hang lamps (Plate 5).

Plate 5: One of the Hooks, Room 4

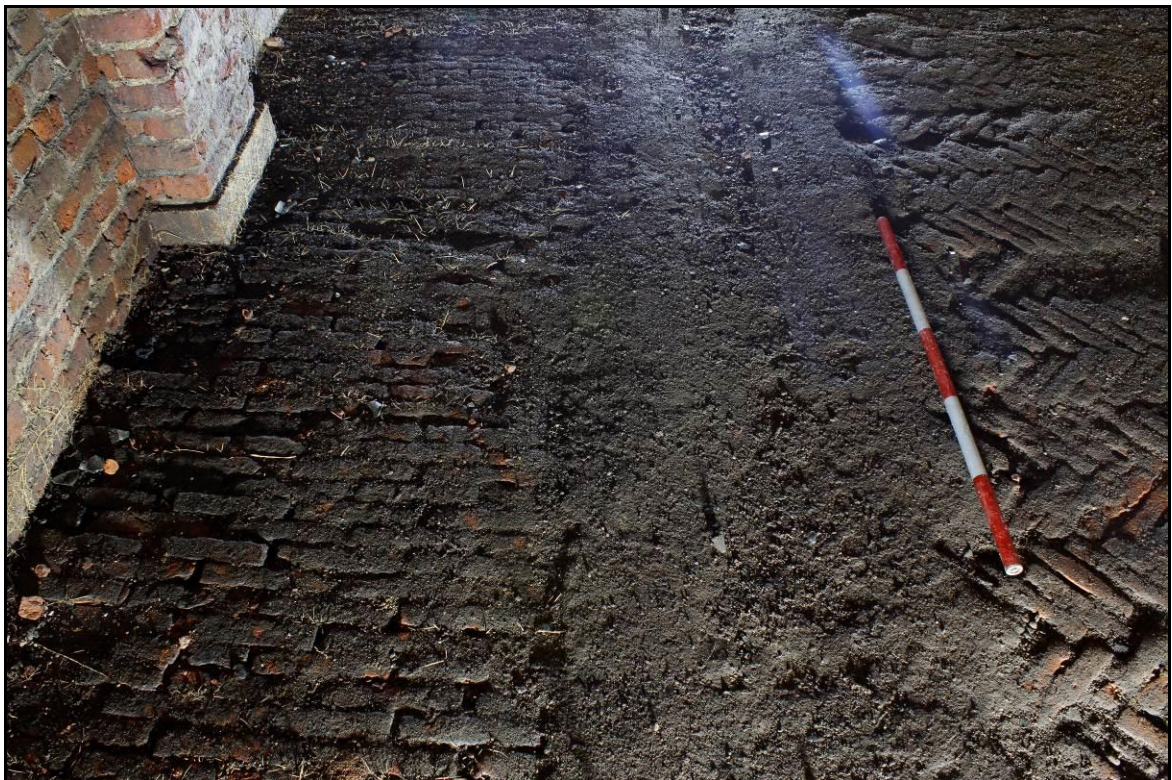
- 6.3 The floor of the first phase rooms is constructed of thin bricks set on edge, just 45mm thick, laid in Herringbone pattern in Room 4 and in panels laid east-west and north-south in Room 5; there is also a strip of bricks laid on bed against the east and west walls of the room, which may be a later relaying of the surface. The area of flat bricks is flanked by a shallow gully which suggests a drain was present (Plate 6); this is partially overlain by a levelling screed, and may become clearer once building works are progressed.

Plate 6: Floor of Room 5, with filled gully

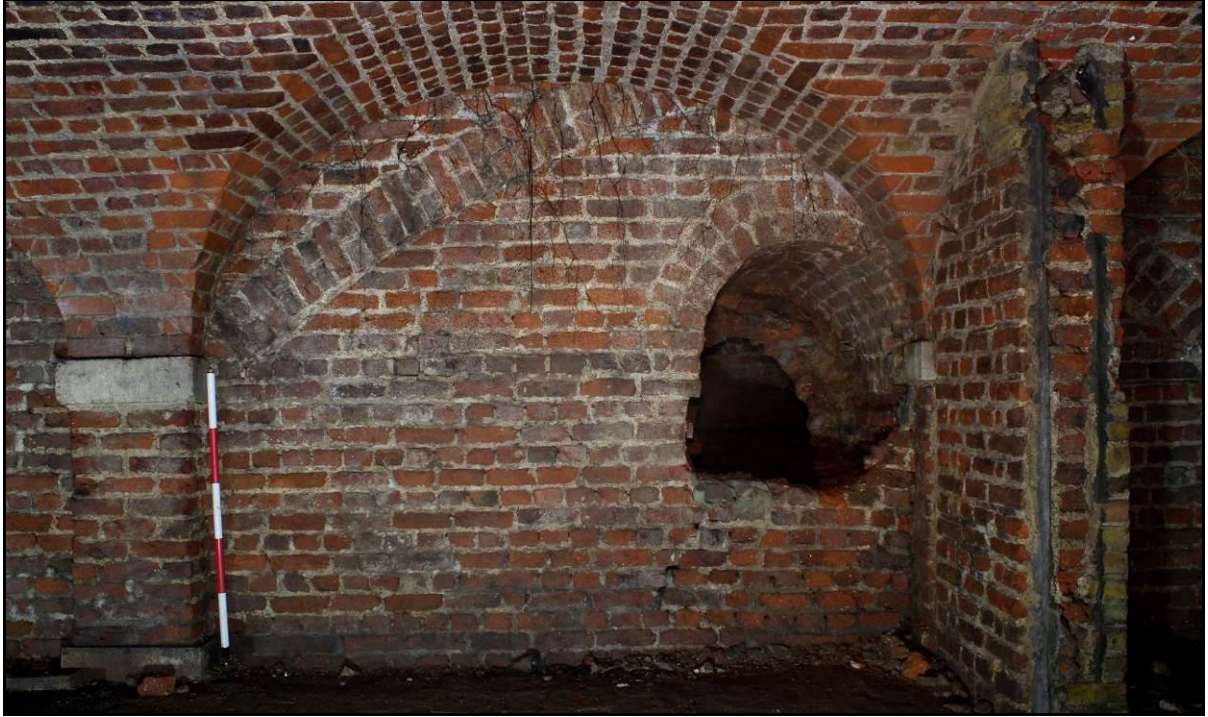
- 6.4 A broken opening to an Icehouse lies west of the junction of the two Rooms, off Room 5. The Icehouse has a diameter of c.2.3m with a domed roof, tapering to a flattish base, and is entirely built of brick. The only access is beyond a short length of a narrow brick arched opening, which appears

to have been broken apart, so its original form is lost (Plate 7). The west wall of the room at this point incorporates a wide relieving arch, most likely to accommodate potential weakness from the Icehouse structure (Plate 8). The hazards of entering a damaged brick dome and the impossibility of exiting the structure successfully debarred entry. It is possible that the entrance was bricked up in antiquity, and was broken apart by trespassers seeking access to the legendary tunnel.

Plate 7: Room 5, Broken Entrance to Icehouse

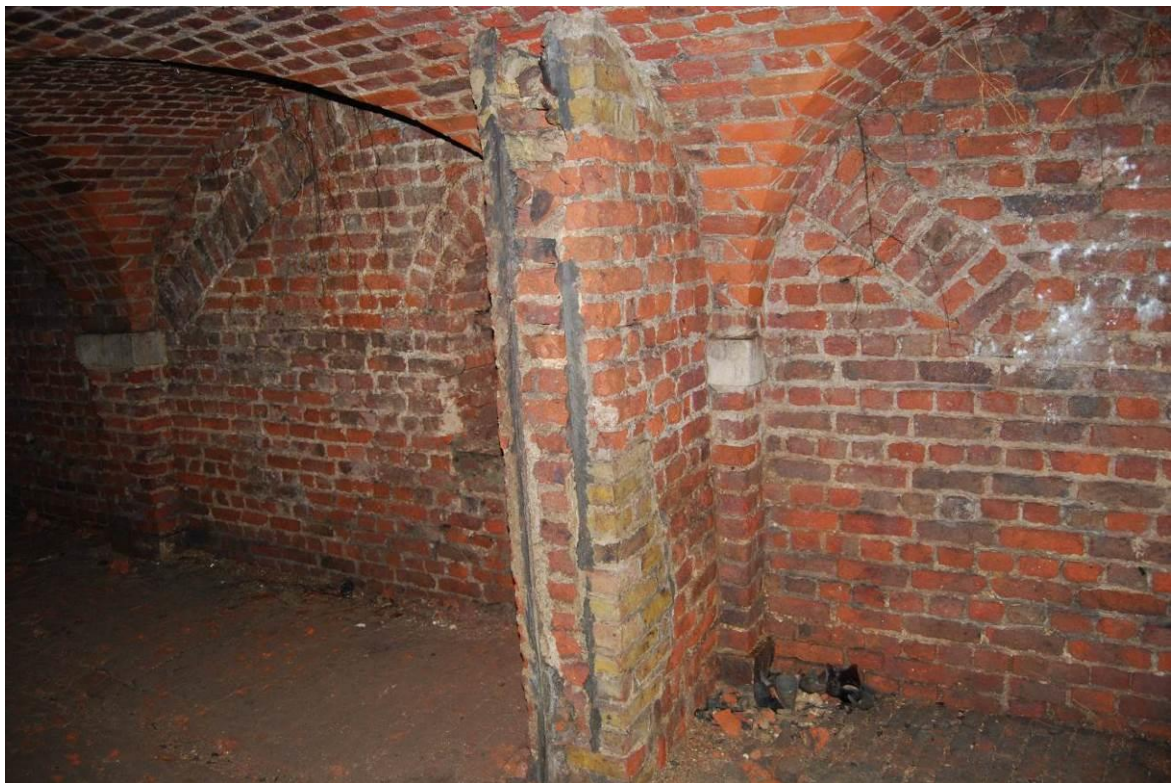
Plate 8: Relieving arch across Icehouse, Rooms 4 and 5, Looking Southwest

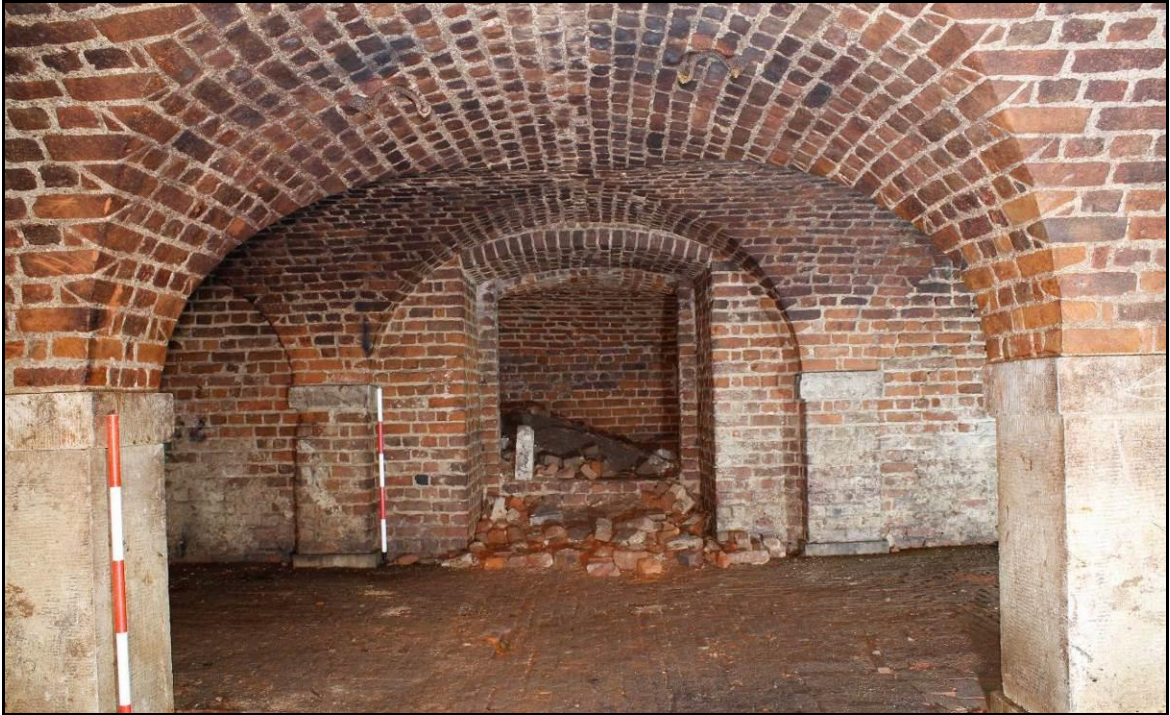
Plate 9: Opening to Room 9 from Room 5

- 6.5 Access between Rooms 4 and 5 is through an unfurnished opening 1.45m wide, with properly pointed brickwork, and was probably never fitted with a door. Both rooms had three openings each 1.72m wide leading east to/from an adjacent corridor (Room 9) (Plates 9 and 10). All have a brick jamb which suggests that there used to be a wooden frame for a doorway or shutter at these locations. Two openings in Room 5 and one in Room 4 have been blocked with a mix of red bricks, and the blocking probably dates to after 1800, using old bricks.

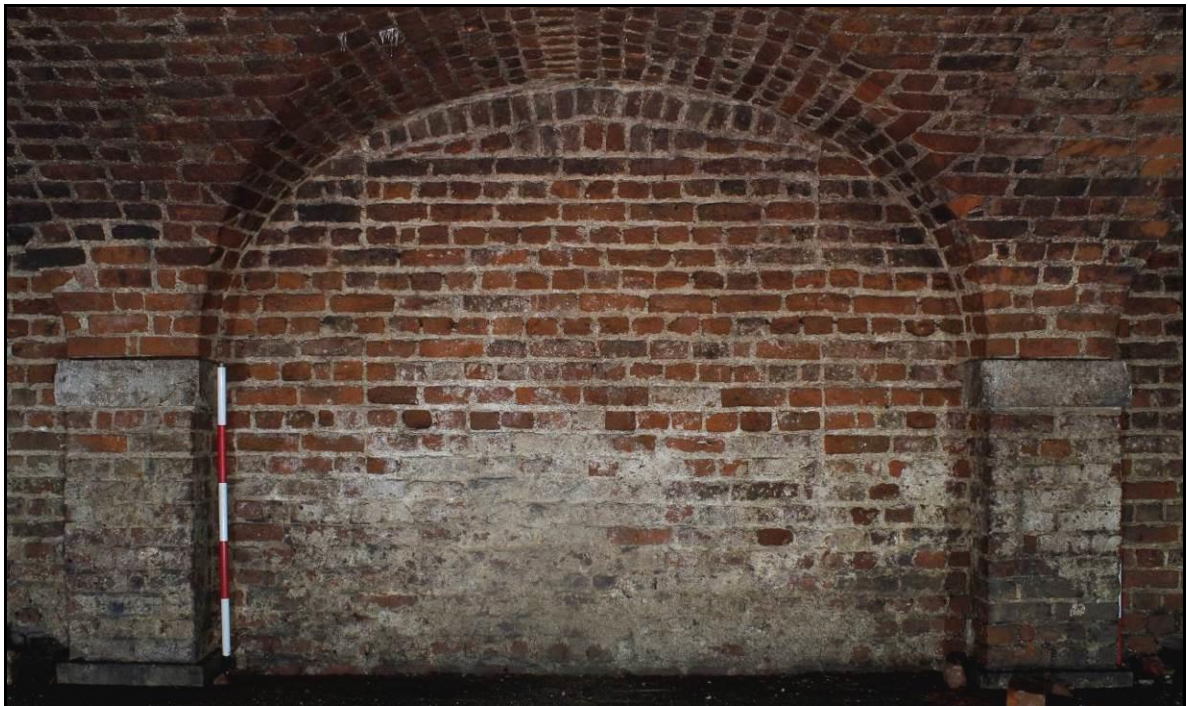
Plate 10: Blocked Opening to Room 9

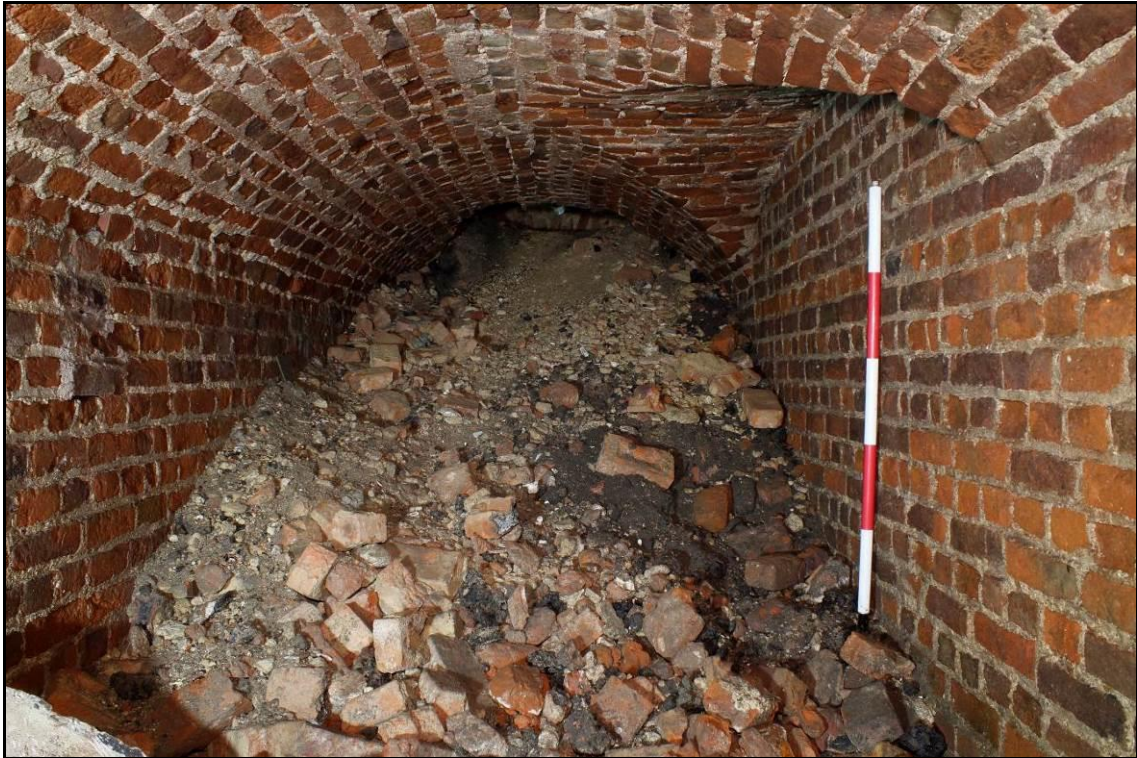
- 6.6 The narrow corridor (**Room 9**) to the west of Rooms 4 and 5 is 1.71m wide, with a major buttress projecting eastwards from the wall of the first two rooms. The bricks are of the same dimensions as the two principal rooms, and the height of the vault (2.01m) is also the same. Much of the length of this corridor is covered with rubble deposited or collapse at demolition of the property, obscuring the floor and rendering parts inaccessible (Plate 11). The rubble comprises brick and Portland Stone blocks, which are likely to represent the above-ground structure of the house. The opening which enabled the rubble to enter appears to be from the eastern side (Rooms 11 and 12), as well as from a collapse of part of the vault. The collapse prevented safe access to the south end of the corridor, in order to confirm the phasing of its construction.

Plate 11: Rubble within Room 9, Looking South

- Rubble removal from the cellar; access and egress.
 - Re-recording of Room 3 once clear of rubble.
 - Recording and accessing the collapsed structures that have caused the rubble to have been dumped/ subsided in Rooms 9, 11 and 12.

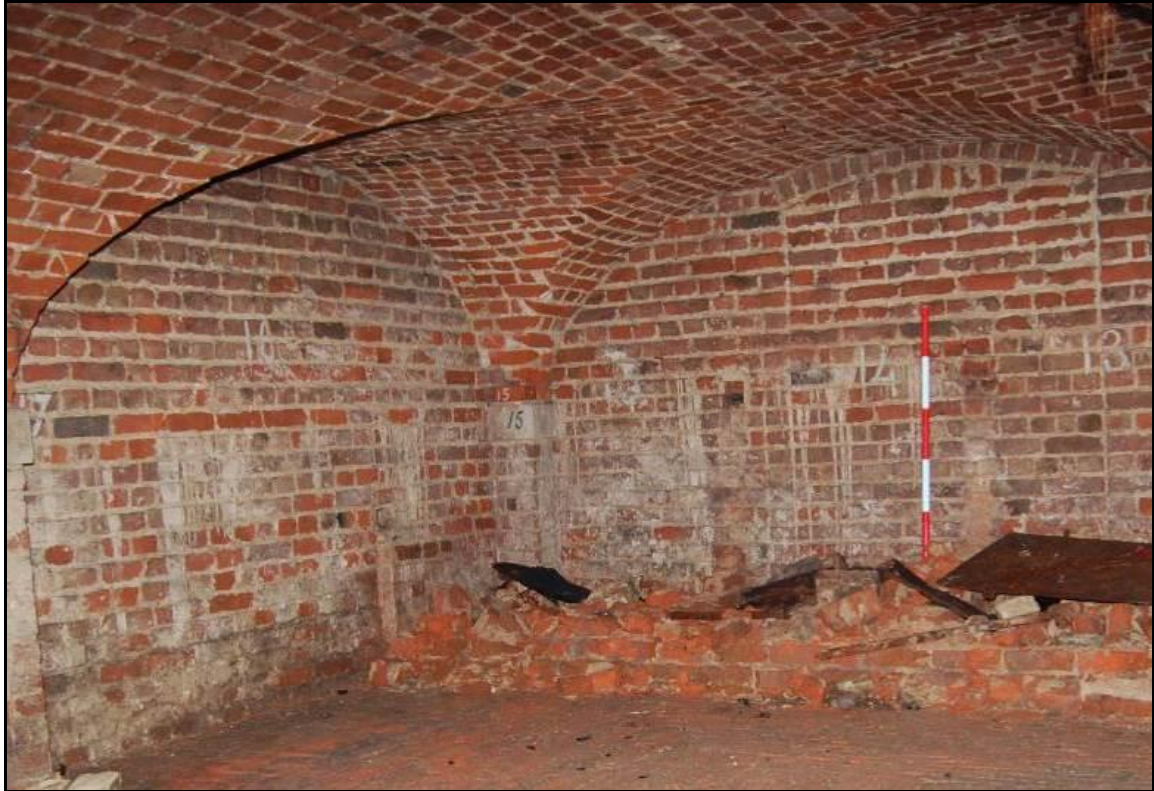
- 6.10 Numerals in the room (Plate 15) comprise painted numbers progressing anti-clockwise with 2, 3, 4, 5, 6 in black and 28 in red on the west wall; 11, 12, 13, 14 and 15 in white on the east wall; 15 in black ink on the northeast corner impost; 16 and 17 in white on the south wall, and 21 on the central pier.

Plate 15: Room 6 with Numerals 13-17, Looking Northwest

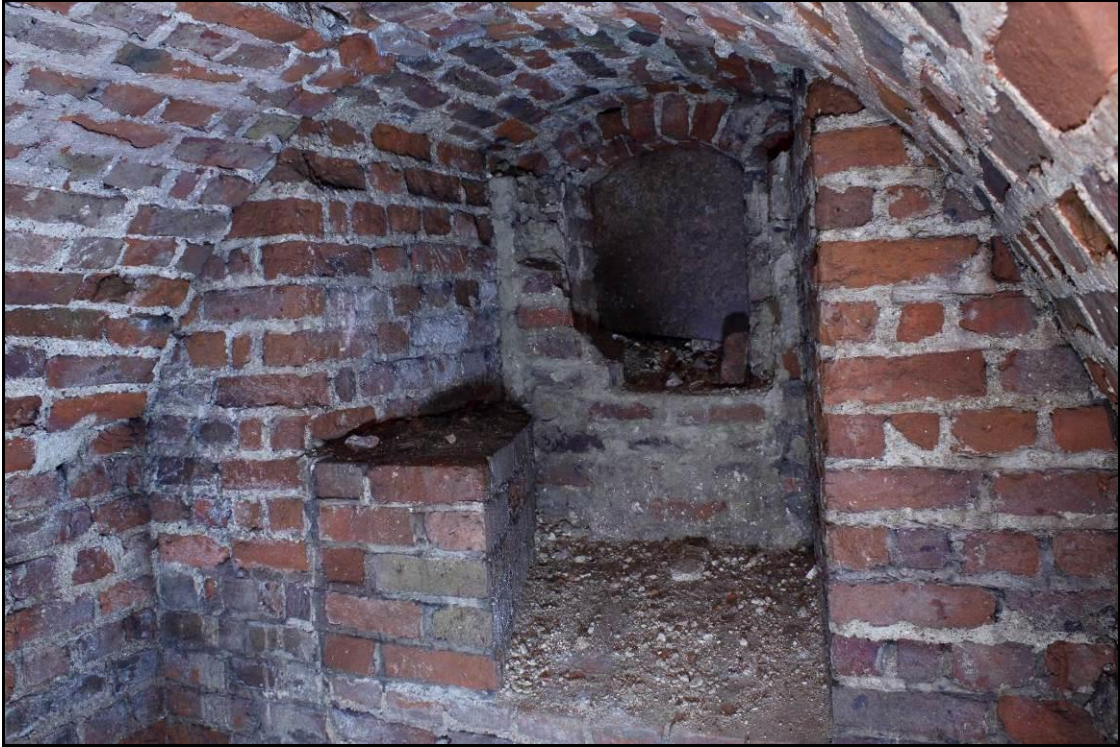
Plate 16: Room 9, extended South end

- 6.11 Two openings in the east wall would have led to a continuation of the parallel corridor (Room 9), which had been extended alongside Room 6. The openings were bricked up. The south end of the corridor included a small segmental arch at its eastern end, which may have supplied air-flow to the basement (Plate 16). This was examined in archaeological trenching (AOC 2022). The examinations showed that if this had been an air duct or flue, it was maintained when the property was extended with its bay window structures, with a narrow, splayed channel to the surface.

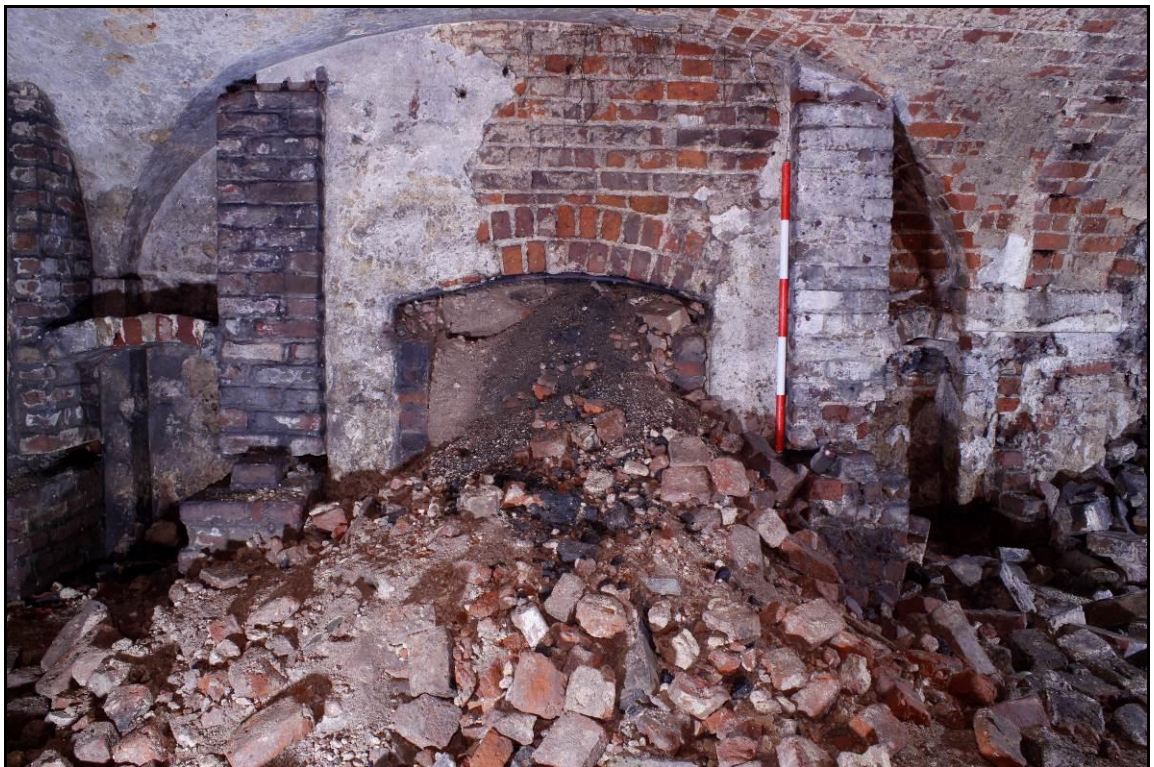
- 6.13 There are two fixtures in the room of significance to its function, suggesting that it could have been used as a kitchen, or at least, a heated store. In the east wall towards the north end of the room is a broad chimneybreast 2.25m wide and 0.56m deep with flanking piers projecting a further 0.35m into the room (Plate 18). The fireplace is 1.05m wide and fully filled with rubble which appears to have been dumped down the flue upon demolition. The presence of any grate or furniture may be revealed during clearance, as part of the forthcoming works. Around the east and south walls of the room, are a series of storage spaces formed of two rows of small brick arches (Plate 19). These have suffered from collapse which resembles deliberate destruction.

Plate 18: Fireplace in Room 3, looking East

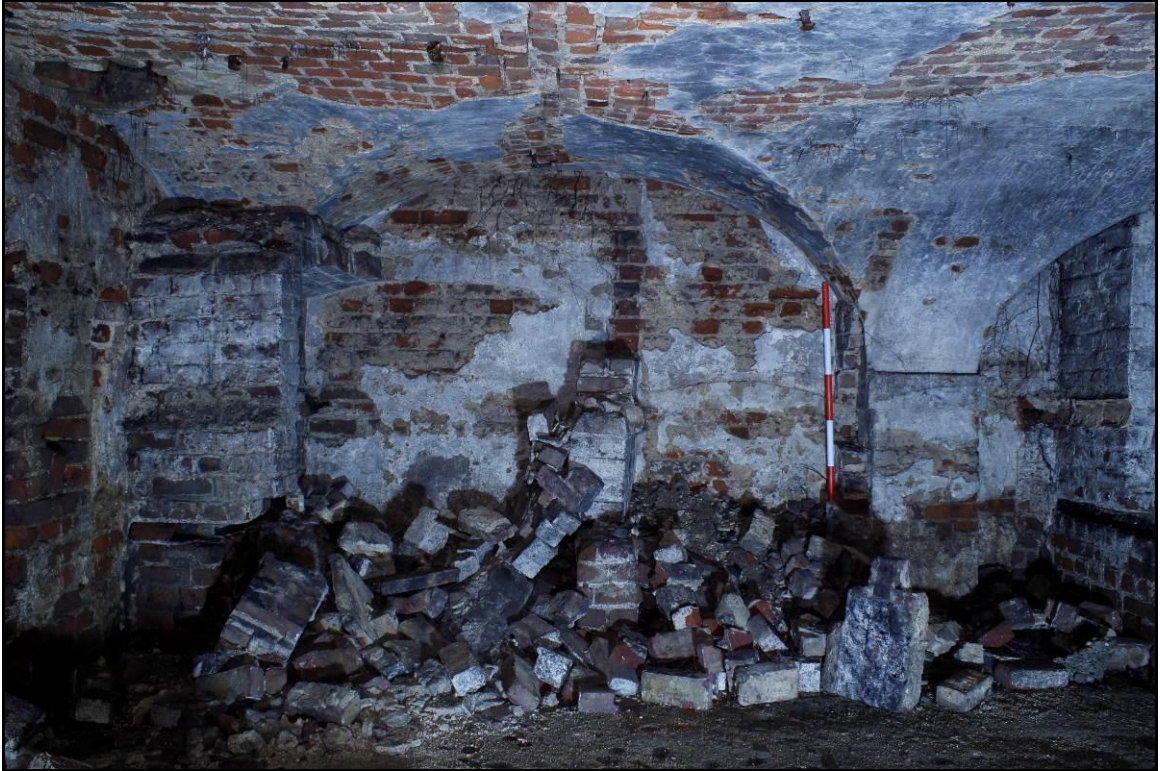
Plate 19: Room 3 demolished brickwork

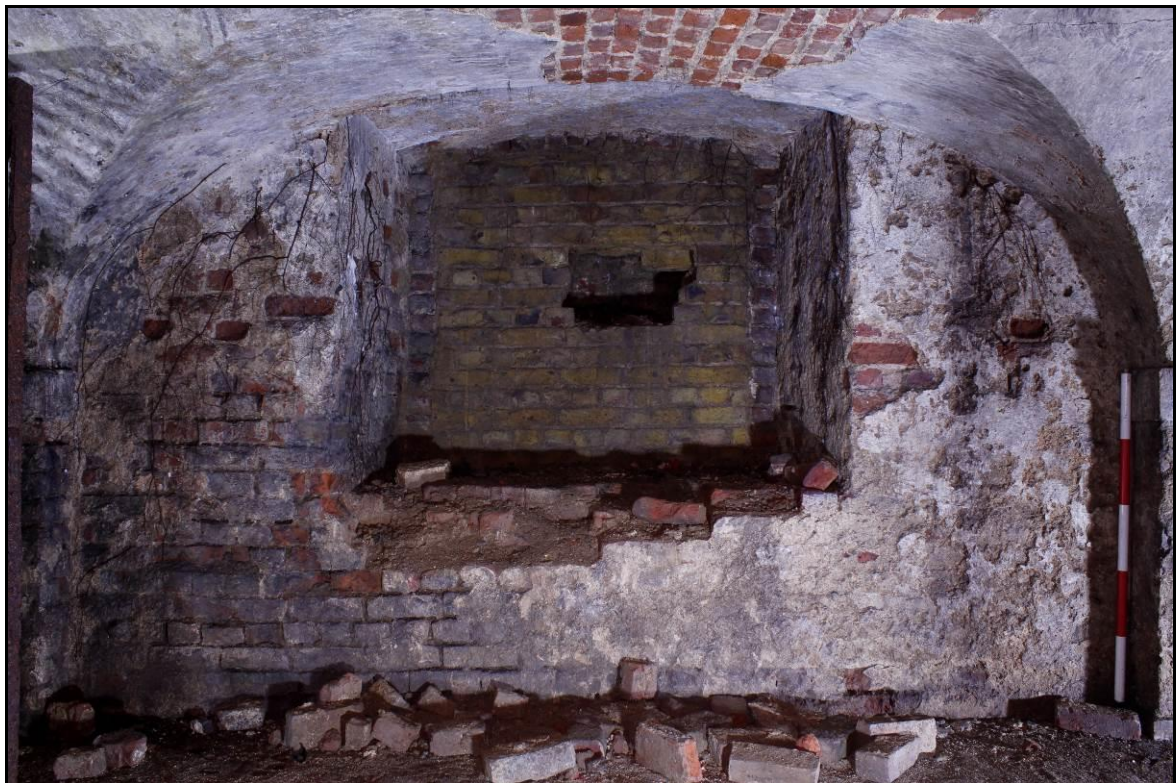
- 6.14 There are two blocked windows in the west wall of the cellars at this location, possibly blocked when the kitchen was partitioned. This indicates that natural light was available in the northwest corner of the cellars. One is blocked deep within the slightly flared reveal, and shows a lightwell beyond, so the outer face must have been hidden at ground level (Plate 20).

Plate 20: Blocked window, Lightwell beyond in Room 2

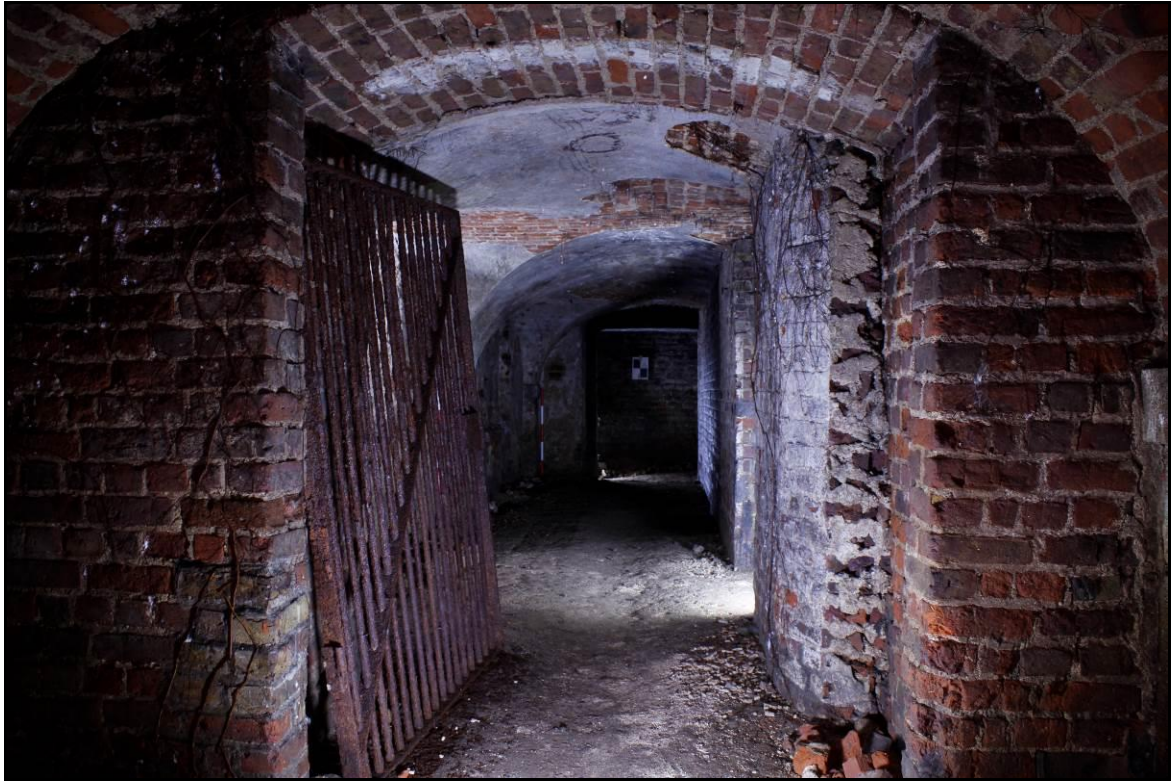
- 6.15 A wrought iron door is propped against the wall of the cellar by the doorway to Room 4 (Plate 21). This was probably affixed to one of the doorways, but with no mounts surviving at any opening, its precise original location is not proved.

Plate 21: Iron door between Room 2 and 4

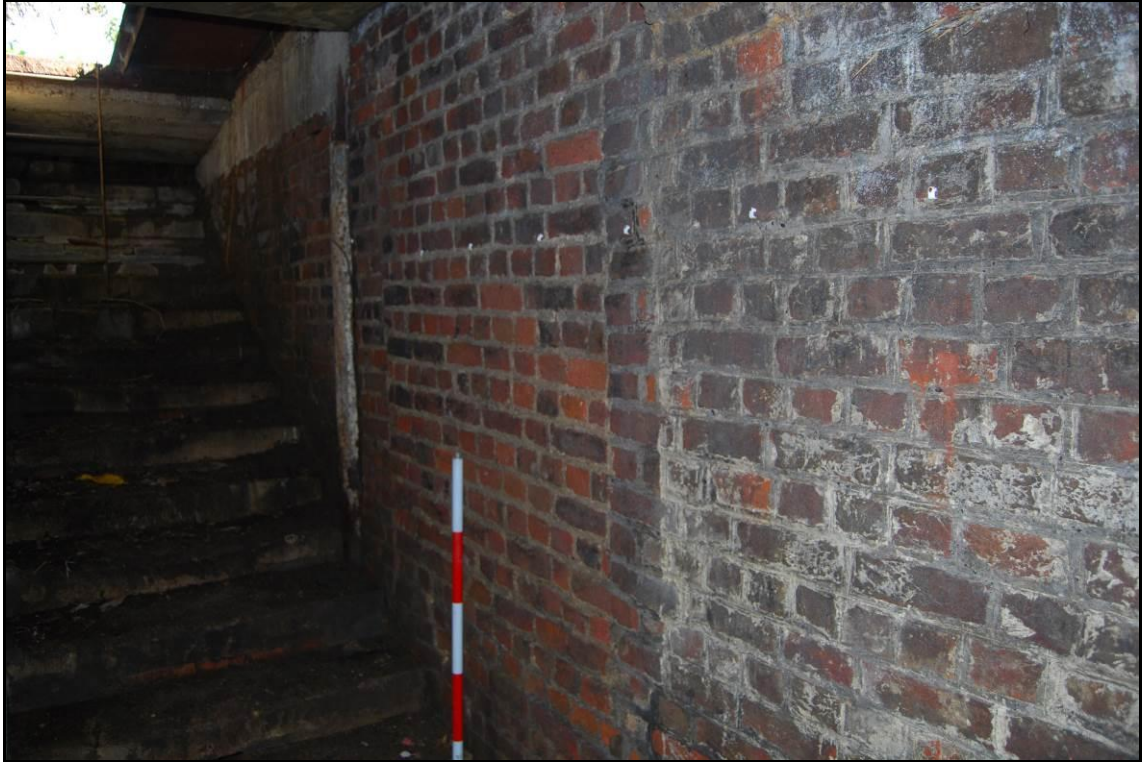
Plate 22: Entrance Area Room 1 Looking Southeast

- 6.16 At the north end of the building, a stairway (Plate 22) drops to the basement from east to west, landing at a small antechamber (Room 1) with bricks laid in north-south rows on the floor at the foot of the stair around a drain cover, and herringbone rows at a doorway into the cellar proper. The doorway to the cellar was once flanked with brick posts to hang a door or doors, 1.25m wide. The north and west walls of the stairwell are constructed of red bricks measuring 225mm by 100mm by 62mm, identical with the other rooms of this phase. This stair would have been overlooked by the window from the kitchen (Room 2). The stairs themselves are now flanked on the north by a cast concrete retaining wall, which is likely to be a repair dating to the demolition phase or shortly after. The presence of a window overlooking the stair implies that at one phase of the building, the stairwell was open to natural light. A steel I-beam now spans the roof above the stairs, supporting a large York Stone slab.

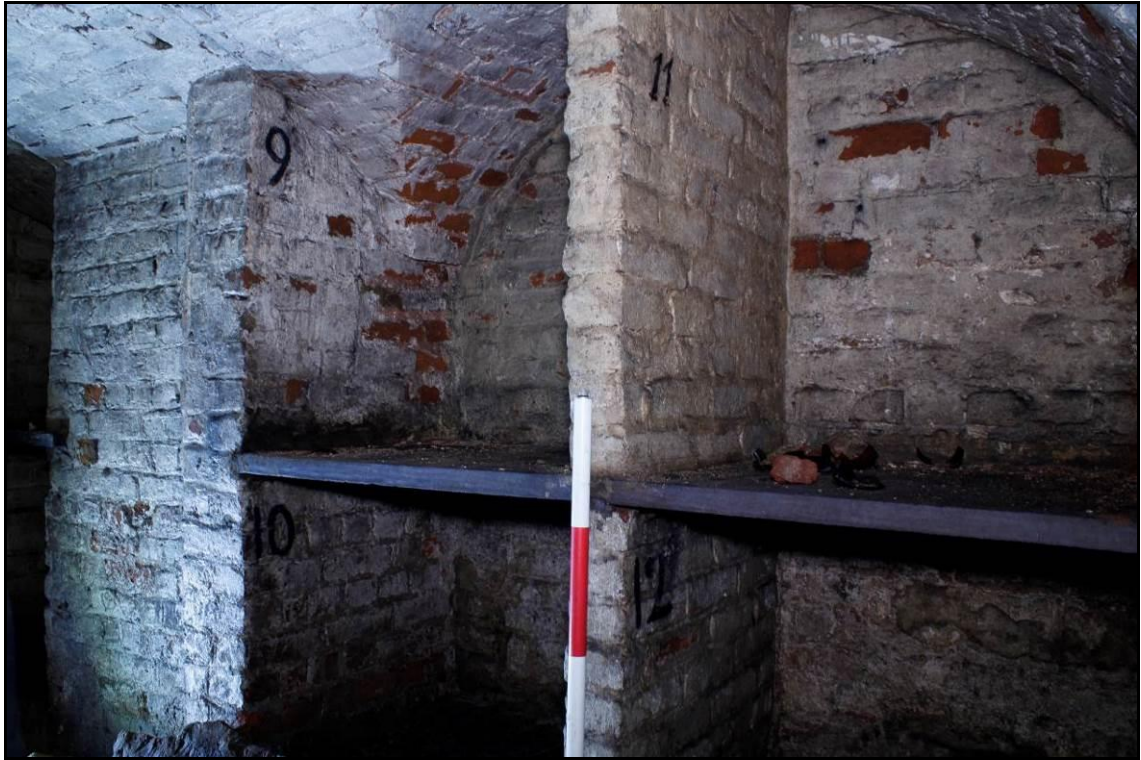
- 6.18 The second alteration is the partial blocking of the narrow corridor (Room 9) to create a store with slate shelves held on brick piers at its northern end (Room 8). The shelves are numbered (Plate 25). A drain in the floor is covered by a stone slab, now cracked and broken. Numerals at the shelf locations indicate a deliberate identifier of locations, presumably for the household to know what was

stored where. These comprise 9, 10, 11 and 12 on the north wall; 14, 15, 16 and 18 on the south wall.

Plate 25: Room 8 numerals 9-12

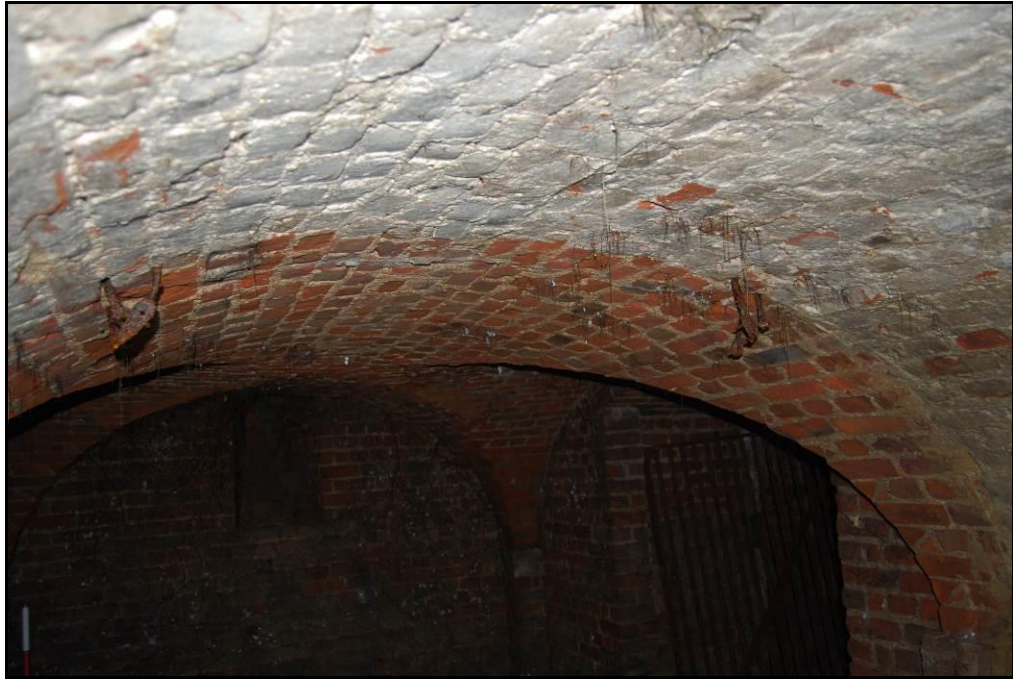
- 6.20 Later alterations to the cellars date to the residency of the 5th Earl Berkeley, his wife Mary Cole as a Dower House, and also changes after 1846. The smallest change was the erection of a narrow partition wall (Plate 26) in the northwest of Room 4, creating a store (Room 7), largely an extension of the small store (Room 8) built into the end of the narrow corridor. The room is equipped with slate shelves supported on brick piers. Not all are complete, with chips, cracks and fallen brickwork present. The bricks of the shelves are a mix of red and yellow stocks, with the yellow measuring 220mm by 110mm by 67mm, and post-dating 1780. The locations are numbered, with 5,6,7 and 8 surviving on the north side (Plate 27). The room itself is whitewashed. Two nails in the ceiling at the east end of the room may be evidence for a lost wooden partition (Plate 28).

Plate 28: Nails in arch at west of Room 7

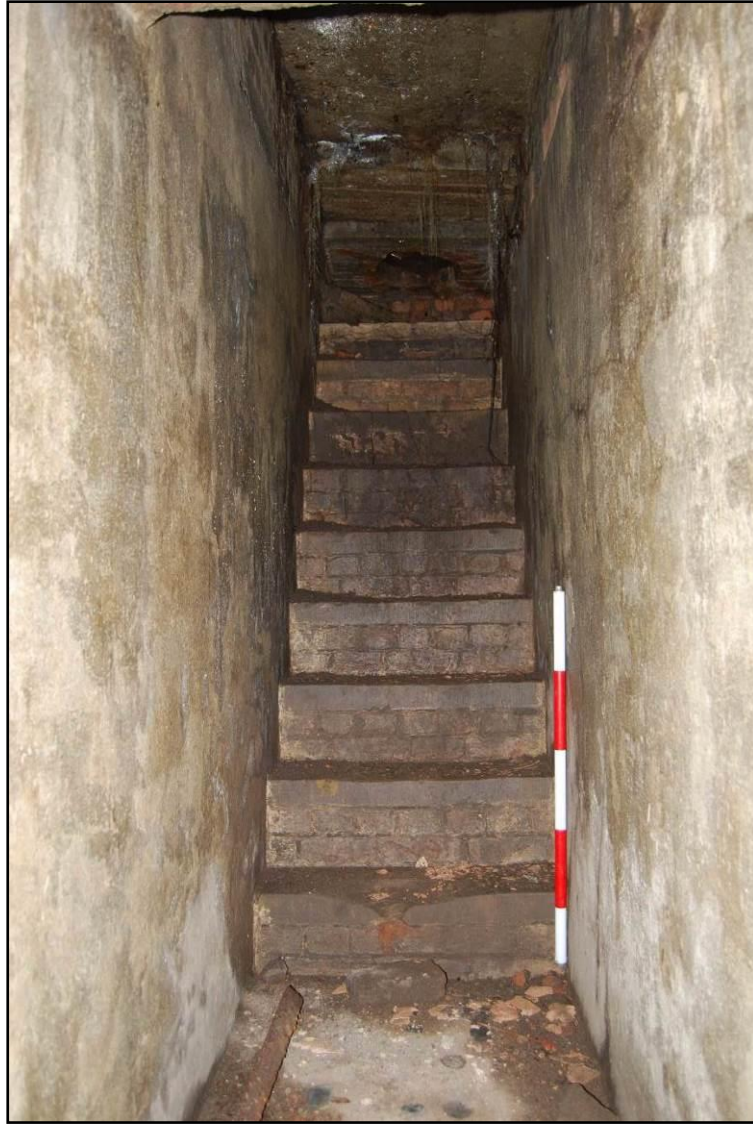
Plate 29: Room 10 Looking east

- 6.21 Three openings in the east wall of the corridor were difficult to access due to influx of demolition materials, and merit further examination following clearance when full examination will be possible. They seem to be latest additions to the cellars.
- 6.22 A secondary stair rises eastwards from the cellars, and is currently capped by a precast slab raised on a low brick plinth, added after demolition. Twelve brick stairs with stone treads rise to a winder after a short passage (Room 10), 0.80m wide with rendered walls (Plate 29).

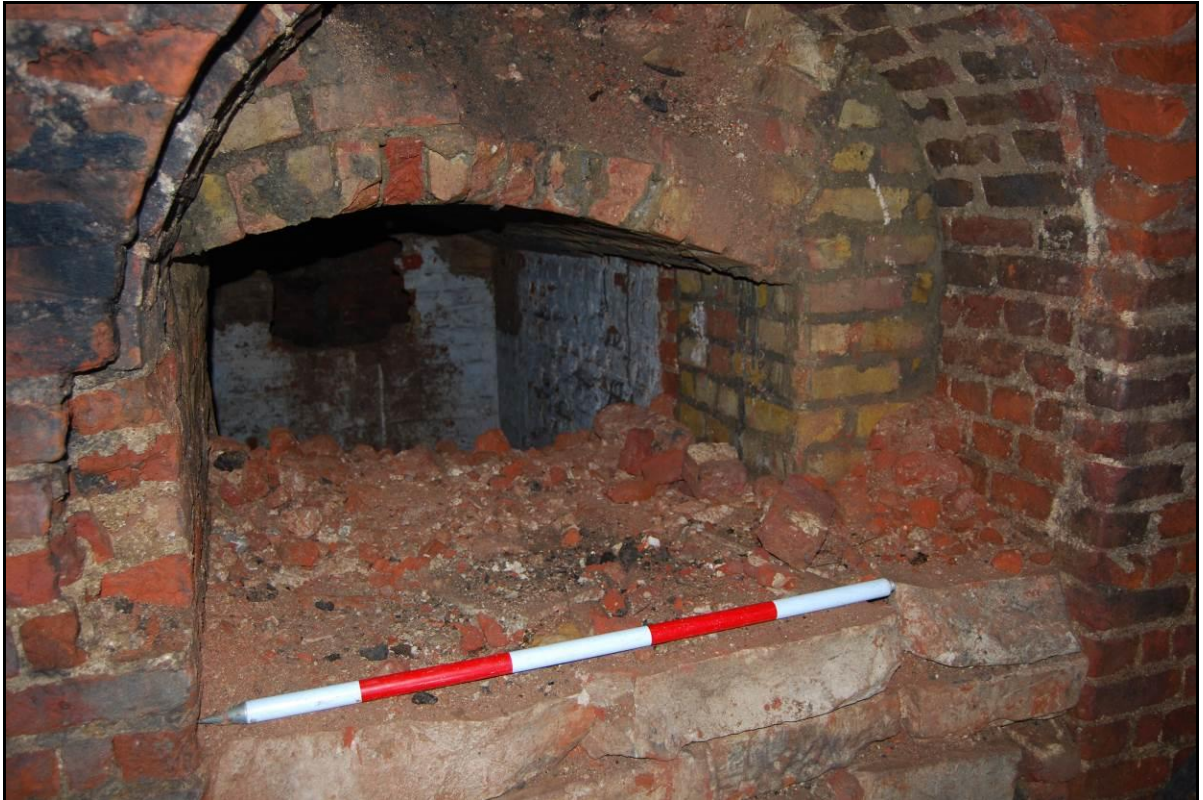
Plate 30: Room 11 Looking Southeast

- 6.23 1m south of the stairs, a brick arch led to a space 2m by 1.50m (Room 11) with a low brick arch just 1.40m above the floor constructed of yellow bricks measuring 225mm by 111mm by 67mm and painted white (Plate 30). This corresponds with the location of a set of toilet cubicles identified in evaluation trenching (AOC 2019a) whose floor lay at 26.01mOD. The entrance to the room was spanned with layers of Portland stone, laid neatly as if trying to obscure its presence. At the back of the room, a hole has been broken through the brickwork, showing additional masonry beyond, suggesting the presence of a narrow passage. Room 11 was filled with rubble and could not be safely entered.

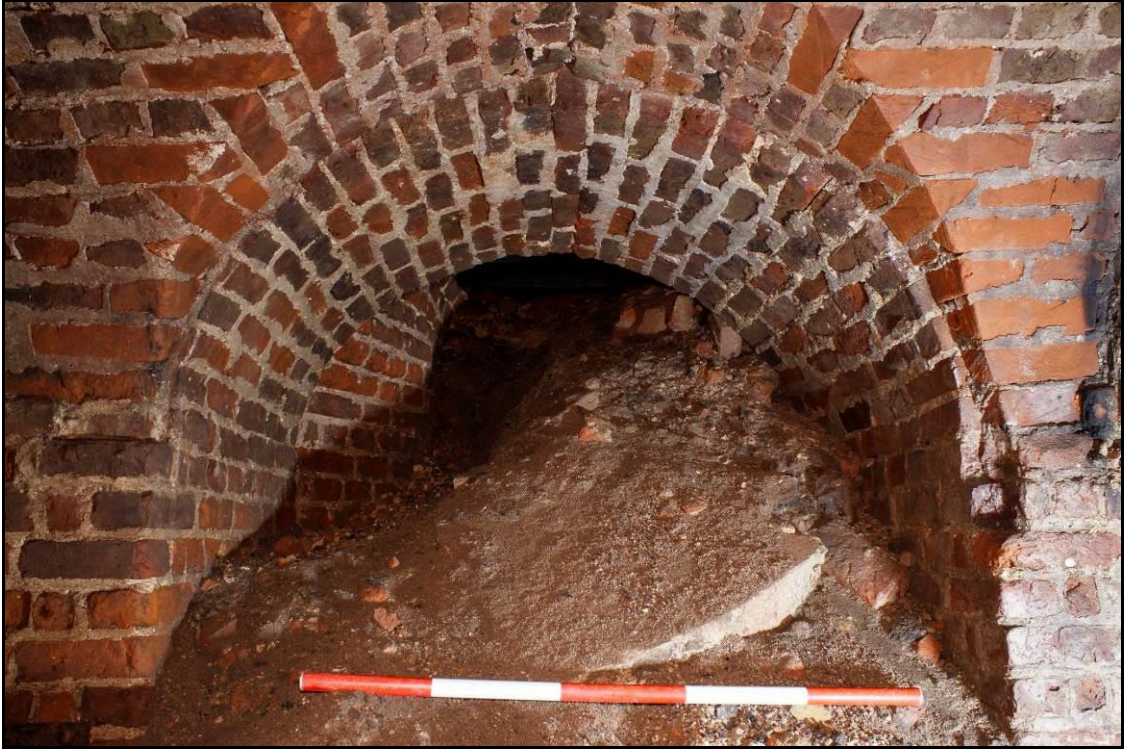
Plate 31: Room 12 looking East

- 6.24 The third opening, a further 1.80m south led to another space filled with rubble and dark brown silty clay soil (Room 12). The opening is a red brick arch 1.25m wide through the cellar wall, and led east for 2.10m and appeared to join the passage at the east of Room 11. A south wall at the top of the room was observed, but the extensive soil and rubble fill blocked observation of its true extent (Plate 31). There had clearly been structural collapse during demolition, since the ground above could be seen to be spanned with reinforced concrete beams, now spalling and cracked laid north-south with blocks above (Plate 32). If there ever was an escape passage from the cellars for Mary Cole, this may be its location.

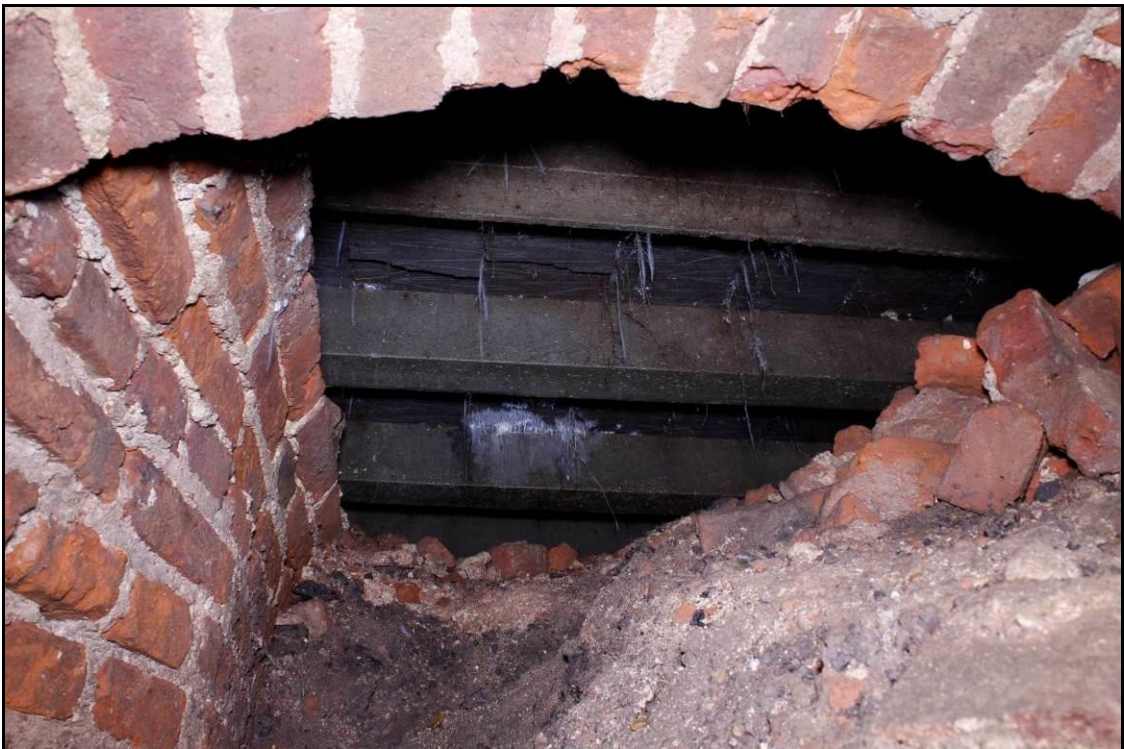
Plate 32: Room 12 Concrete beams
