Arboricultural Consultancy for Aviva - Commercial

1. Case Details

Insured	Q UW FAITH COMBINED BORDEREAUX	Address	Bridle Road, Pinner, Greater London, HA5 2SH		
Client	Subsidence Management Services	Contact	Simon Friel	Claim No.	IFS-AVI-SUB-24-0112106
ES Ref	SA-254771	Consultant	Andrew Cayley	Contact No.	0330 380 1036
Report Date	12/06/2024

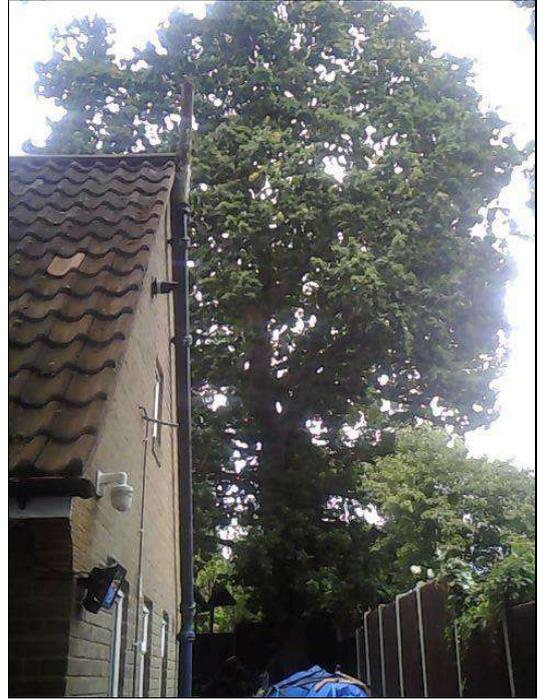
TG1 - Oak

Our survey of the site identified the Oaks (T2, T3, T6 and TG1) which, in our opinion, will be the source of the roots recovered below the property and as such, we have identified their collective / cohesive influence as the primary cause of the current subsidence damage.

Consequently, we have advocated the complete removal of the Oaks (T2, T3, T6 and TG1) as it will offer the most certain arboricultural solution likely to restore long-term stability.

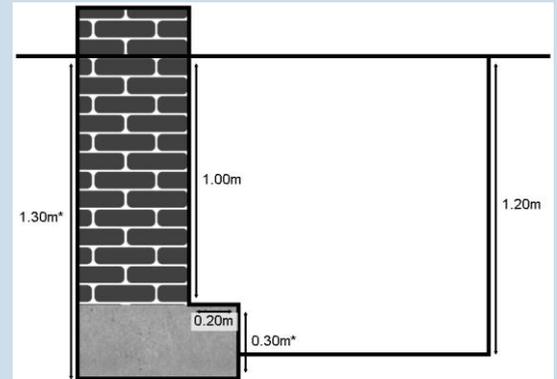
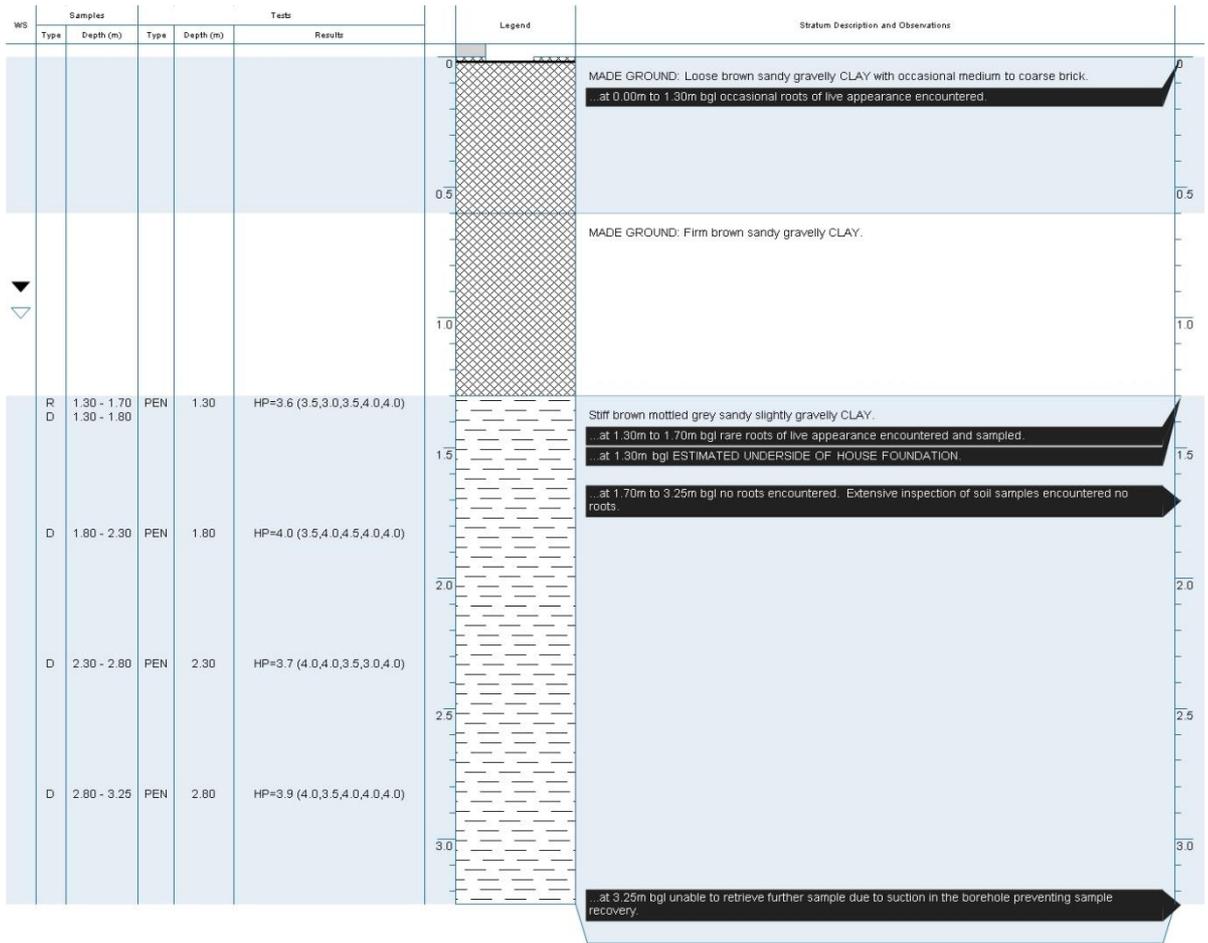
TP/BH1 Foundation Detail and Borehole Log

House foundation comprised of brick wall to 1000mm bgl, bearing on concrete to an estimated depth of 1300mm bgl, with a total projection of 200mm from the elevation. Underside of foundation (USF) was estimated by pushing a probe, approximately 50mm back from the face of the foundation, at an angle with no apparent contact with the face of the foundation beyond the estimated depth.

-- End of borehole at 3.25m --
Groundwater encountered at 1.00m bgl. Standing water level within the exploratory hole at 0.90m bgl on completion. Borehole completed by hand auger. Roots encountered to 1.70m bgl. PEN = Hand Penetrometer (kg/sq cm). Trial pit excavated to 1.20m bgl. Borehole completed by hand auger.

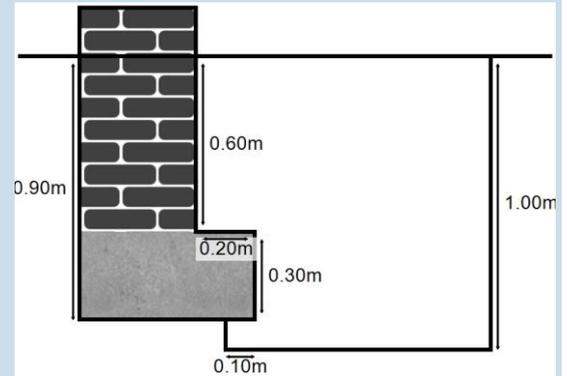
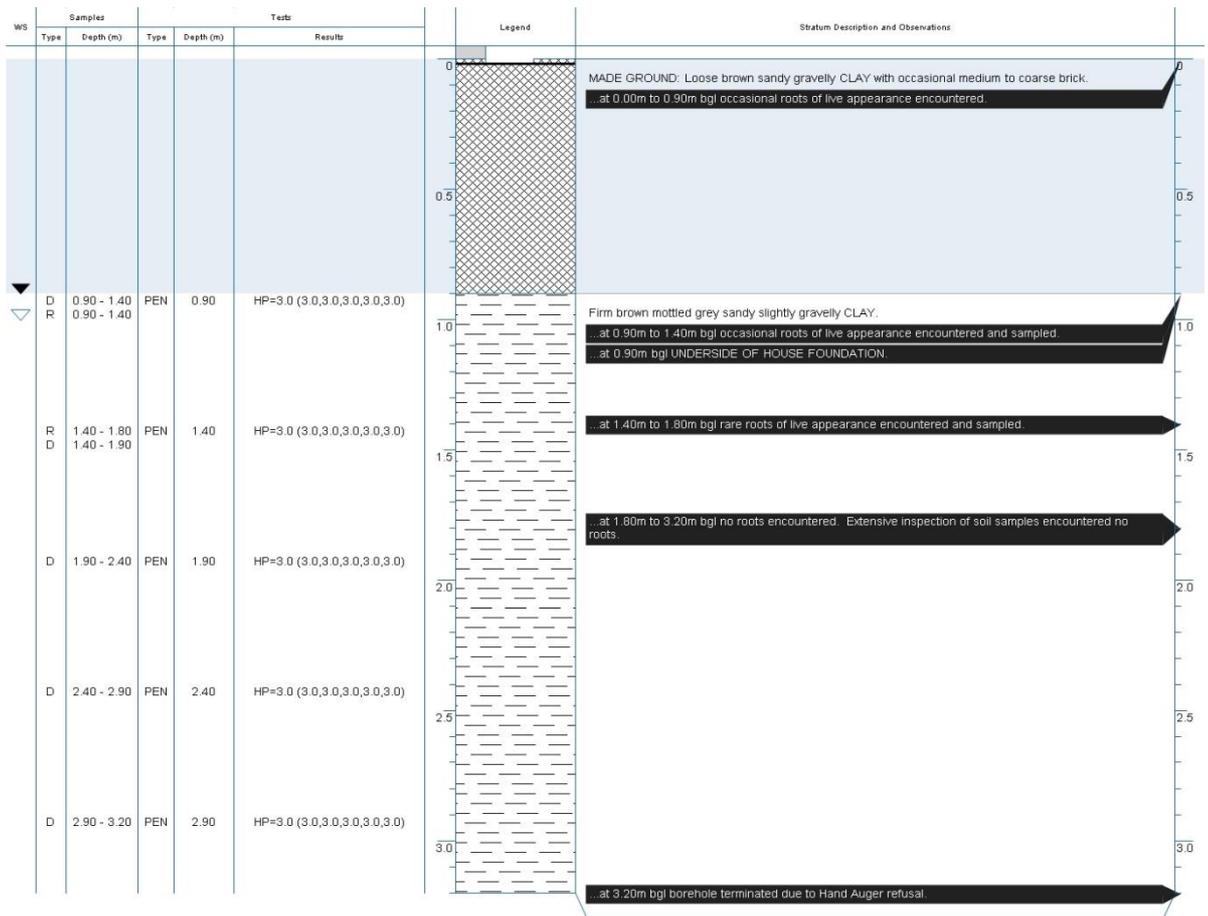
TP/BH2 Foundation Detail and Borehole Log

House foundation comprised of brick wall to 600mm bgl, bearing on concrete to 900mm bgl with a total projection of 200mm from the elevation. Underside of foundation (USF) was exposed to 100mm back from the face of the foundation and probed 350mm back from the face of the foundation.

-- End of borehole at 3.20m --
Borehole completed by hand auger. Roots encountered to 1.80m bgl. PEN = Hand Penetrometer (kg/sq cm). Trial pit excavated to 1.00m bgl. Borehole completed by hand auger. Groundwater encountered at 0.90m bgl. Standing water level within the exploratory hole at 0.90m bgl on completion.

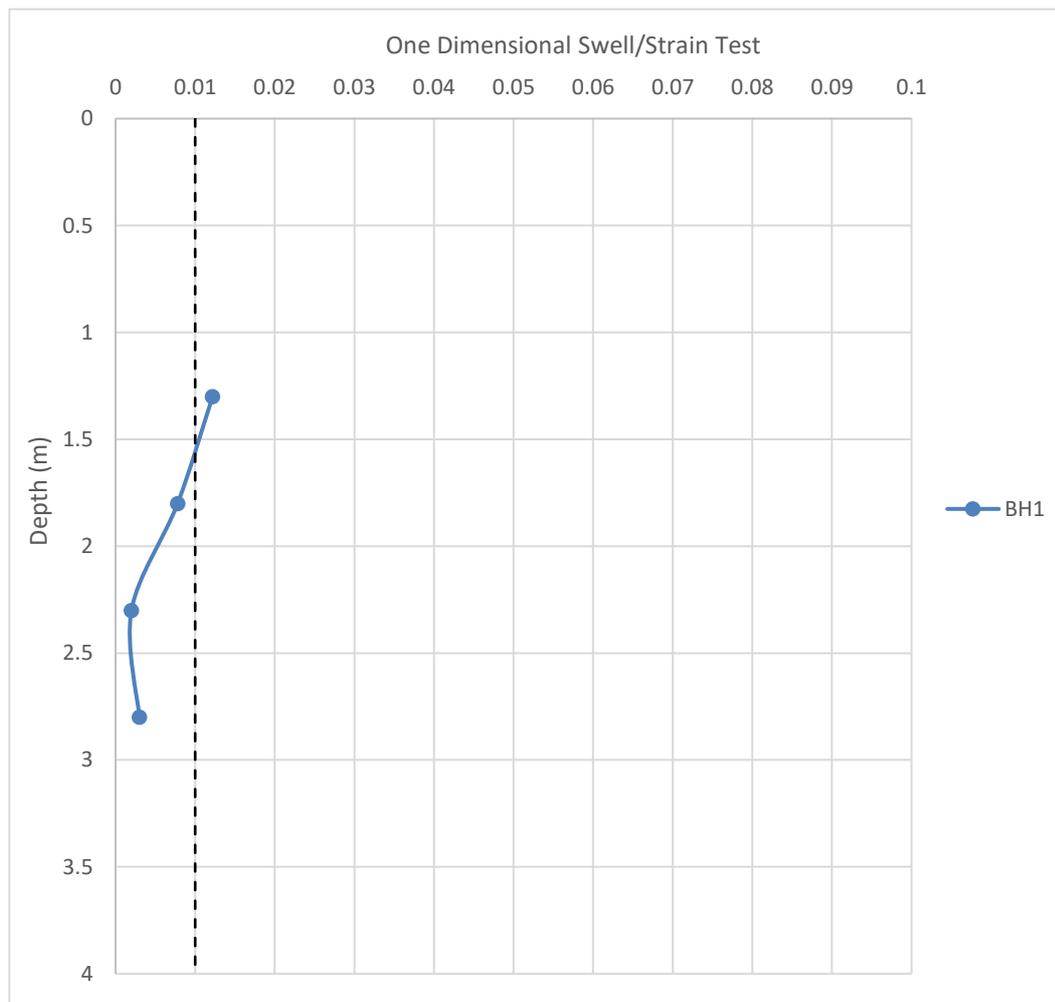
Summary of Oedometer Testing for BH1

Lab Ref	Depth (m)	Strain	Heave (mm)	Remarks
1	1.3	0.0122	7.9	
2	1.8	0.0078	0	
3	2.3	0.002	0	
4	2.8	0.003	0

BH 1 estimate of heave	8mm
------------------------	-----

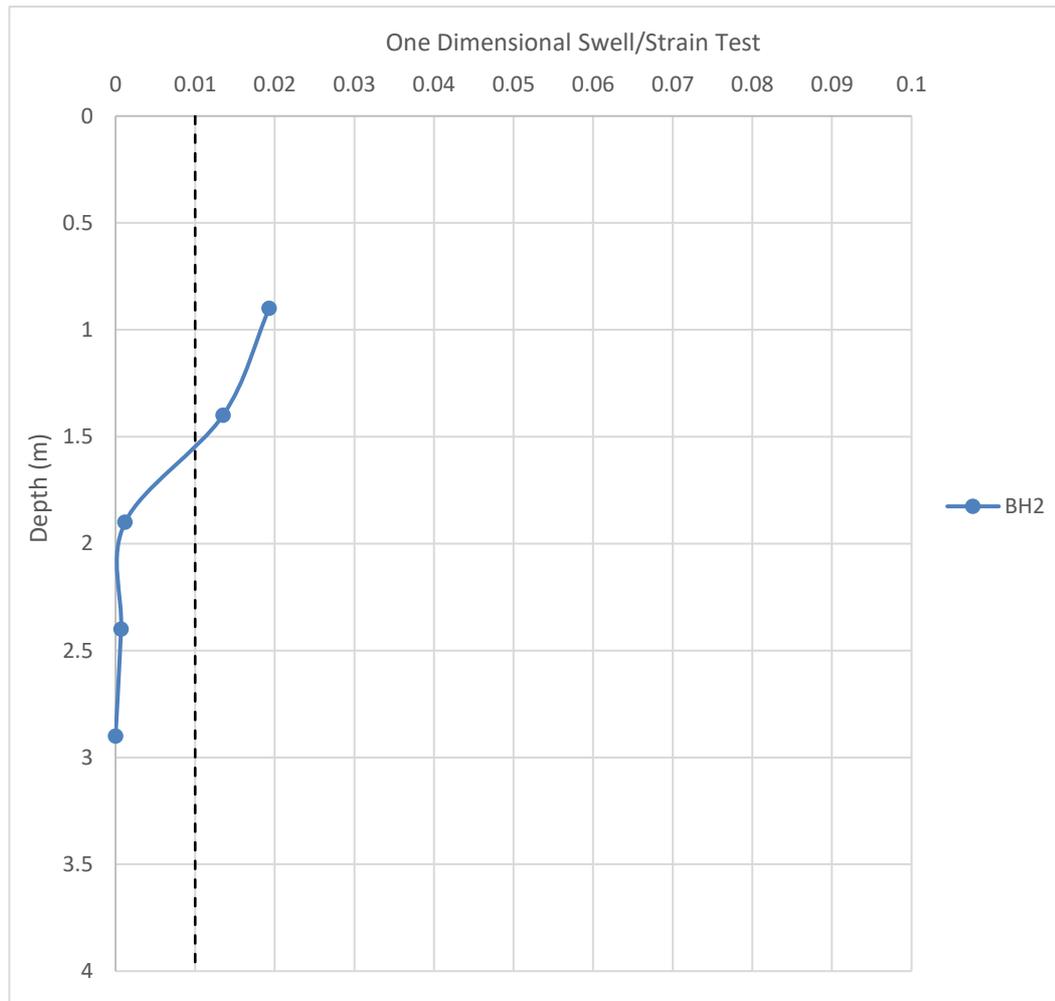
Summary of Oedometer Testing for BH2

Lab Ref	Depth (m)	Strain	Heave (mm)	Remarks
5	0.9	0.0193	8.7	
6	1.4	0.0135	3.4	
7	1.9	0.0012	0	
8	2.4	0.0007	0	
9	2.9	0	0

BH 2 estimate of heave	12mm
------------------------	------
