## **38 Linksway, Northwood**

**BS 5837:2005 Tree Survey and  
Report**

**Elizabeth Greenwood CMLI., F. Arbor A.**

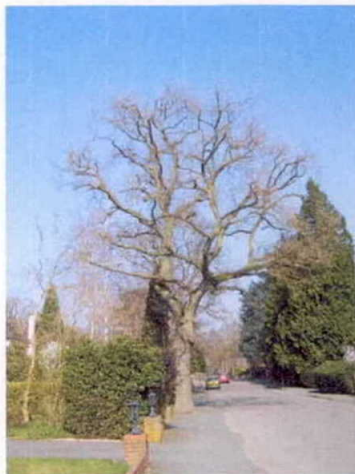
**Above left**, the oak, T1, **left centre**, T18 and **right centre**, T34. **Right**, the Norway spruce T30  
**Below left**, the two purple leaved plums within the front garden, **left centre**, the hornbeam and beech within 40 Linksway, an overgrown hedge, **right centre**, Lawson Cypresses T22, T23 and T25 and **below right**, T31

| Tree Survey in accordance with BS5837:2005 | | | | Age class- | | | M-Mature | Contribution in years | Root protection area | BS5837:2005 Quality assessment | | |
|---|---|---|---|---|---|---|---|---|---|---|---|---|
| T1 | Oak (in road outside) | 19.4 | 770 | N 5.6<br>E 6.1<br>S 5.3<br>W 4 | 5 | m | good | Growing on the pavement with restricted rooting area, and lifting the footpath tarmac-surfaces up to buttress root- Has been reduced in the past- with regrowth-some deadwood in canopy | Remove deadwood | 20-40 | 9.24 | B1 |

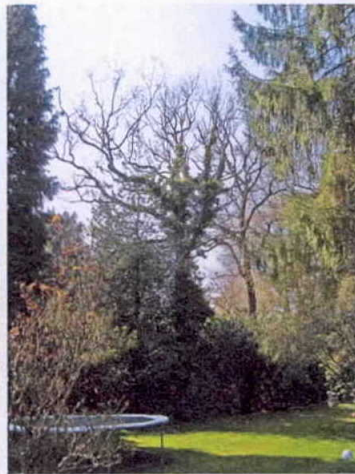
- 5.3 The other three oaks are at the south western side of the garden, two of which (T18 and T19) have severe die back of peripheral branches in the crown. The third tree appears to be a healthy specimen but on observation has incurred damage to the western side of the trunk with exposed bark and evidence of a scar of decayed wood, consistent with fire damage. Some tree surgery would be recommended to reduce the risk of deadwood falling or causing damage.

| T18 | Oak | 18 | 530 | N 3.2<br>E 5.8<br>S 3.5<br>W 2.8 | 5 | m | in decline | Ivy ascending into<br>the crown,<br>deadwood- the tree<br>has been reduced- | Remove deadwood<br>and cut ivy out of<br>crown- observe | 20 to 40 | 6.36 | B/C |

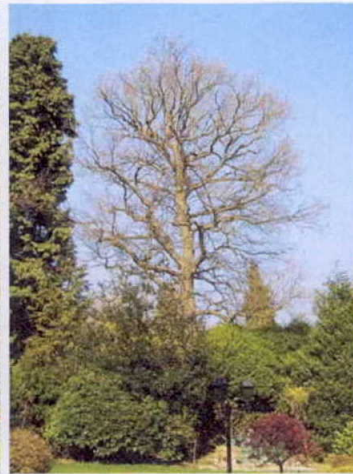
- 5.2 Of the oaks the best specimen (T34) has a well formed crown, which has been subject to crown reduction. It has an exposed buttress root on the eastern side and is within 8.4 metres of 36 Linksway. Its extensive root protection area extends into the grounds of 38 and would act as a constraint to development.

- 6.2 According to the British Standards there might be scope for some development within the root protection areas of trees given the option for 20% incursion of this area. This may be feasible with special design of the foundations. It is noted that although the new house is close to the oak (T34) although the building only extends 5% into the tree root protection area.

- 6.4 A further constraint to development will be the terrace proposed within the oaks root protection area. On calculation this was found to be 14.6% incursion into this area. To mitigate any detriment to the tree, there is scope for the terrace to be constructed with minimal excavation, all carried out by hand, and with the use of geo textile. Indicative details are included within the method statement, and use of permeable material within this area would ensure the underlying soil remains hydrated.

| T34 | Oak within<br>36<br>Linksway | 18.3 | 700 | N 4.9<br>E 5.5<br>S<br>W 5.5 | 2 | M | good | Surface buttress<br>roots on NE side.<br>Tree has been<br>reduced - bunched<br>regrowth with some<br>deadwood | Under management<br>of owner-Crown<br>management with<br>thinning at the<br>reduction points | 40+ | 8.4 | A |

| Tree no | Species | Management recommendations |
|---|---|---|
| T34 | Oak | Face back from building work and crown lift as required to avoid damage during construction works. |

- Minimise levels and excavation of the terrace within the root protection area of the oak (T34)- design permeable paving and carry out all excavation by hand.

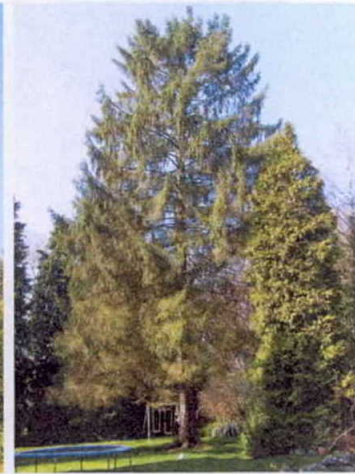
| T30 | Norway spruce | 26 | 760 | N 5.7<br>E 5.1<br>S 6.1<br>W 5.7 | 1.5 | m | Good | Exposed buttress roots, resinous discharge on northern side of the stem with sooty moulds, apical dominance has been lost | May be prone to lightning damage-consider management of height | 20 to 40 | 9.12 | A/B |
