Building Survey

**Hutchings House
32 Hillingdon Road
Uxbridge
UB10 0AD**

Partial survey and structural comment on

**Job No: 35427
Date: 23 April 2025**

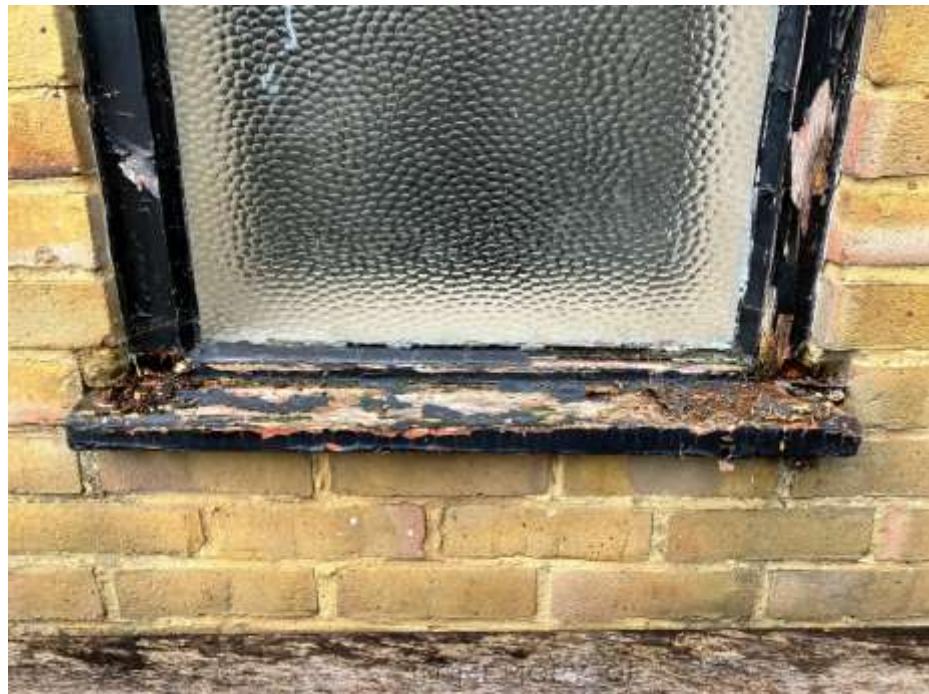
Photo 5

The windows have been poorly maintained. Paint has worn away and wet rot has set in to various locations of almost all the windows.

Indicative window sill and jamb rot and poor paint

Remedial works will vary by individual frames. Some will be some work to cills, jambs, rails, glazing bars and these will be splices, replacement sections, filling (if permitted) and remaking of joints.

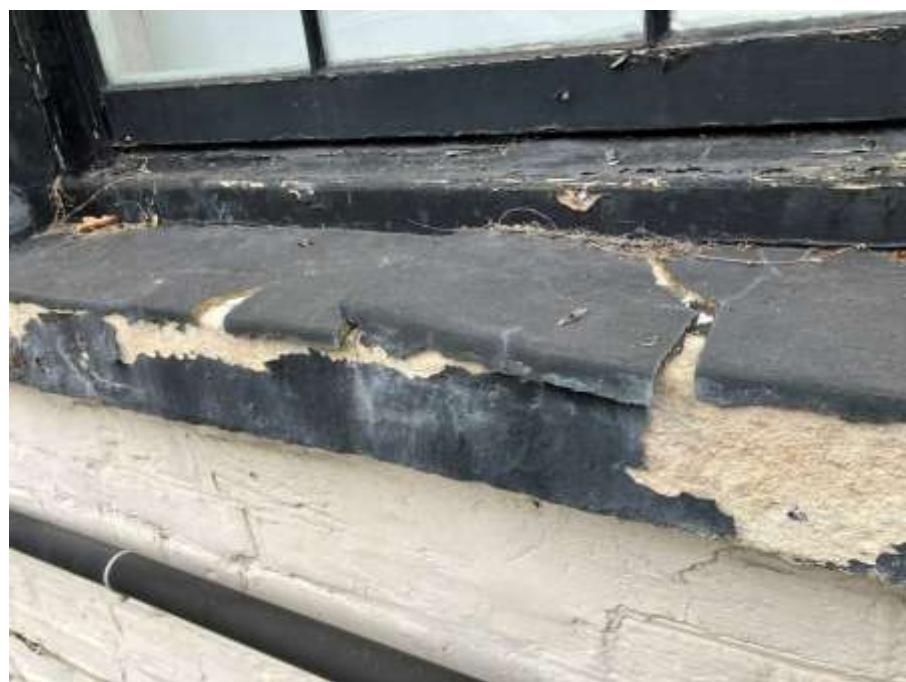
Photo 6

Indicative associated damage to stone cills

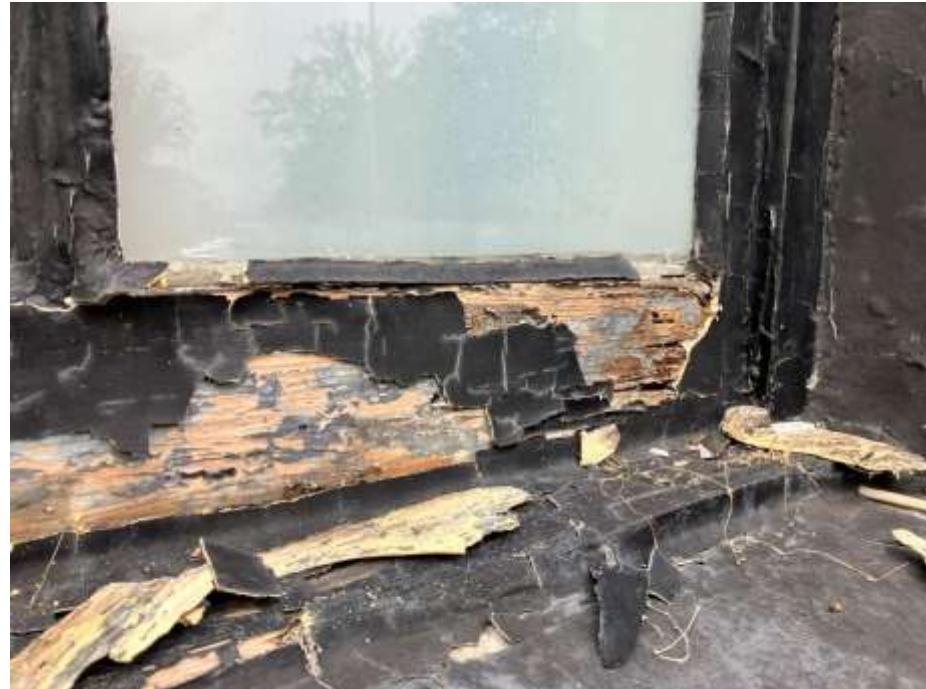
Photo 7

Indicative damage to window sash and glazing putty

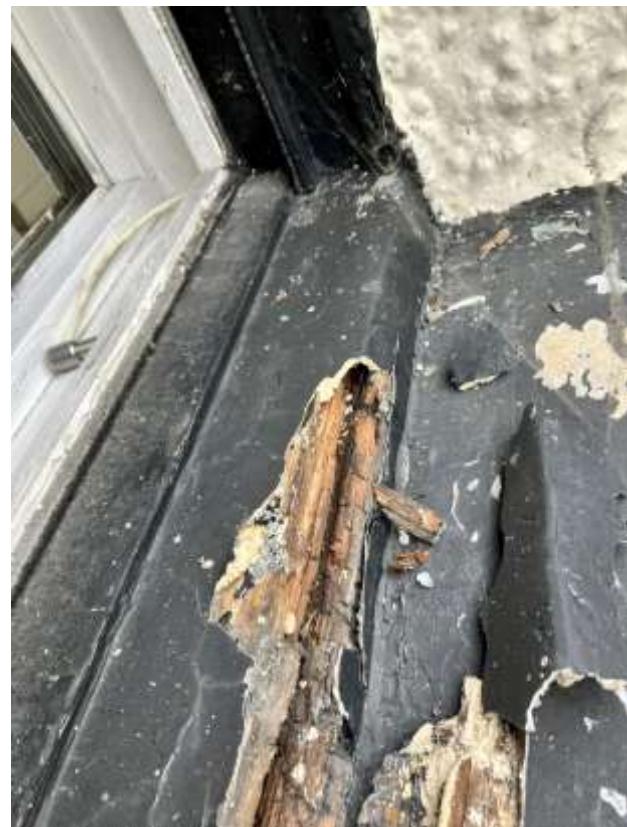
Photo 8

Over the years there does appear to have been some repairs to the frames in various forms. There may be replacement sections or filled sections which are obscured by layers of paint and may become apparent once work begins and may require further works or different works to those originally planned.

Indicative damage to sash cills. Note previous repair with filler, creating hollow areas beneath the paint coating.

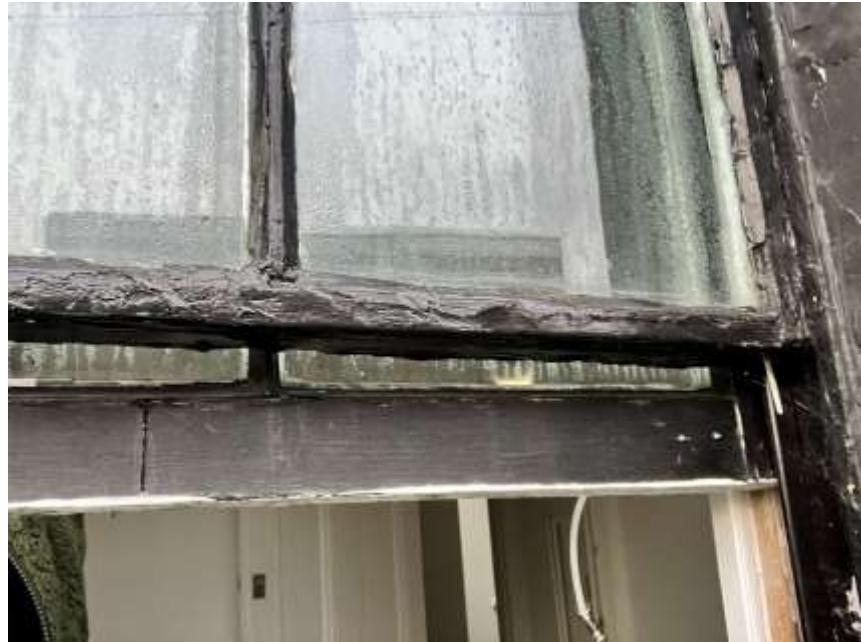
Photo 9

Indicative poor condition of glazing beads to sashes

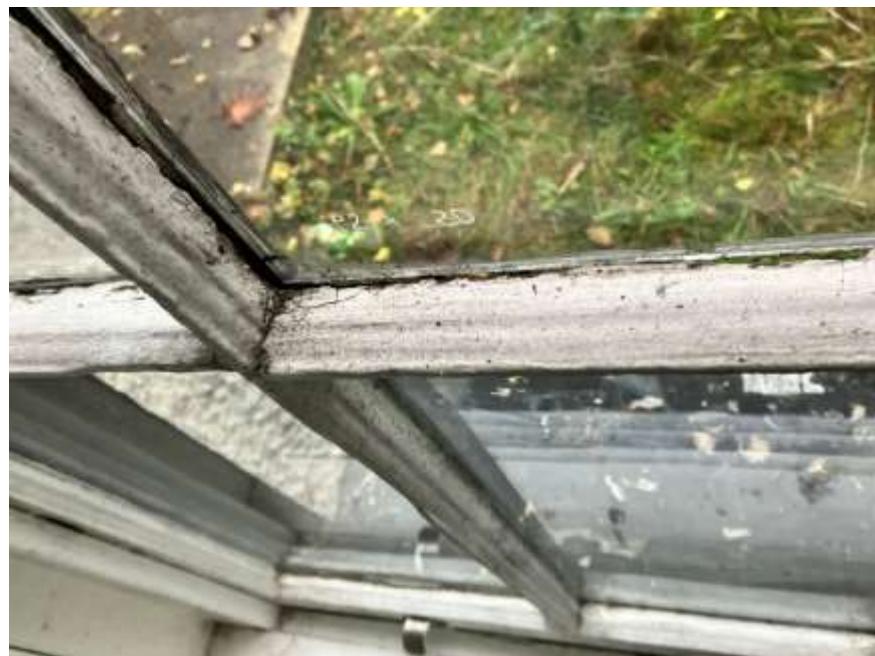
Photo 10

Indicative poor condition of glazing beads internally, with loose joints

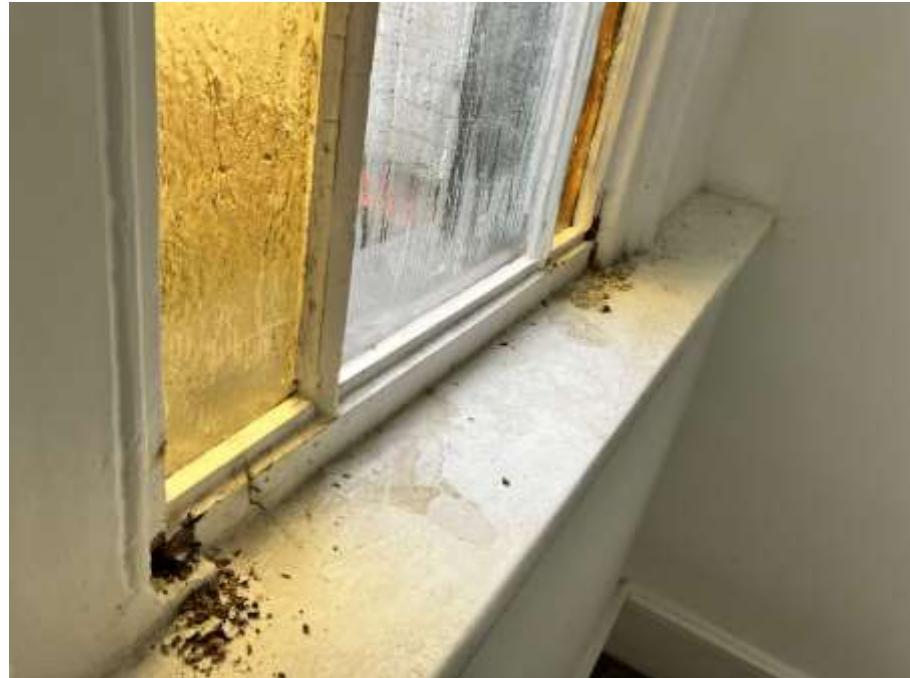
Photo 11 Stair window showing rot to sill and jambs and water on window board which drips onto wall below

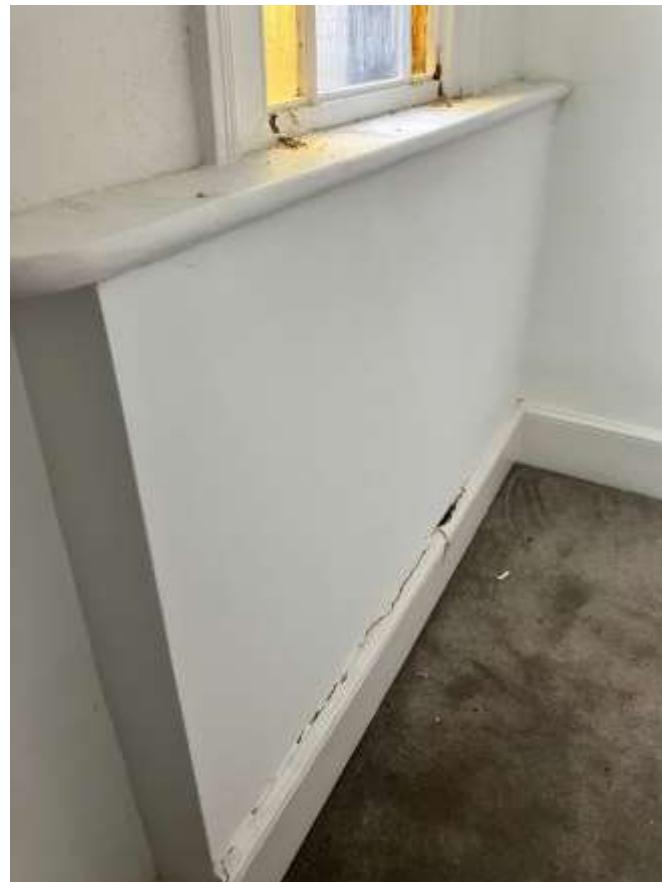
Photo 12 Wall below stair window showing damp to plaster and skirting

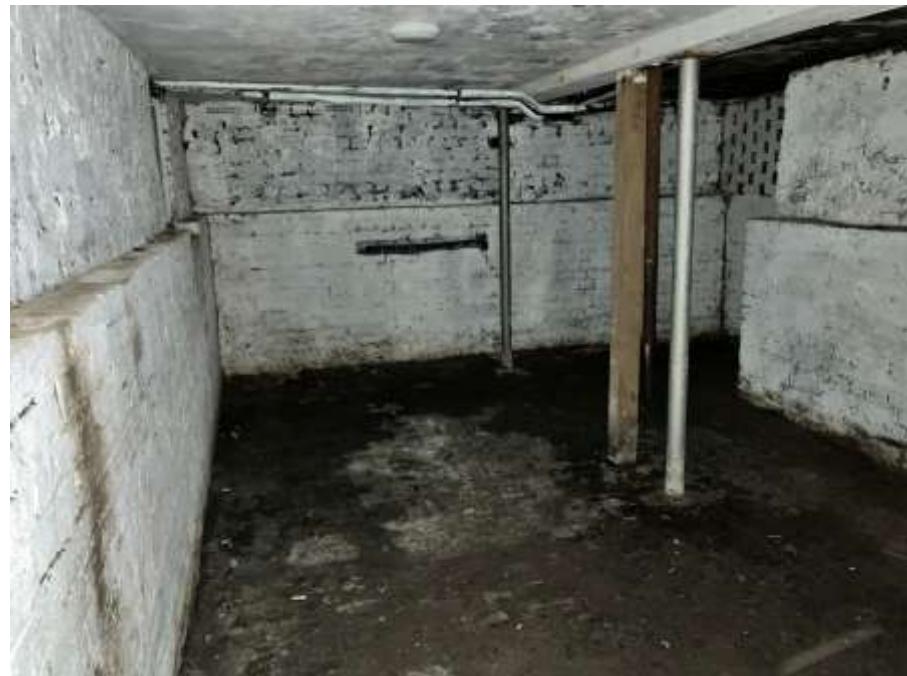
The temporary propping of the timber beam in the large room would imply that some deflection the floor above has occurred, perhaps by softened timber, but this cannot be confirmed. Presumably the need to prop the timber also suggests the need to replace this timber beam. If so, this would need input from a suitably qualified structural engineer.

Photo 13 Cellar – main room, with propped timber beam. Mould on walls and ponding to floor

The propped beam in the cellar implies that the floor needs support. The reasons for this are unknown, however high moisture levels were noted within timber in the basement which may have affected the loading capacity of the timber beam, and there is a risk of fungal attack to the timber. This beam may potentially need replacing and as such, outline LBC consent should be sought to replace this beam with a suitable steel replacement. The location of the beam will have little visual impact.

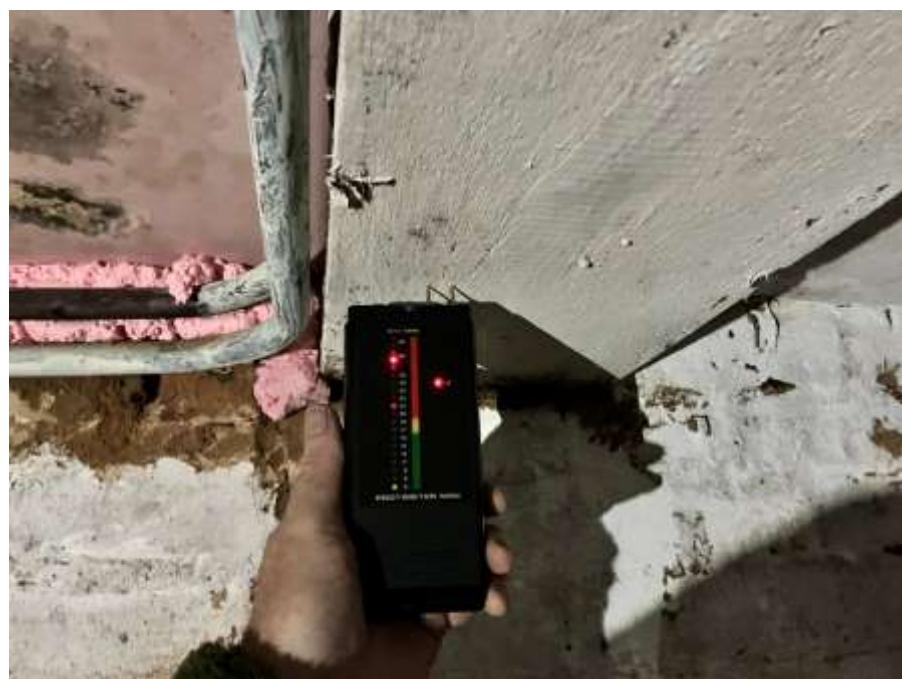
The cellar is excessively damp. Whilst some dampness was “how it was” back in the day when the house was built, over time the persistent dampness has created conditions where dampness becomes more and more prevalent.

Photo 14 Cellar – very high moisture reading to timber beam in main room

The cellar damp is extensive and the ground floor damp significant. The two causes are connected but unrelated and require different remedies. Each will need specialist comment and design input, and a strategy to manage this can be devised and implemented

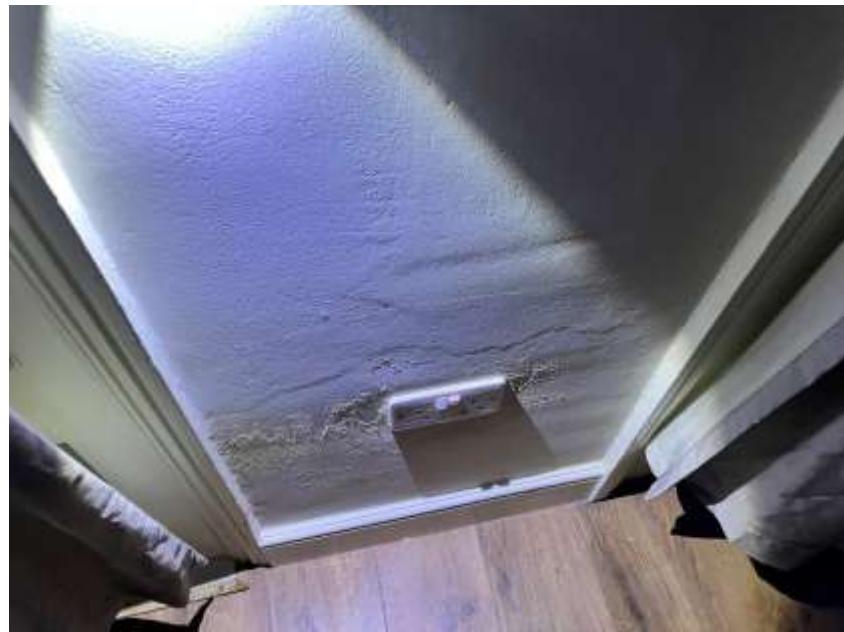
Photo 15

Front room, damp and salt clusters

There is no DPC. Further investigations are required to fully detail the most appropriate remediation, however initial interventions could be carried out to improve this including introducing sub-floor ventilation and replace any cement render with a breathable type or remove layers of paintwork which could be impeding breathability of the wall.

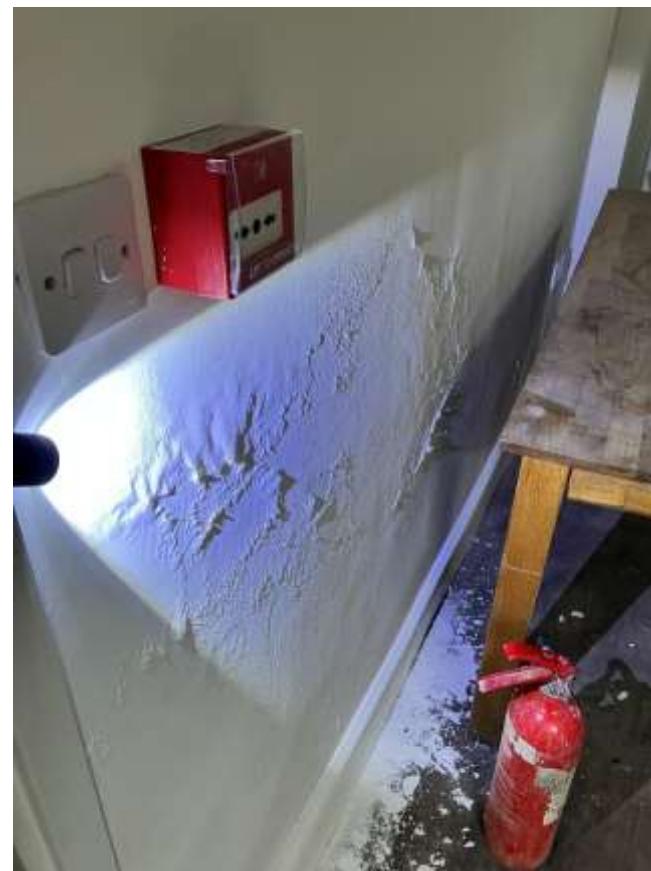
Photo 16

In the laundry, there is dampness at a much higher level than would normally be expected. This room is at a lower level than the main house and is not above the cellar but shares an internal wall that is – and this could explain the relatively high level of dampness. However damp heights of up to 1.8m on the external wall would be more likely to have contributory penetrating dampness from the external wall. Externally there are cracks in the render in this location and above, and conceivably water penetrating the cracks could be making the wall damp at high level. Alternatively, a window at high level could be allowing water to penetrate the wall via the frame or sill.

Laundry room, high level damp and salt clusters

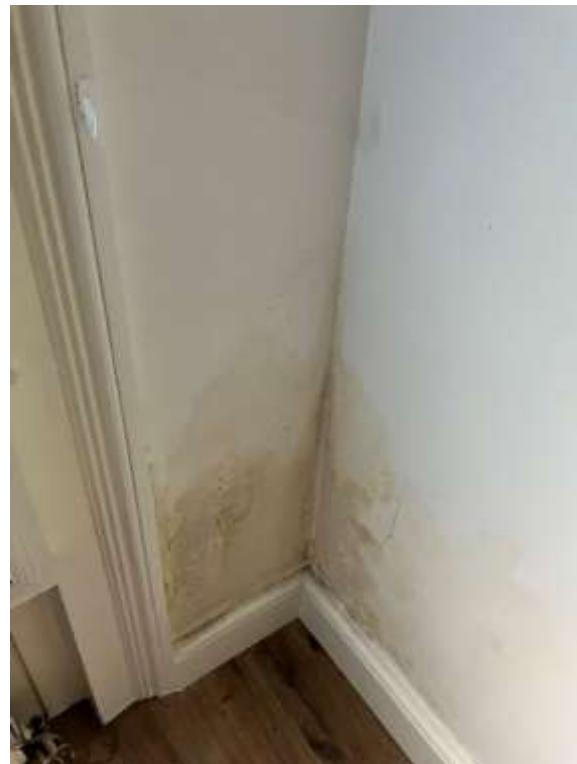
Photo 17

Front room damp to S/E corner

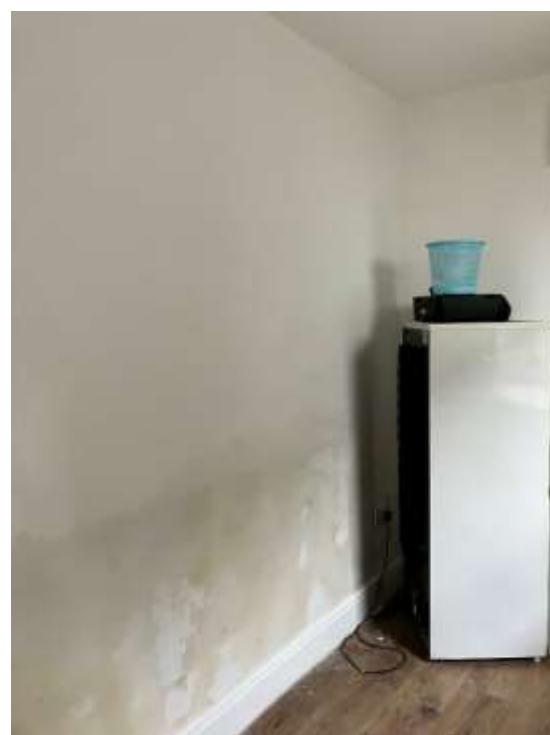
Photo 18

Rear extension – band of damp to boundary wall

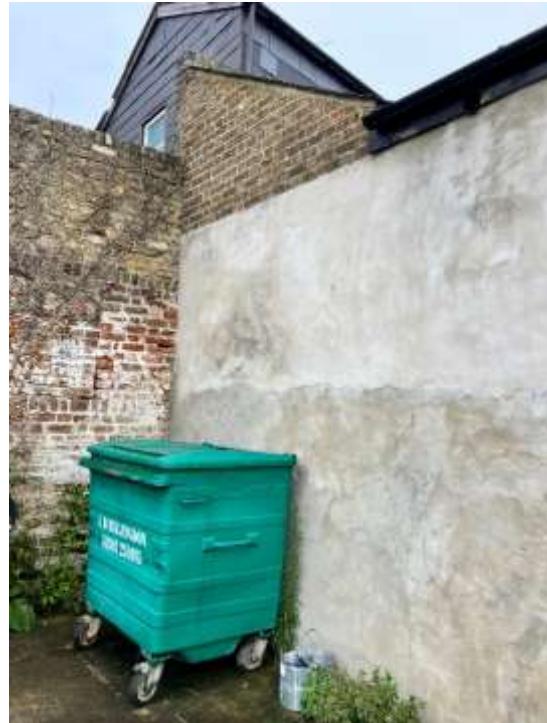
Photo 19

The render on the rear wall is defective with crazing and cracking at various locations. Render is normally retrospectively applied to help deal with some water penetration of poor brickwork, and if so, it is not performing well in this respect. It is also poorly applied right down to ground level, and this can wick ground moisture up and into the wall behind. Surface painting is unlikely to remedy any water penetration of the render and in this situation the only viable option is to replace the render.

Rear extension – defective render to end wall

Where fitted, render should be assessed to ensure that there are no cracks or detachment from the wall, as these can lead to moisture penetrating to the inner walls. The render side/end of the rear extension will need renewing or replacing with an alternative method of waterproofing the wall. Render should not touch external ground level, however if this is altered retrospectively, it will expose previously rendered bricks which may give an unacceptable appearance. The roughcast render may be cement based and if so, will impede breathability of the wall.

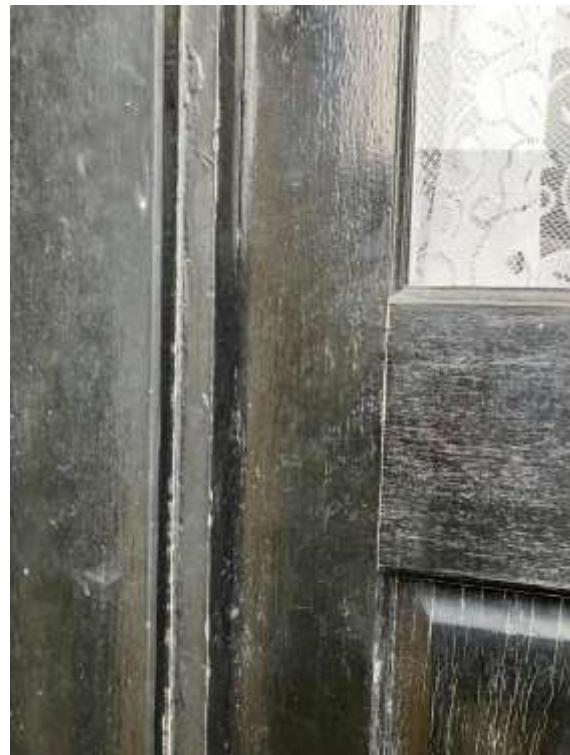
Photo 20

Doors to the rear of the main house and extension are standard profiles - 2nr *Georgian* to the main house and 1nr *Richmond* to the extension, all of which may be hardwood. Some joints between the rails and stiles have opened slightly, and wear is more prominent at the base of the door and frame. The frame to the rear hallway door of the main house has a fanlight which has been over-boarded – the board material is unknown.

Indicative open joint on rear timber doors

Generally, more work is required to various rear doors at sill level – to sills, weatherboard and the lower jambs. These are common areas for wear and tear from traffic and rain water splashes. Typical remedial works will involve either splice repairs to jambs, and replacement of sills and weatherboards.

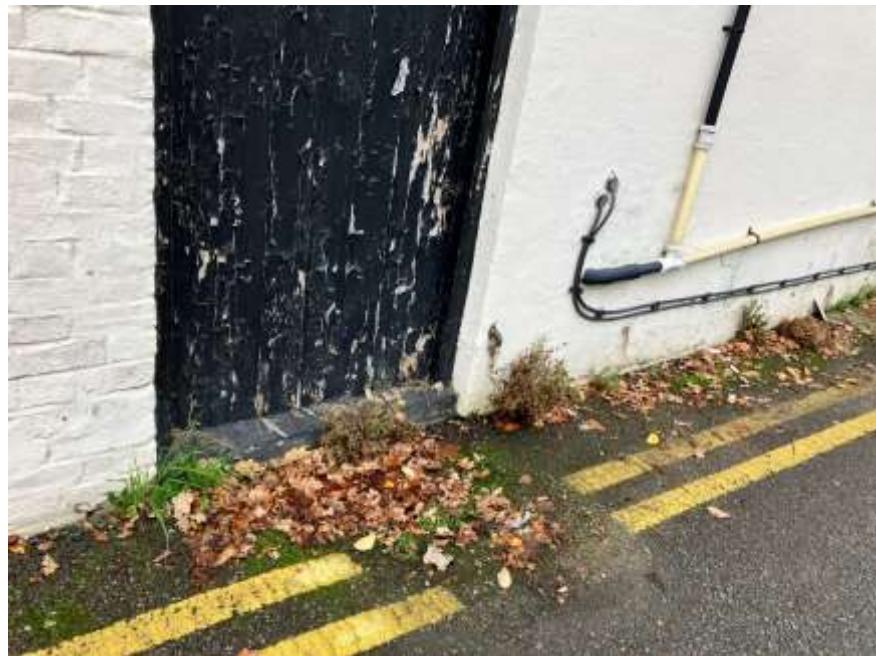
Photo 21

The door facing the side road has excessively worn and flaking paint and some wet rot to the bottom edges of the boards. The construction of this door is not known, but is similar to a boarded ledged and braced door (similar to a tall garden gate) It may be possible to carry out localised repairs to this door to maintain its character, however if any repairs become extensive it may be more economically viable to replace the door complete.

Side elevation door – poor condition at bottom

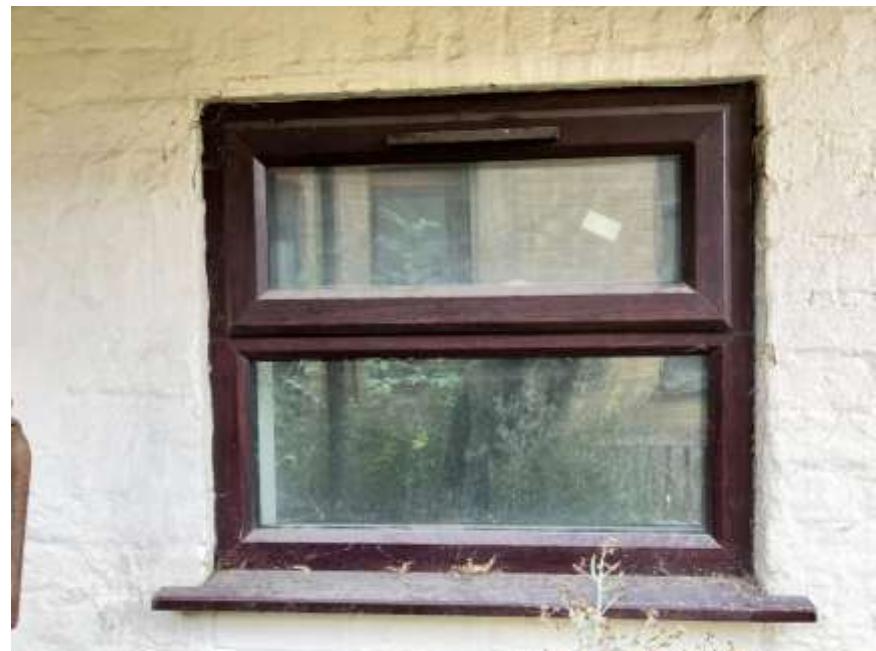
Photo 22

The replacement uPVC window to the office is out of character with the rest of the building.

Office window – uPVC

- There is a UPVC window fitted, which may be unauthorised and should be replaced in timber.
- The steel beams to the rear projecting first floor should be replaced with steel beams and encased to conceal them from view. Associated renewal of the render above is required.

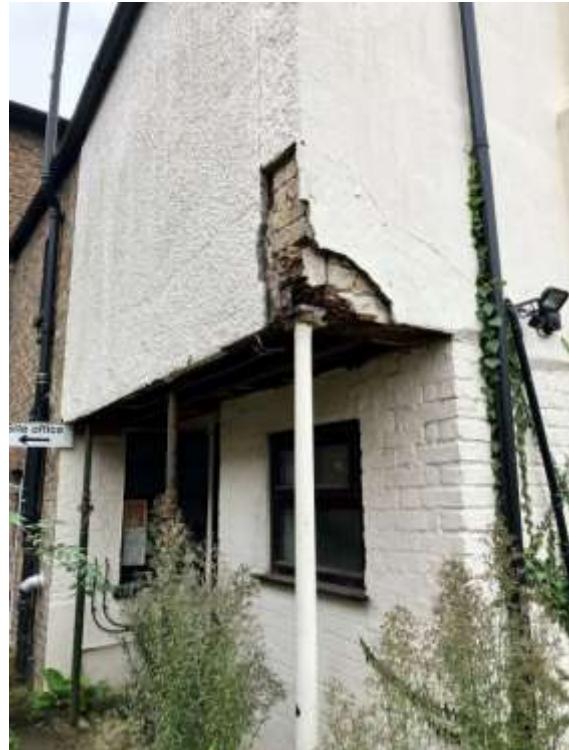
Photo 23

It appears that rainwater has penetrated behind the render and caused the timber beams to decay. In addition, the render above appears to be detached from the wall, and there is some cracking extending up the eaves level.

The timber beams supporting the projecting floor are rotten in parts and in need of replacement.

Rear projection and defective timber beams

The walls above are rendered and will not only require suitable temporary propping with care to not allow movement, but render may become detached in areas not obvious. Any loose render can allow rainwater behind it to then penetrate the rooms or any other timber within the walls, therefore it may be prudent to allow for complete replacement of the render above this beam.

Partial repair of the external render may not be sufficient to protect the wall face owing to any joint of new to existing render and natural thermal movement of the render. Therefore, complete renewal of the render panel above the beam would be prudent.

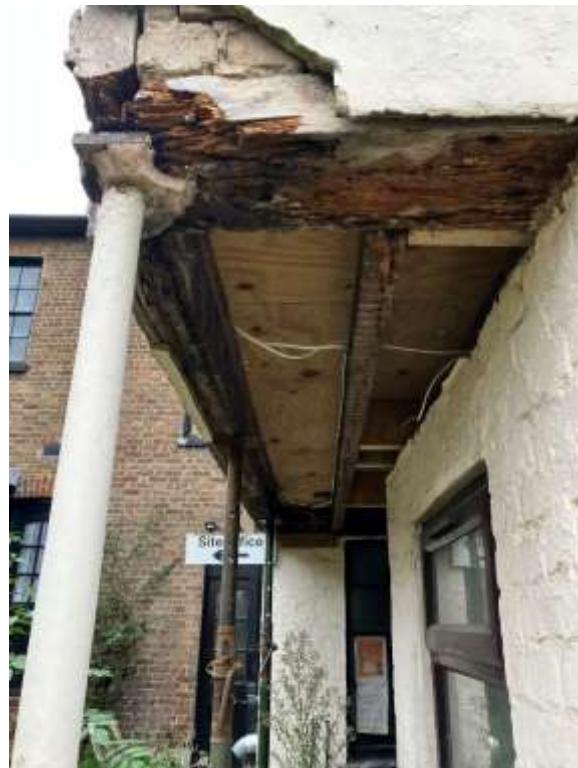
Photo 24

For the beam to the rear extension projection, this has failed from continuous rot over many years. The design and detailing of the beam and render is flawed and has allowed moisture to penetrate the beam undetected. The risk of moisture penetrating behind render is ever-present, and it is important to mitigate such risks. In this case, replacement of the beam with another timber beam may introduce unnecessary risk of the beam failing again in the near future.

Underside of rear projection showing rotten beams

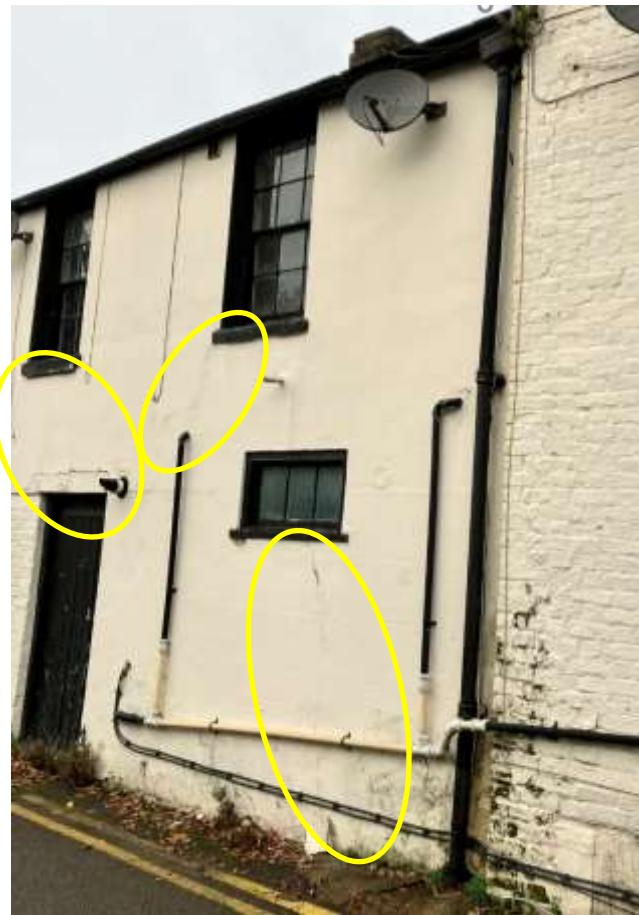
Photo 25

The rear wing is not directly above the cellar but is adjacent to it. This wall is smooth rendered and there are various cracks in various locations and directions, and these appear to be structural cracking not just in the render coat. Again, water entering such cracks will travel downwards and potentially cause dampness at lower levels.

Side elevation cracking

There is cracking to the rear wing on the south (road) elevation, and this could be allowing water penetration to the inner rooms. This will need further assessment and removal of large areas of render to investigate the wall beneath. It is conceivable that some form of crack stitching may be necessary to control further movement, prior to re-rendering the affected areas
