ASHBY FARM, DUCKS HILL ROAD, NORTHWOOD

PRE-DEMOLITION AUDIT

PROJECT NO. 25/296 DOC NO. D014

DATE: JANUARY 2026

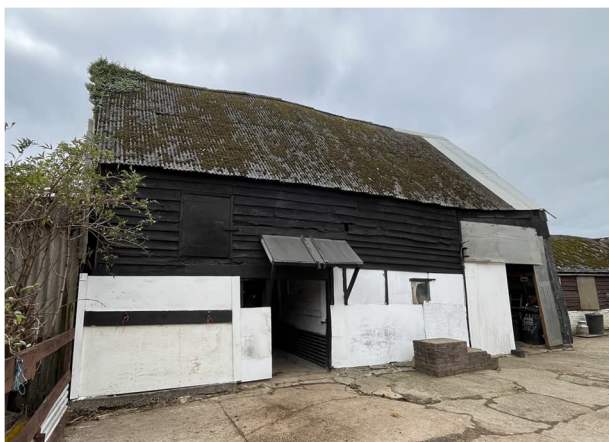
Figure 2-2 Large Stable Frontage

- 2.3.4 Within the scope of the audit, two structures have been identified as large stables. Both appear to be two storeys and feature timber-framed facades. Sections of the lower walls incorporate concrete blocks, painted white. In parts, corrugated steel has been used for later repairs on the facades. Corrugated steel, composite sheeting and a trussed timber framework comprise the roof space. Two small timber doors feature within one façade of the structures to allow for farm animal access. Minor lighting fixtures are installed around the perimeter of the stables.
- 2.3.5 Figure 2-2 to Figure 2-4 below show the external facades of the large stables and the corrugated steel which has been used for later repairs.

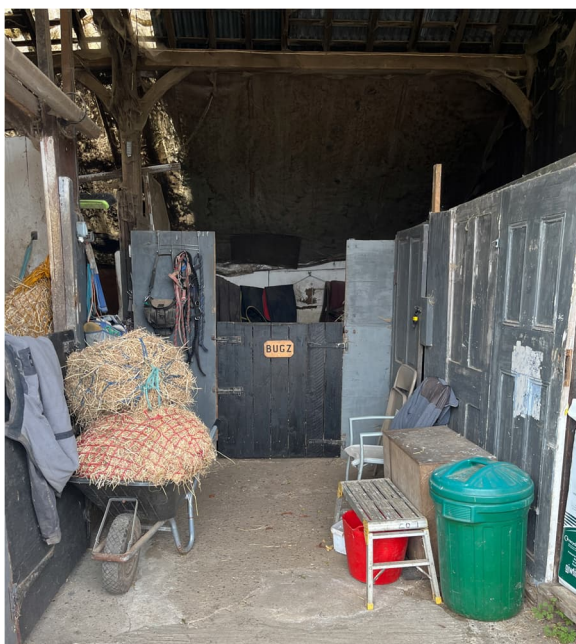
Figure 2-5 Timber Stalls - Large Stable

- 2.3.6 Timber partitions and beams feature within the large stables, providing individual stalls for horses.
- 2.3.7 The majority of the floorspace of each stable consists of concrete hardstanding.
- 2.3.8 Figure 2-5 and Figure 2-6 below show the interior of one of the large stables, including the exposed trussed framework.

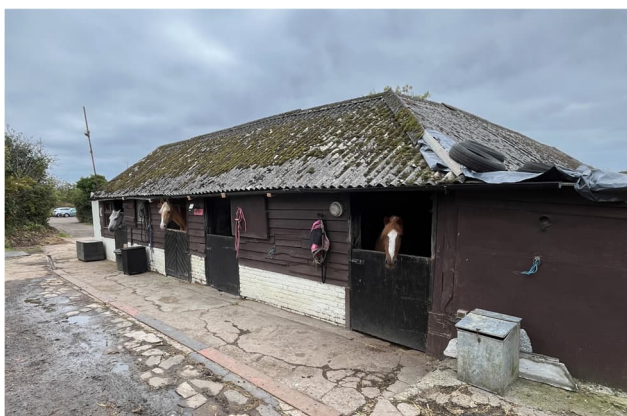
Figure 2-7 Northernmost Single-Storey Stable Frontage

- 2.3.9 Several single-storey stable buildings are situated across the Site, each constructed in a similar manner. These stables are single-storey structures and feature timber-clad facades. Roof coverings comprise a mix of composite and corrugated metal sheeting and slate tiles, while the lower sections of the facades consist of a brickwork.
- 2.3.10 Each single-storey stable features timber stable doors, single glazed windows, and some external floodlighting fixtures.
- 2.3.11 All stables on site display high levels of wear and deterioration.
- 2.3.12 Figure 2-7 to Figure 2-9 show examples of the single-storey stables throughout the Site.

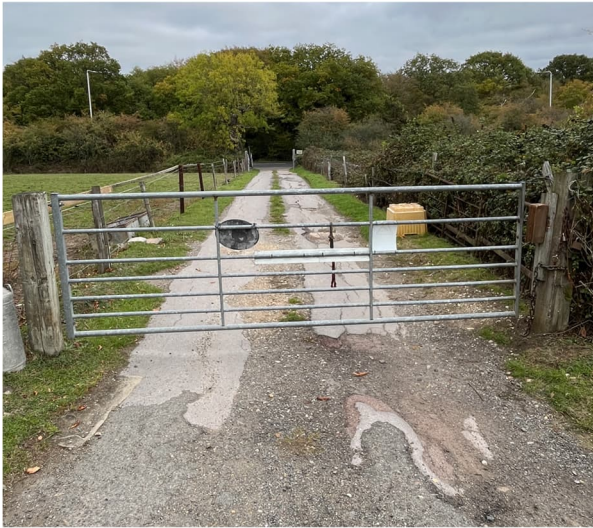
Figure 2-10 Steel Farm Gate

- 2.3.13 Access to the Site is gained via a galvanised steel farm gate, supported by two timber posts on either side of the entrance track. The gate is positioned along the main approach from Ducks Hill Road and serves as the primary entrance to the Site.
- 2.3.14 The steel gate is shown in Figure 2-10 below.

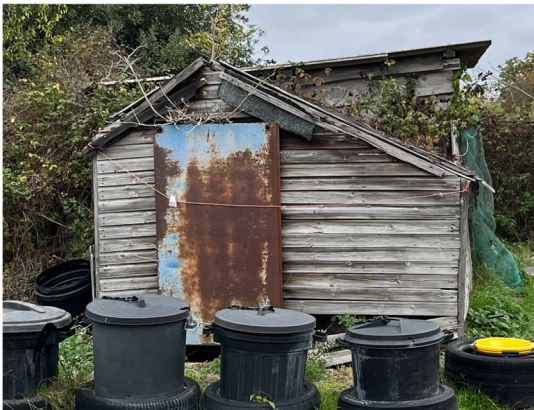
Figure 2-11 Timber Shed

- 2.3.15 The northern boundary of the Site features two small sheds. The facades are made up of timber cladding, which show high levels of deterioration. Roofing of the sheds comprise of bitumen and corrugated metal sheeting. A standalone shed is shown in Figure 2-11 below.

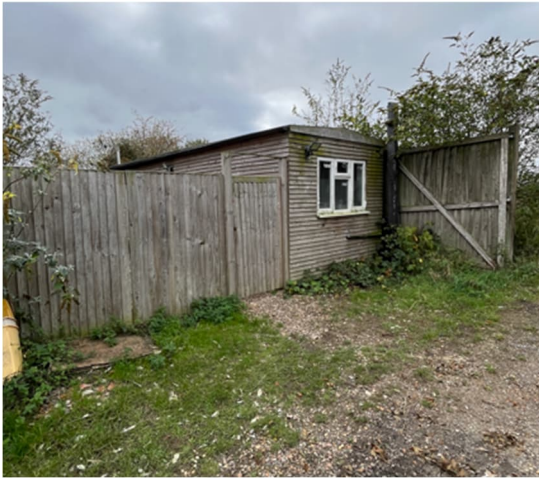
Figure 2-12 Staff Rest Room

- 2.3.16 A standalone staff rest room structure is situated on the southern boundary of the Site. The main structure is predominantly timber and comprises a bitumen and timber roof, double-glazed PVC windows, glass and uPVC entrance doors and some external lighting fixtures.
- 2.3.17 A section of timber fencing extends from the eastern elevation, enclosing a small garden space by a timber gate.
- 2.3.18 The staff rest room is shown in Figure 2-12 below.

- 4.1.10 Similarly, the standalone staff rest room features a similar construction method. The cladding and fencing panels that feature on this structure are in good condition and if dismantled carefully, should be considered for reuse on other projects.

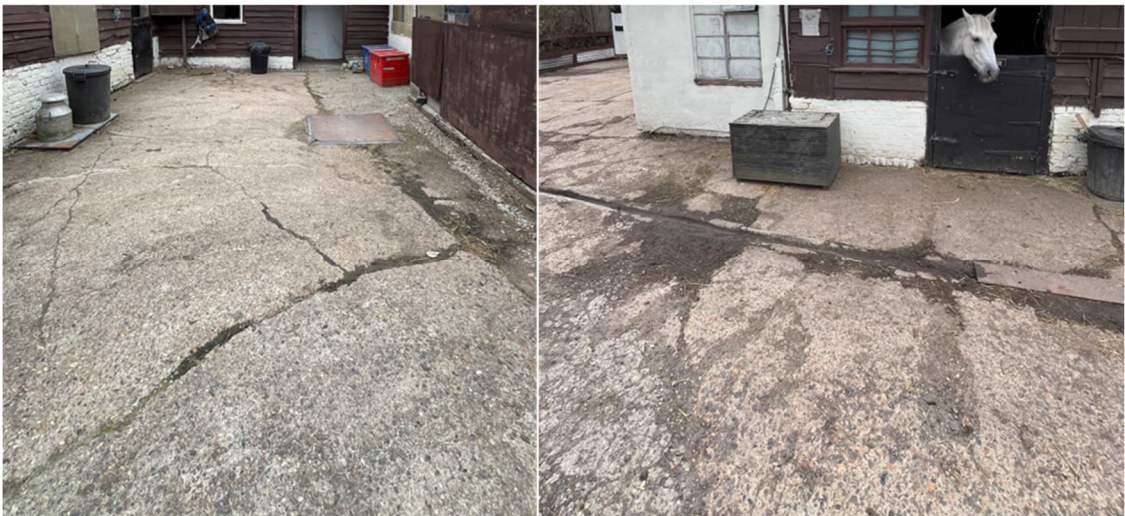
Figure 2-13 Concrete Hardstanding

2.3.19 Concrete hardstanding surfaces are present through the central yard spaces between stables. The hardstanding displays significant wear, surface cracking, and patch repairs.

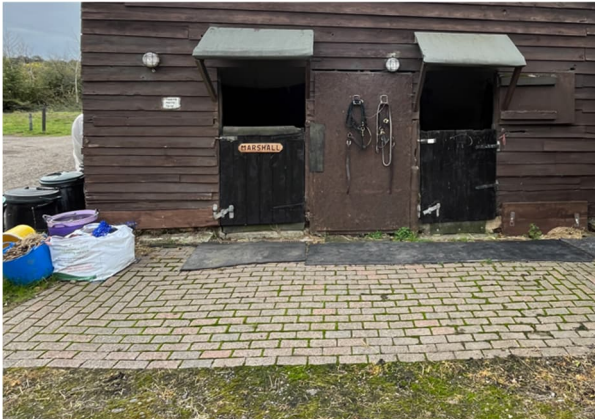
Figure 4-1 Brick Paving

4.1.5 The foot of a large stable on site features brick paving which appears to be in reasonable condition. Though dependent upon the exact demolition methodology, it is anticipated that the bricks should be considered for reuse on other projects.

4.1.7 Figure 4-1 below shows the brick paving at the foot of the northern façade of a large stable on site.

4.1.6 This will be dictated by the demolition methodology, condition of the bricks and market conditions at the time of the process.

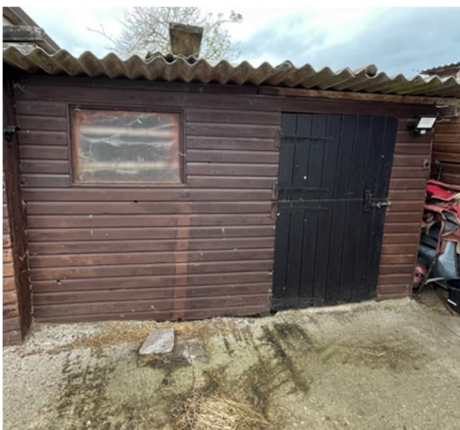
Figure 4-2 Timber Panels - Stables

- 4.1.8 The majority of the elevations of structures within the scope of the audit feature timber panels or cladding, which should be considered for reuse. Although many of the timber panels are of poor quality, there is still an opportunity to reuse those that are still in good condition.

- 4.1.9 Due to the method of construction of the stables, the structures could, in theory, be dismantled. The recovery of such panels will depend on the exact demolition methodology. Given the modular nature of the timber panels and framing, they could be reused on other similar projects.

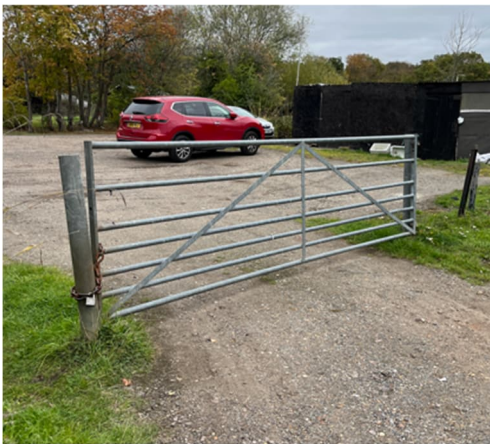
Figure 4-4 Steel Farm Gate

- 4.1.12 There are multiple steel farm gates situated on Ashby Farm, one of which is used to gain entry to the Site via the main entrance. The farm gates, which are supported by two timber posts, are in good condition and should be considered for reinstatement for their original purpose within other similar developments.
- 4.1.13 Figure 4-4 below shows an example steel gate on Ashby Farm.
