SITE INVESTIGATION FACTUAL REPORT

Report No: SI-816196
Client: Crawford Claims Management
Site: 6 Nicholas Way
Hillingdon
Client Ref: SU2205005
Date of Visit: 15/02/2024

Investigation Layout Plan

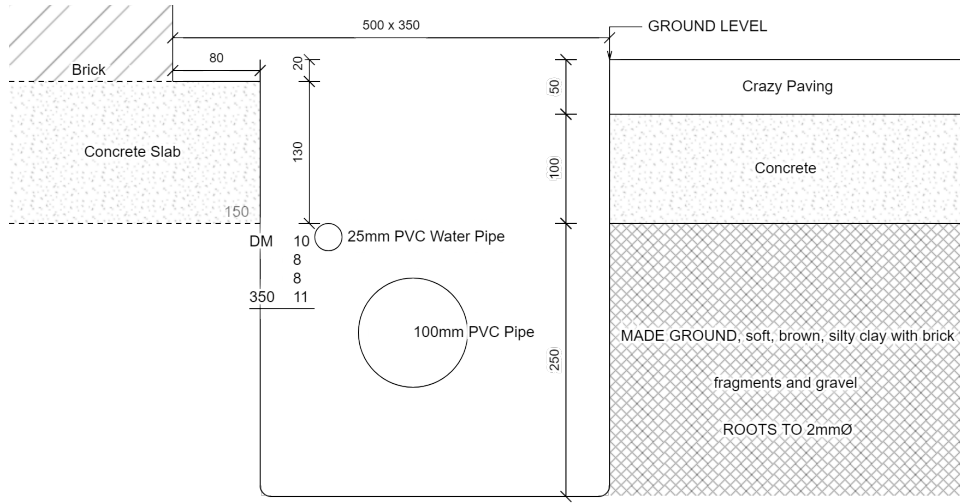
REPORT NUMBER: C1085425 / 286647.1.1.1
 TRIAL PIT REF: TP1
 CLIENT: Crawford & Co
 JOB NO: 816196
 EXCAVATION METHOD: Hand tools

For Strata below 400mm see Bore Hole log

Curved Steel pin driven under concrete 200mm at 150mm below ground level.
