## SITE INVESTIGATION FACTUAL REPORT

Report No: SI-542609  
Client: Crawford Claims Management  
Site: 6 Nicholas Way  
Hillingdon  
Client Ref: SU2205005  
Date of Visit: 19/12/2022

# Investigation Layout Plan

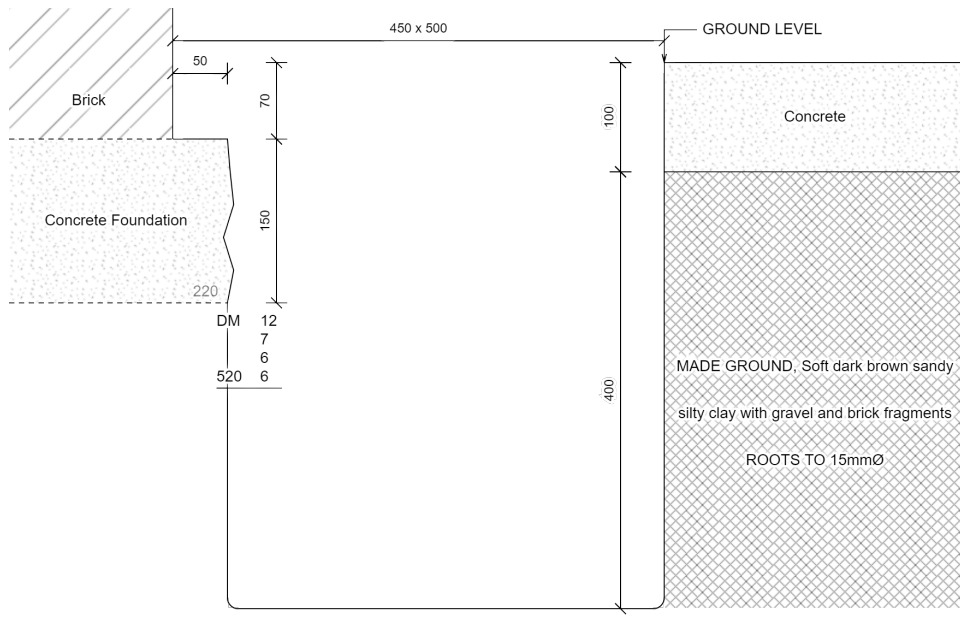
**TEST REPORT:** Trial Pit  
**REPORT NUMBER:** C1071973 / 229932.1.1.2  
**TRIAL PIT REF:** TP1B **DATE:** 09/01/2023  
**CLIENT:** Crawford & Co **SITE:** 6 Nicholas Way  
**JOB NO:** 542609 **WEATHER:** Dry  
**EXCAVATION METHOD:** Hand tools

Trial pit ends at 500mm

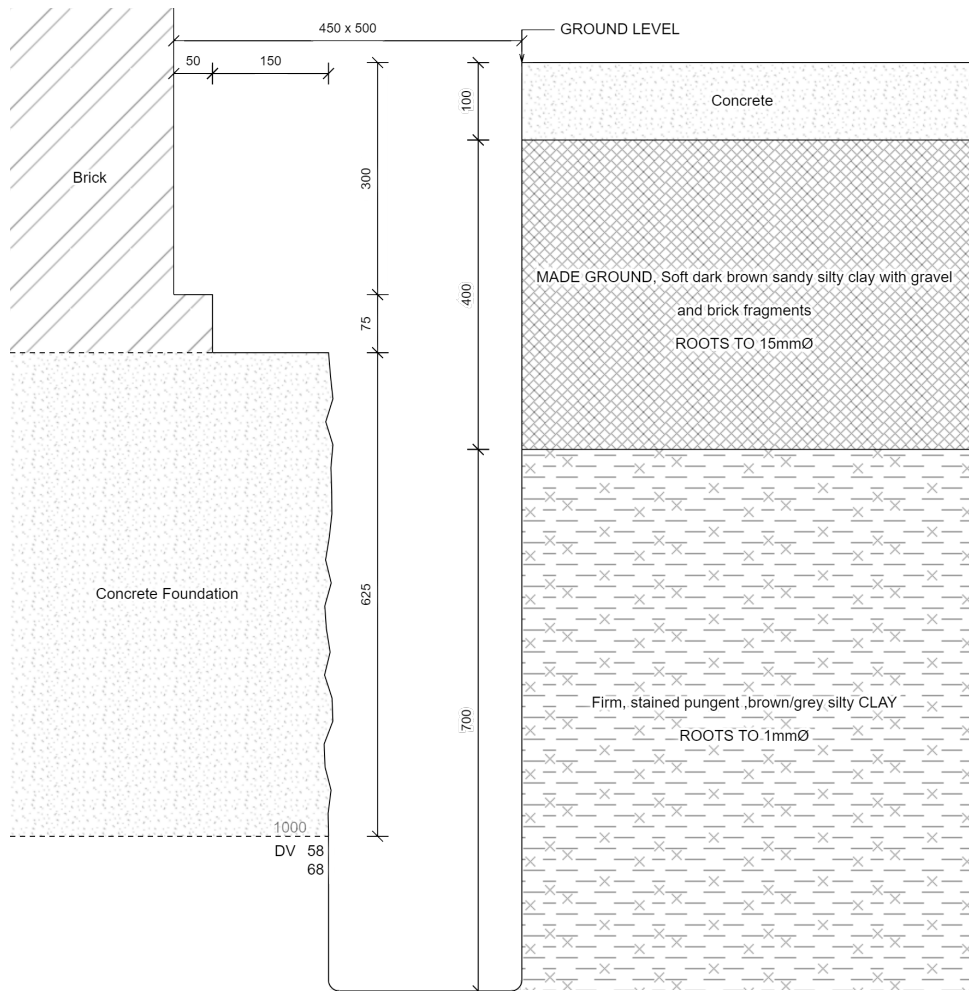
**TEST REPORT:** Trial Pit  
**REPORT NUMBER:** C1071973 / 229932.1.1.1  
**TRIAL PIT REF:** TP1 **DATE:** 09/01/2023  
**CLIENT:** Crawford & Co **SITE:** 6 Nicholas Way  
**JOB NO:** 542609 **WEATHER:** Dry  
**EXCAVATION METHOD:** Hand tools

For Strata below 1200mm see Bore Hole log

Water strike at 375mm, standing water level on completion at 375mm. Unable to avoid water ingress.
