Addendum Arboricultural Report

Subsidence Damage Investigation at:

6 Nicholas Way
Northwood
HA6 2TS

CLIENT:	Crawford & Company
CLIENT REF:	SU2205005
MWA REF:	SUB230609-13370Rev02
MWA CONSULTANT:	Giles Mercer (BSc Hons) David Mahon MICFor
REPORT DATE:	07/05/2025

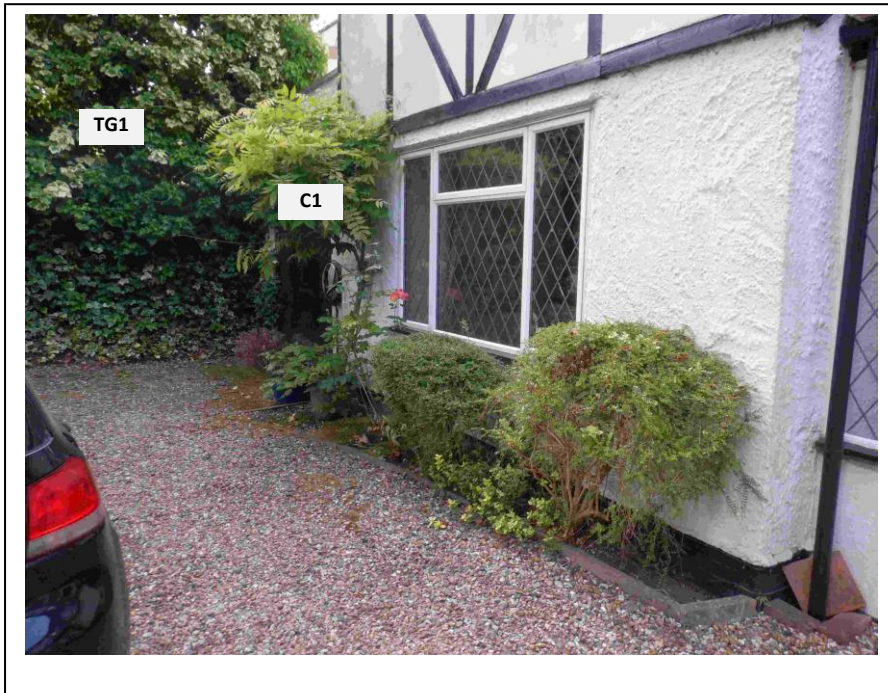
The roots of the Laurel hedge (H1) and the Ivy-covered Cypress group (TG1) are likely to have been present below foundation level in proximity to the area of movement/damage and influencing soil moisture and volumes prior to their removal in February 2025 and late 2023 respectively.

Based on the technical reports currently available, engineering opinion and our own site assessment we conclude root induced clay shrinkage subsidence is a cause of movement/damage. We concluded the Laurel hedge (H1) and the Cypress group (TG1) to be contributory to the damage recommending their removal which has now been completed.

View of C1 and TG1

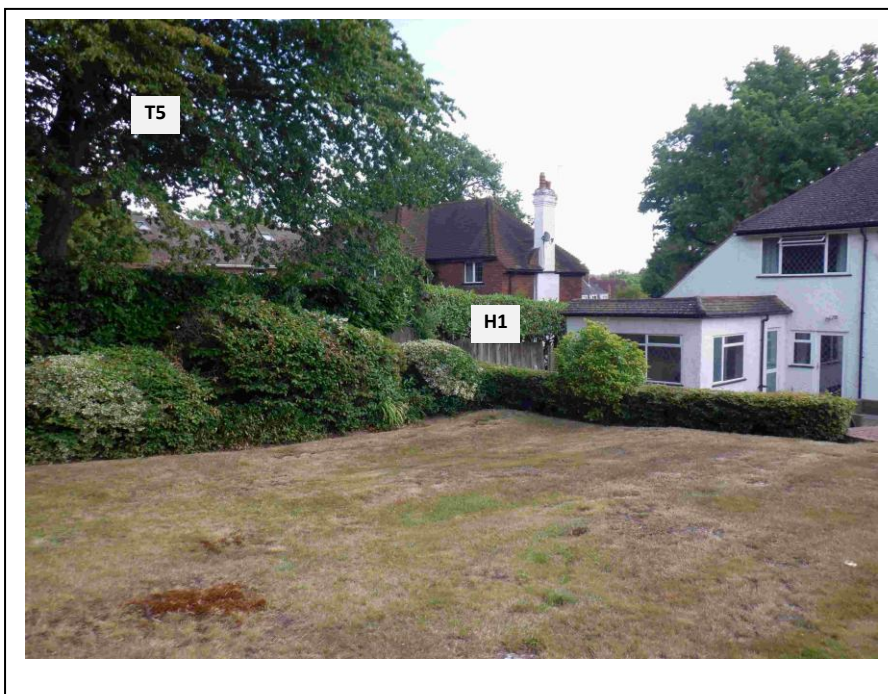
View of H1 and T5

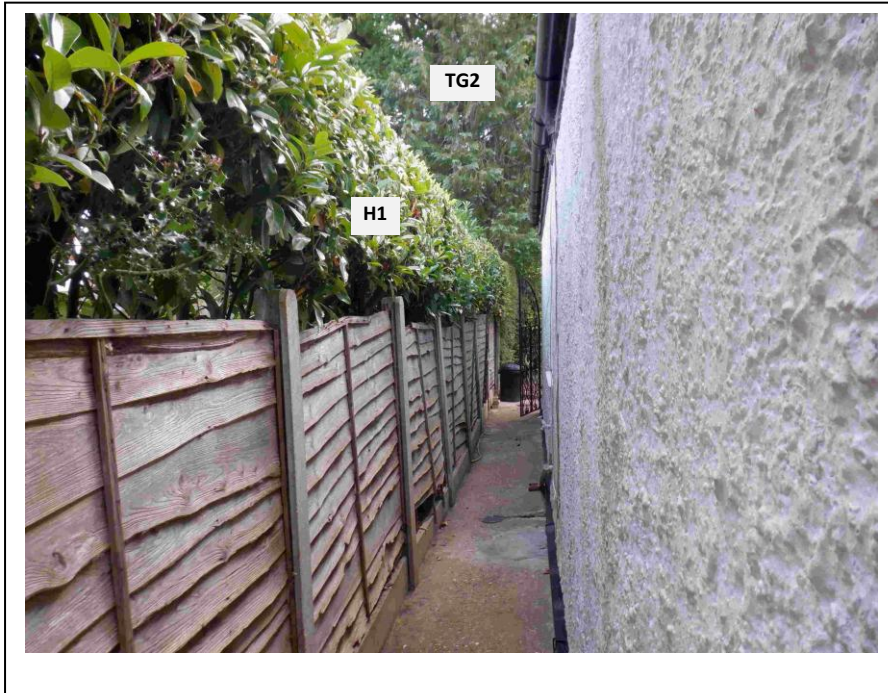
View of H1 and TG2

Management history		No significant recent management noted.					
Recommendation		Do not allow to exceed current dimensions.

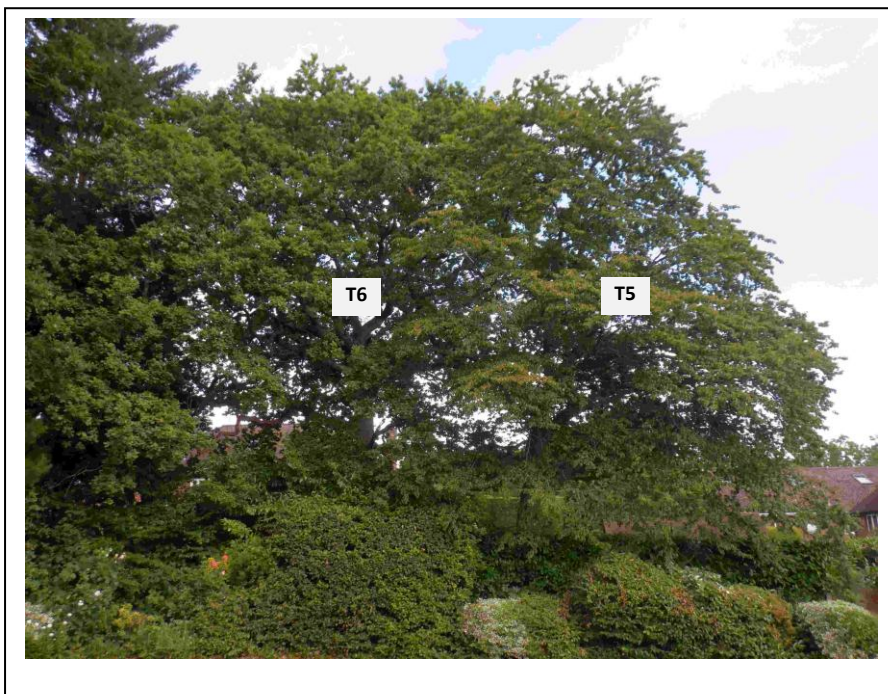
View of T5 and T6

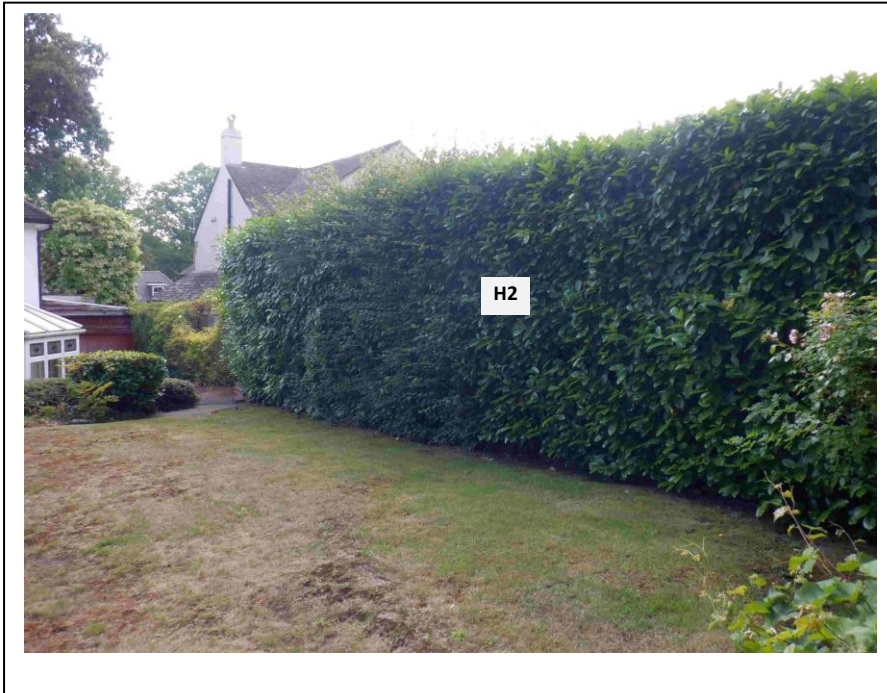
View of H2

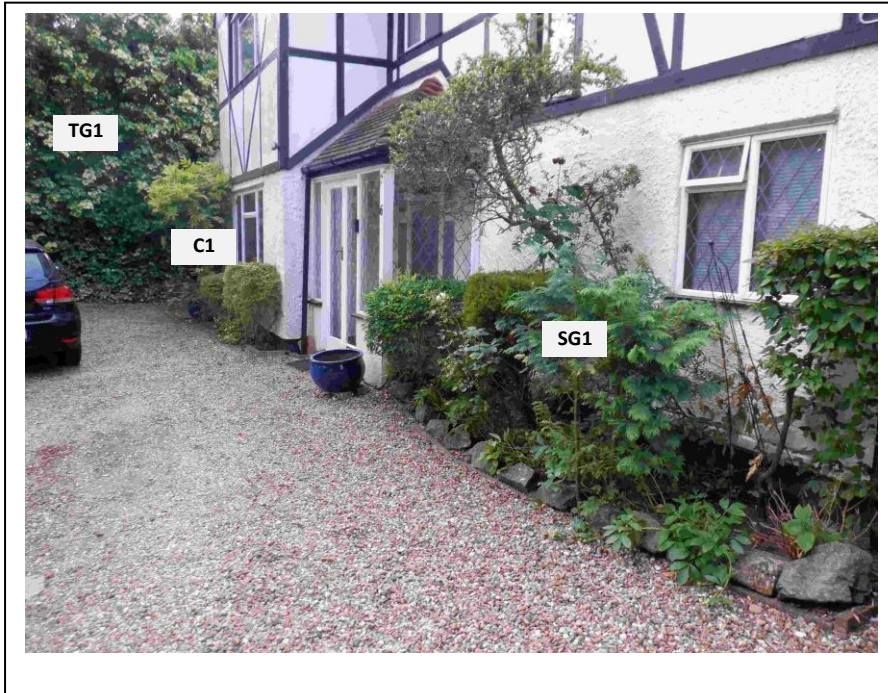
View of SG1, C1 and TG1

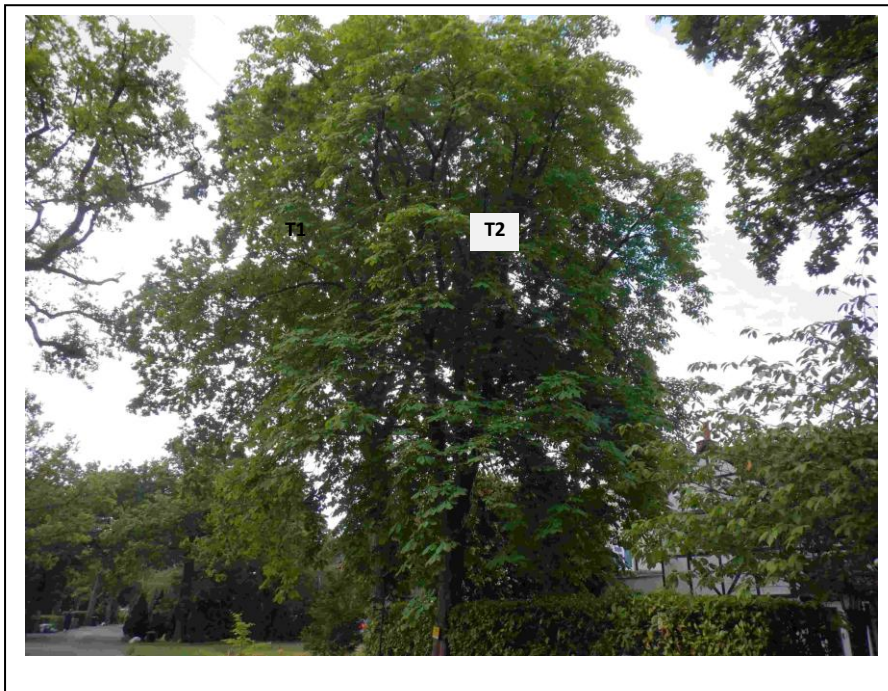
Roots from T1 and T2 were recovered from below foundation level to the front of the garage in the March 2025 ground investigation confirming their influence on soil moisture and volumes.

Level monitoring has recorded a pattern of seasonal movement consistent with the influence of vegetation with the most significant movement at the front left corner of the garage (pin 9) during the summer of 2024 after the removal of TG1 in late 2023 which indicates the influence of T1 and T2.

Based on the root evidence and level monitoring we now consider that the influence of T1 and T2 is established and that both trees are causal to damage warranting their removal.

View of T1 and T2

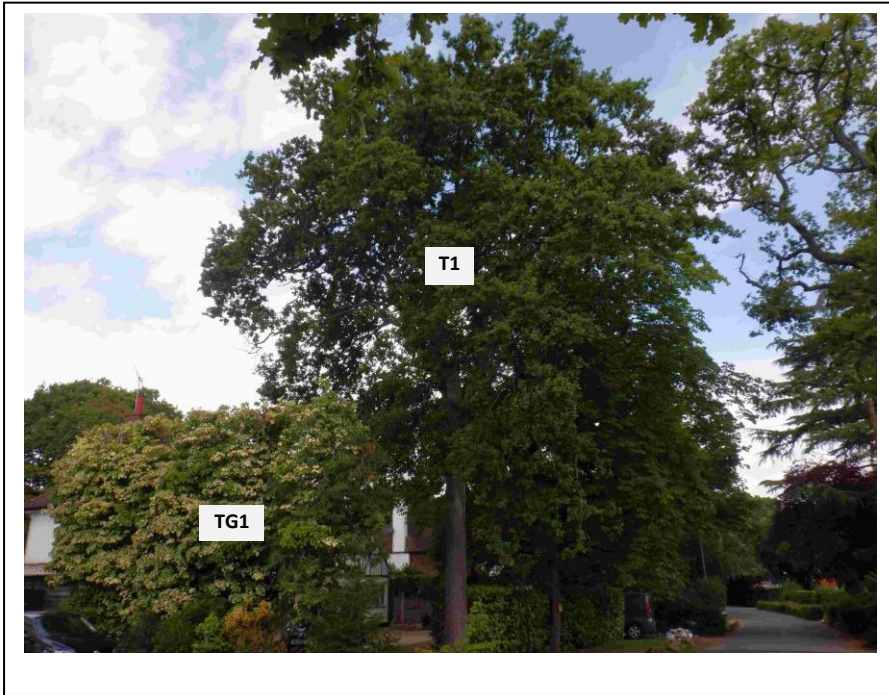
View of T1 and TG1

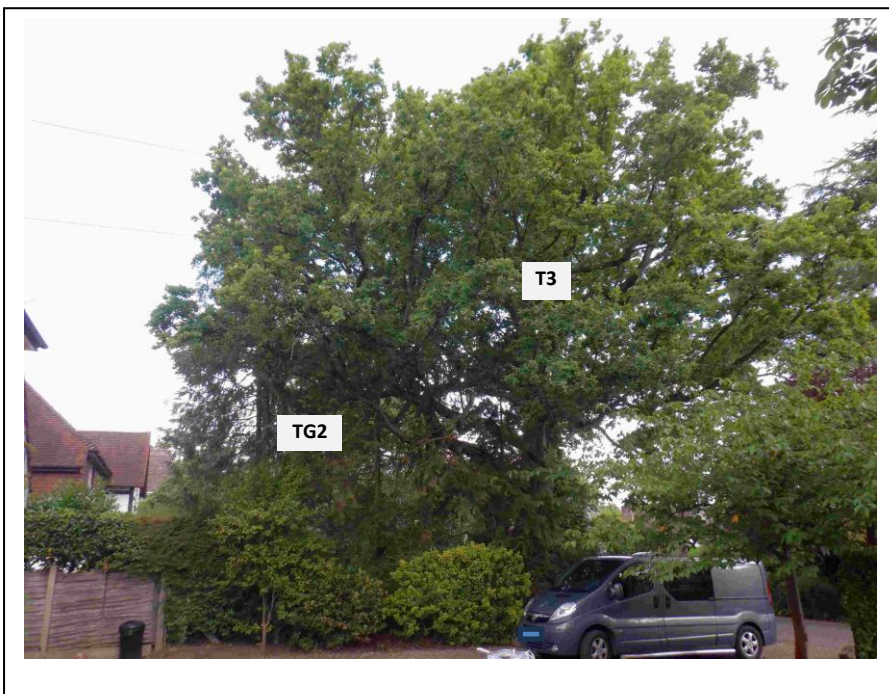
View of T3 and TG2

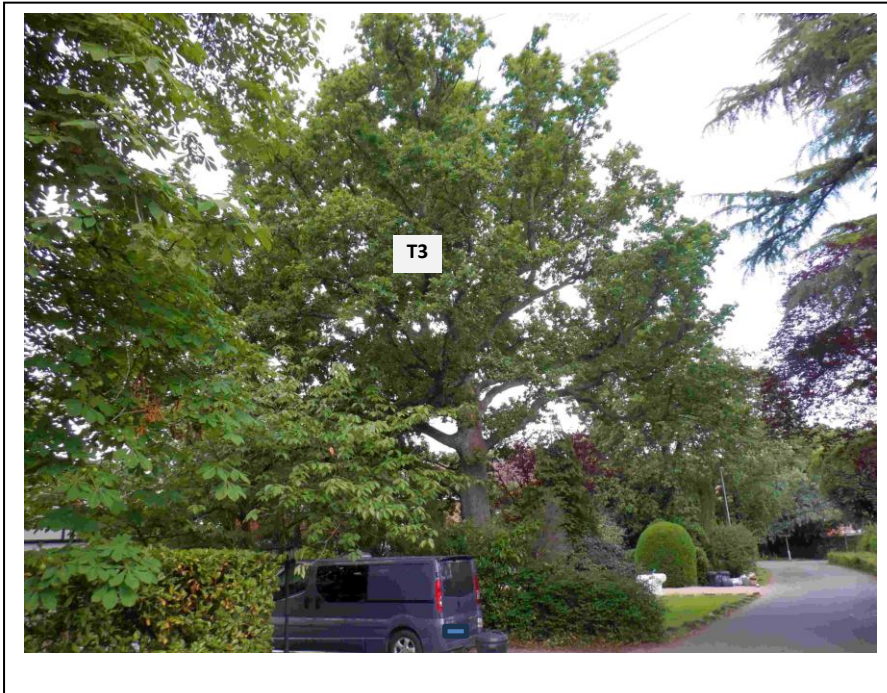
View of T3

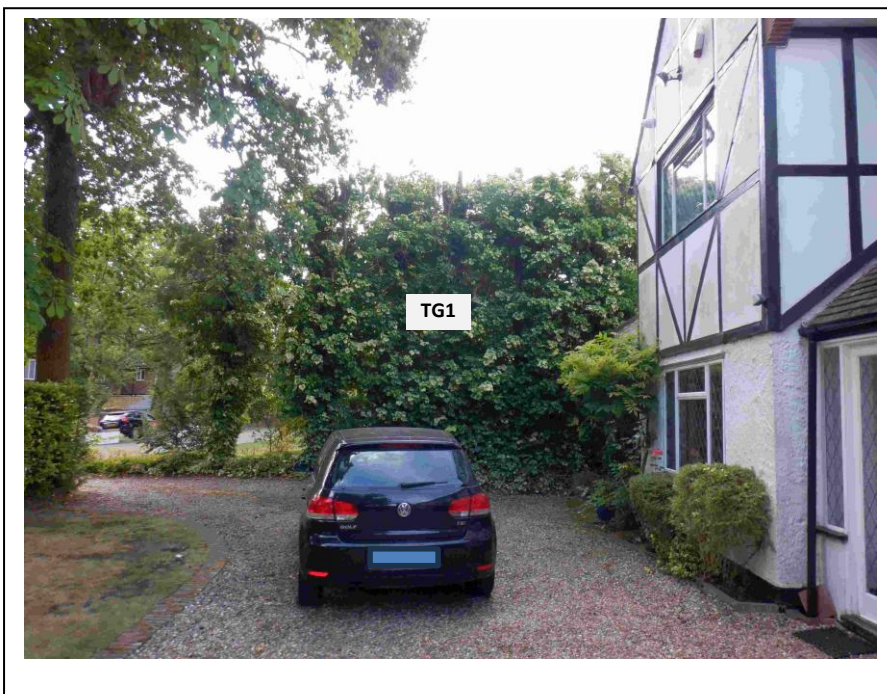
View of TG1

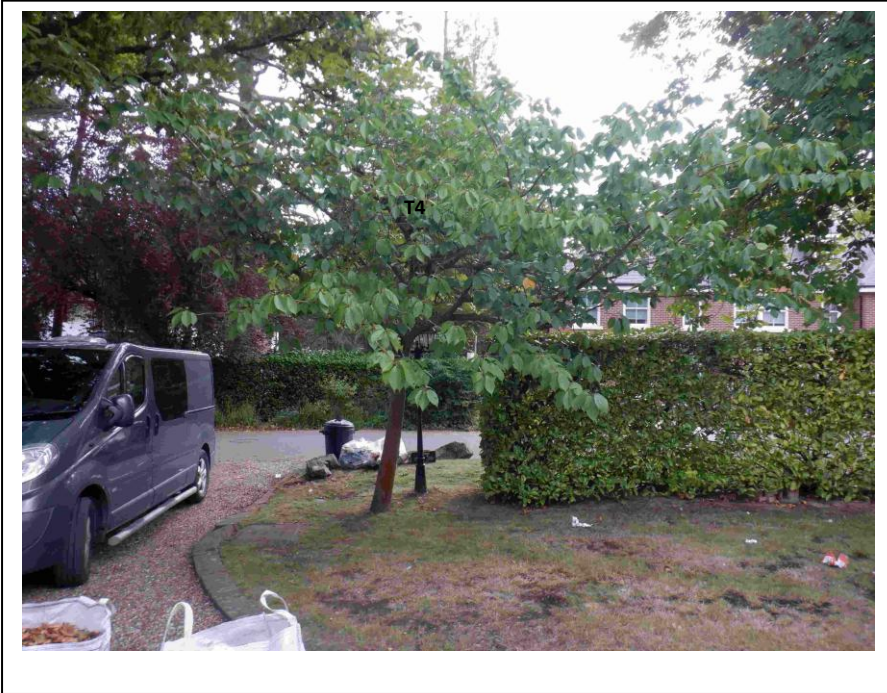
View of T4
