# CBC Structural Report

## Part-Demolition of Existing Building

102 green lane Northwood Middlesex HA6 1AJ

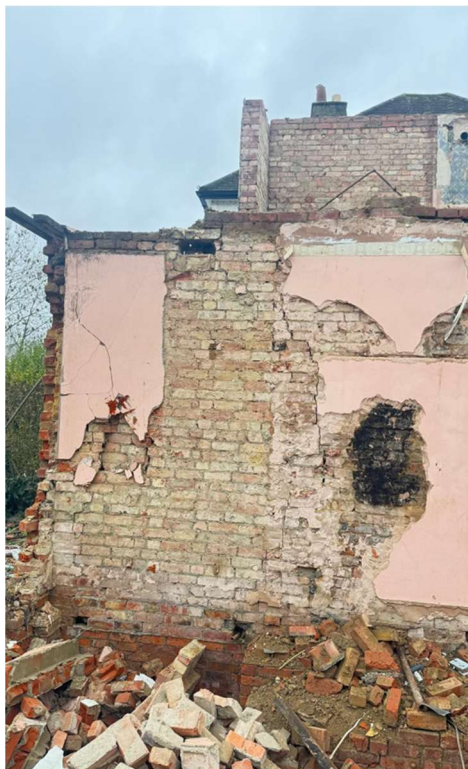
- 1.2.1. The property is a two-storey detached building, which was been built with traditional masonry walls plus its external walls part rendered as well as timber roof. The property has a two-storey bay window at the front elevation. The property could either be a Victorian or Edwardian building and assumed to be built in early 1900.
- 1.2.2. Pictures : - NB These pictures are not exhaustive in showing the full catalogue of damage defects to the property.
- (a) Badly damaged/dilapidated parts of internal wall

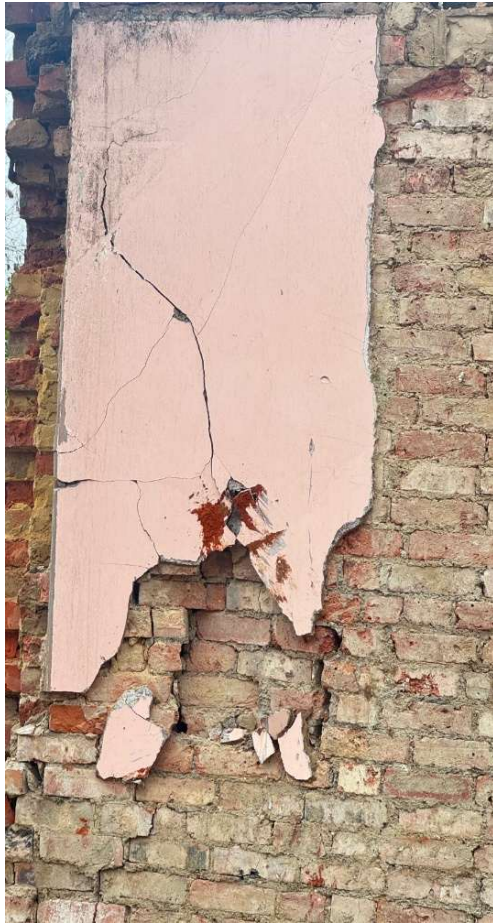
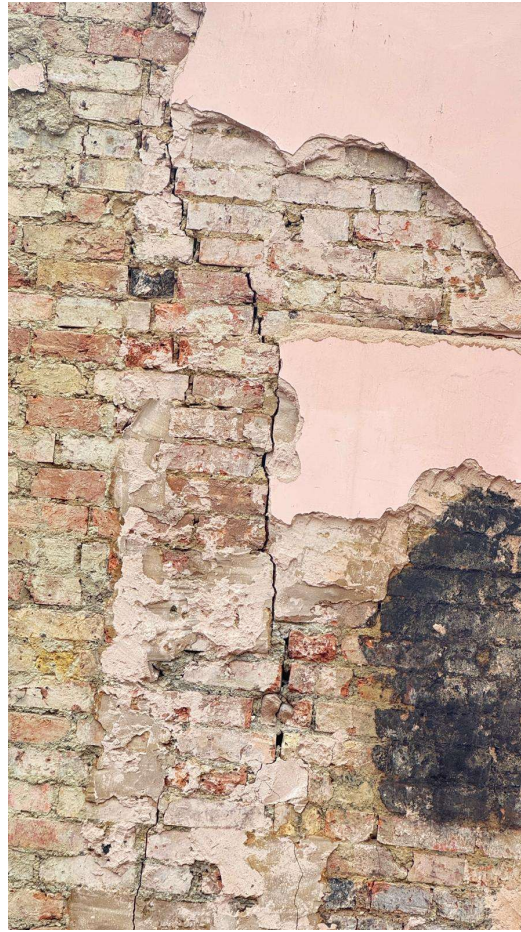
(b) Close-up of category 3 cracks of wall above mentioned in Pic (a)

This wall had been seriously dilapidated and damaged. The cracks on this wall were multiple and of category 3 "**SERIOUS**" according to BRE 251 (table shown below). The fact that these cracks were multiple and the seriousness of any such crack compromises the structural integrity of the building structure.

Moreover the damage was observed to be consistent with cracks generated by subsidence.

| Category of Damage | Approximate crack width (mm) | Description of typical damage<br>Ease of repair in <i>italic type</i> |
|---|---|---|
| 3 | 5mm to 15mm ( or a number of cracks up to 3) | Breaking/down demolition of walls the mentioned -above badly affected walls, due to the afore-mentioned |
| | >10mm | Underpinning and foundation strengthening to be considered for other parts of the building not demolished to avoid further movements due to subsidence. |

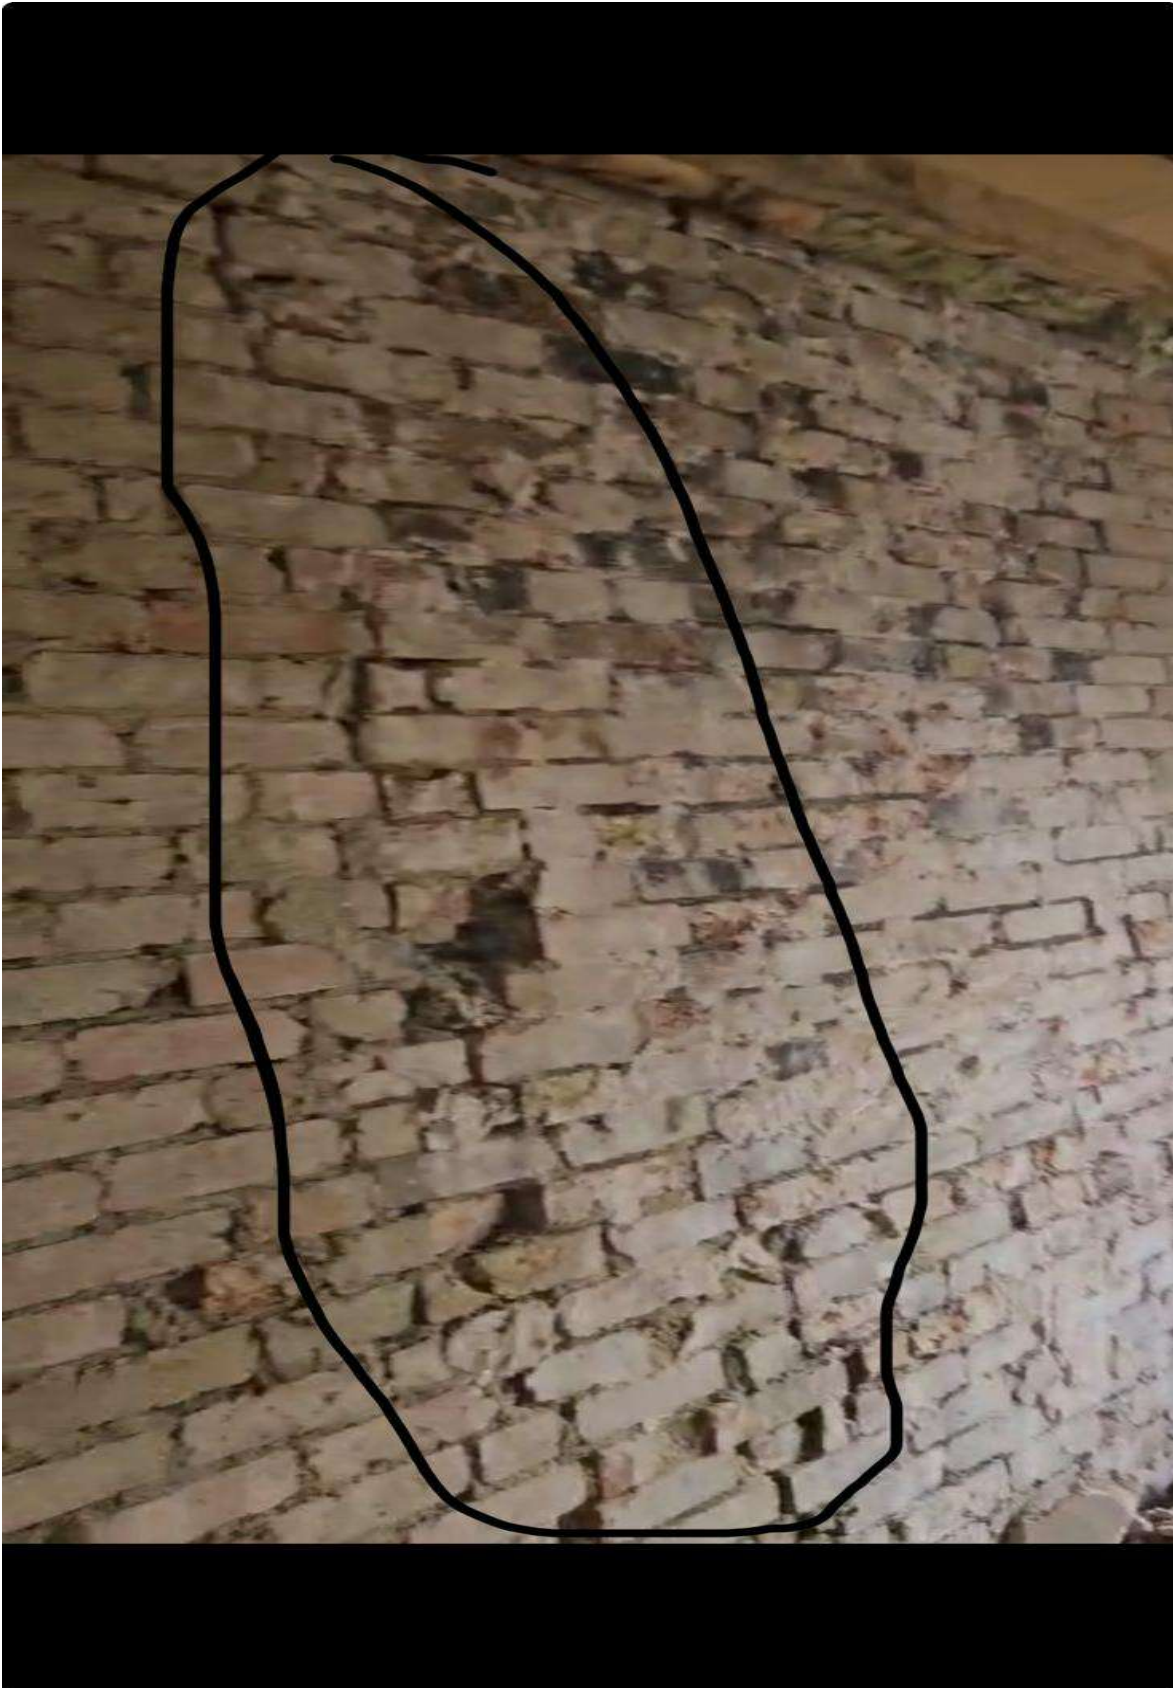
- (c) A typical example of vertical cracks observed of the internal fabric of external/internal walls

- 3.5.1.1. Internal Walls, especially close to the right frontal building area and right flank wall of the first floor were observed to have a general pattern of multiple cracking, broken down, and or partially damaged.
- 3.5.1.2. Multiple vertical cracks on the interior parts of the outside/external wall were observed. These cracks could potentially have resulted from one or more of a combination of the following problems:- (a) Structural movement and or subsidence, (b) Foundation settlement, or (c) Thermal expansion or contraction of the building materials.
