# BS5837:2012

## Tree Survey

44 Murray Road  
Northwood HA6 2YL

Date: 26/03/2025  
Job number: 2707  
Report reference: TGA.2707.TreeSurvey

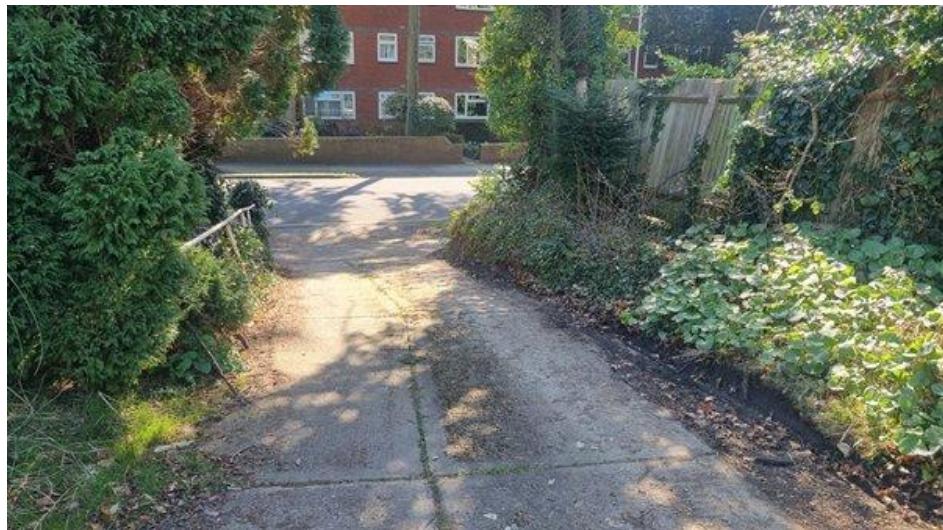
3.2. There is an existing access driveway at the south the site running adjacent to the south western boundary. The access is within the RPA of the adjacent trees, but there would be scope to utilise this access for a new development subject to design, and adherence to an arboricultural method statement to ensure no damage is caused to underlying roots.

**Existing driveway**

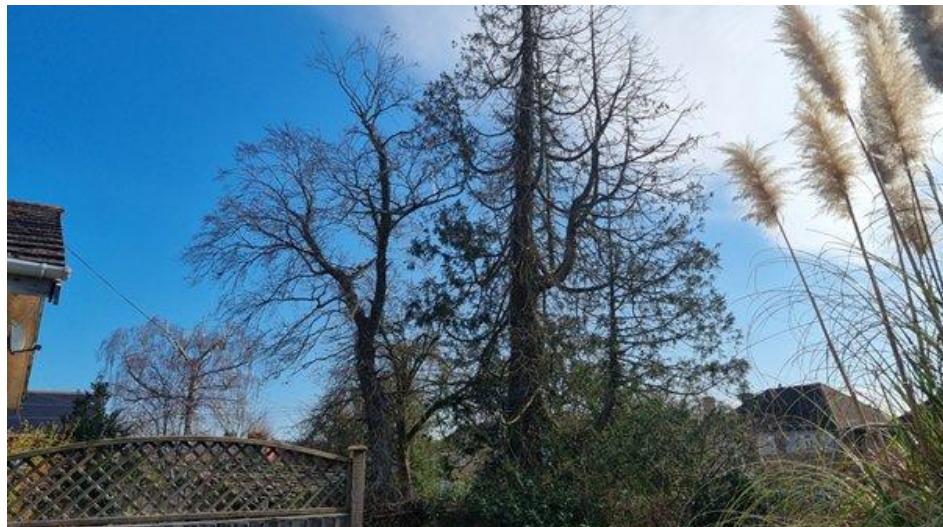
**T3 and T4**

- 4.8. T4 has minimal live foliage for the age and species, and the top 5m of the tree is clearly dead. The cause is unknown, but due to its size could just be attributed to over maturity and natural decline. The tree will not survive beyond 10 years and is therefore U category, and not a constraint in development terms. Again, however the tree is offsite so removal would need to be agreed with the owner and council.

T4	Thuja plicata (Western Red Cedar)	20(4)	750(1)	3, 5, 5.5, 3	M	<10	<p>Offsite tree. Dieback throughout crown, with upper 5m of crown visible dead. Most of the crown has minimal live foliage, and unlikely to have any live growth beyond 10 years, making it U category. Dead ivy on stem where it has been severed.</p> <p><b>Recommend that the tree is removed as good arboricultural management irrespective of any development.</b></p>	U

- 4.5. Where trees are located offsite, these must be considered a constraint to development unless their removal is agreed with the relevant owner.
- 4.6. Trees T3 & T4 are in a very poor condition, and both trees would be recommended for removal as good arboricultural management, irrespective of any development proposals. However, the trees are located offsite within third party ownership, and protected by tree preservation order. Their removal would therefore need to be agreed with the neighbour and subject to TPO application, or full planning permission being granted.

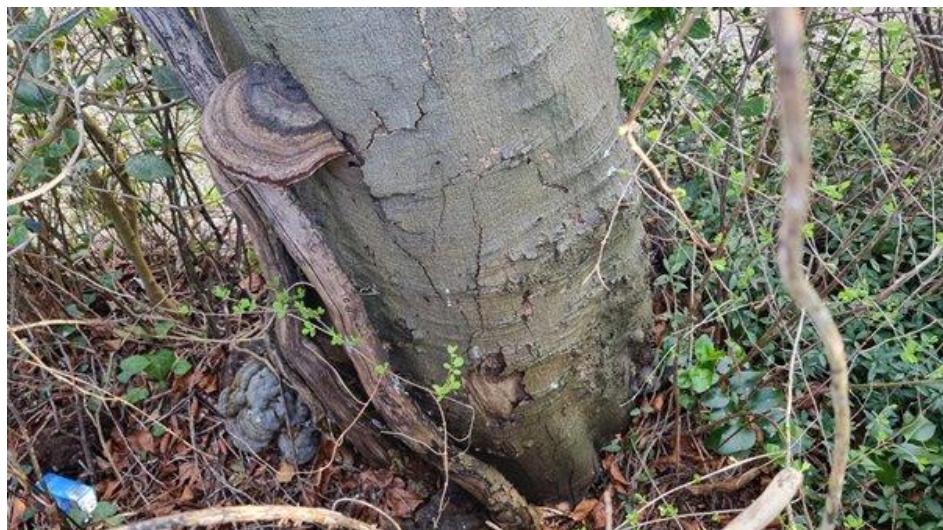
**T3 trunk showing Ganoderma brackets**

- 4.7. T3 is a beech tree with four Ganoderma fruiting bodies growing at the base of the main trunk. Ganoderma is an aggressive decay pathogen which causes degradation of woody tissue within the main stem and roots. It therefore causes main stem failure and 'root heave' due to root decay. The tree represents a significant hazard in terms of health and safety, and it is recommended that the tree is removed, due to the high risk of the tree falling over.
