**Arboricultural Statement:**  
**Virtus Lon 14 – DC6 Prologis Park Heathrow**

**Prepared for:**  
Bouygues Energies + Services  
One Didsbury Point  
2 The Avenue  
Manchester  
M20 2EY

Document reference: 976/25, Revision 0

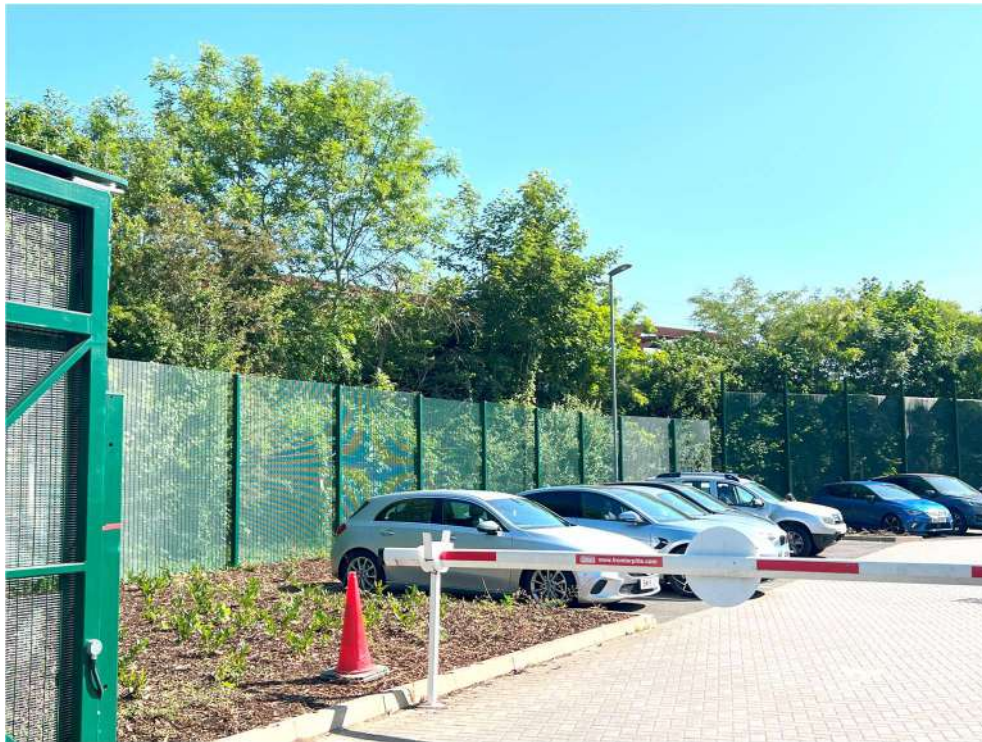
Photograph 1: Showing the third-party tree group beyond the northern boundary in relation to the internal security fence and car park.

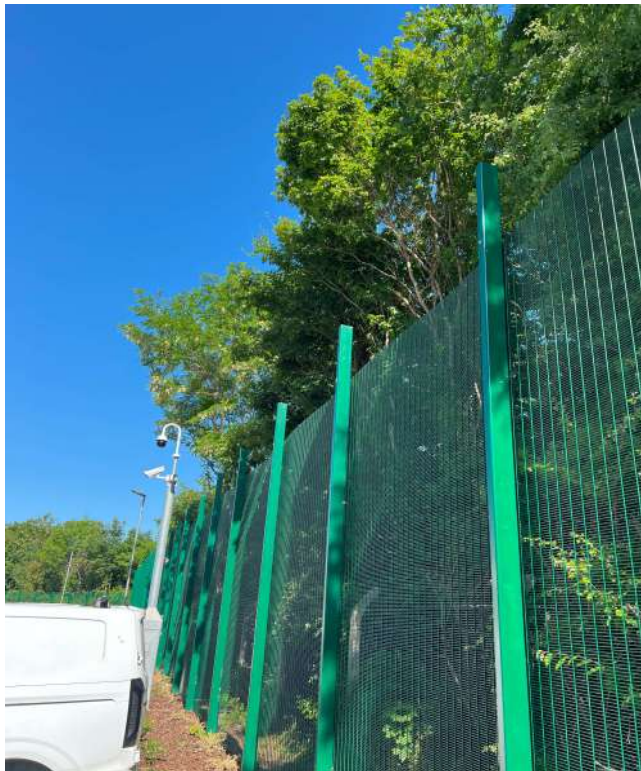
Photograph 2: Trees were previously pruned to provide clearance to the fence and CCTV masts. There is no obvious negative impact as a result of previous root severance.

- 4.4 In the main, the tree belt to the north of the car park has not manifested any significant symptoms of stress following the previous trench associated with the installation of the taller security fence itself.

- 4.5 Minor internodal stubs remain where internodally pruned branches have died back to the next live junction point. Given the context of the tree group, no remedial further pruning work is necessary at this stage.

- 4.6 It is noted that, in the long term, additional selective branch pruning for overhanging elements will be necessary in order to maintain clearance from both the lamp columns intended to illuminate the car park but also the CCTV pole positioned along this boundary. Currently there is at least 1.5m clearance from these points of infrastructure, meaning that it would likely be necessary to review tree pruning to give clearance in around 2027/2028. Such works can be specified and carried out in accordance with best practice.

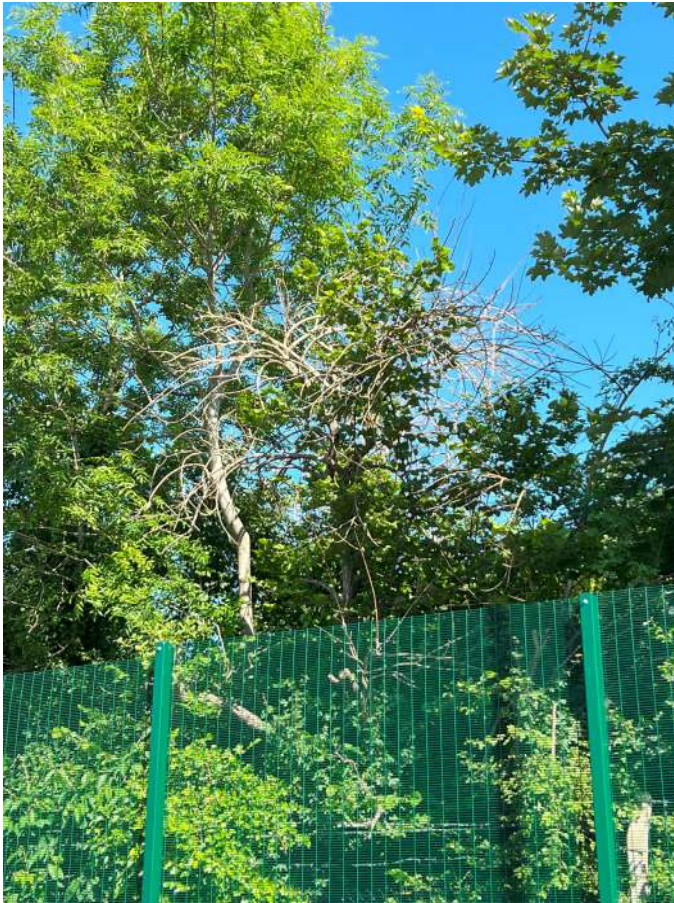
Photograph 3: Only a minor willow stem has died back. This poses no safety/security concern and has live growth from an adjacent hazel intermingling.

- 4.3 Only one modest dying-back willow stem was noted in the off-site tree belt due north of the site boundary. This is intermingled with live growth of a younger hazel shrub beneath and does not pose any significant safety concern to either the internal car parking area or the boundary security fence.

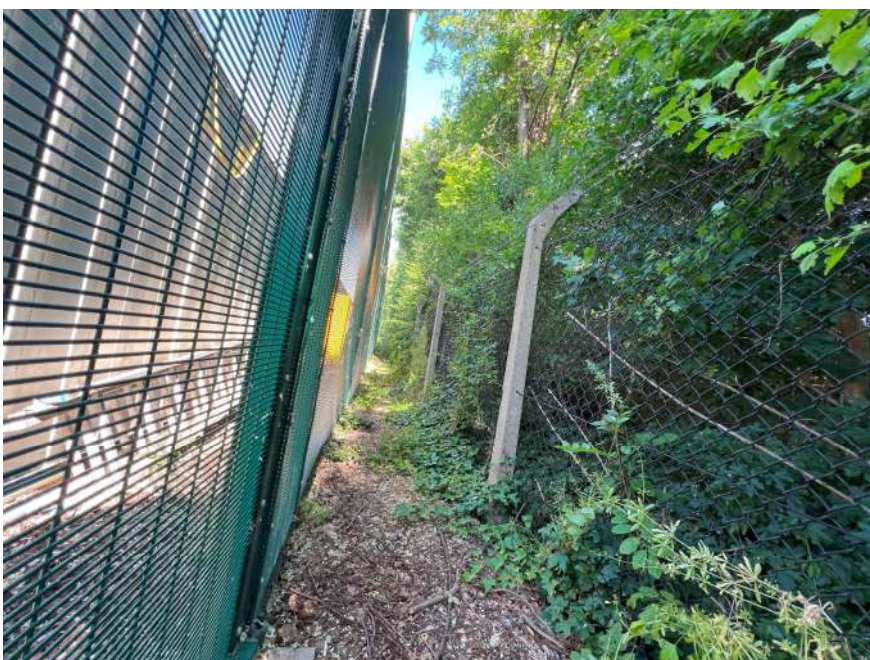
Photograph 4: Access strip with gate allows for future maintenance.

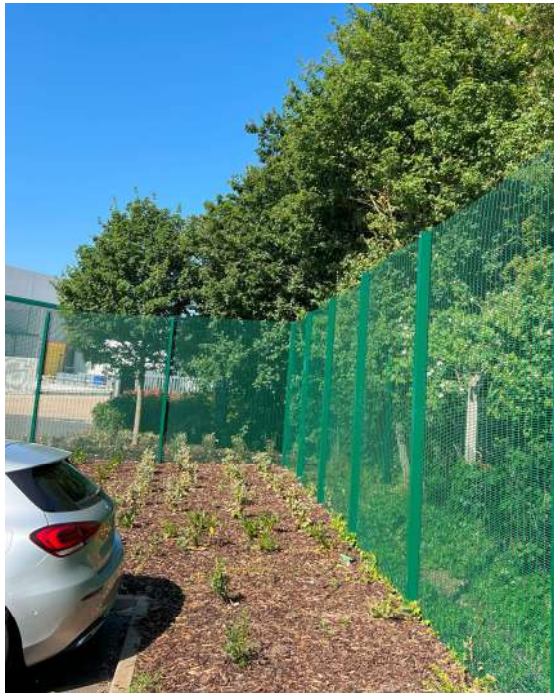
Photograph 5: Landscaping has been planted without any deep cultivation.

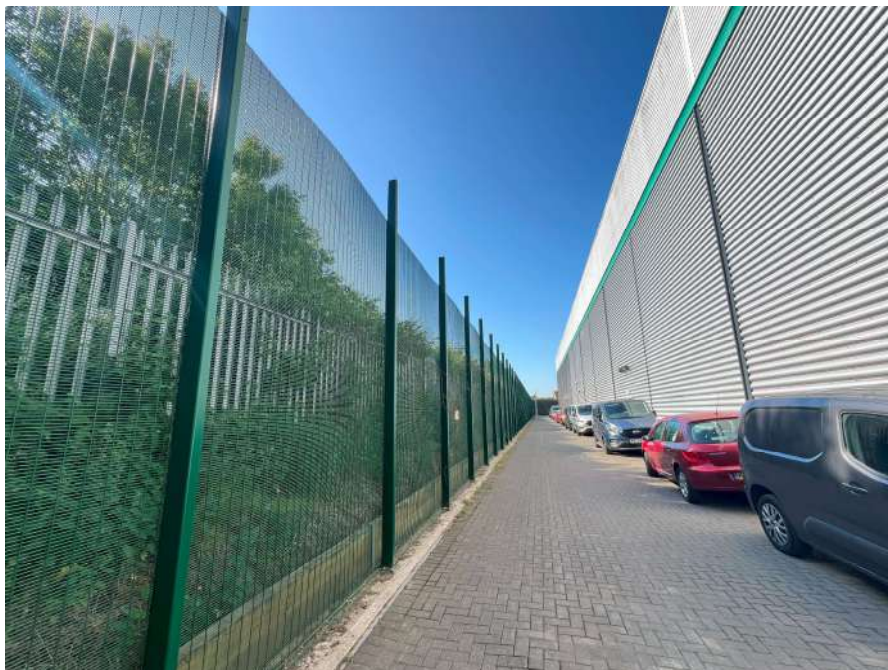
Photograph 6: Trees along the eastern boundary are all beyond the original palisade fence.

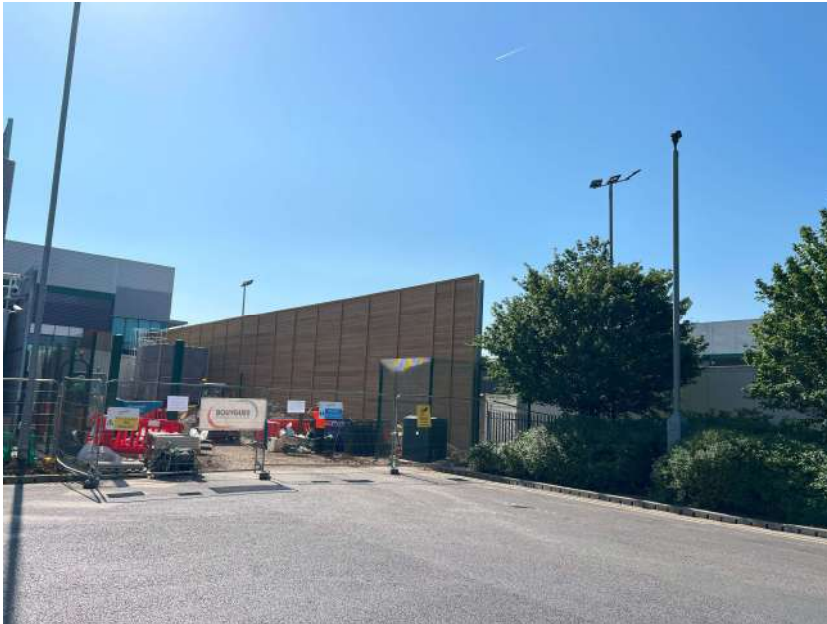
Photograph 7: The acoustic barrier has not impacted the retained trees along the southern boundary.

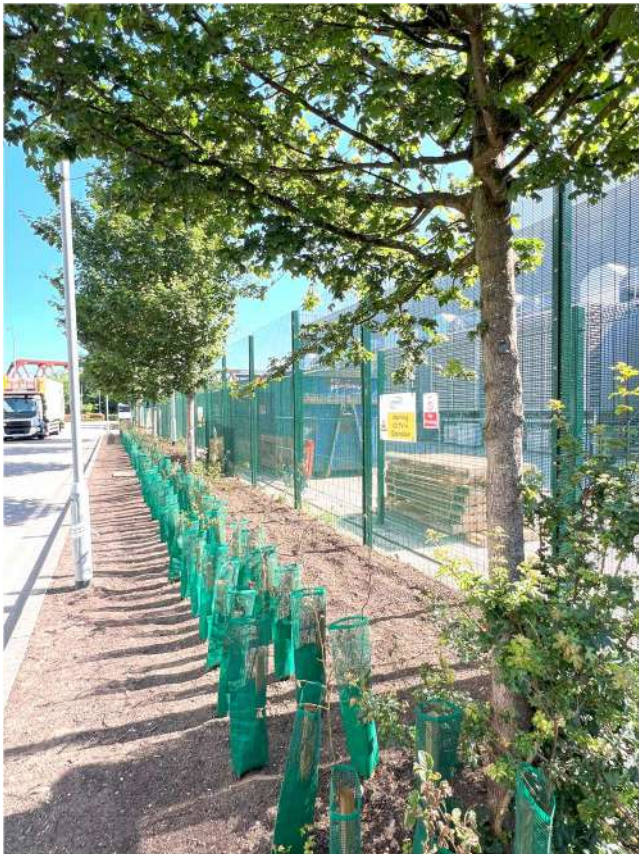
Photograph 8: the existing infrastructure tree planting along the western boundary remains and a new native hedge has been planted.

- 4.7 Recently established trees will require an ongoing regime of maintenance, watering and monitoring to ensure successful establishment. No other specific points of arboricultural post-construction monitoring are necessary or justified.
