Harlington School

Remediation Strategy and Verification Report Update

Wates
Construction

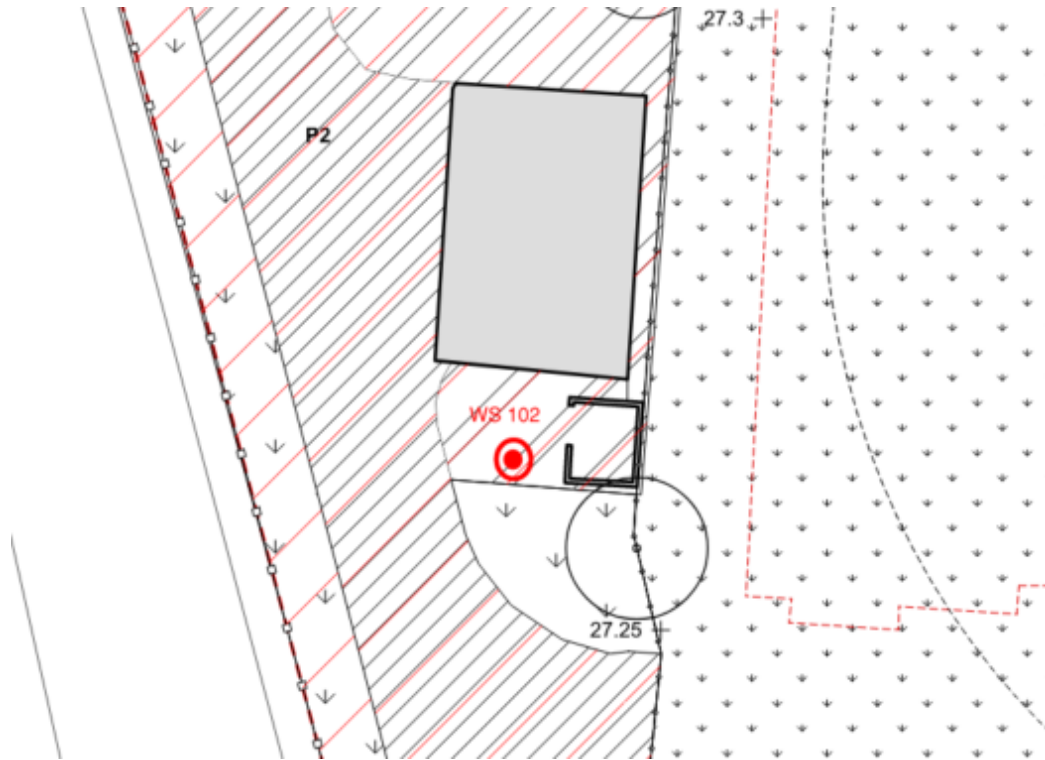
As indicated on the approved landscape design drawings, WS102 lies within an existing soft-landscaped area intended for retention in the final layout. The area was not proposed for excavation as part of the build works, and therefore the assumptions made within the original remediation strategy did not align with the final design intent.

Figure 1 WS102 location in proposed landscaping general arrangement drawing 102451-ALA-00-XX-DR-L-0021

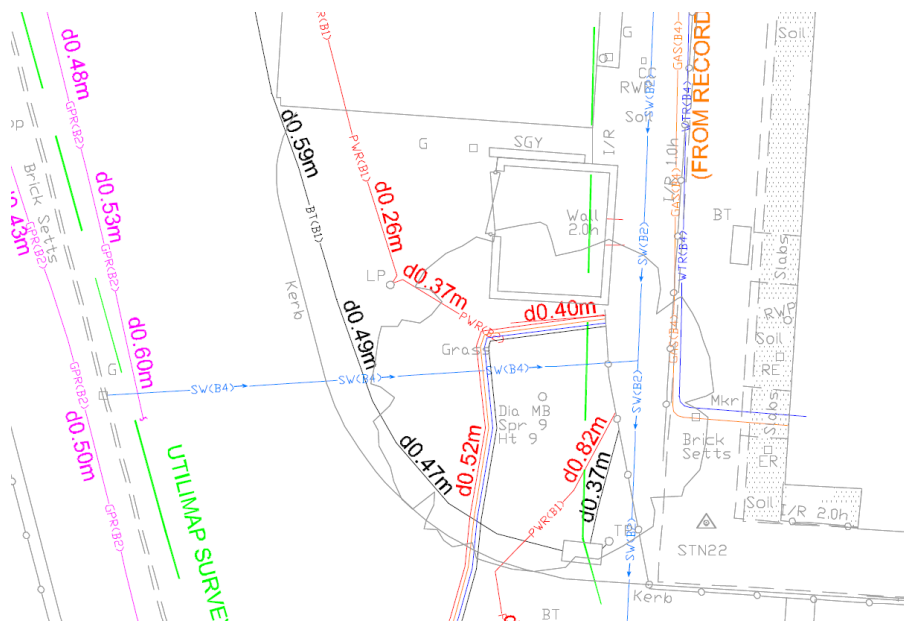
Under HSE HSG47 – Avoiding Danger from Underground Services (2014), intrusive excavation in the vicinity of live services must be minimised and, where unavoidable, undertaken only via carefully controlled methods such as hand digging or vacuum excavation.

- Hand digging within asbestos contaminated soils would conflict with Regulation 11 of the Control of Asbestos Regulations 2012 (CAR 2012), which requires exposure to be prevented or reduced to the lowest practicable level.
- Vacuum excavation is unsuitable due to the risk of fibre contamination of plant and cross-contamination of adjacent ground.

Figure 4 – Extract of GPR existing buried services to remediation zone

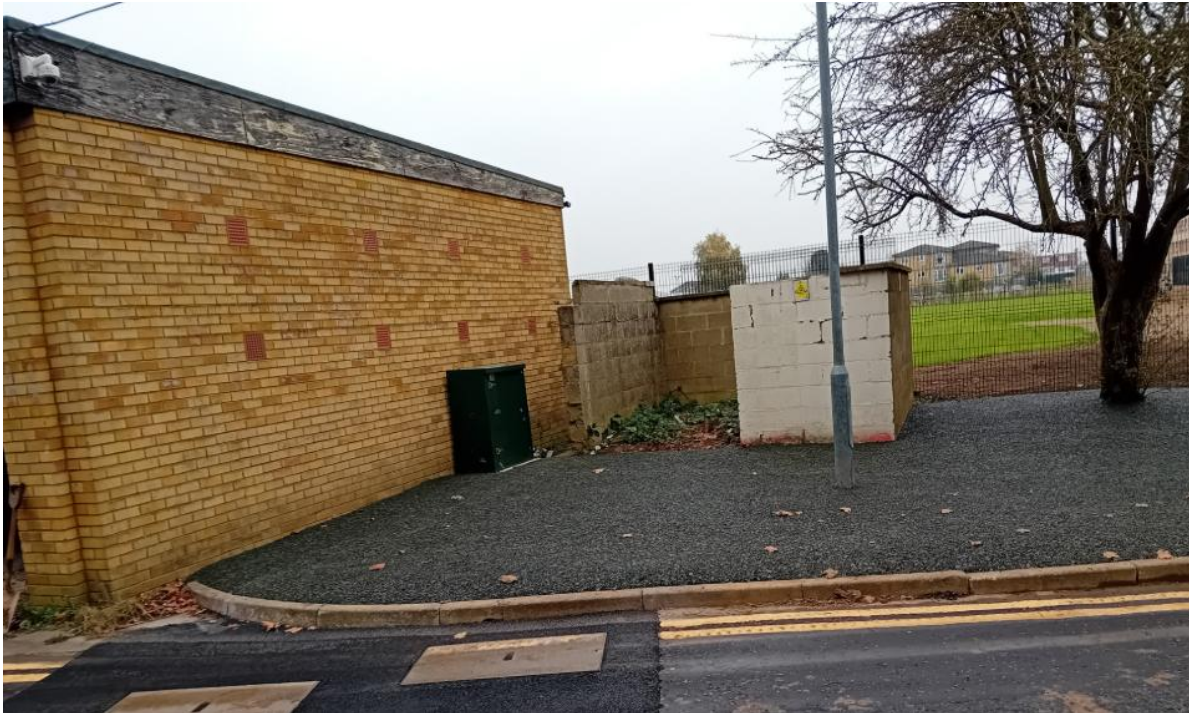
Figure 5 photo of location of WS 102 capped off with proprietary bonded granular rubber mulch

- Capping of the area using a proprietary bonded granular rubber mulch system
- Remediation area increased to approximately 9 m x 12 m, significantly larger than the footprint in the RSK strategy

- Full encapsulation of the impacted soils, consistent with best practice outlined in CIRIA C733 – Asbestos in Soil and Made Ground (2014)

This solution mitigated putting people at risk of asbestos exposure, potential further risk of the extent of asbestos being larger than just the extent of the window sample location and clashing further with the RPZ of the nearby tree, which would then require an encapsulation approach in any case.

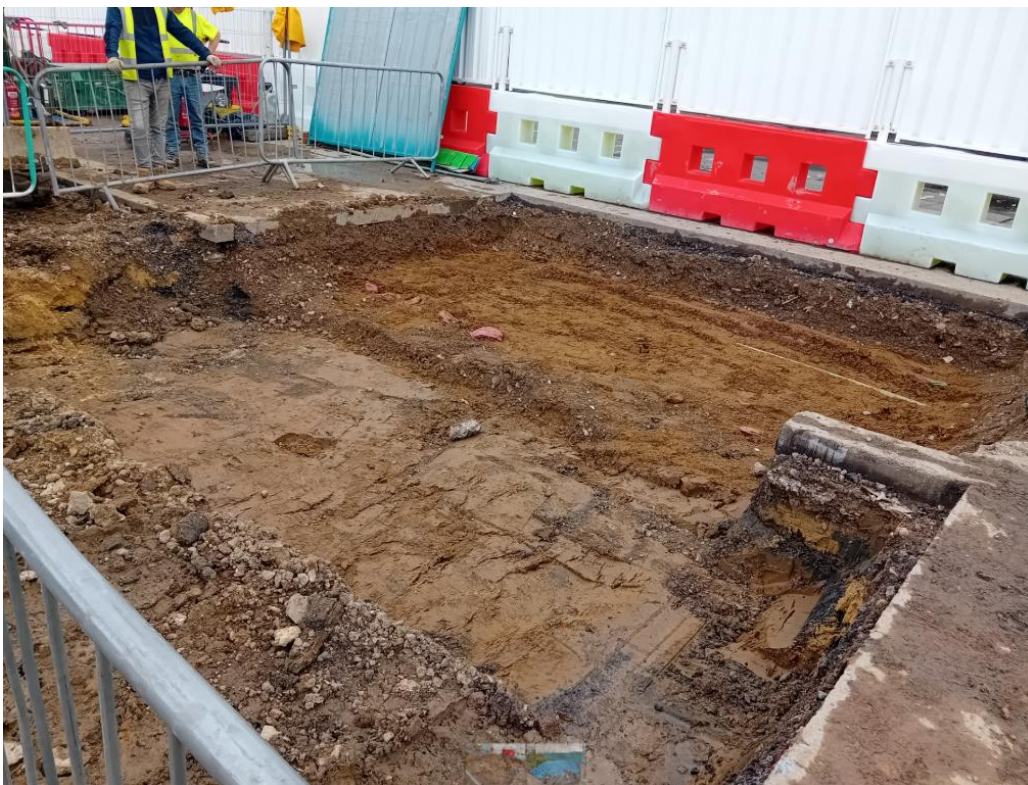
Figure 6 – photo of excavated remedial area of WS 103

- 5 m x 5 m excavation to 0.6 m depth
- Removal of all arisings by a licensed asbestos waste carrier in compliance with the Hazardous Waste Regulations 2005 and the Environmental Protection Act 1990 (Duty of Care)
- Verification samples taken at base and external edges of excavation, to prove extent of contaminated area. Results can be seen in the appendices, confirming no asbestos present.
- Replacement of the excavated area with engineered fill to suit the new road and hard-standing construction
- Photographic verification of excavation, waste arisings, and reinstatement (Figures 6–8)

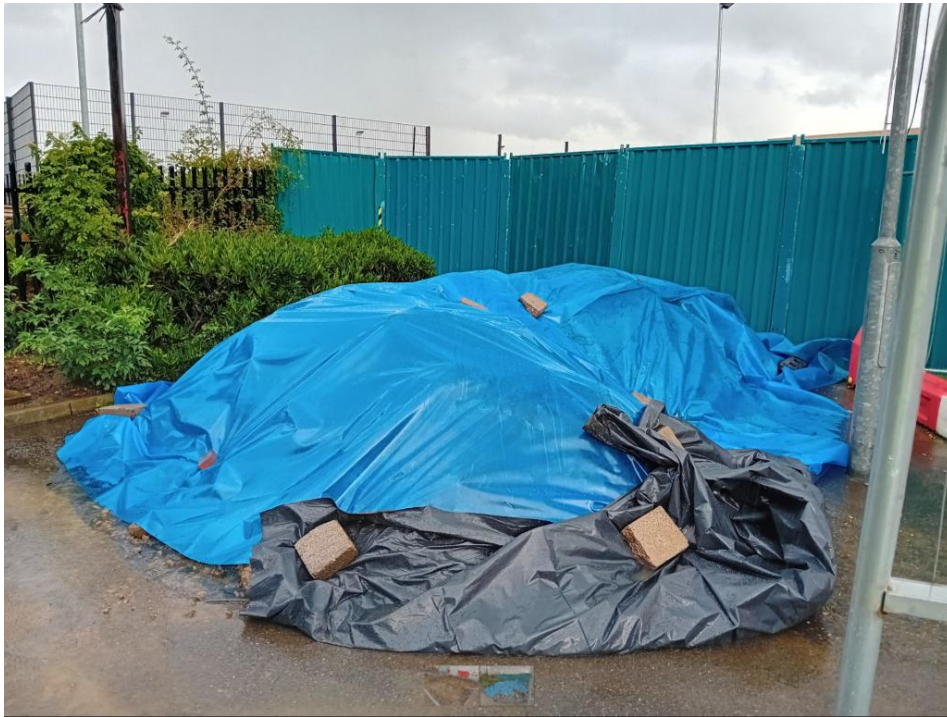
Figure 7 – photo of spoil heap / arisings from remediated area of WS 103

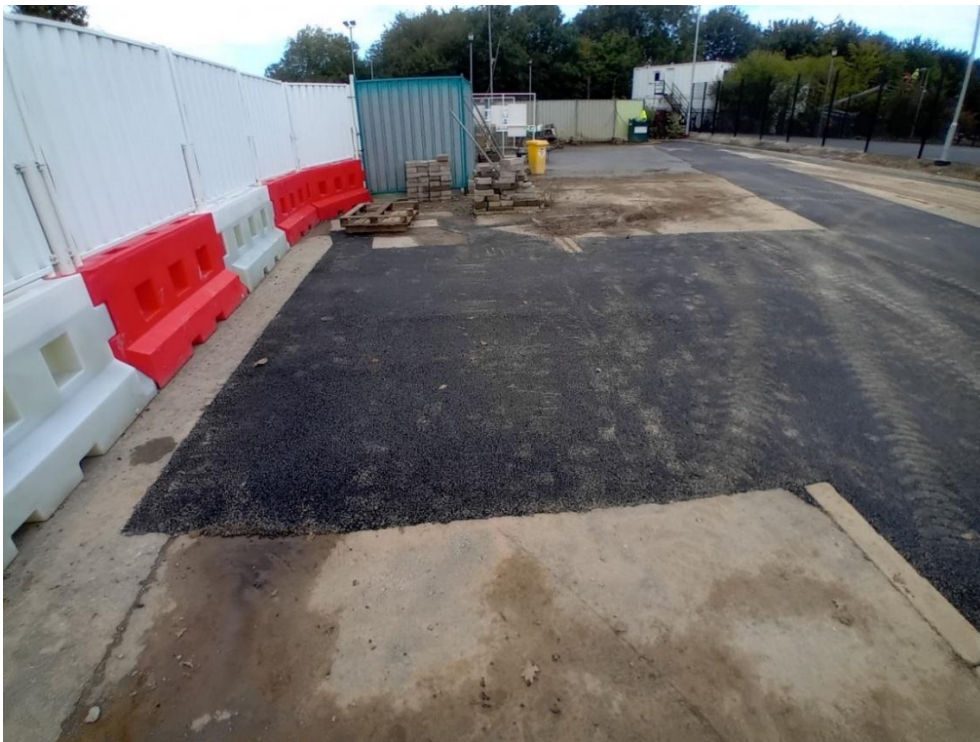
Figure 8 - photo of hard surfacing to remediated area of WS 103

No soil samples are available because the remediated area was excavated, removed, and subsequently hard-surfaced.
