### **Arboricultural Report**

**Whiteheath Junior School, Whiteheath Avenue  
Ruislip, HA4 7PR**

Date: 24<sup>th</sup> April 2019

Ref: TH 1965

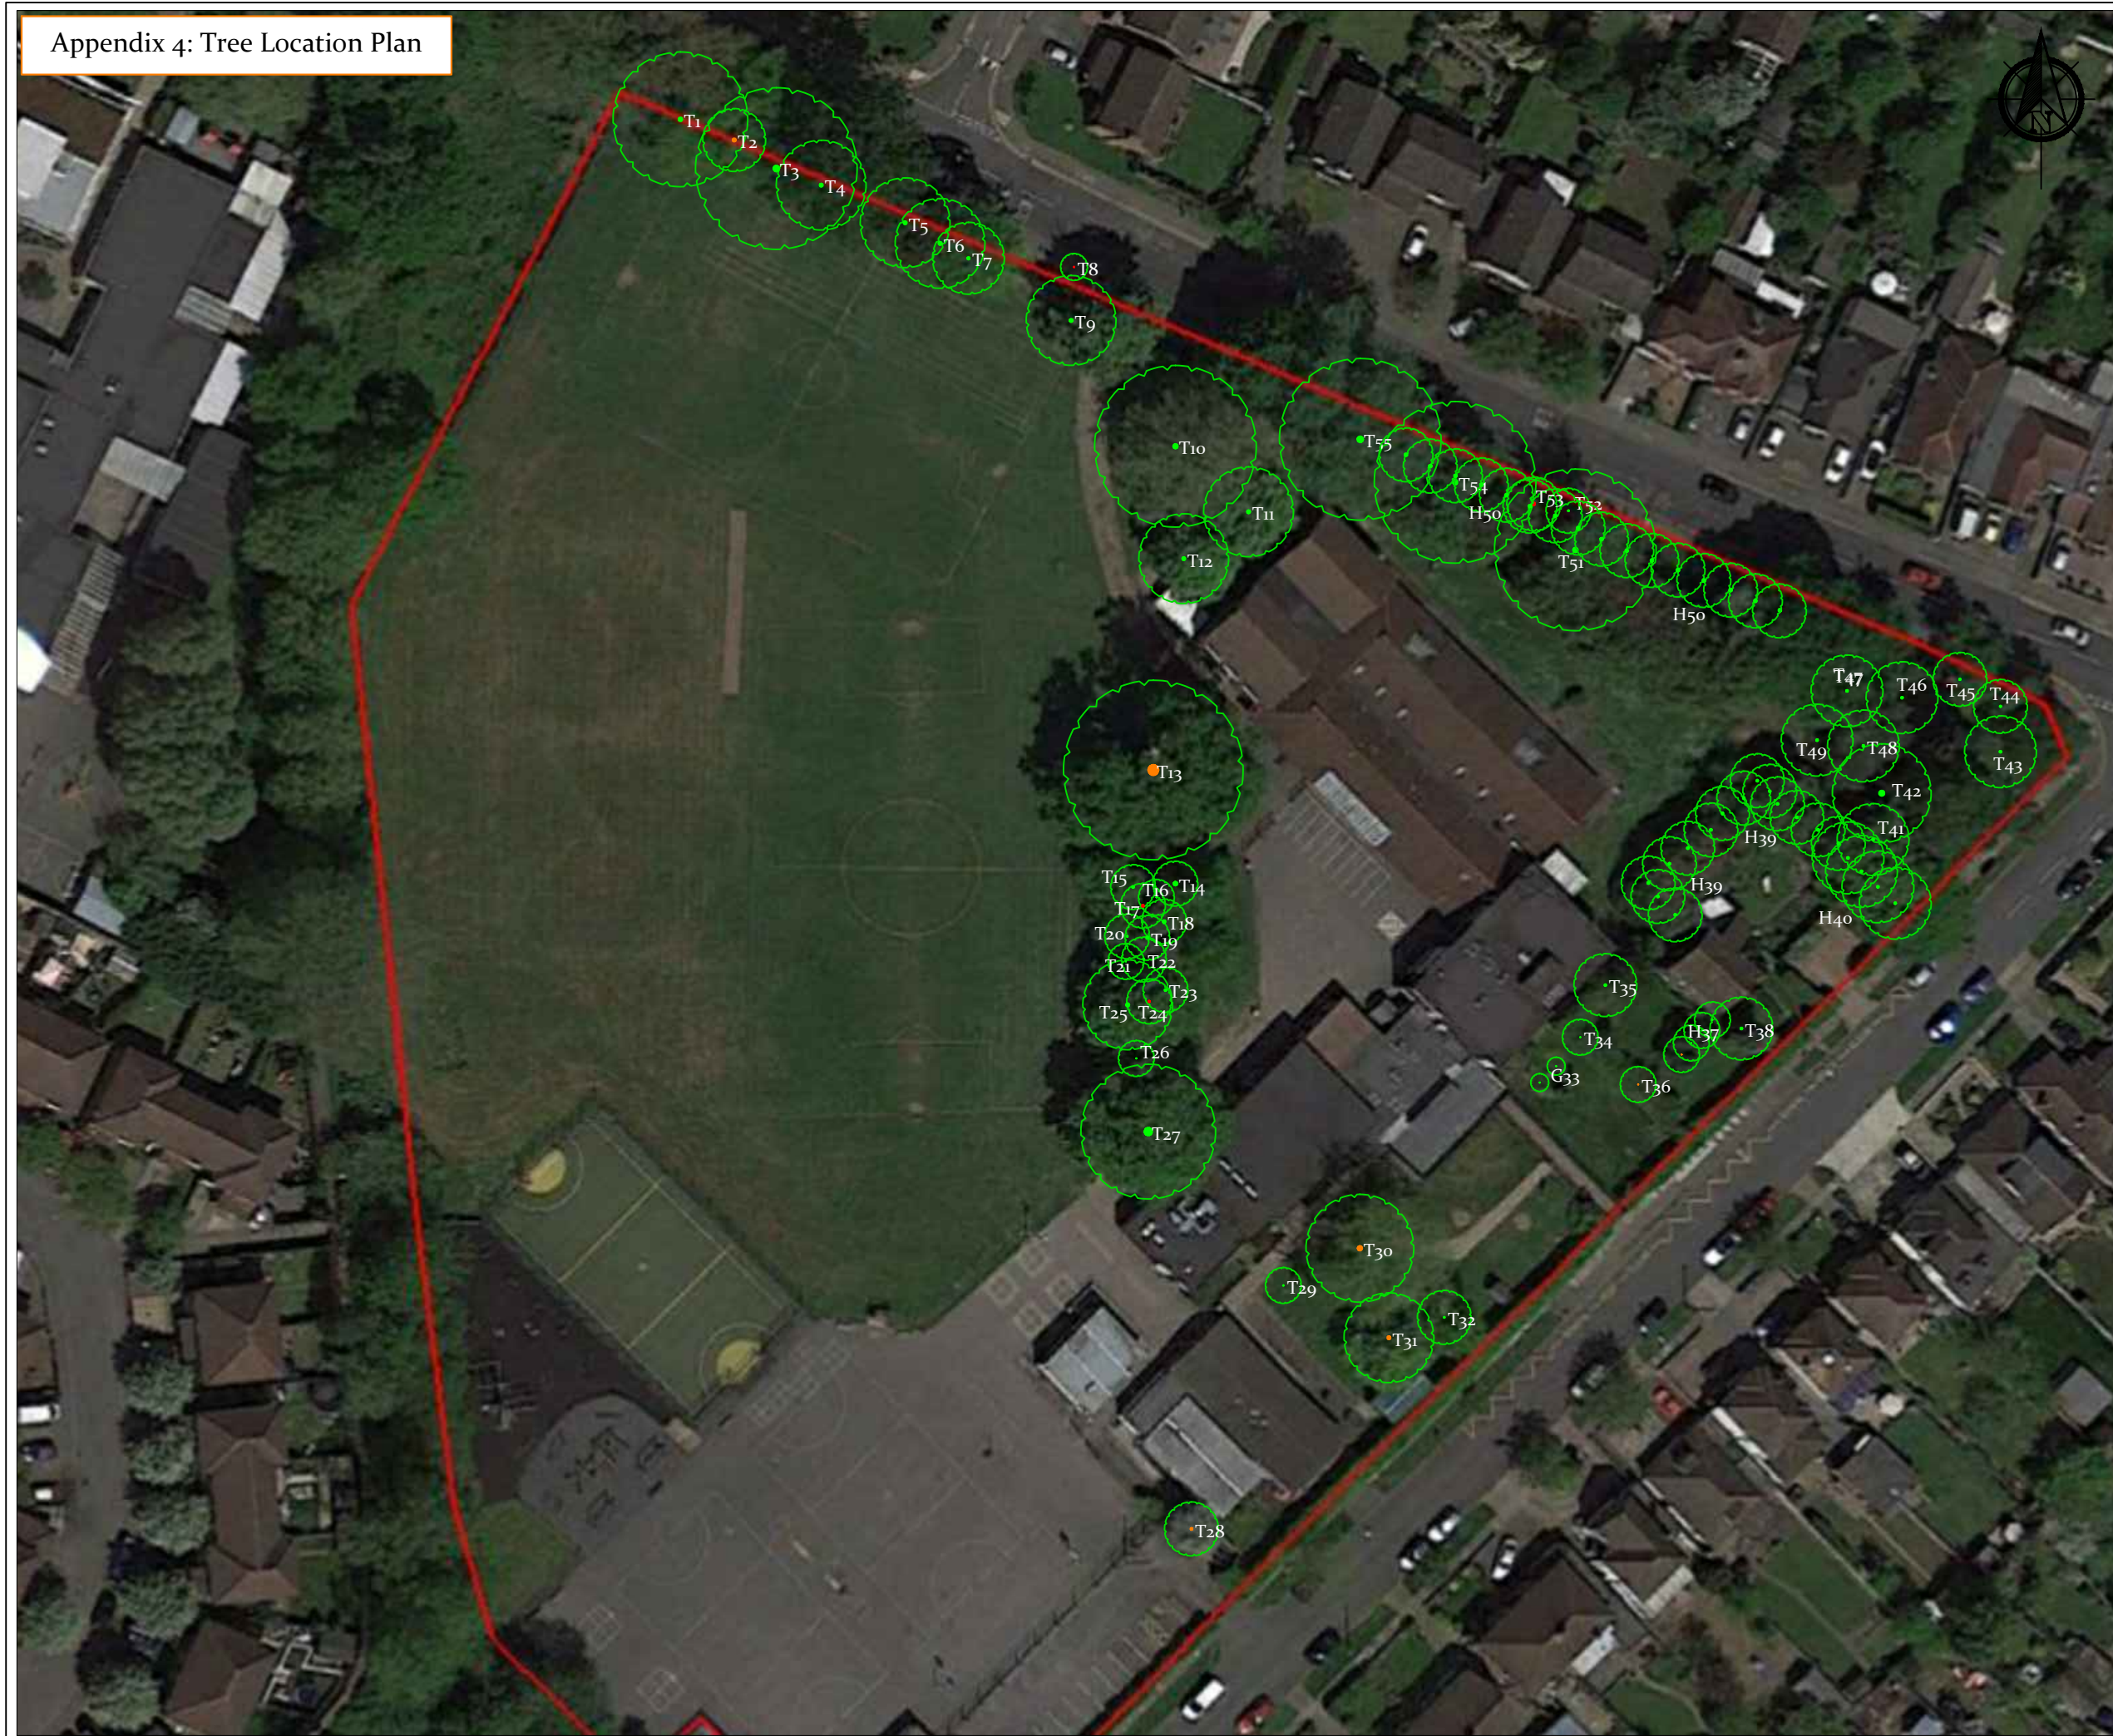
Appendix 4: Tree Location Plan

6.1 The locations of all the trees surveyed are shown on the site plan in Appendix 4. Further information about the trees can be found in appendices 2 & 3.
