Botwell Lane, Hayes

# Geo-Environmental Ground Investigation Report

for Lidl UK GmbH

Date: 22<sup>nd</sup> June 2015 Reference: J-M0167.00.R2 Status: **FINAL**

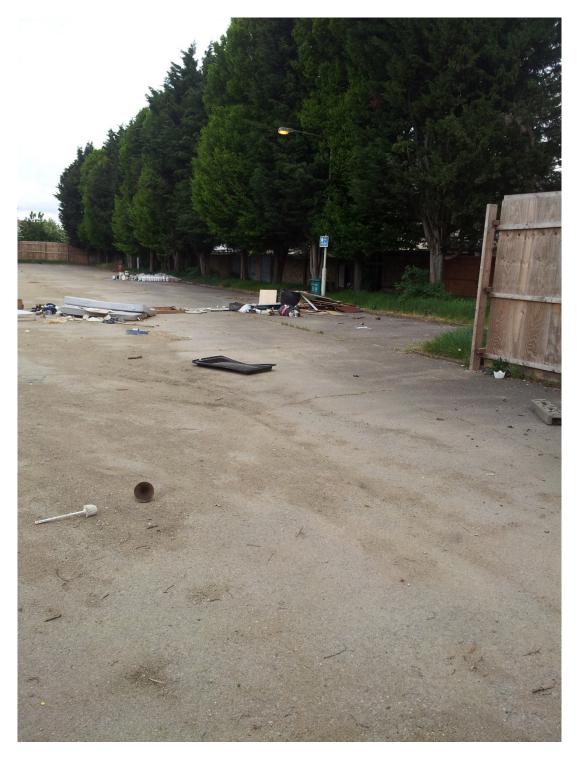
Plate 1: View north showing eastern site boundary and fly tipping on site.

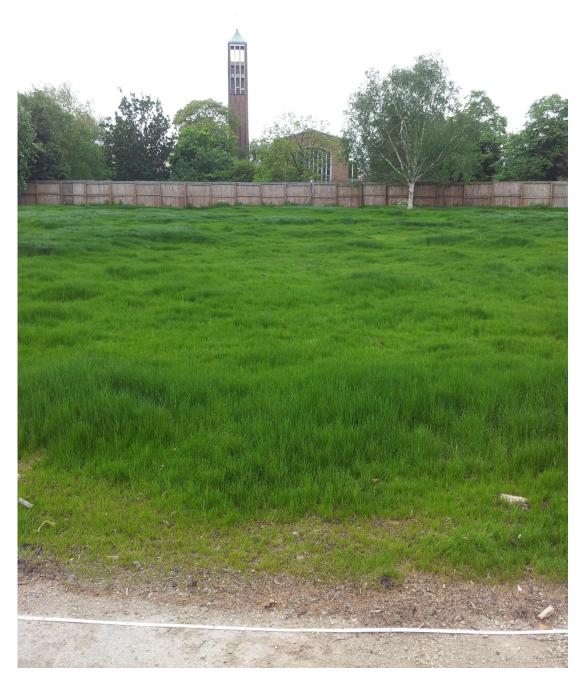
The fill within the former swimming pool and basements appeared to be poorly sorted and not engineered. It was unstable and contained wood and metal indicating it hadn't been screened or crushed to a specific grade. It would be advisable to excavate the fill to a specified depth, crush and screen the material and replace to an engineered specification suitable for constructing the car park across and/or excavating foundations through. Alternatively the Made Ground could be excavated for off-site disposal and replaced with a compacted clay fill to allow foundations to be excavated through, however due to the depth of the Made Ground possibly being greater than 3.8m bgl in some areas this is not considered to be feasible. The maximum depth of Made Ground in the south eastern area where the proposed supermarket building is to be location was 2.4m bgl.

Plate 2: View west showing area of former swimming pool.

The proposed car park covers the area of the infilled swimming pool, in the western portion of the site. The fill in this area is considered to be un-engineered therefore it is recommended that the Made Ground is excavated to a specified depth, the material is crushed and screened, and replaced to an engineered specification suitable for constructing the car park across.

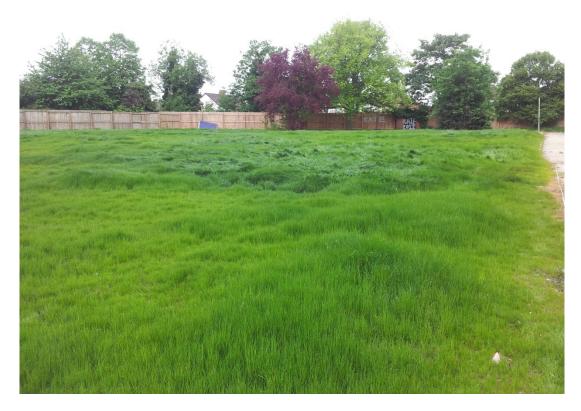
Plate 3: View north showing area of former swimming pool.

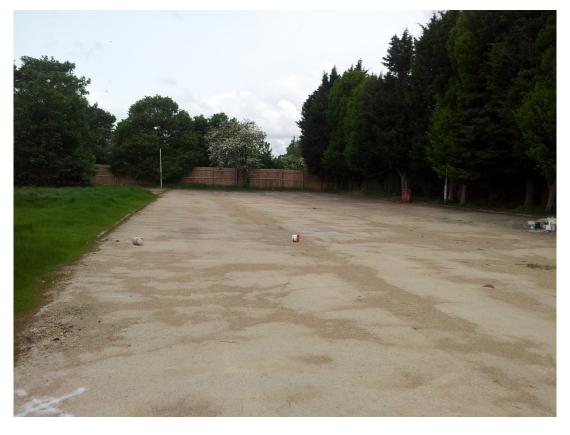
Plate 4: View north showing former car park.
