Homebuyer Tree Report

47 Kewferry Road, Northwood, HA6 2PE

Job Reference: 03968R

Survey Date: 2.5.2023

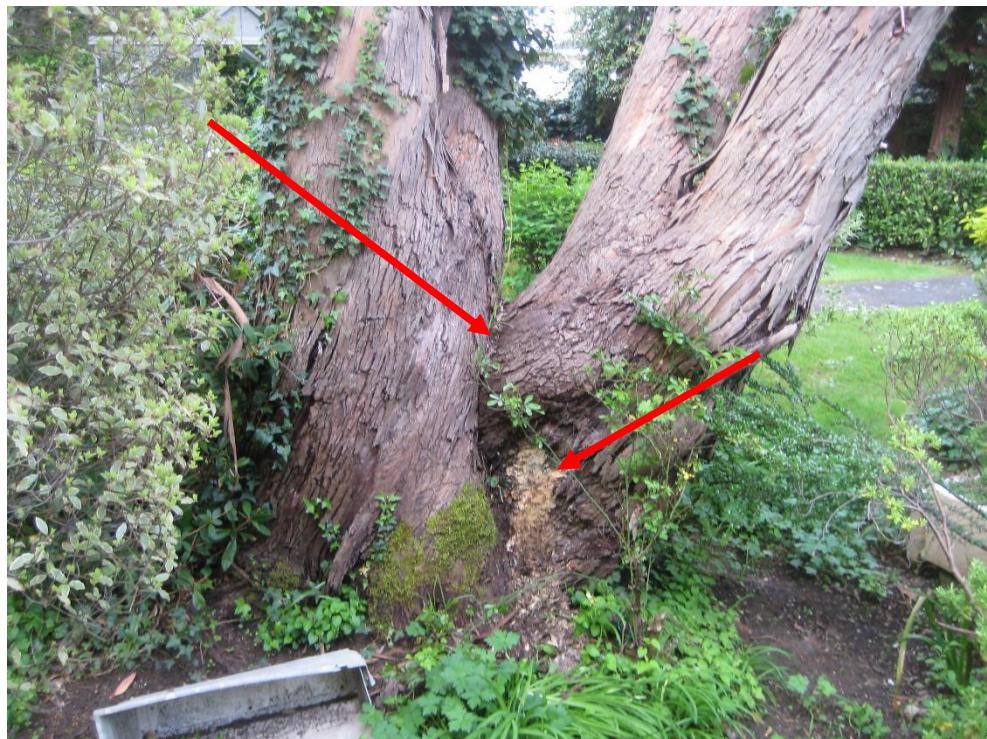
5.23 T6 (Eucalyptus) is the main health and safety issue having an infection from *Kretzschmaria deusta* and this tree should be removed. It is unclear whether this tree is old enough to be covered by the TPO but to air on the side of caution a TPO application is advised. The defect requires action to resolve but is unlikely to lead to the failure of the tree within the 8 week TPO determination period.

5.24 This fungal pathogen causes an intense white rot when established and ultimately leads to the failure of infected trees. In addition the decay is developing close to a weak basal stem union and it is unlikely the council will be resistant to the removal of the tree, particularly as seems not old enough to be affected by the TPO.

Fig 3 – Weak basal union (left arrow) and established *Kretzschmaria deusta* infection (right arrow) render T6 (Eucalyptus) dangerous and this tree should be removed.

Tree No.	Species	Age Cat	Approx. Height (m)*	Distance to Building (m)*	Ownership	Health & Safety (Tree Condition) Observations	Subsidence Risk Action	Recommended Tree Work
T6	Eucalyptus	A	11	15.2	No 47 Kewferry Road	<i>Kretzschmaria deusta</i> present. Weak basal unions. Previously reduced. Difficult to ascertain exact age of tree. Likely not old enough to be protected by the TPO but TPO application advised given uncertainty on age of tree.	Action to Avoid Future Risk	Remove on H & S grounds

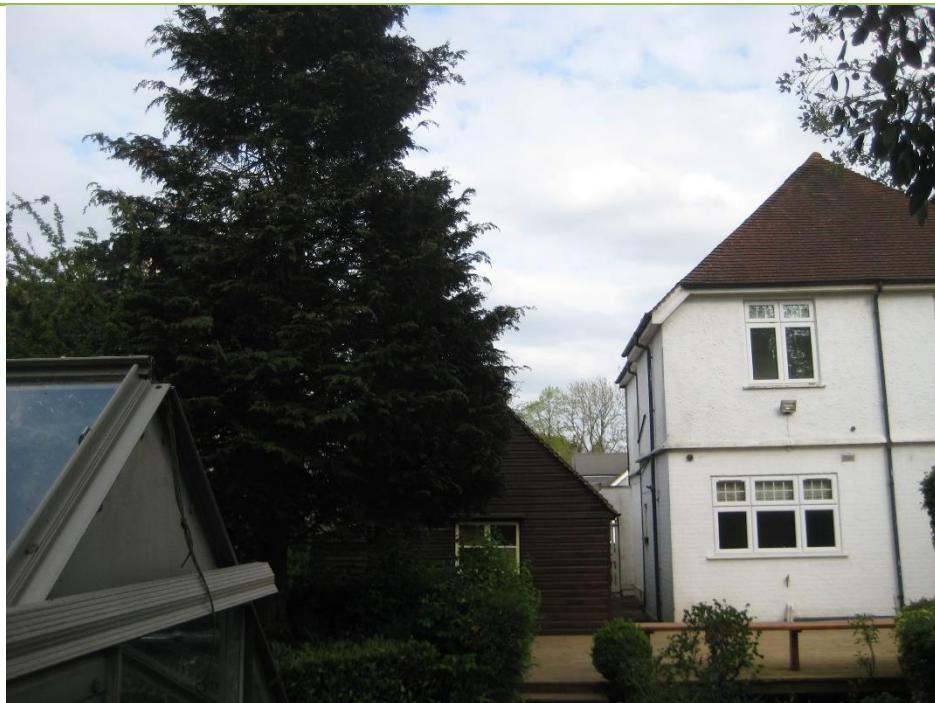
T5	Cypress	A	8	7.6	No 47 Kewferry Road	Established tree with shrubs at base. Likely included within TPO limiting removal options.	Action to Avoid Future Risk	Do not allow to exceed current dimensions

Image 3 – T5 Cypress

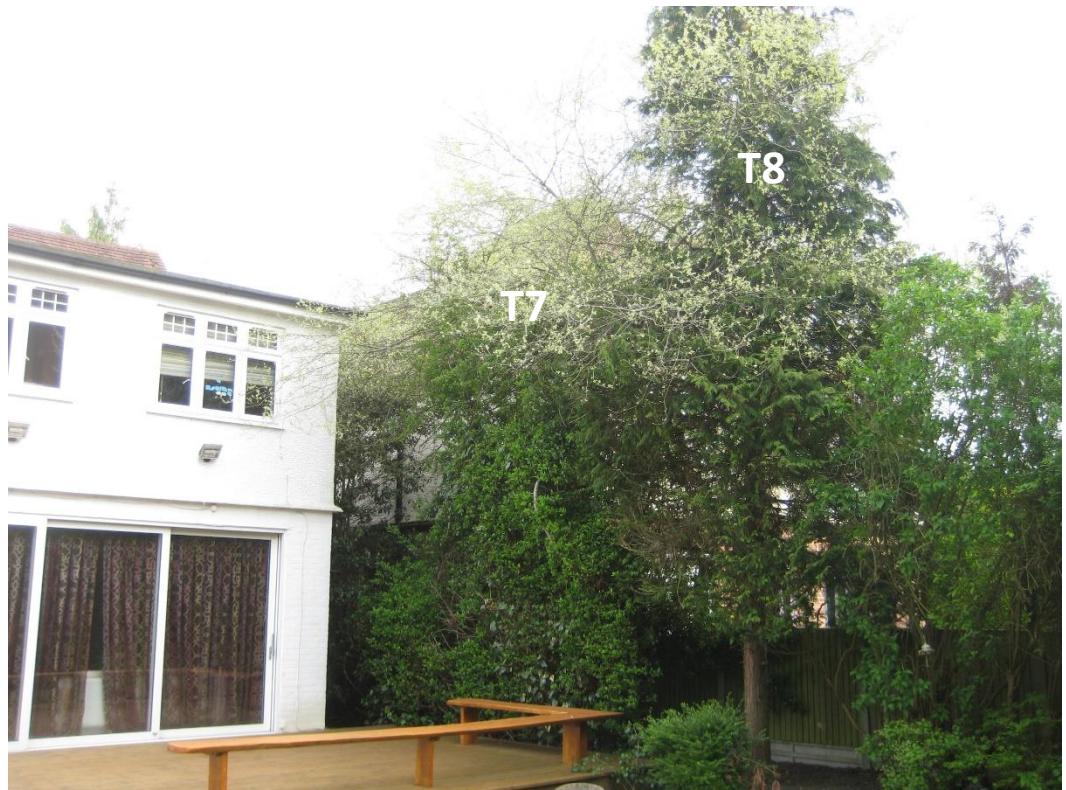
Image 4 – SG3 with T7 & T8 visible

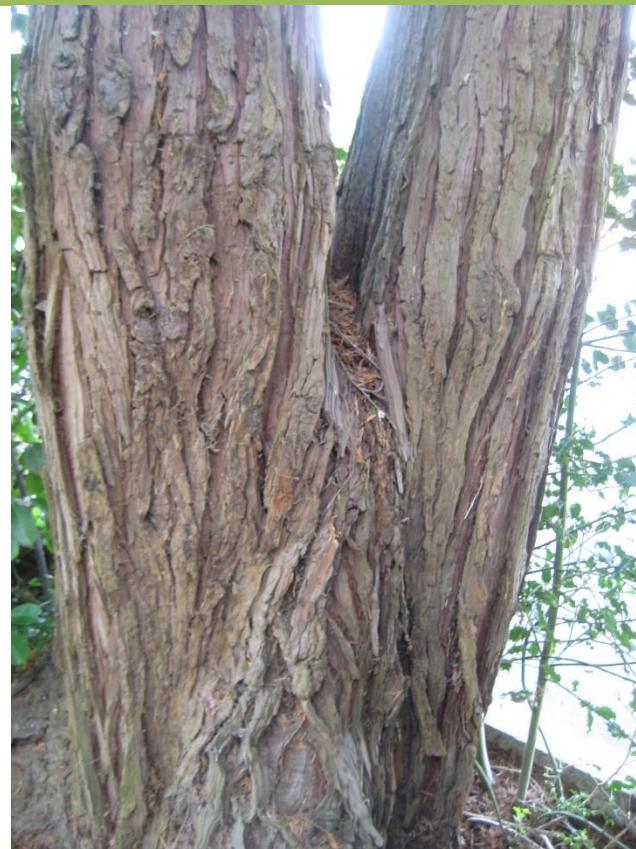
Image 5 – Basal area of T3 Cypress showing twin stem union from west.

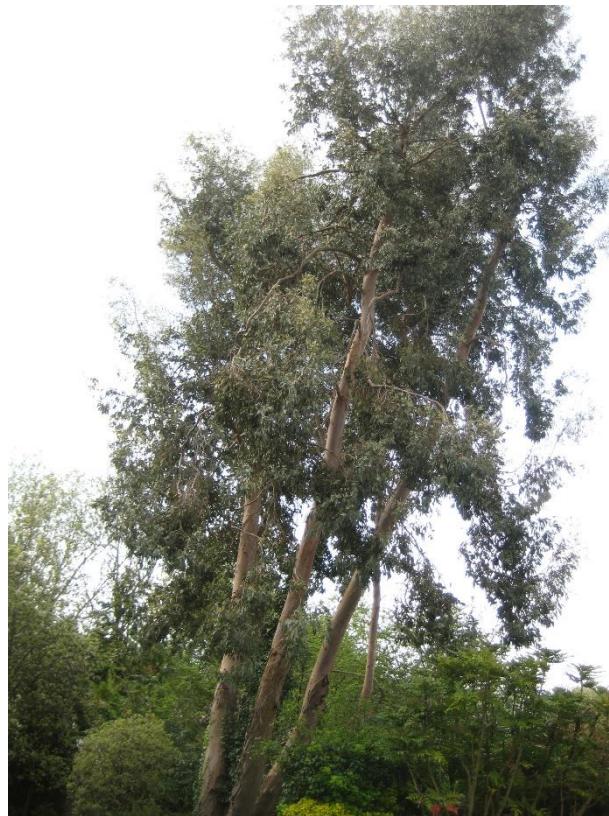
Image 6 – T6 Eucalyptus (canopy). Basal area detail shown in Fig 3.
