REFURBISHMENT SURVEY

Site Name: Bungalow , London meat company , Sheds, Two storey storage unit, Veterinary Clinic

Site address: The Elms, 371A High Street, Harlington, Hayes, Greater London, UB3 5DQ

Report Ref: J043984

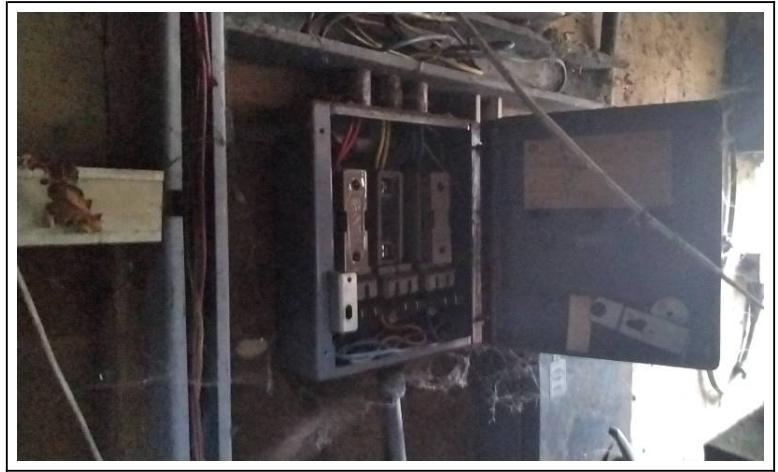
Floor	Ground Floor				
Room Area	Pump room				
Position	Within switch box				
Quantity	3no.				
Accessibility	Usually inaccessible or unlikely to be disturbed				
MATERIAL RISK ASSESSMENT					
Product Type	Condition	Surface Treatment	Asbestos Type	Material Risk Score	Risk Category
Asbestos Textiles/Paper (2)	(0)	(1)	Chrysotile (1)	4	Very Low
Comments:					
General Observations:					
Corrugated roof (sampled from externals) masonry walls and a concrete base.

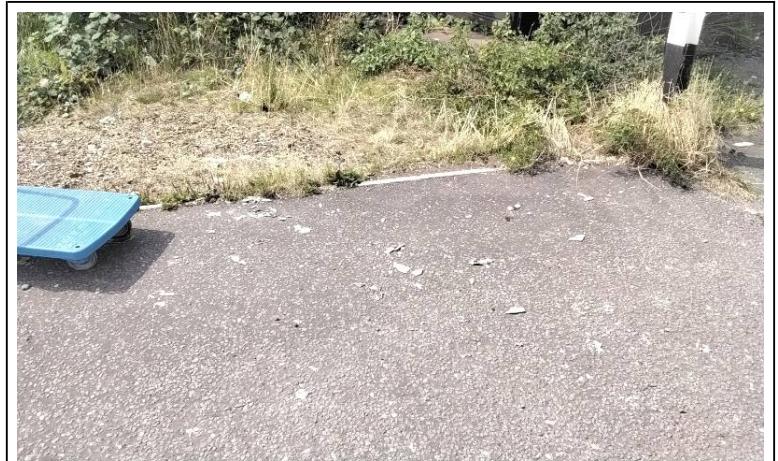
Quantity	20m ²						
Accessibility	Routinely Disturbed

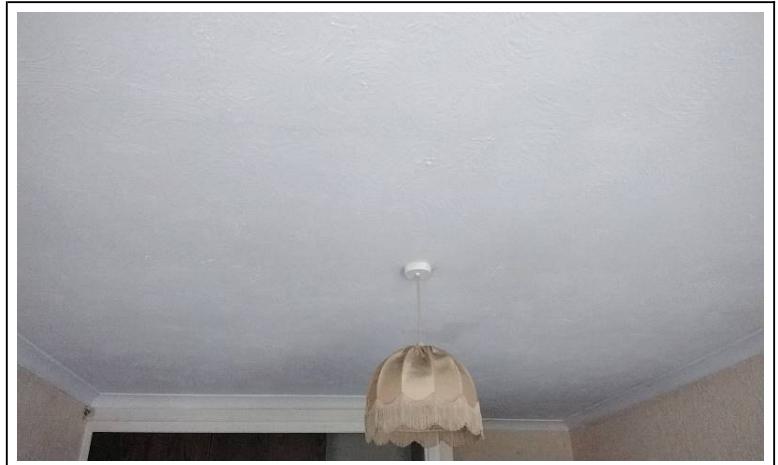
Floor	Ground Floor				
Room Area	Bedroom 1				
Position	To plasterboard ceiling				
Quantity	10m ²				
Accessibility	Occasionally likely to be Disturbed				
MATERIAL RISK ASSESSMENT					
Product Type	Condition	Surface Treatment	Asbestos Type	Material Risk Score	Risk Category
Textured Coating (1)	(0)	(0)	Chrysotile (1)	2	Very Low
Comments:					
General Observations:					
Room consists of a plasterboard ceiling, masonry walls with modern flat finish plaster and a concrete floor with carpet. Timber door and frame, Metal window and frame with timber sill, modern mastic and masonry reveals.

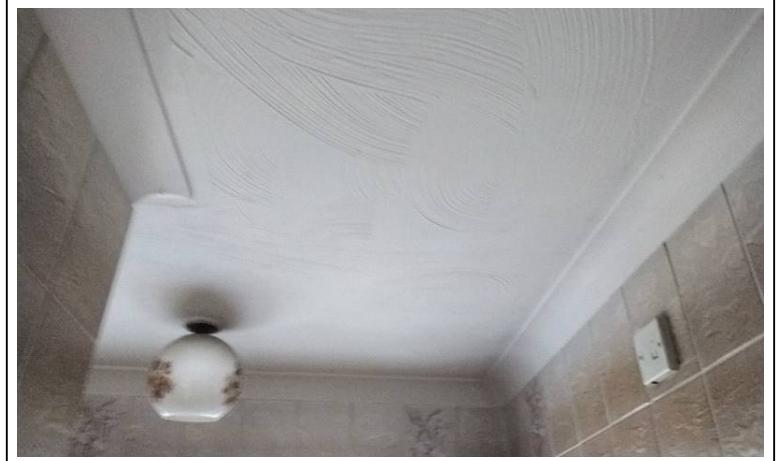
Floor	Ground Floor				
Room Area	Bathroom				
Position	To plasterboard ceiling				
Quantity	4m ²				
Accessibility	Occasionally likely to be Disturbed				
MATERIAL RISK ASSESSMENT					
Product Type	Condition	Surface Treatment	Asbestos Type	Material Risk Score	Risk Category
Textured Coating (1)	(0)	(0)	Chrysotile (1)	2	Very Low
Comments:					
General Observations:					
Room consists of a plasterboard ceiling, masonry walls with modern flat finish plaster and a concrete floor with modern vinyl. Timber door and frame, Metal window and frame with timber sill, modern mastic and masonry reveals.

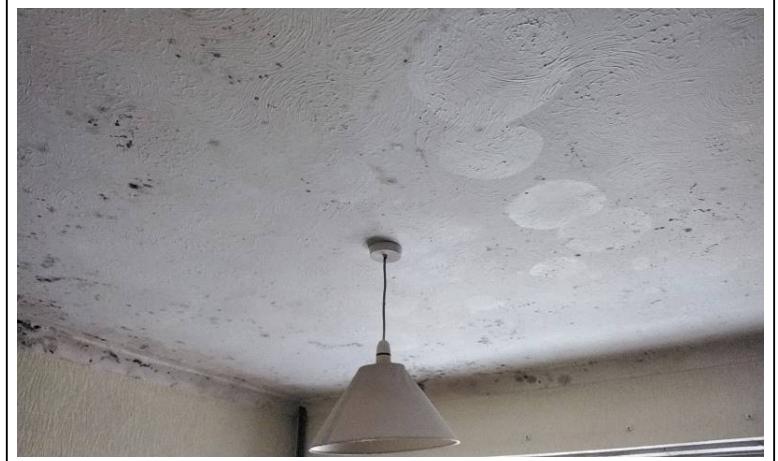
Floor	Ground Floor				
Room Area	Bedroom 2				
Position	To plasterboard ceiling				
Quantity	10m ²				
Accessibility	Occasionally likely to be Disturbed				
MATERIAL RISK ASSESSMENT					
Product Type	Condition	Surface Treatment	Asbestos Type	Material Risk Score	Risk Category
Textured Coating (1)	(0)	(0)	Chrysotile (1)	2	Very Low
Comments:					
General Observations:					
Room consists of a plasterboard ceiling, masonry walls with modern flat finish plaster and a concrete floor with carpet. Timber door and frame, Metal window and frame with timber sill, modern mastic and masonry reveals.

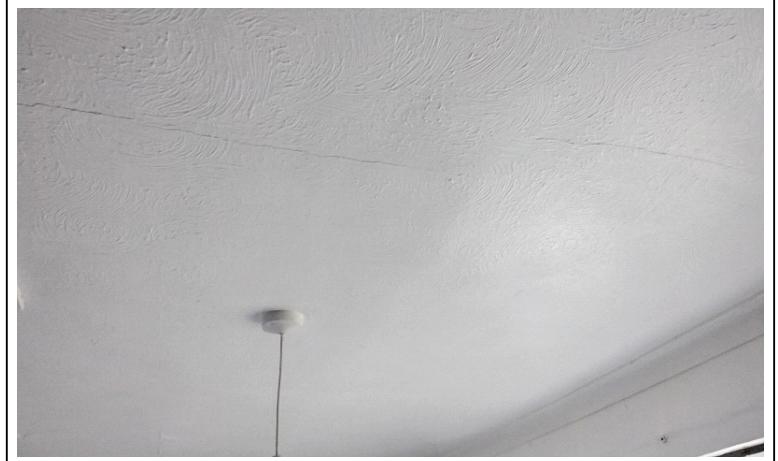
Floor	Ground Floor				
Room Area	Bedroom 3				
Position	To plasterboard ceiling				
Quantity	8m ²				
Accessibility	Occasionally likely to be Disturbed				
MATERIAL RISK ASSESSMENT					
Product Type	Condition	Surface Treatment	Asbestos Type	Material Risk Score	Risk Category
Textured Coating (1)	(0)	(0)	Chrysotile (1)	2	Very Low
Comments:					
General Observations:					
Room consists of a plasterboard ceiling, masonry walls with modern flat finish plaster and a concrete floor with carpet. Timber door and frame, Metal window and frame with timber sill, modern mastic and masonry reveals.

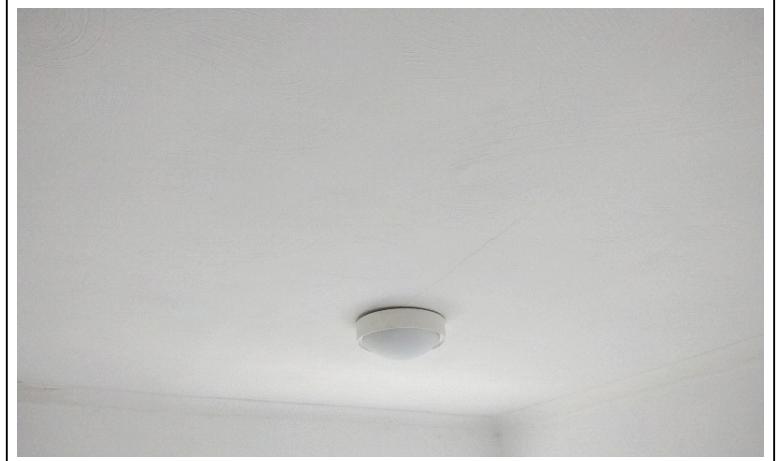
Floor	Ground Floor				
Room Area	Bathroom 2				
Position	To plasterboard ceiling				
Quantity	6m ²				
Accessibility	Occasionally likely to be Disturbed				
MATERIAL RISK ASSESSMENT					
Product Type	Condition	Surface Treatment	Asbestos Type	Material Risk Score	Risk Category
Textured Coating (1)	(0)	(0)	Chrysotile (1)	2	Very Low
Comments:					
General Observations:					
Room consists of a plasterboard ceiling, masonry walls with modern flat finish plaster and a concrete floor with modern vinyl. Timber door and frame, Metal window and frame with timber sill, modern mastic and masonry reveals.

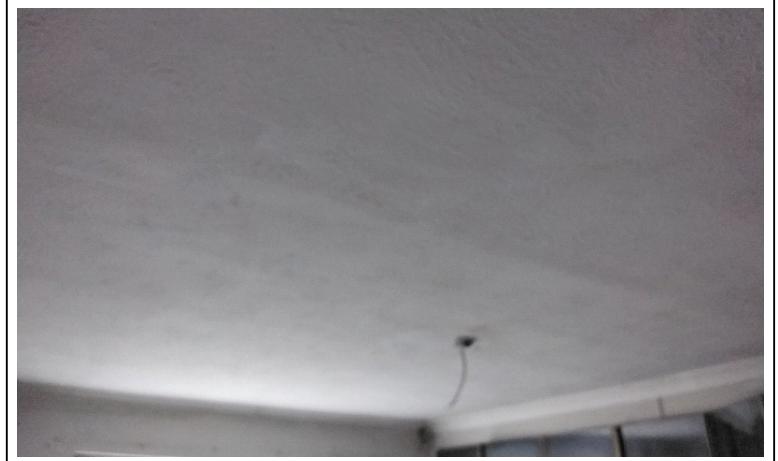
Floor	Ground Floor				
Room Area	Bedroom 4				
Position	To plasterboard ceiling				
Quantity	10m ²				
Accessibility	Occasionally likely to be Disturbed				
MATERIAL RISK ASSESSMENT					
Product Type	Condition	Surface Treatment	Asbestos Type	Material Risk Score	Risk Category
Textured Coating (1)	(0)	(0)	Chrysotile (1)	2	Very Low
Comments:					
General Observations:					
Room consists of a plasterboard ceiling, masonry walls with modern flat finish plaster and a concrete floor with carpet. Timber door and frame, Metal window and frame with timber sill, modern mastic and masonry reveals.

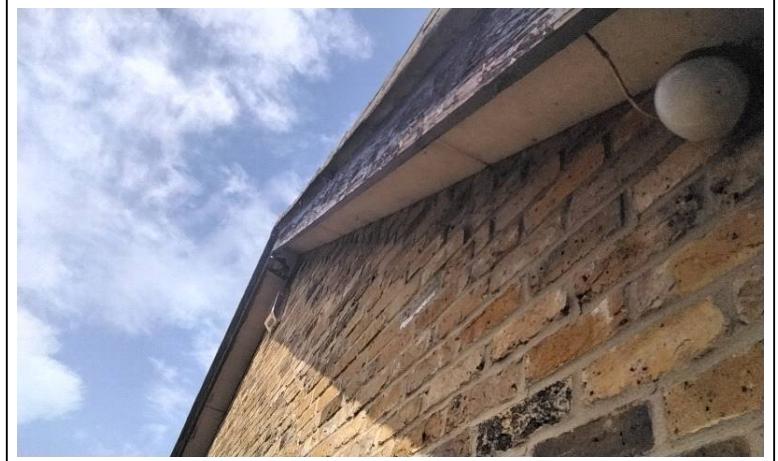
Floor	External				
Room Area	Front Elevation				
Position	Soffits				
Quantity	8lm				
Accessibility	Usually inaccessible or unlikely to be disturbed				
MATERIAL RISK ASSESSMENT					
Product Type	Condition	Surface Treatment	Asbestos Type	Material Risk Score	Risk Category
Asbestos Insulating Board (2)	(0)	(2)	Amosite (2)	6	Low
Comments:					
General Observations:					
Building is brick built with plastic rainwater goods, lead flashing, no visible DPC, metal windows and frames,

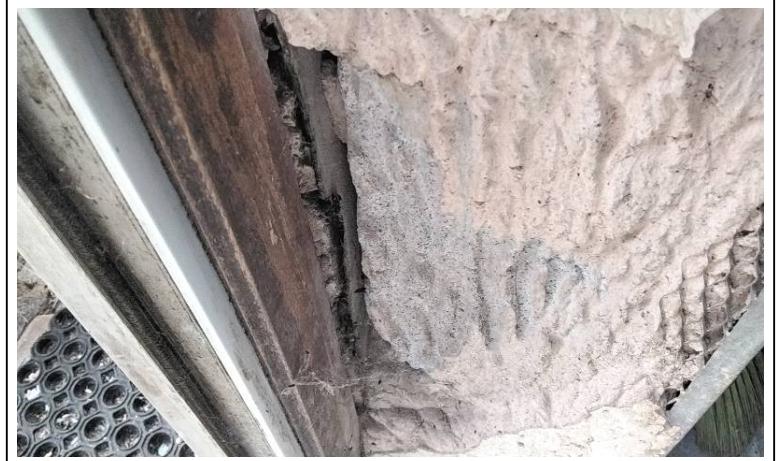
Floor	External				
Room Area	Right Elevation				
Position	Within cavity wall				
Quantity	200m ²				
Accessibility	Usually inaccessible or unlikely to be disturbed				
MATERIAL RISK ASSESSMENT					
Product Type	Condition	Surface Treatment	Asbestos Type	Material Risk Score	Risk Category
Reinforced Composite (1)	(0)	(0)	Chrysotile (1)	2	Very Low
Comments:					
General Observations:					
Building is brick built with plastic rainwater goods, lead flashing, no visible DPC, metal windows and frames,

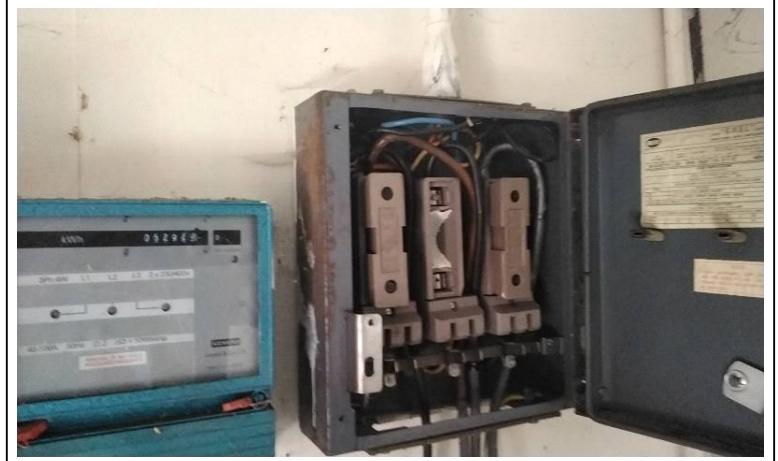
Floor	Ground Floor				
Room Area	Shed 3				
Position	Within switch box				
Quantity	3no.				
Accessibility	Usually inaccessible or unlikely to be disturbed				
MATERIAL RISK ASSESSMENT					
Product Type	Condition	Surface Treatment	Asbestos Type	Material Risk Score	Risk Category
Asbestos Textiles/Paper (2)	(0)	(1)	Chrysotile (1)	4	Very Low
Comments:					
General Observations:					
Timber built structure with fibre board ceiling, plasterboard cladding to internal walls and a concrete base.

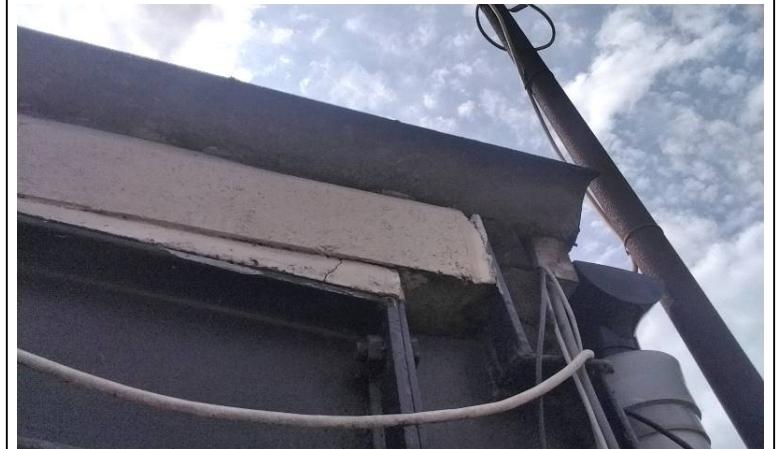
Floor	External				
Room Area	Externals				
Position	Roof sheets				
Quantity	320lm				
Accessibility	Occasionally likely to be Disturbed				
MATERIAL RISK ASSESSMENT					
Product Type	Condition	Surface Treatment	Asbestos Type	Material Risk Score	Risk Category
Asbestos Cement (1)	(0)	(1)	Chrysotile (1)	3	Very Low
Comments:					
General Observations:					
Building is brick built with cement rainwater goods, lead flashing, no visible DPC, Upvc windows and frames, Upvc soffits and facias,

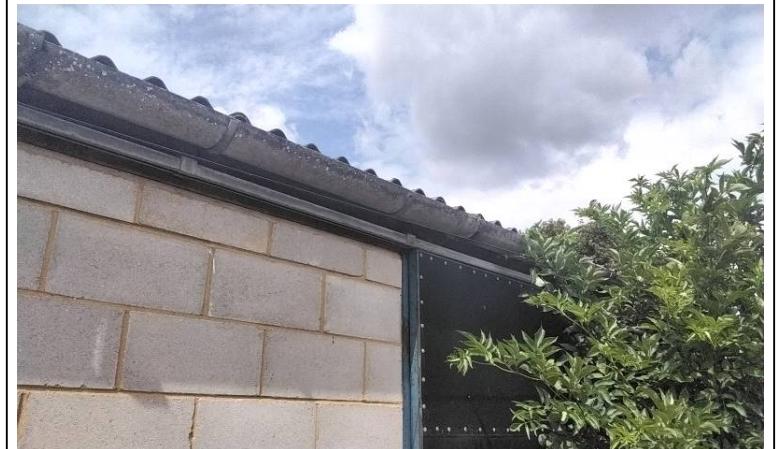
Floor	External				
Room Area	Externals				
Position	Guttering				
Quantity	30lm				
Accessibility	Occasionally likely to be Disturbed				
MATERIAL RISK ASSESSMENT					
Product Type	Condition	Surface Treatment	Asbestos Type	Material Risk Score	Risk Category
Asbestos Cement (1)	(0)	(1)	Chrysotile (1)	3	Very Low
Comments:					
General Observations:					
Building is brick built with cement rainwater goods, lead flashing, no visible DPC, Upvc windows and frames, Upvc soffits and facias,

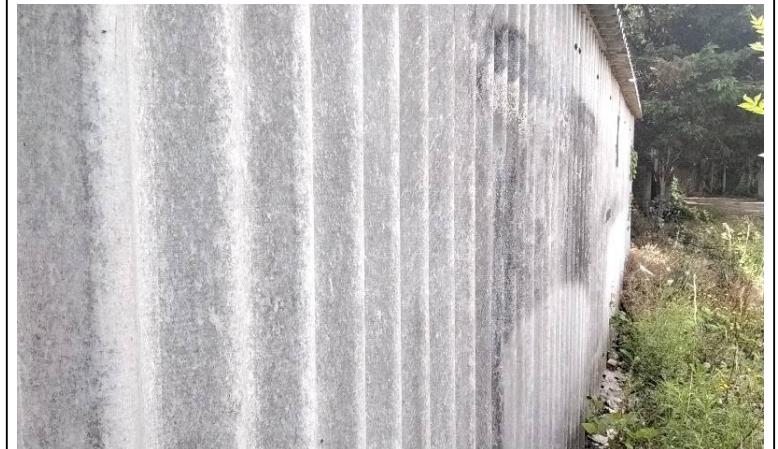
Floor	External				
Room Area	Externals				
Position	Cladding				
Quantity	35m ²				
Accessibility	Occasionally likely to be Disturbed				
MATERIAL RISK ASSESSMENT					
Product Type	Condition	Surface Treatment	Asbestos Type	Material Risk Score	Risk Category
Asbestos Cement (1)	(0)	(0)	Chrysotile (1)	2	Very Low
Comments:					
General Observations:					
Building is brick built with cement rainwater goods, lead flashing, no visible DPC, Upvc windows and frames, Upvc soffits and facias,
