# Arboricultural Appraisal Report

## Subsidence Damage Investigation at:

31 Copse Wood Way  
Northwood  
Harrow  
HA6 2TZ

**CLIENT:** QuestGates  
**CLIENT REF:** QG1S1210326  
**MWA REF:** SUB230417-12934  
**MWA CONSULTANT:** Giles Mercer B.Sc Hons  
**REPORT DATE:** 03/08/2023

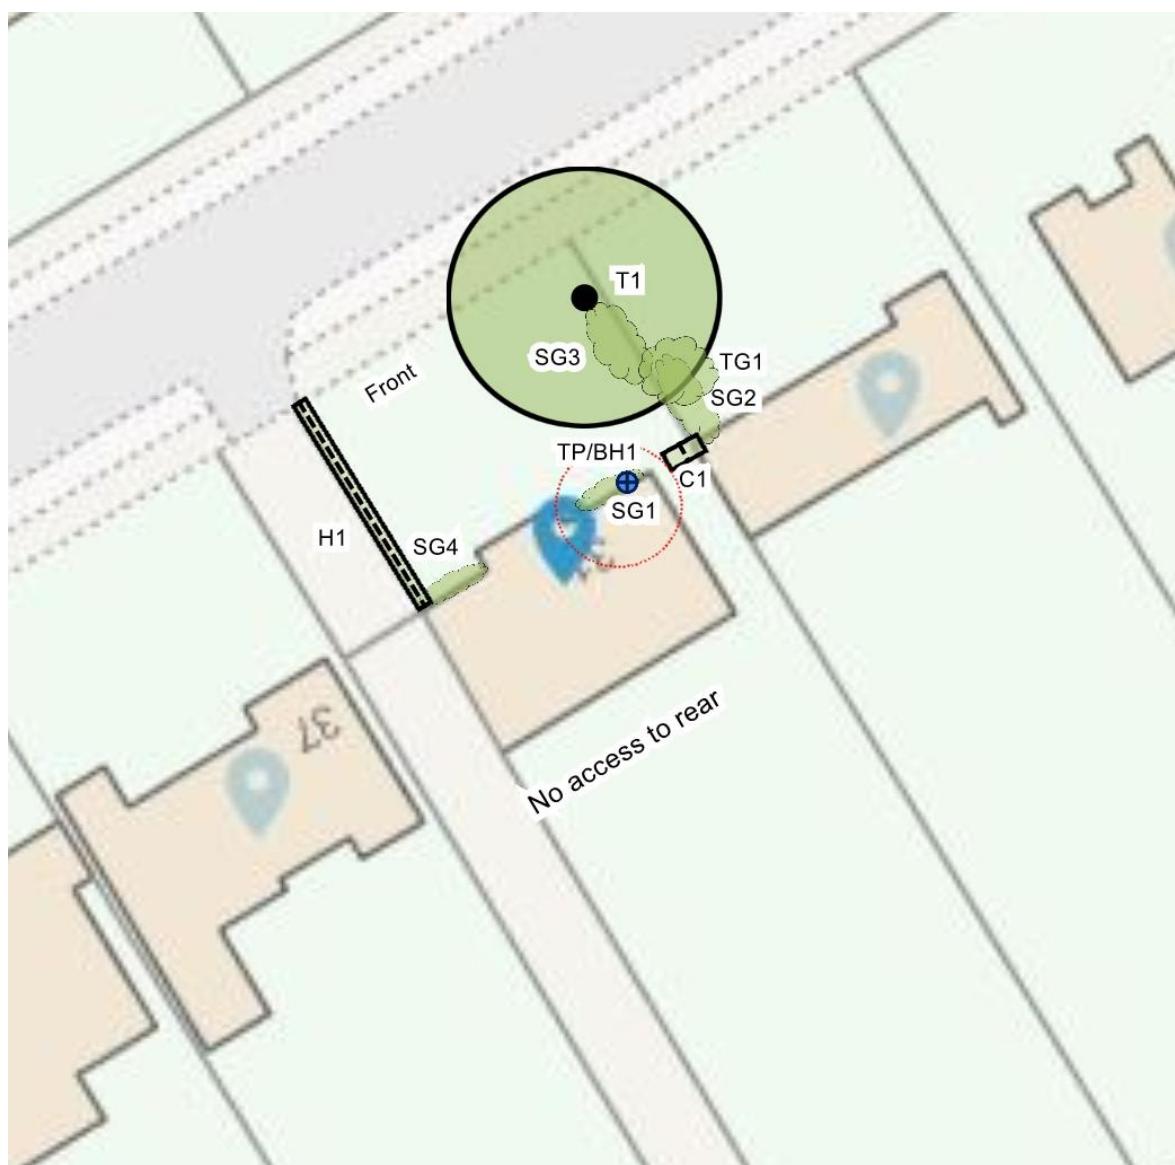
## Site Plan

Approximate areas of damage

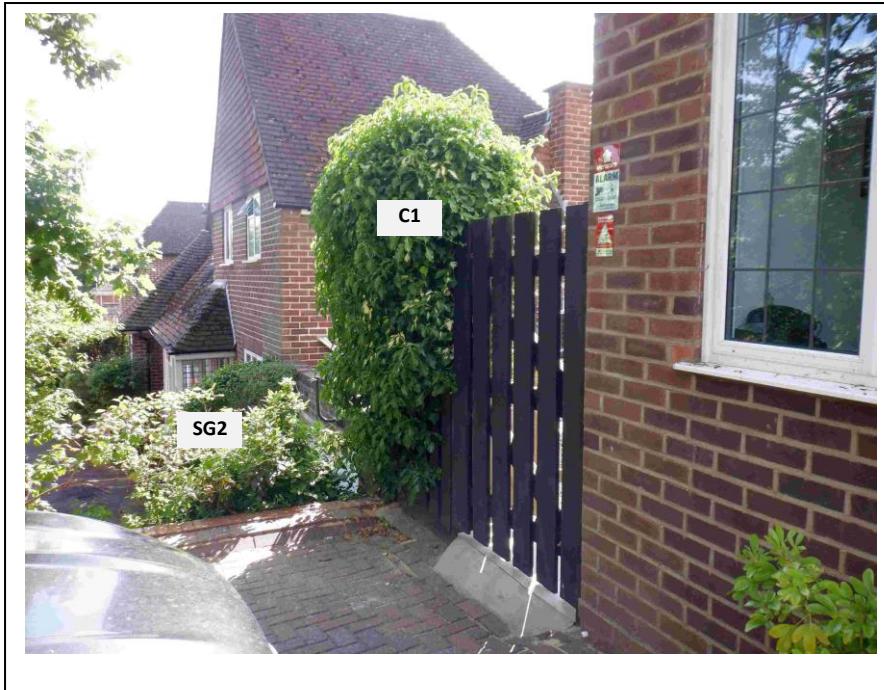
By virtue of their size and species profiles the mixed species shrub groups SG1 and SG2 are not considered to be a material influence in the current subsidence event.

View of C1 & SG2

Tree No.	Species	Ht (m)	Dia (mm)	Crown Spread (m)	Dist. to building (m)	Age Classification	Ownership
C1	Ivy	3	10 Ms *	1.2	2.4 *	Younger than Property	Policy Holder
Management history		Managed shrubs.					
Recommendation		Do not allow to exceed current dimensions.					
H1	Laurel	1.4	30 Ms *	1.25	1.1	Younger than Property	Policy Holder
Management history		Managed hedge.					
Recommendation		Do not allow to exceed current dimensions.

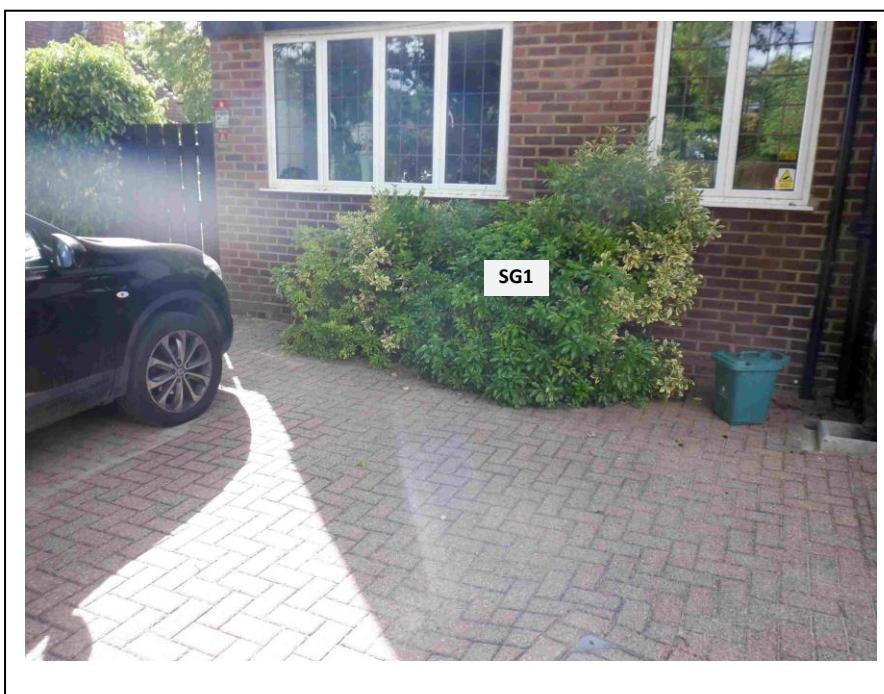
View of SG1

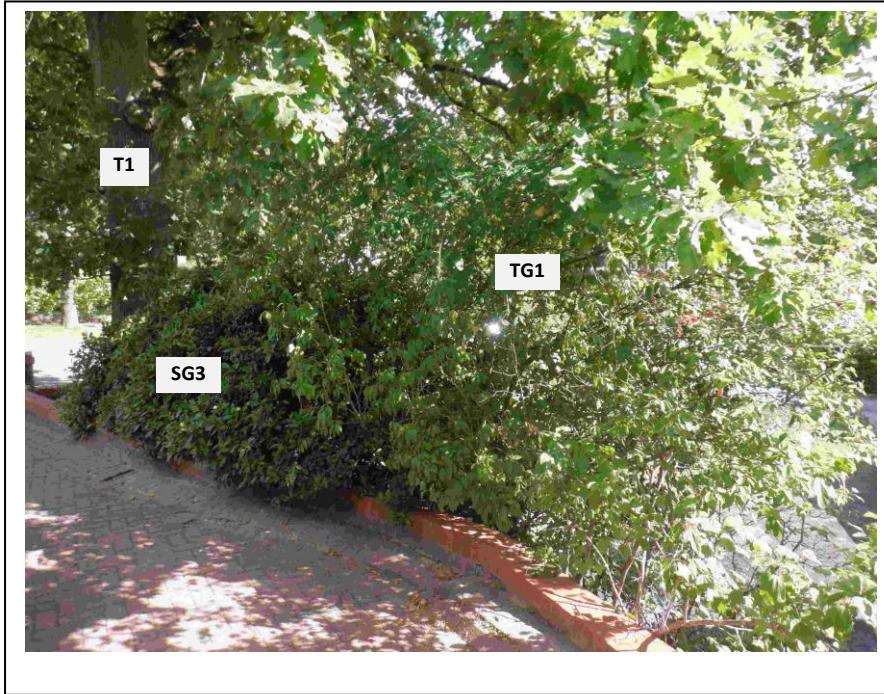
View of SG3 & TG1

Tree No.	Species	Ht (m)	Dia (mm)	Crown Spread (m)	Dist. to building (m)	Age Classification	Ownership
TG1	Laburnum and amelanchier	4 *	35 Ms *	4 *	5.5 *	Younger than Property	Third Party 29 Copse Wood Way HA6 2TZ
Management history		No significant recent management noted.					
Recommendation		Maintain broadly at no more than current dimensions by periodic pruning.					
SG1	Choisya and euonymus	1.85	10 Ms *	1.3	0.25	Younger than Property	Policy Holder
Management history		Managed shrubs.					
Recommendation		Maintain broadly at no more than current dimensions by periodic pruning.					
SG2	Mixed species shrubs including viburnum, currant, forsythia	3 *	10 Ms *	1.5 *	3.25 *	Younger than Property	Third Party 29 Copse Wood Way HA6 2TZ
Management history		Managed shrubs.					
Recommendation		Maintain broadly at no more than current dimensions by periodic pruning.					
SG3	Viburnum	3.8 *	15 Ms *	2 *	6.5 *	Younger than Property	Policy Holder

Management history		Managed shrubs.					
Recommendation		Maintain broadly at no more than current dimensions by periodic pruning.					
SG4	Euonymus	1.55	10 Ms *	1.3	0.25	Younger than Property	Policy Holder
Management history		Managed shrubs					
Recommendation		Maintain broadly at no more than current dimensions by periodic pruning.

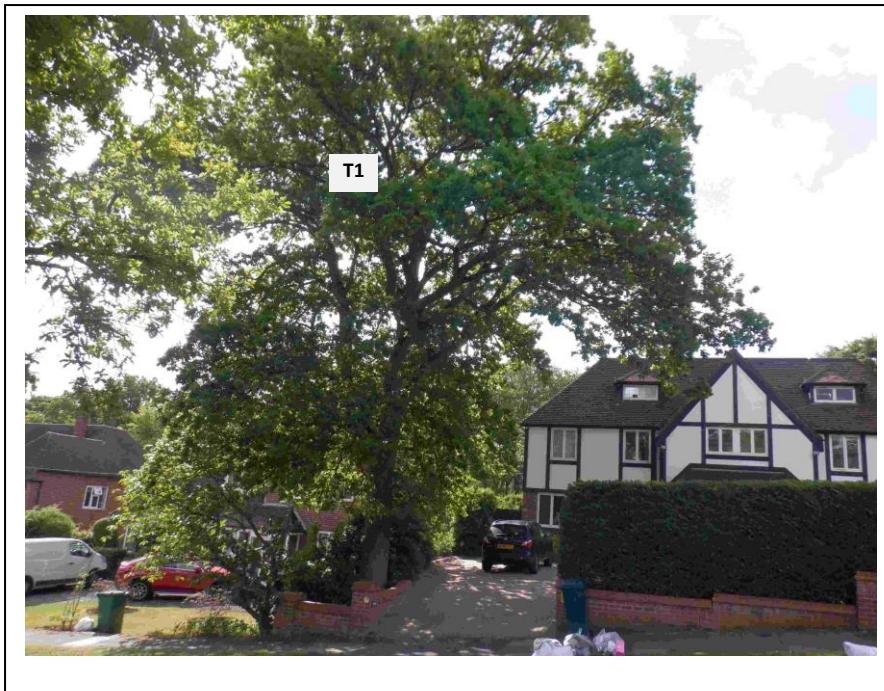
Irrespective of the identification of recovered root samples, the roots of the Oak (T1) are likely to be present below foundation level in proximity to the area of movement/damage and influencing soil moisture and volumes.

Based on the technical reports currently available, engineering opinion and our own site assessment we conclude the damage is consistent with shrinkage of the clay subsoil related to moisture abstraction by vegetation. Having considered the information currently available, it is our opinion that the Oak (T1) is the principal cause of the current subsidence damage.

View of T1

If an arboricultural solution is to be implemented to mitigate the influence of the implicated trees/vegetation we recommend that the Oak (T1) is removed. Other vegetation recorded presents a potential future risk to building stability and management is therefore recommended.

Tree No.	Species	Ht (m)	Dia (mm)	Crown Spread (m)	Dist. to building (m)	Age Classification	Ownership
T1	Oak	19.9	675 *	20.2	9.4	Older than Property	Policy Holder
Management history		No significant recent management noted.					
Recommendation		Remove (fell) to near ground level and treat stump to inhibit regrowth.
