Site Investigation Report

145212.1.USI

Auger were commissioned by - to undertake a site investigation and CCTV inspection of the underground drainage within the area of concern (AOC) at the property.

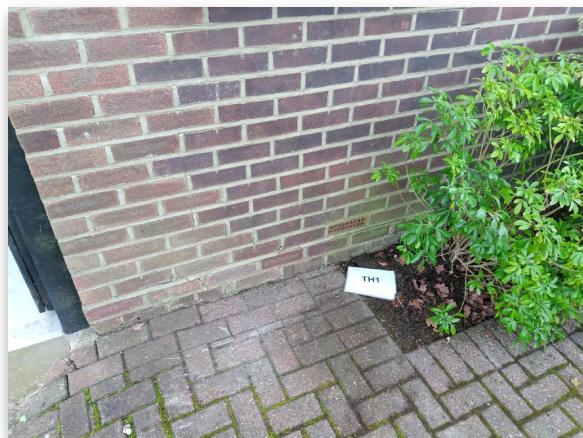
Fig 1.1: Trial Hole 1 Location

TH1 was completed in the proposed location and the footing was determined, soil and root samples were taken. Please note the footing was determined by probing to a depth below 1m therefore exact depth cannot be guaranteed.

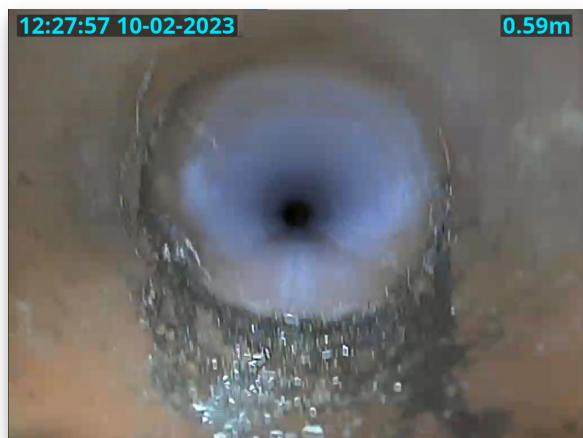
Our survey of line 1 revealed root ingress at 0.6m and cracking at 4.1m.

The above mentioned defects to the below ground drainage system have been caused by ground movement.

Fig 2.1: Line 1 Roots

Refer Back to Client	<p>It is recommended that the following repairs are carried out to prevent an escape of water from the system:</p> <p>Line 1 Install 4.5m of 100mm liner directly upstream of MH1.</p> <p>Line 2 Excavate and replace SVP2 restbend and 1m 100mm pipework at a depth no greater than 1m through block paving. Install 2m 100mm liner directly downstream of the excavation.</p> <p>Line 3 Excavate and replace WG1 and 1m of 100mm pipework at a depth no greater than 1.0m through block paving. Install 1m of 100mm liner directly downstream of excavation.</p> <p>Line 4 Excavate and replace the RWP1 restbend and 3m of 100mm pipework at a depth no greater than 1.0m through block paving.</p> <p>Auger have not allowed or will not be held responsible for any alteration or modification to the above ground drainage following the removal of the existing gully and reinstatement of a new gully. The customer must ensure that the above ground drainage correctly expels into the gully pot and avoids overcrowding the gully with numerous downpipes which could lead to the gully overflowing.</p> <p>During the clean-up/reinstatement process we will endeavour to leave the area we are working in clean and tidy and as close to how we found it as possible. There will always be an element of general debris/mud/waste that will build up in the area which cannot be prevented. There may however be elements of this process that are outside our remit i.e., Repainting or cleaning. If this is the case, then we will need to speak to the customer's insurer to help in this regard.</p> <p>We will now refer the claim back to the client in order to progress the claim.</p>

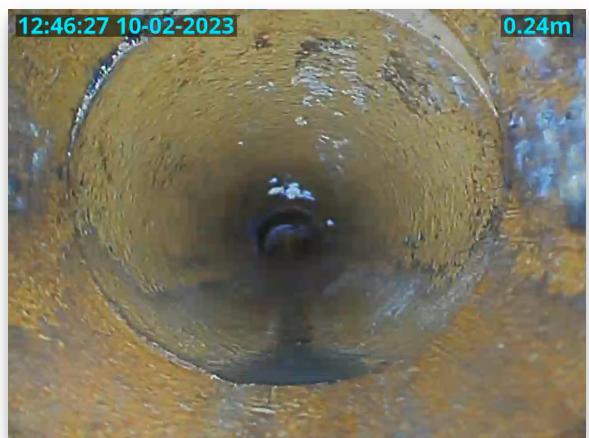
Our survey of line 2 revealed root ingress at 1m and 3.8m and joint displacements at 1.5m, 2m 2.5m and 3m.

Fig 2.2: Line 2 Displacement

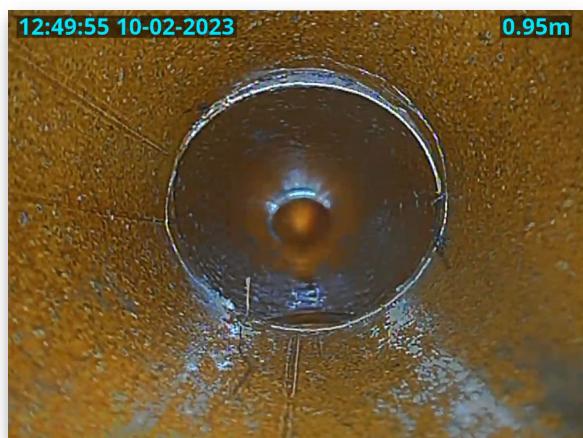
Our survey of line 3 revealed joint displacements at 2m and cracking at 1m.

Fig 2.3: Line 3 Cracking

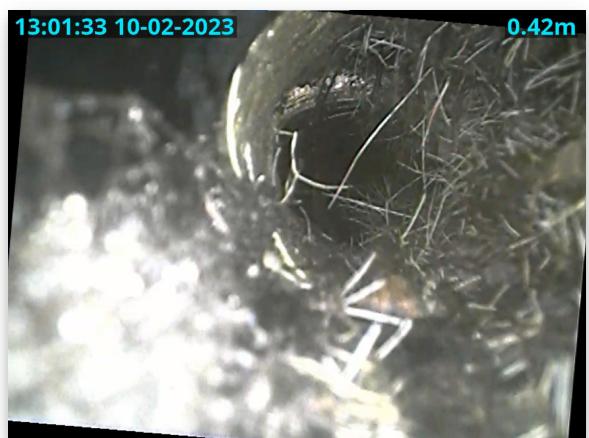
Our survey of line 4 revealed root ingress through the pipe.

Fig 2.4: Line 4 Roots
